Executive Summary 2018

This report represents a brief discussion on several research projects conducted by or with Parjana® Distribution in collaboration with various government, private, and educational entities to validate the efficacy of the Parjana® Energy-passive Groundwater Recharge Product (EGRP®) system. These individual research projects generated experimental data documenting how the EGRP® system performs in various applications. The overall aim of conducting these research projects is to determine the efficacy of the EGRP® system in eliminating standing surface water without disturbing ecological balance. There are seven independent research projects that have been conducted to date that are summarized in this report (Table 1). Overall, findings of these research reports suggest that the EGRP® system successfully reduces standing surface water, significantly increases surface infiltration and does not have an adverse effect on groundwater quality. Additional information and reports to supplement this summary are available upon request.

Summary List of Research Investigations and Goals

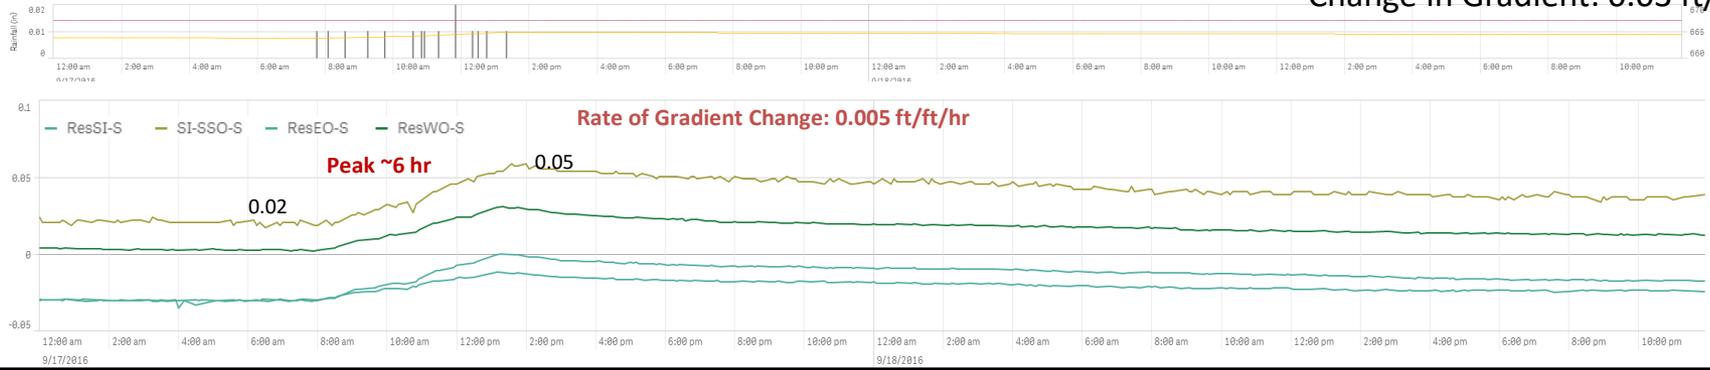
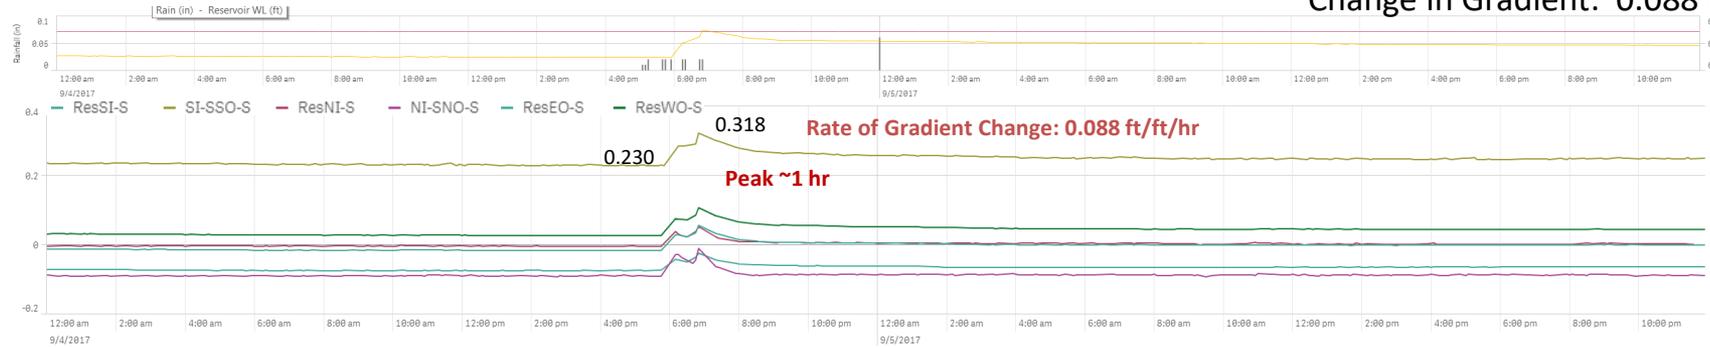
Figure 1: Data Set 1 - Horizontal Hydraulic Gradients - Short Term

Sept. 17, 2016 vs Sept. 4, 2017

Total Precip: 0.21 in/8 hr
Change in Gradient: 0.03 ft/ft

Total Precip: 0.51 in/6 hr
Change in Gradient: 0.088 ft/ft

ResSI-S = Gradient between Reservoir and South Inside Shallow wells
SI-SSO-S = Horizontal Hydraulic Gradient between South Inside and Outside shallow wells
Applies for N, E, and W

A preliminary, 3rd party evaluation of the impact of the EGRP[®] on groundwater elevation and recovery time at the Lawrence Technological University site was conducted and compiled by Drummond Carpenter, PLLC. Specific findings were:

- Magnitude of change in groundwater elevation was greater during storm events in 2017 vs. 2016
- Groundwater elevations increased more rapidly during storm events in 2017 vs. 2016
- Groundwater levels recover to baseline elevations faster in 2017 vs. 2016
- Horizontal hydraulic gradients measured in the wells increased more rapidly during rain events in 2017 vs. 2016

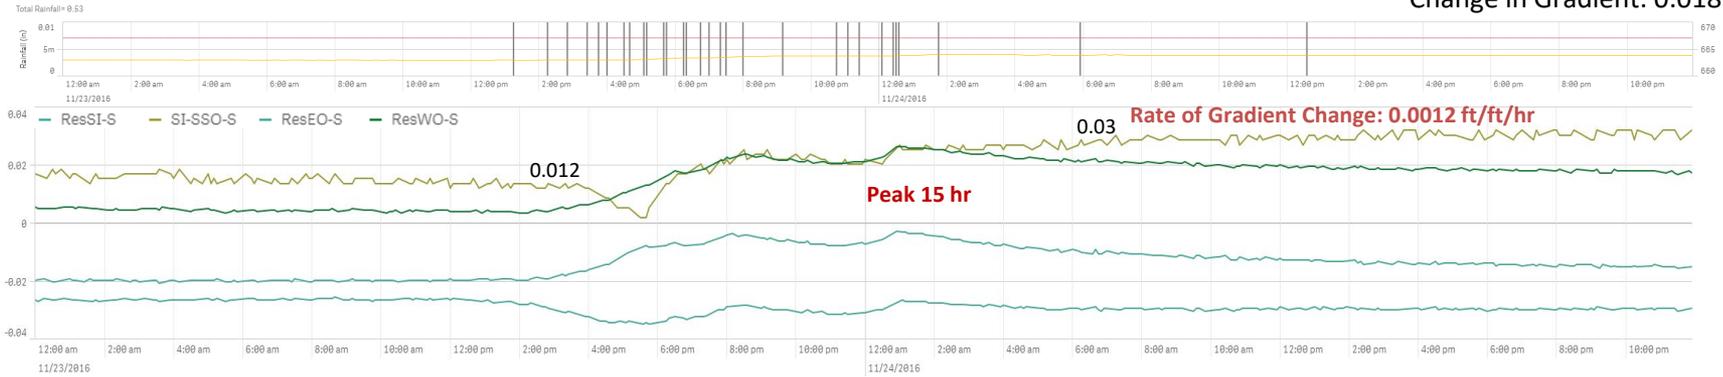
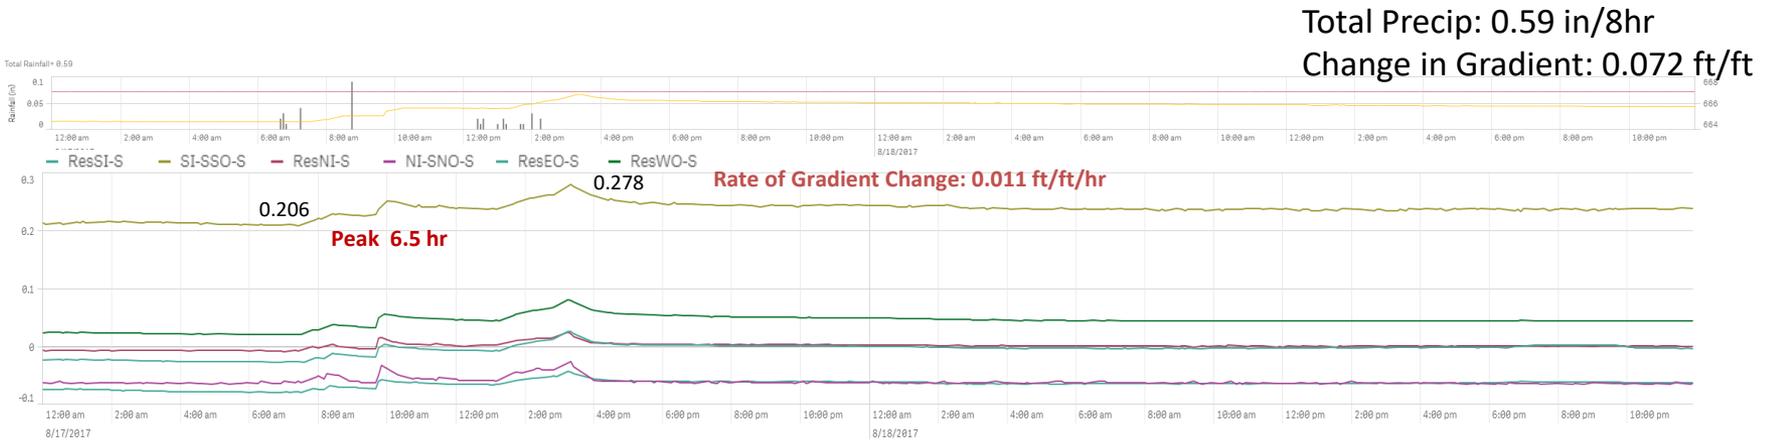
Figure 2: Data Set 2 - Horizontal Hydraulic Gradients - Short Term

Nov. 23, 2016 vs Aug. 17, 2017

Total Precip: 0.51 in/13hr
Change in Gradient: 0.018 ft/ft

ResSI-S = Gradient between Reservoir and South Inside Shallow wells
 SI-SSO-S = Horizontal Hydraulic Gradient between South Inside and Outside shallow wells
 Applies for N, E, and W

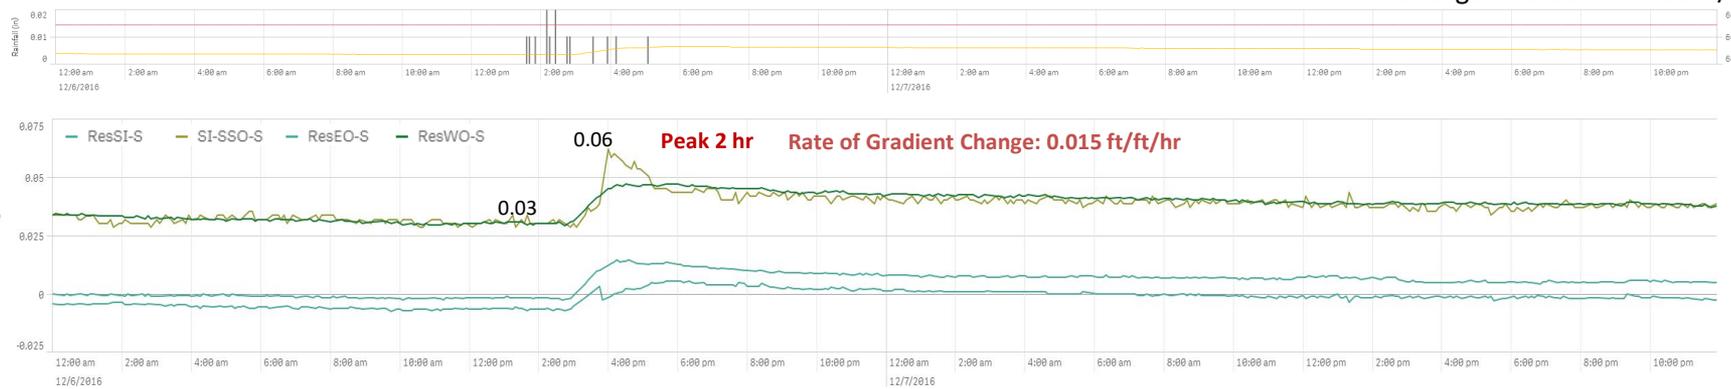
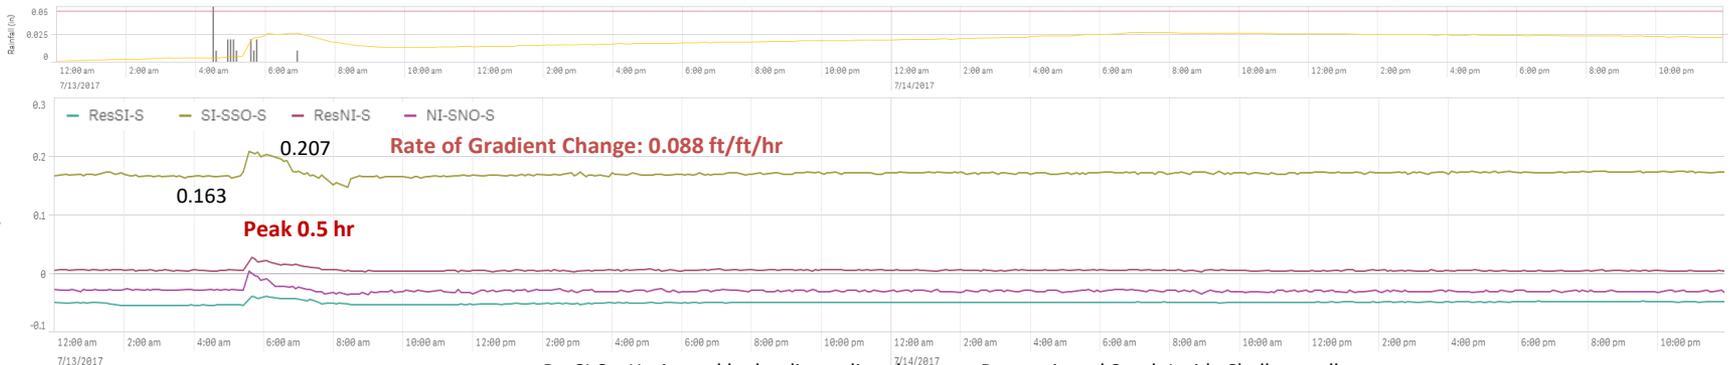
Figure 3: Data Set 3 - Horizontal Hydraulic Gradients - Short Term

Dec. 6, 2016 vs Jul. 13, 2017

Total Precip: 0.21 in/3hr
Change in Gradient: 0.03 ft/ft

Total Precip: 0.30 in/3hr
Change in Gradient: 0.044 ft/ft

ResSI-S = Horizontal hydraulic gradient between Reservoir and South Inside Shallow wells
SI-SSO-S = Horizontal hydraulic gradient between South Inside and Outside shallow wells
Applies for N

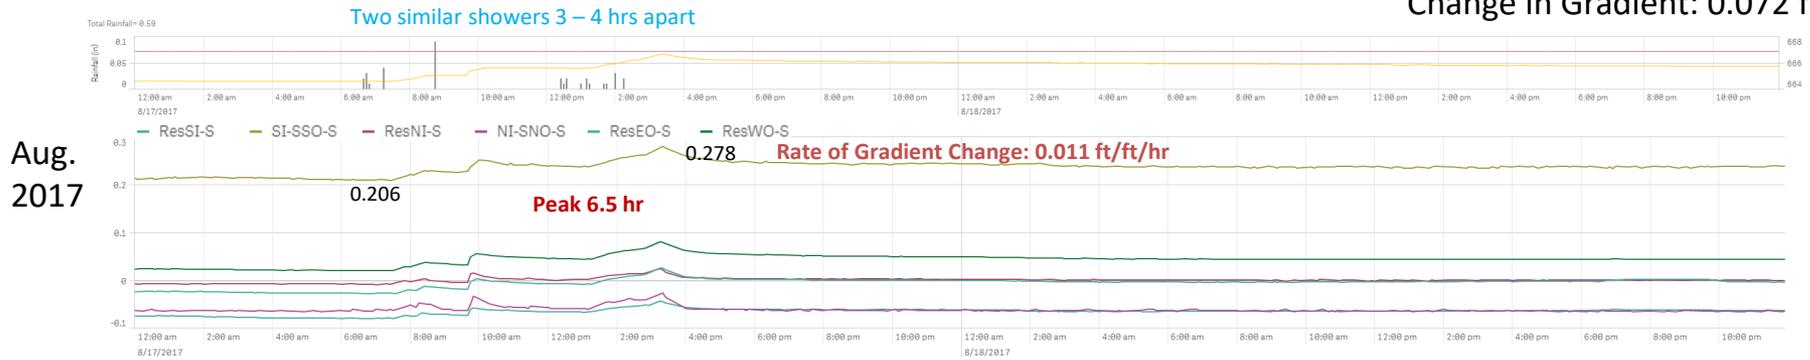
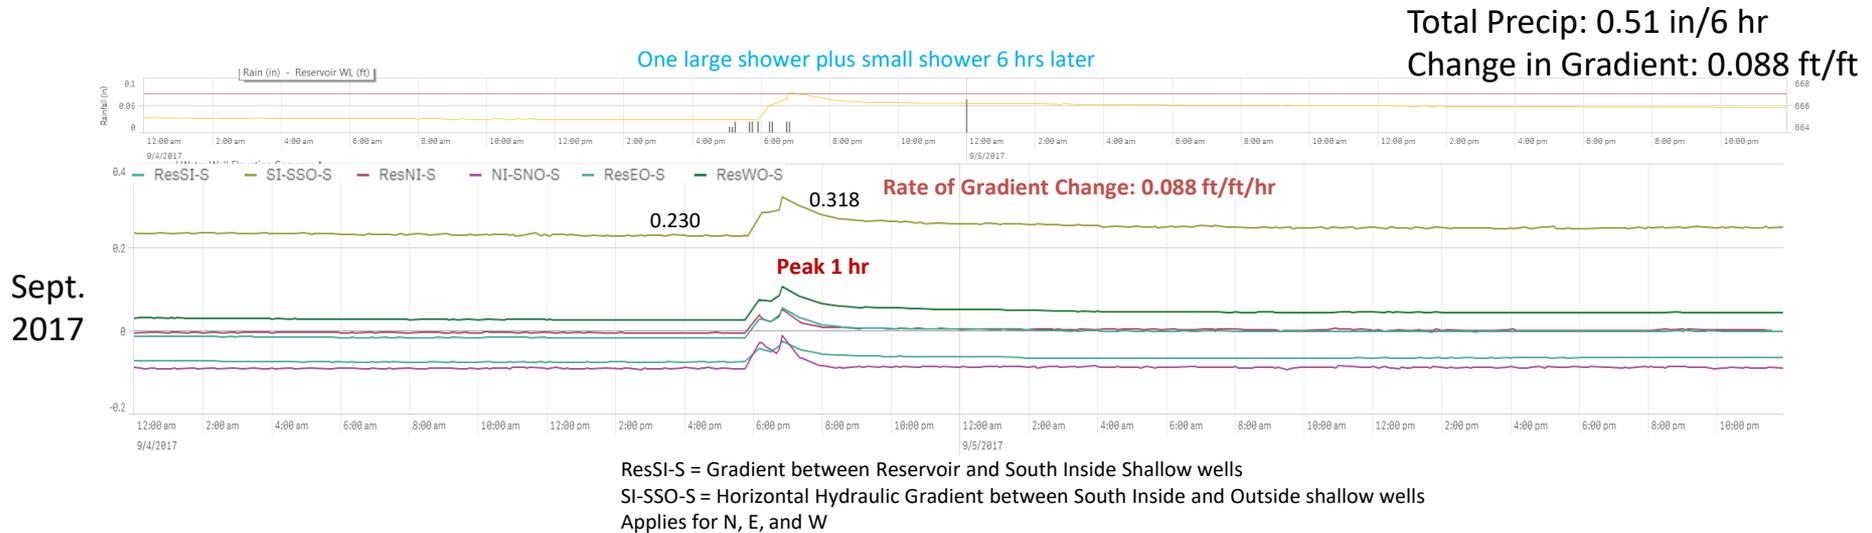
Figure 4: Data Set 4 - Horizontal Hydraulic Gradients - Short Term

Aug. 17, 2017 vs Sept. 4, 2017

Total Precip: 0.59 in/8hr
Change in Gradient: 0.072 ft/ft

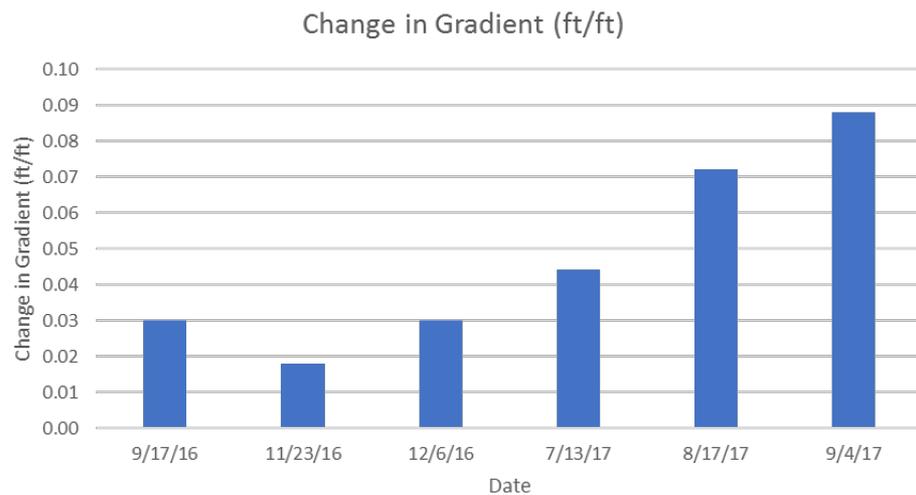
Figure 5: Change in hydraulic gradient (ft/ft) per date.

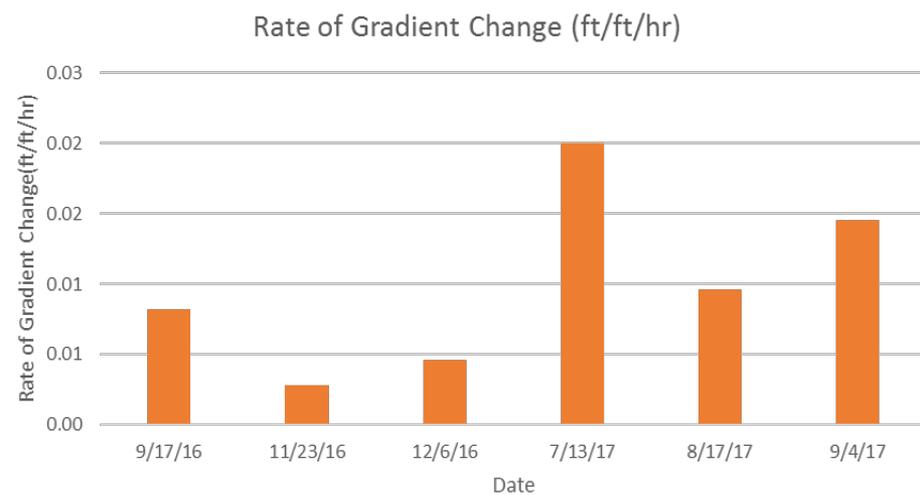
Figure 6: Rate of change in hydraulic gradient (ft/ft/hr) per date.

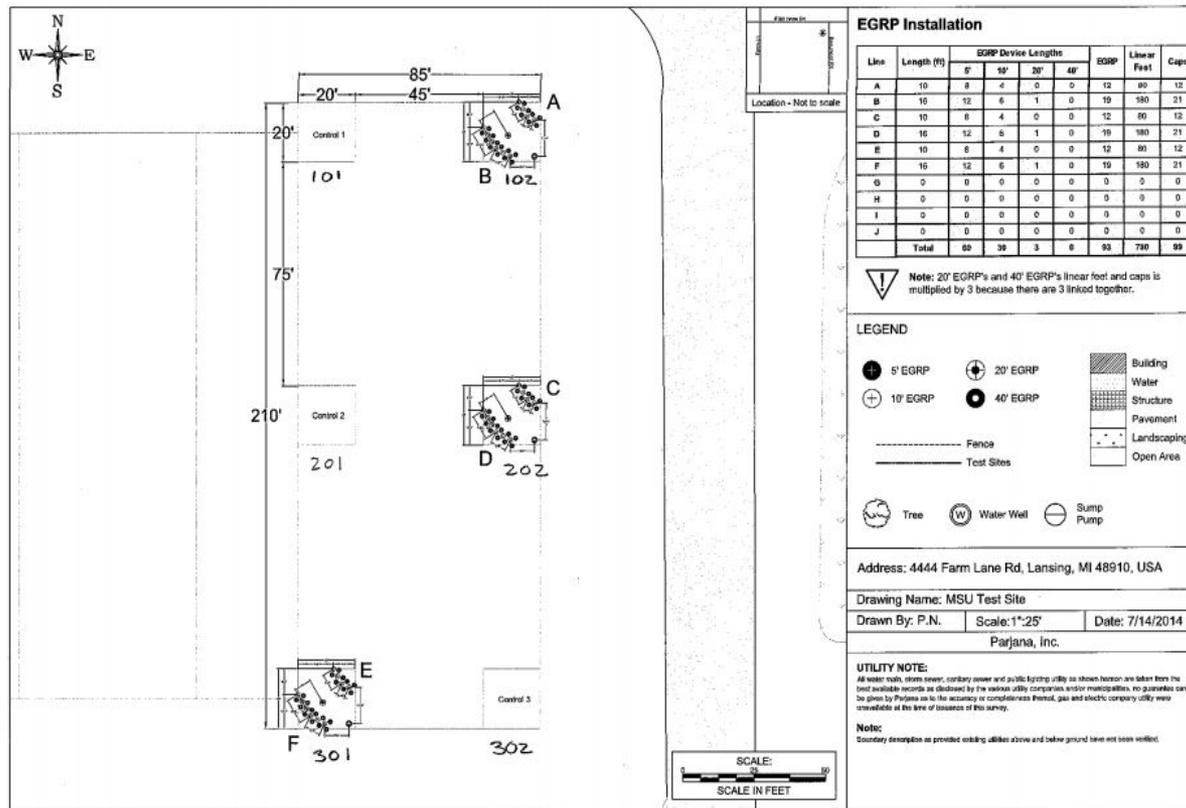
Figure 8: Site layout of the EGRP® installation at the Hancock Turfgrass Research Center.

The study is comprised of three replications of two treatments (Figure 8), which include: 20' x 20' plots with the EGRP® system installed and 20' x 20' plots with no drainage installed. Each 20' x 20' treatment plot replication is separated by 45' east to west and 75' north to south to minimize the effects, if any, of the sphere of influence the EGRP® system may have on drainage in a check plot. Toro Turf Guard sensors were placed in each plot as follows. A line was made with twine between the NW and the SE corners of each plot. Sensors were placed 7 feet into the plot from the SE corner marker on that diagonal line (Figure 4). The top of the sensors were buried at a 4-inch depth below the soil surface which means the Turf Guard sensors probes are approximately 5 inches and 10 inches from the soil surface. Turf Guard sensors measure and record the volumetric moisture content (VMC) on 5-minute intervals 24 hours per day.

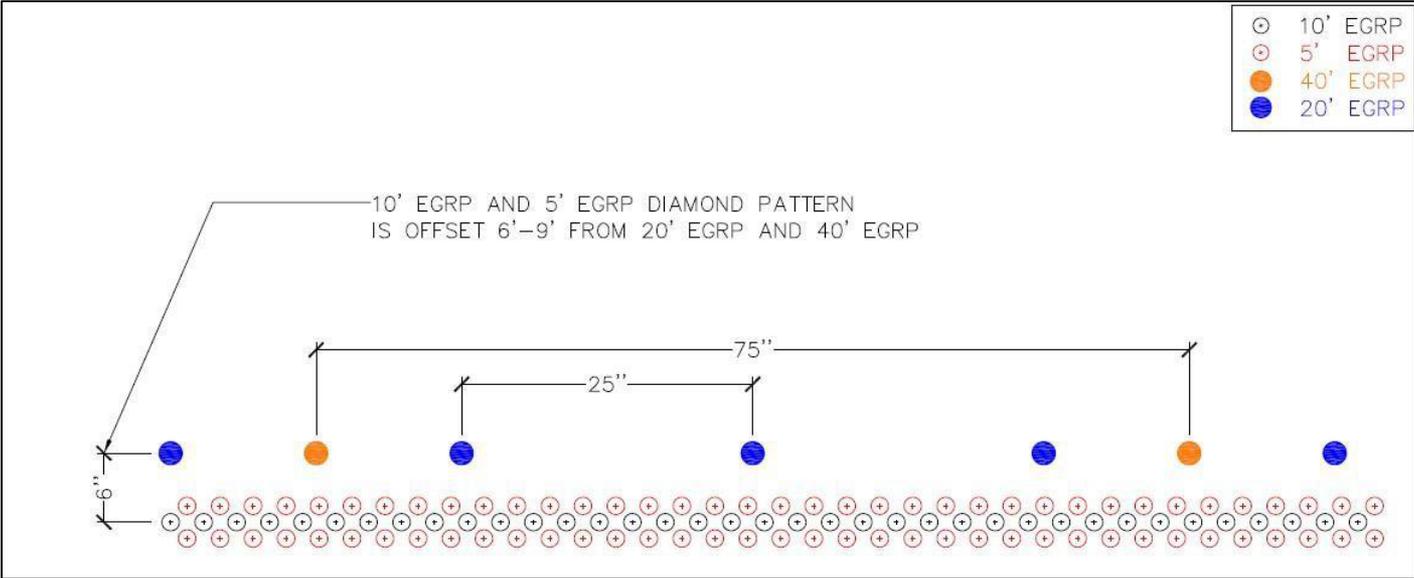
Figure 10: Configuration of EGRP® diamond pattern

Installation on Belle Isle consisted of eleven lines of diamond pattern EGRP® (Figure 10). The location of the EGRP® lines can be seen in Figure 3 along with the overall study design information. Belle Isle consists predominantly of interbedded sands and silty clays to a depth of approximately 20 feet. The potentiometric surface varied from 0.5 to 6 feet below the surface depending on rainfall and piezometric well location (ECT 2016).

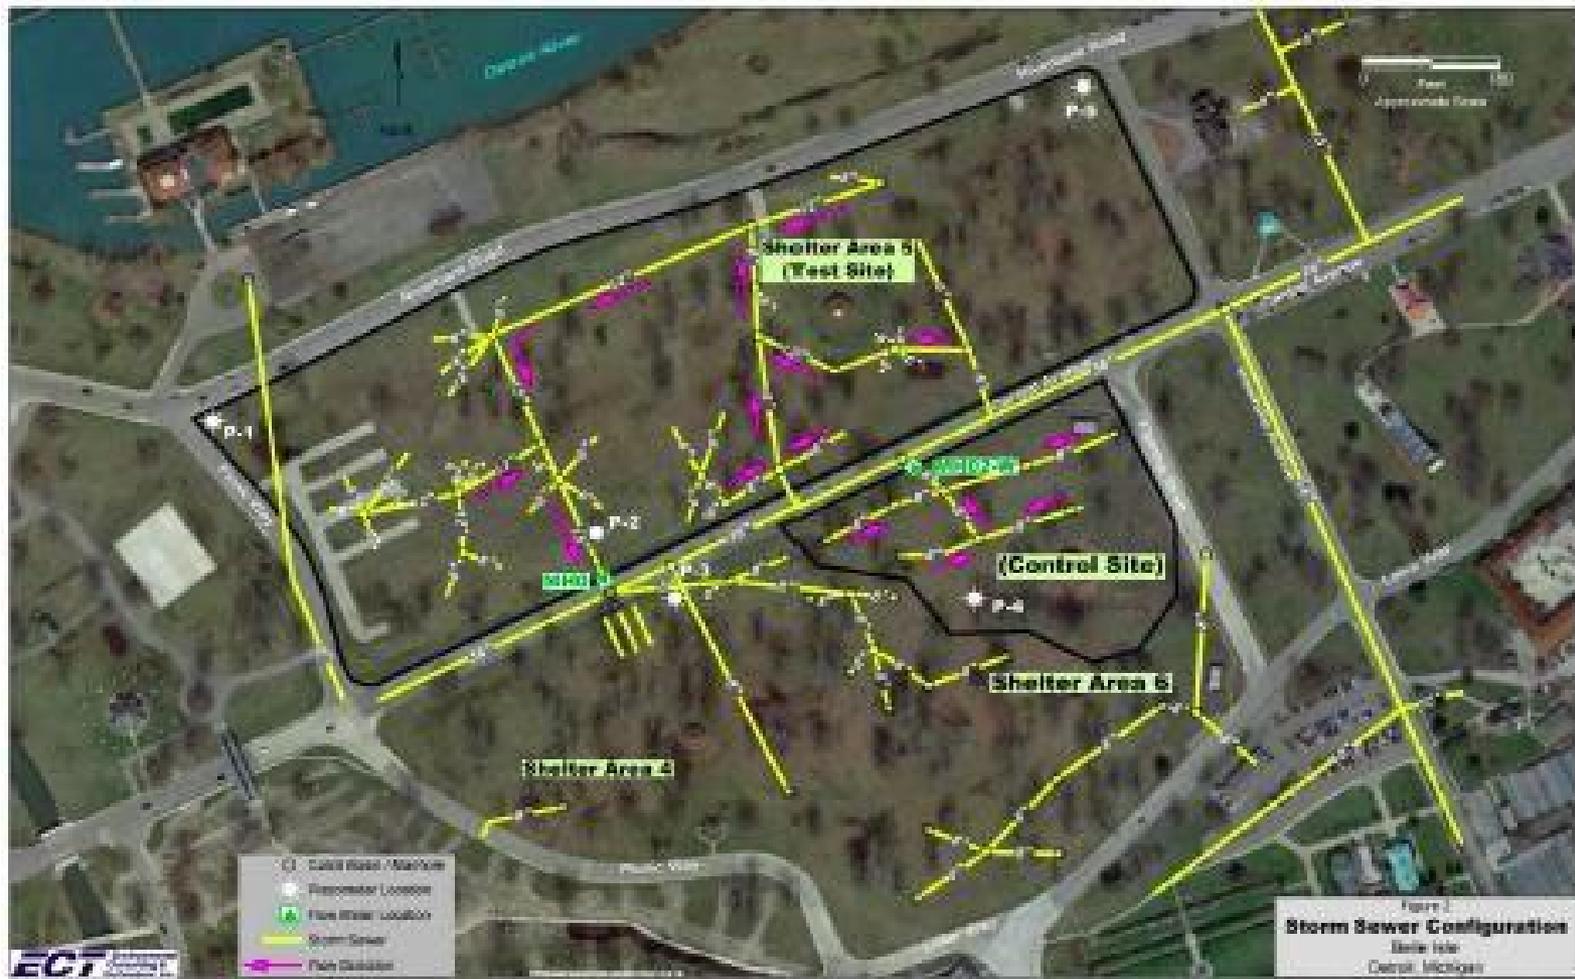
Figure 11: Locations of grey infrastructure and flow direction on Belle Isle (ECT 2016).

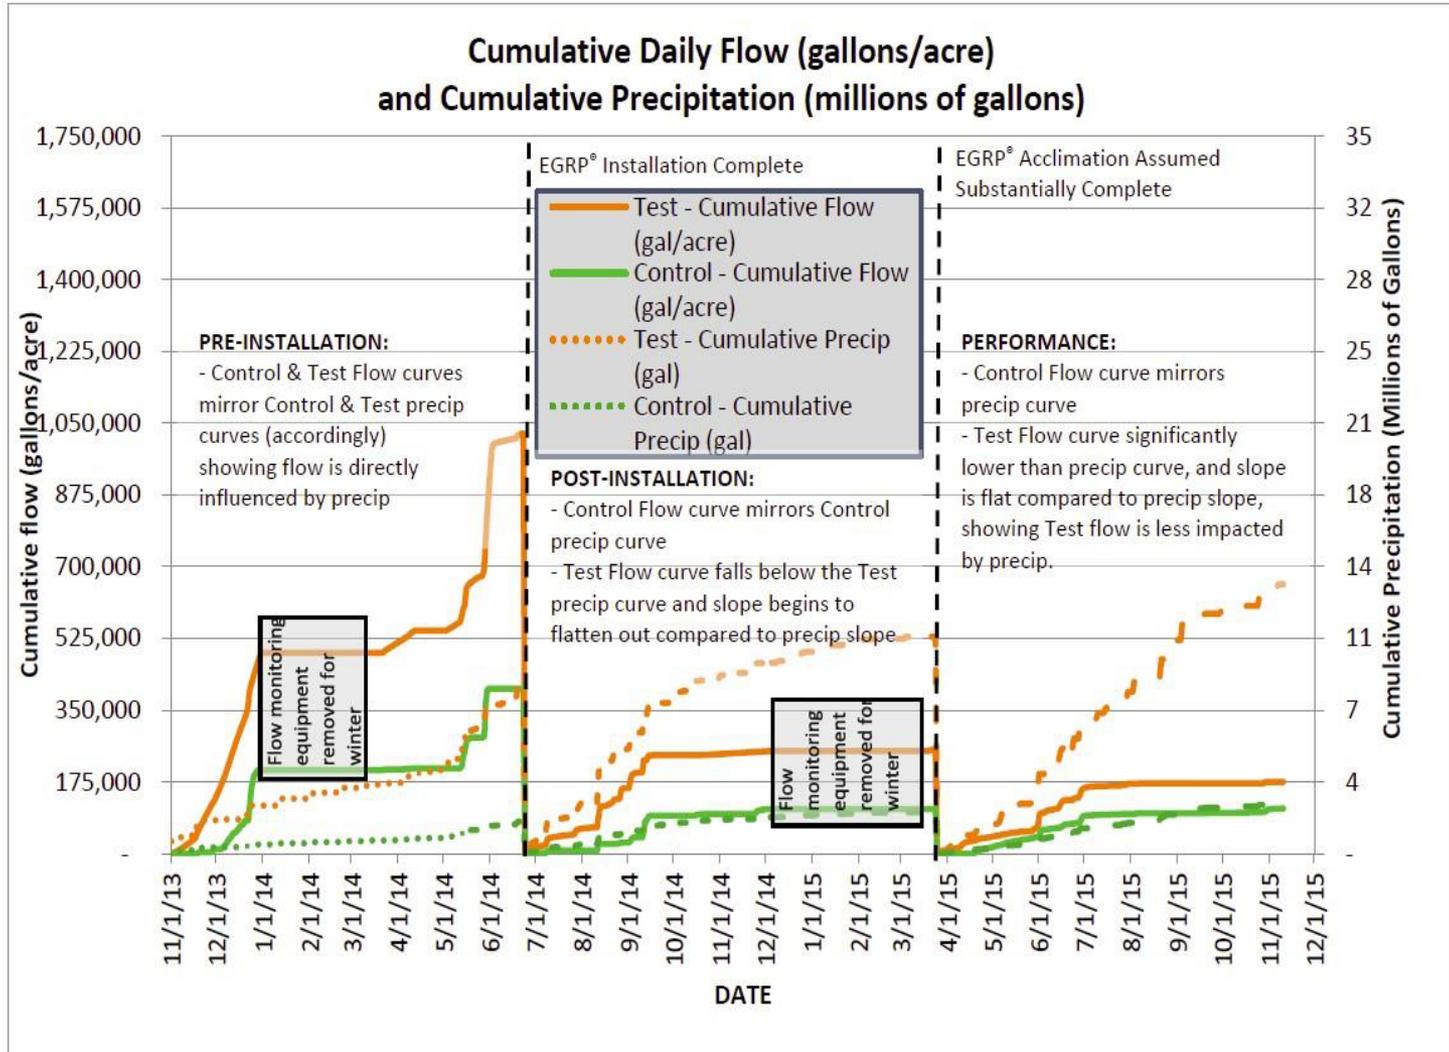
Figure 12: Cumulative daily flow and precipitation during study investigation (ECT 2016).

Figure 12 and 13 represent total cumulative in-pipe flow from test site before and after installation. Both figures are separated into three distinct time periods (Pre-Installation, Post-Installation, and Performance) with the cumulative flow and precipitation initialized to zero at the beginning of each time period for ease of interpretation. These figures graphically depict the main findings of the investigation which include (ECT2016):

- Prior to installation, the amount of runoff volume was nearly double the amount of rainfall volume due to the pipe network capturing water from a larger area of the island and possibly influenced by the Detroit River.
- After installation, the runoff volume is much less than rainfall volume.
- The rainfall has less direct impact on the amount of runoff from the site when comparing control site versus test site.
- There was an 80% reduction in the total amount of runoff volume from the test site.

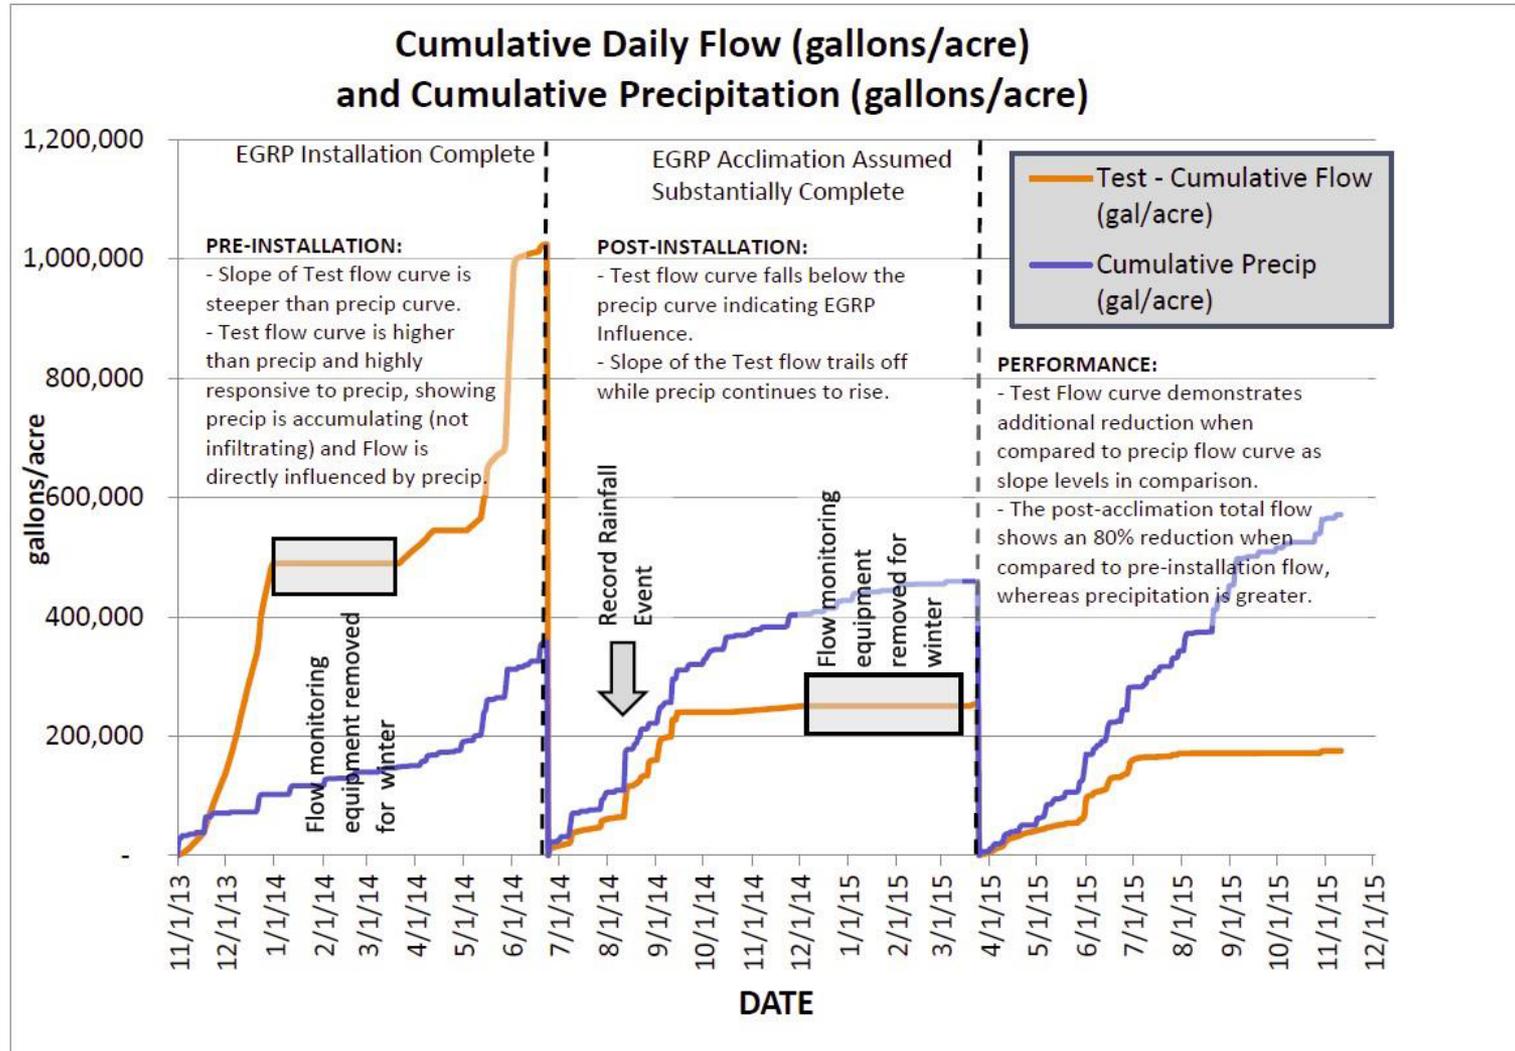
Figure 13: Cumulative daily flow and precipitation for test site during study investigation (ECT 2016).

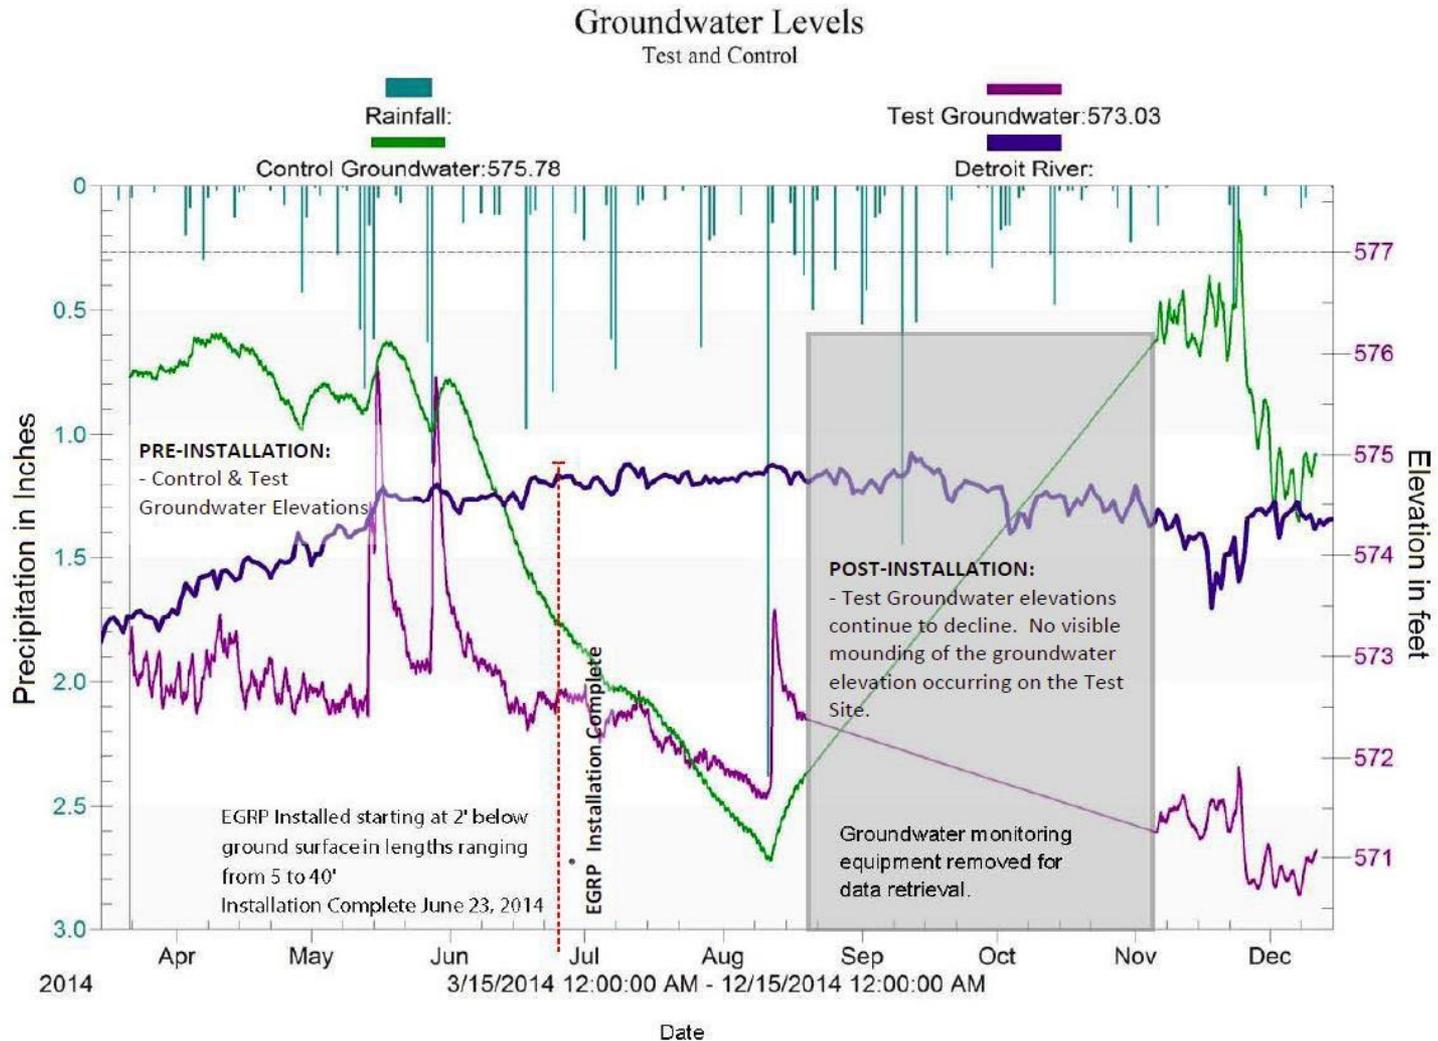
Figure 14: Groundwater and Detroit River water levels during investigation (ECT 2016)

In addition to in-pipe flow monitoring, groundwater elevation monitoring was conducted in 10-minute intervals at five monitoring well locations (Figure 14). Results suggest no effect on the local groundwater elevation related to the presence of EGRP®s with groundwater elevation fluctuating similarly in response to rain events on both the test and control sites (ECT 2016). Finally, on October 10, 2014 groundwater was collected from locations both in the control and test sites and measured for total phosphorus, chloride, total dissolved solids, and E. coli and there was no discernable difference between the two locations (ECT 2016). While no definitive conclusions can be made from a single data point, it is encouraging that there was no measured detrimental effects to groundwater quality post installation.

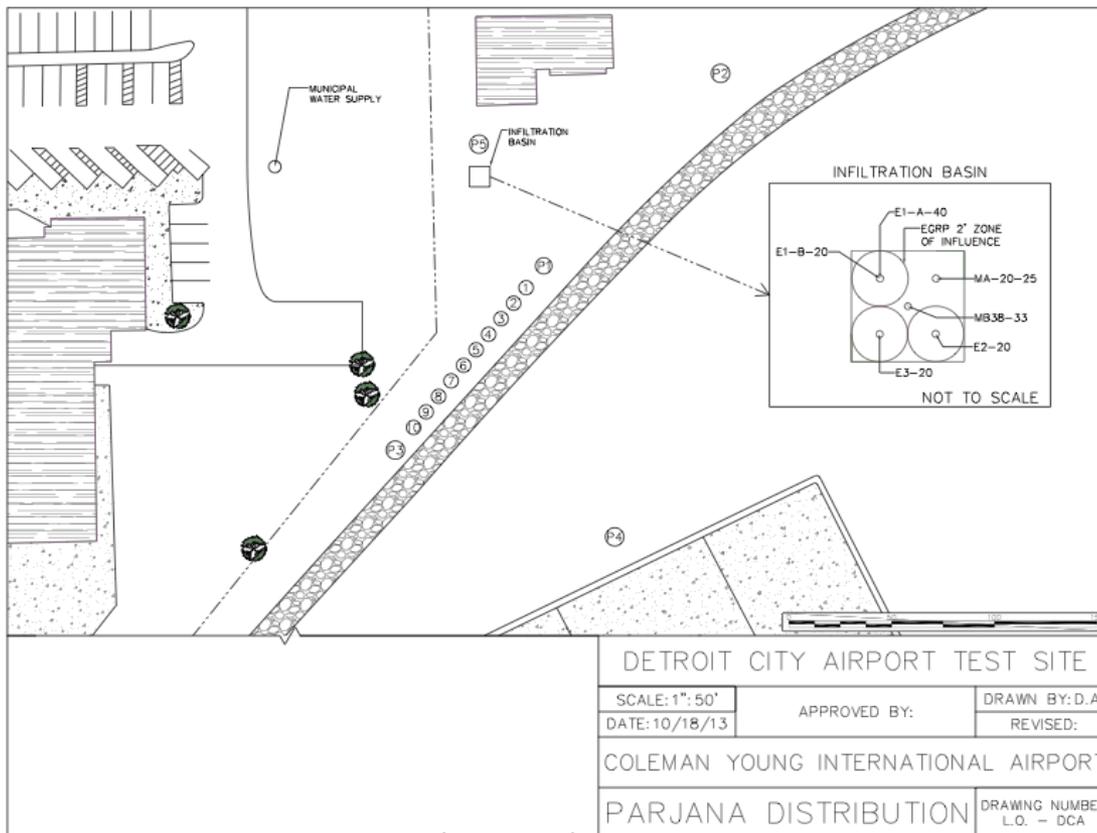
Figure 15: Site Layout for Coleman A. Young Infiltration Study

This test site is located in the south west corner of the Coleman A. Young International Airport in Detroit, Michigan (Figure 15). This project was developed to address to the concerns of the Michigan Department of Environmental Quality (MDEQ) in regards to the EGRP® system's influence on the infiltration of surface water and its potential to accelerate surface water contaminates into the groundwater supply. The project was under the supervision of the MDEQ and conducted by Dr. David Lusch from Michigan State University (MSU) with consultation from Dr. Donald Carpenter from Lawrence Technological University (LTU). The testing involved the launching of a bromide slug into an infiltration pond where EGRP®s were installed. After the slug was launched a continuous water level of 6" was kept on the pond to simulate a "worst case" scenario of long-term ponding of storm water runoff.

Table 4: Description of Monitoring Wells and EGRP®s show prior in Figure 15.

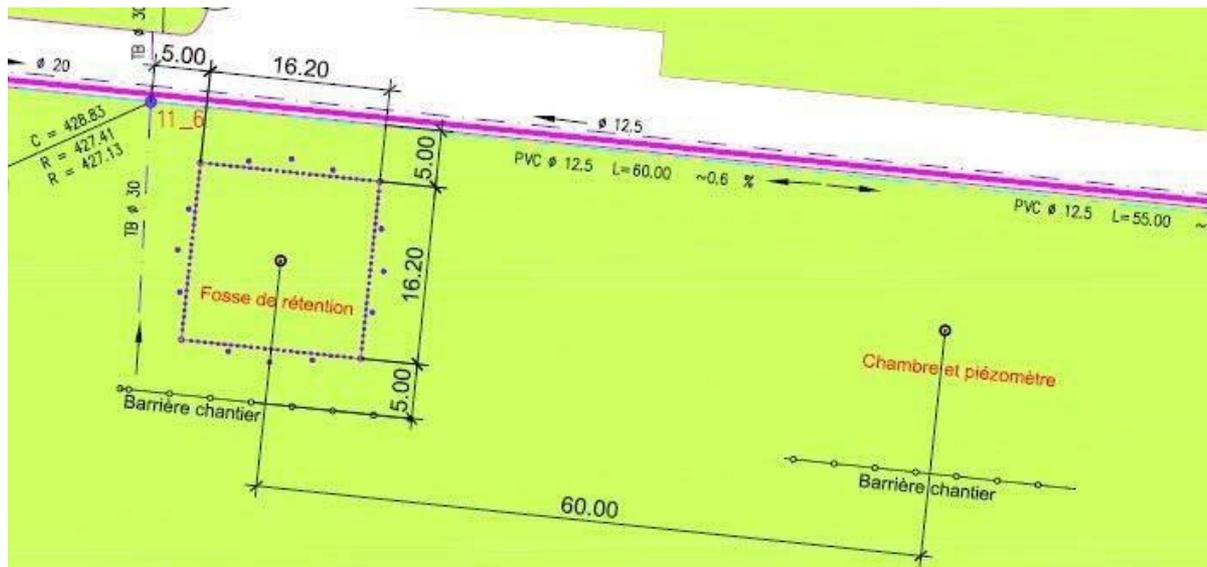
Figure 17: Test study layout adjacent to taxiway at GIA (GADZ 2014).

Geotechnique Appliquee Deriaz SA (GADZ) compared piezometric water levels between two different zones - one with and one without the EGRP® (Figure 17 and 18). The top soil layers were primarily silt and silty fine sands and were found to have low permeability. The deeper soil layer consisted of a well stratified preconsolidated sandy loam (glacial Moraine) with higher vertical permeability and significantly higher horizontal permeability (10 to 100 times greater) (PCS 2014). The 40 ft deep EGRP® installations on the four corners, and some of the shallower EGRP® installations, penetrate the deeper Moraine soils (Figure 10) (GADZ 2014).

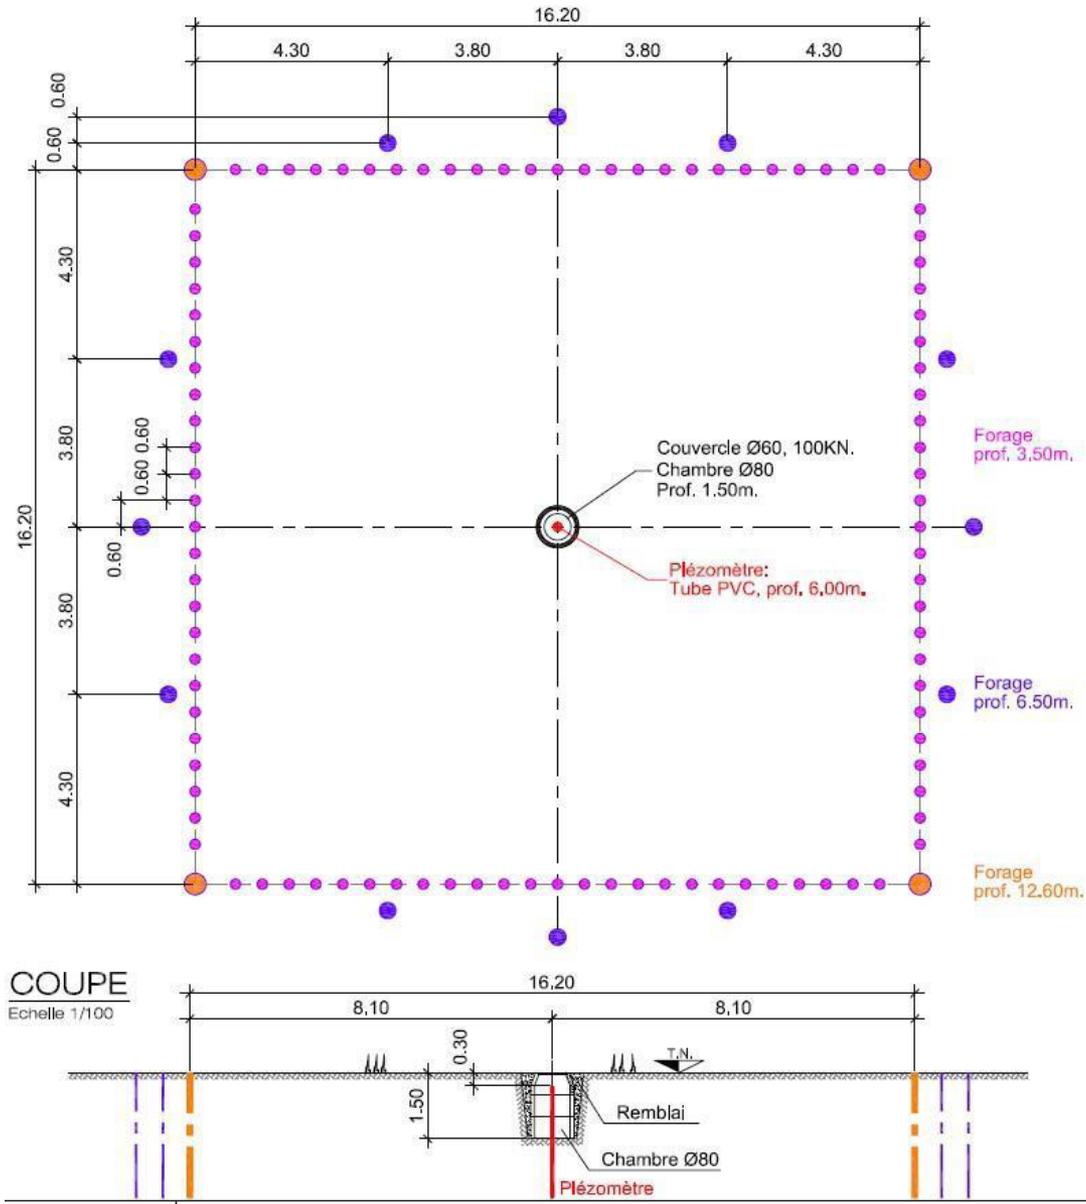
Figure 18: Layout of EGRP® system at GIA (GADZ 2014).

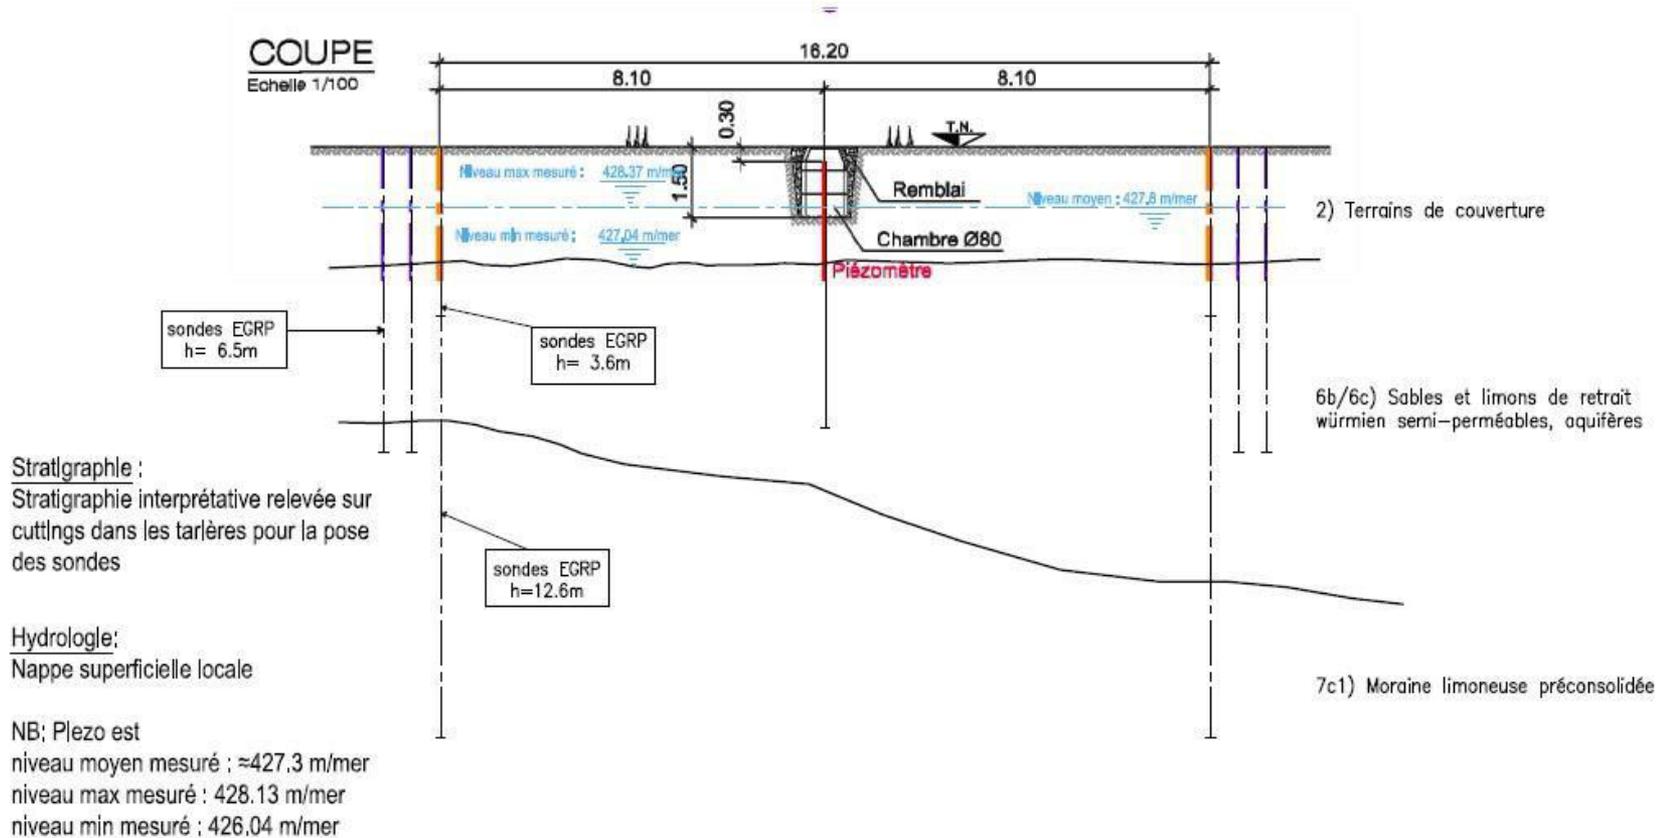
Figure 19: Cross-section of EGRP® installation through stratified soils (GADZ 2014).

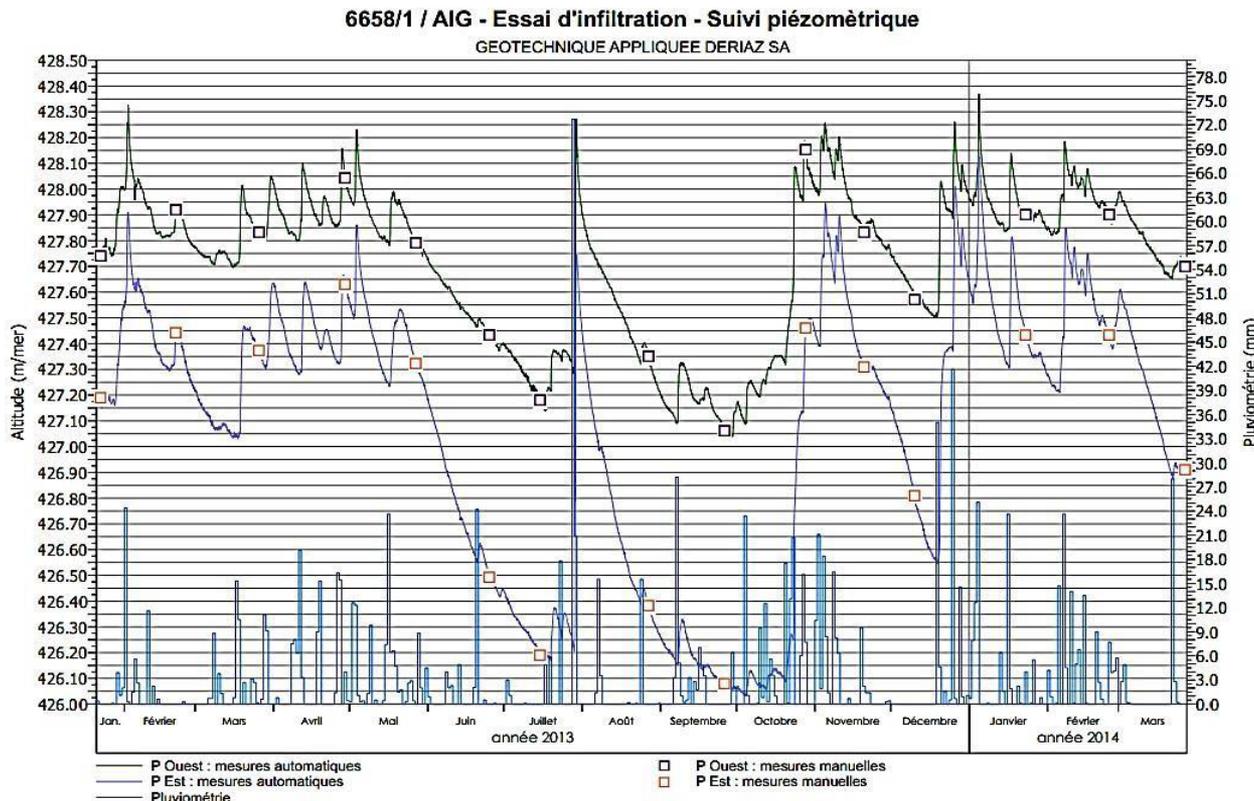
Figure 20: Comparison plot of variation of groundwater levels along with rainfall over period of time at the locations with and without EGRP®, installed at Geneva airport (GADZ 2014)¹.

¹Original figure in French – groundwater elevation is on left axis and rainfall on right axis

Initial results (PCS 2014) concluded that the level of water table reacts immediately in both zones during "extended" (over 24 consecutive hours) and "intense" (over 0.4 inch) rainfall periods. However, the impact of those rainfall events on increasing the water table level is clearly less in the EGRP® zone (average of 73% less). Likewise the lowering of the water table level after a rainfall event is often clearly less in the EGRP® zone. An example of this is visible in Figure 20 which presents the results of three months of testing (January to March) (GADZ 2014). The report also indicated the water table was higher in the area of the EGRP® system during dry periods. GADZ attributed this to the fact the EGRP® “worked to maintain a degree of saturation as constant as possible in the soil” and the EGRP® system is moving water vertically in both directions thereby creating communication between the surficial layers of topsoil and the permeable to semi- permeable soils beneath (PCS 2014).
