Executive Summary 2018

This report represents a brief discussion on several research projects conducted by or with Parjana® Distribution in collaboration with various government, private, and educational entities to validate the efficacy of the Parjana® Energy-passive Groundwater Recharge Product (EGRP®) system. These individual research projects generated experimental data documenting how the EGRP® system performs in various applications. The overall aim of conducting these research projects is to determine the efficacy of the EGRP® system in eliminating standing surface water without disturbing ecological balance. There are seven independent research projects that have been conducted to date that are summarized in this report (Table 1). Overall, findings of these research reports suggest that the EGRP® system successfully reduces standing surface water, significantly increases surface infiltration and does not have an adverse effect on groundwater quality. Additional information and reports to supplement this summary are available upon request.

Summary List of Research Investigations and Goals

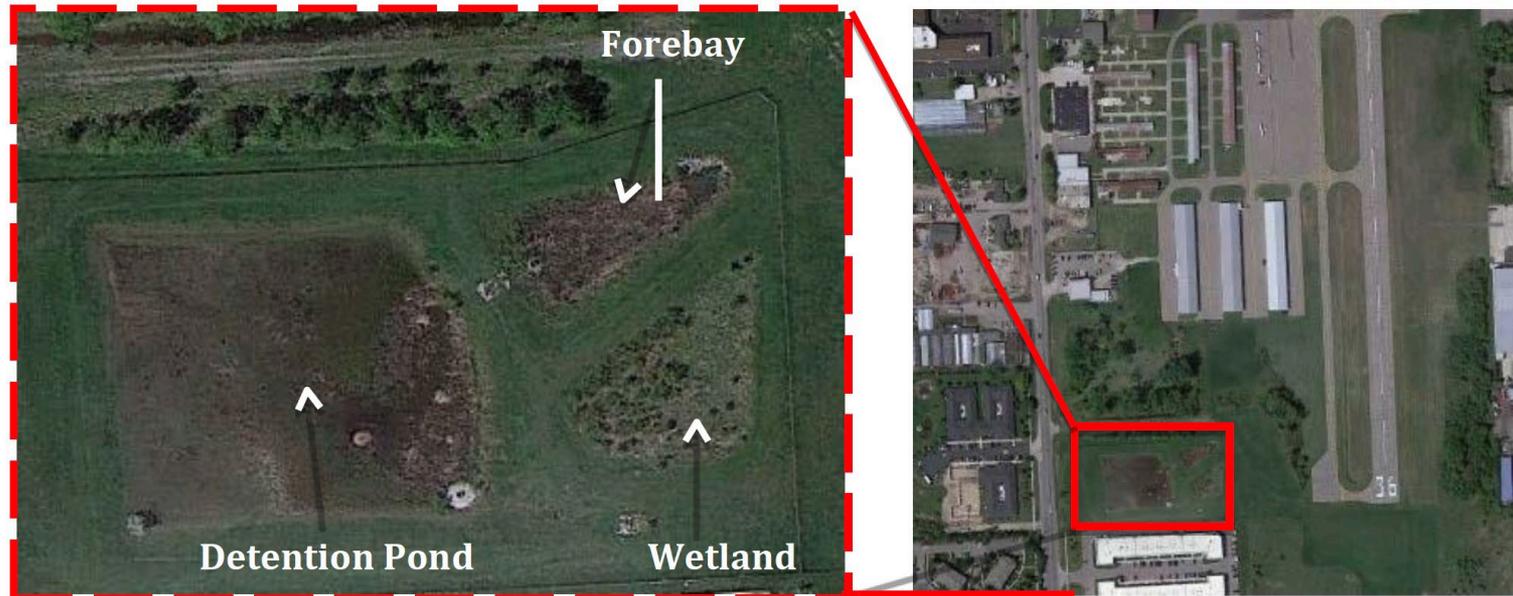
Figure 21: Geographical location and layout of Mettetal airport showing position of installed EGRP® System.

The site is located in the south-west corner of the Mettetal Airport in Canton, Michigan. Figure 21 shows the geographical location of the testing site in relation to the rest of the airport property and the layout of EGRP® installed around forebay. The test site consisted of an initial forebay where water flows and infiltrates into the larger detention pond. The forebay was originally designed for a 1-inch rain event. When there is a rain event above 1-inch or multiple rain events in a row, the water overflows and is released into the detention pond without filtration. Prior to the installation, the forebay did not adequately drain.

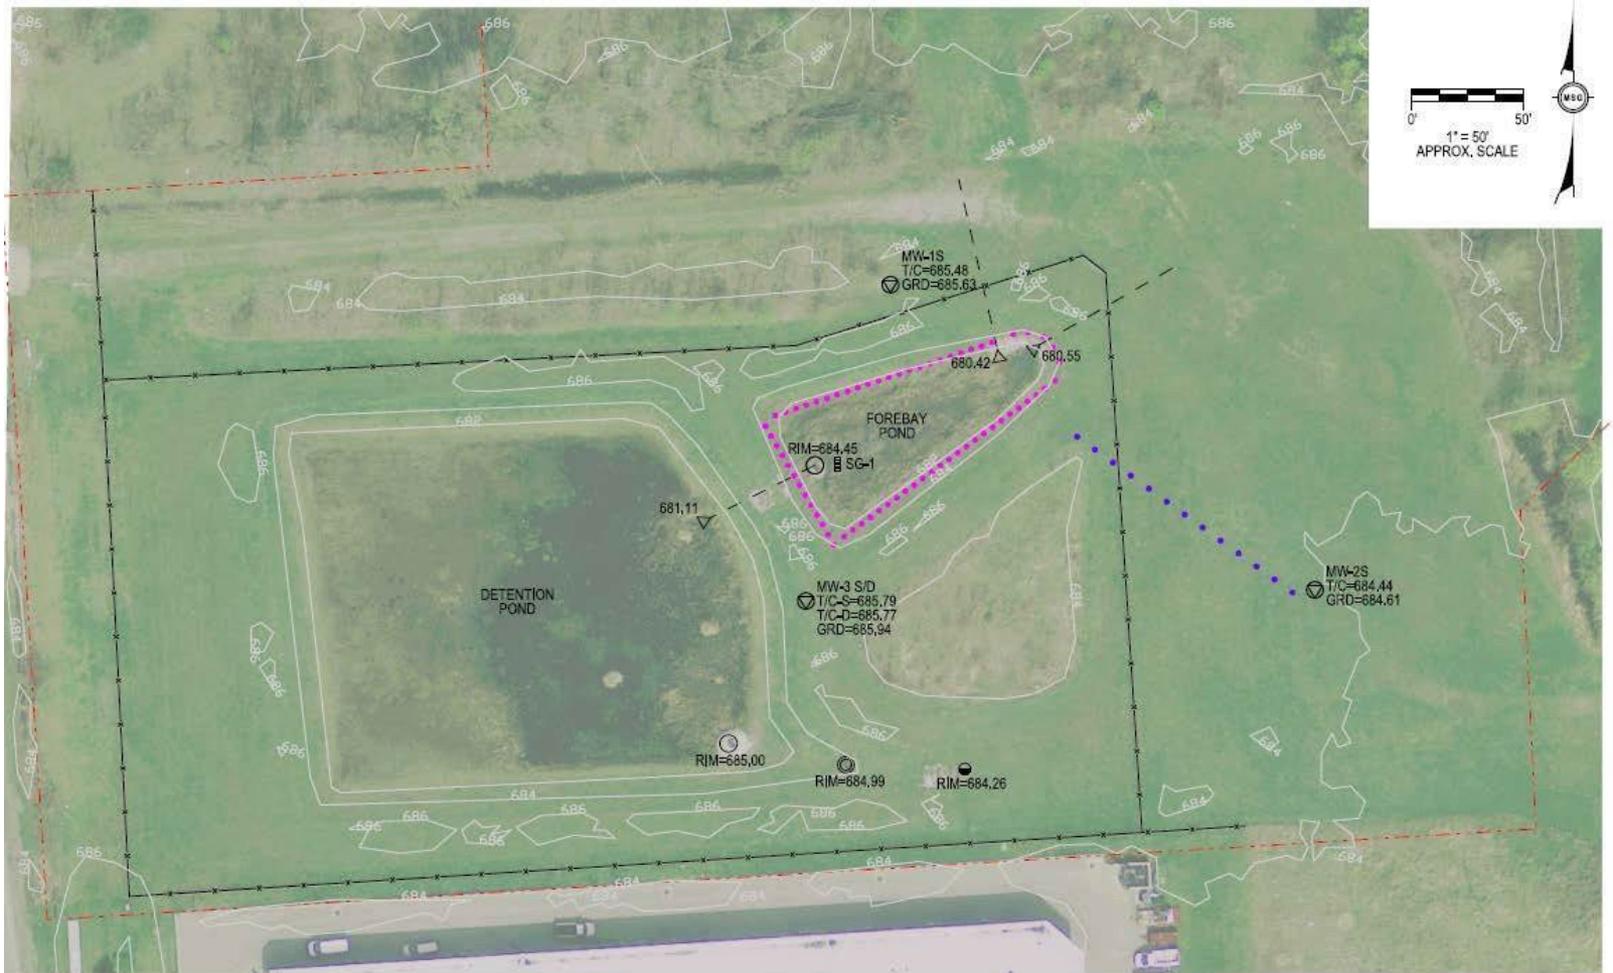
NOTE: EGRP LAYOUT WAS ADAPTED BASED ON DESIGN DRAWING PROVIDED BY PARJANA DISTRIBUTION, DATED 9/9/13.

Figure 22: Layout of EGRP® system installed and location of monitoring wells (MSG 2015).

The testing was conducted by Mannik & Smith Group, Inc. (MSG 2015). The investigation included tracking water levels in the sediment forebay and four close proximity monitoring wells. The purpose of the investigation was to determine if the EGRP® system would reduce surface water in the forebay and eliminate water within 72 hours following a 1" rain event.

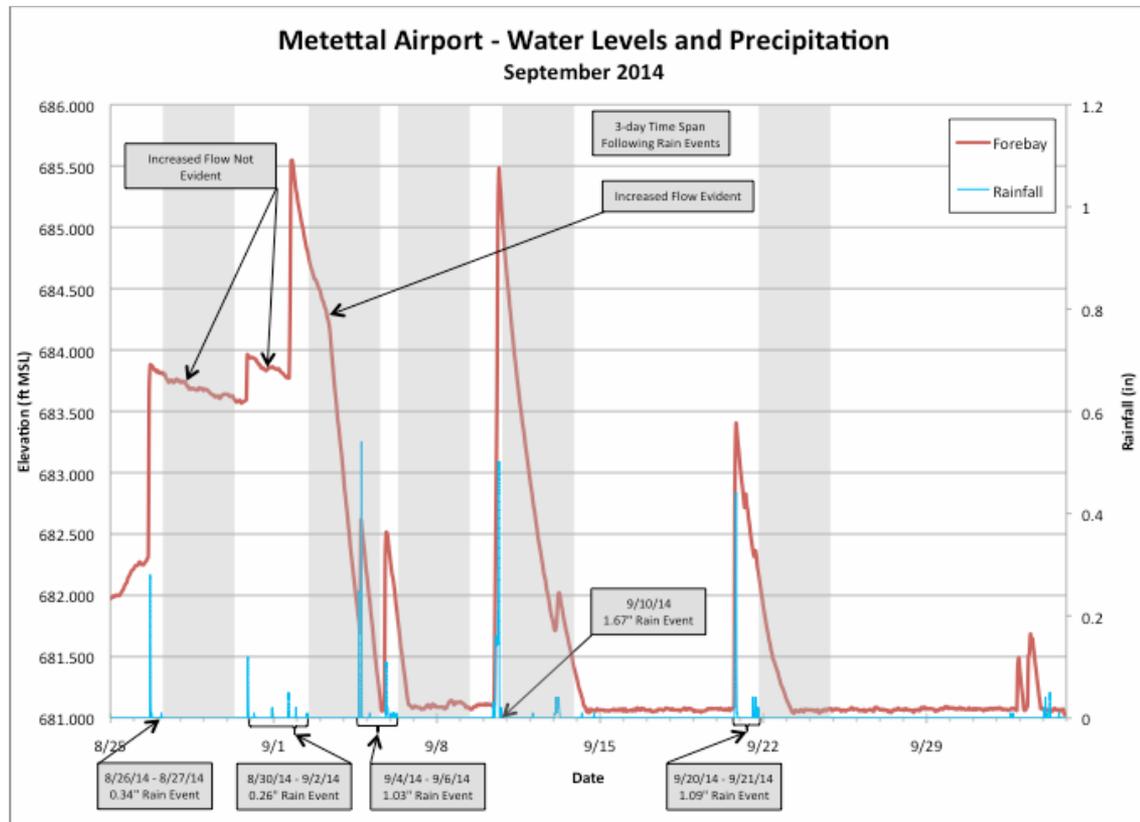
Figure 23: Metttal Airport water levels in response to precipitation (MSG 2015).

Figure 23 shows the water level decreasing to previous levels less than 72 hours after a 1" rainfall, which was the goal of the EGRP® system for this project. However, lack of pre- installation data and inconsistencies in variables during the course of the investigation means that MSG is unable to confirm the influence of the EGRP® system on improving infiltration (MSG 2015). MSG did determine that water levels in the shallow monitoring wells mimic the water levels in the forebay closely and are shown to be influenced by rainfall events almost immediately. This indicates good hydrologic connection between the forebay and shallow monitoring wells. Water levels in the deep monitoring well (located in underlying class soils) do not exhibit the same fluctuations and there appears to be no significant hydrologic connection. (MSG 2015).

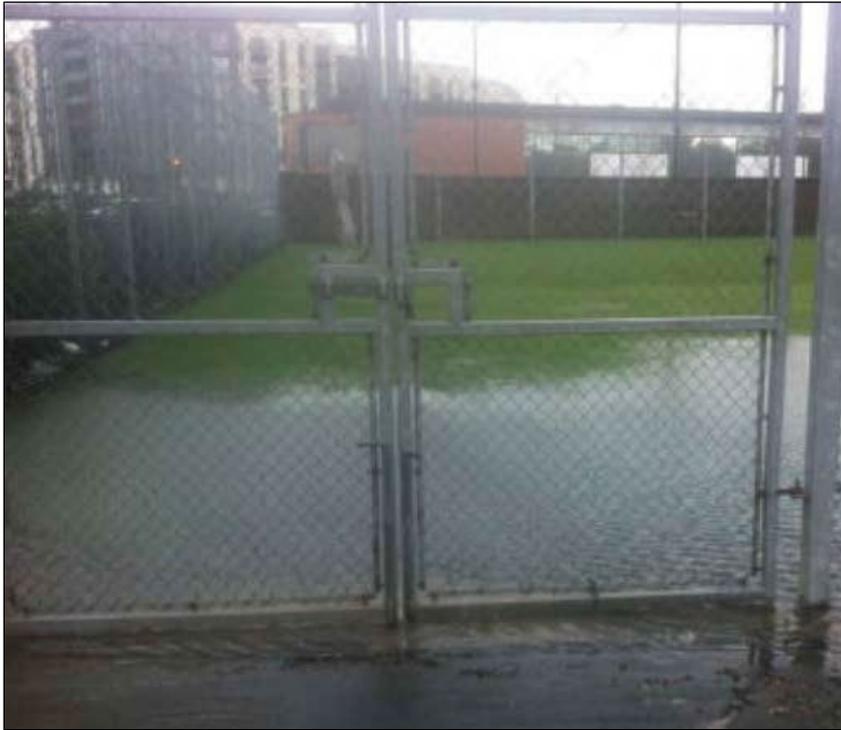
Figure 24: Edgbaston Cricket Ground practice field in Birmingham, England in March 13, 2014 at 5pm.

The Edgbaston County Cricket Club (Club) had an EGRP® system installed by Groundwater Dynamics in May of 2013 (GDL 2013) to improve drainage on a practice area that was known for standing water (Figure 24).

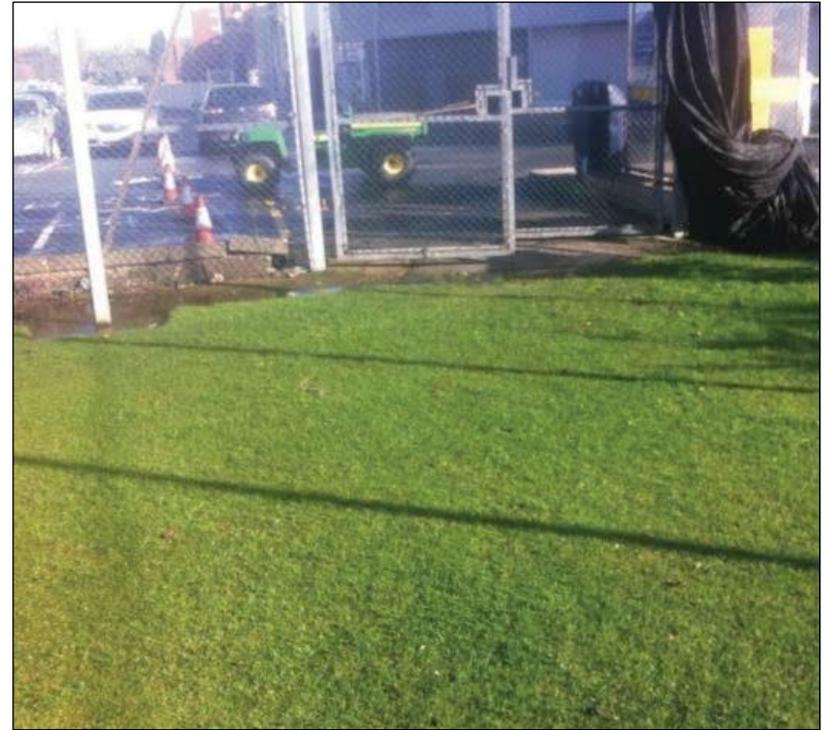
Figure 25 :Edgbaston Cricket Ground practice field in Birmingham, England on March, 14 2014 at 9 am.

STRI Ltd found increased infiltration in areas that were previously deemed unusable for play by the Club (Woodham 2014) which is shown in Figure 25. They also reported that the turf health was in good health for the time of year (May) and that given recent inclement weather “the playing surface was relatively firm and dry (Woodham 2014).” They concluded that the drainage infiltration rates “are more promising and higher than could have been expected given the nature of the site” and were likely contributable to the EGRP® system (Woodham 2014). However, they are unable to confirm these results because there was no testing performed prior to installation. Finally, they conclude that surface firmness and moisture content do not appear to be correlated with the location of the EGRP® system and that excess moisture retention is more likely the result of “excess thatch and compaction” (Woodham 2014).
