## Inspection by the Invasive Species Program

Division of Ecological Resources  
Minnesota Department of Natural Resources

**Lake:** Cross      **DOW Number:** 58011900

**Type of inspection:** Mid-summer delineation of Eurasian watermilfoil.

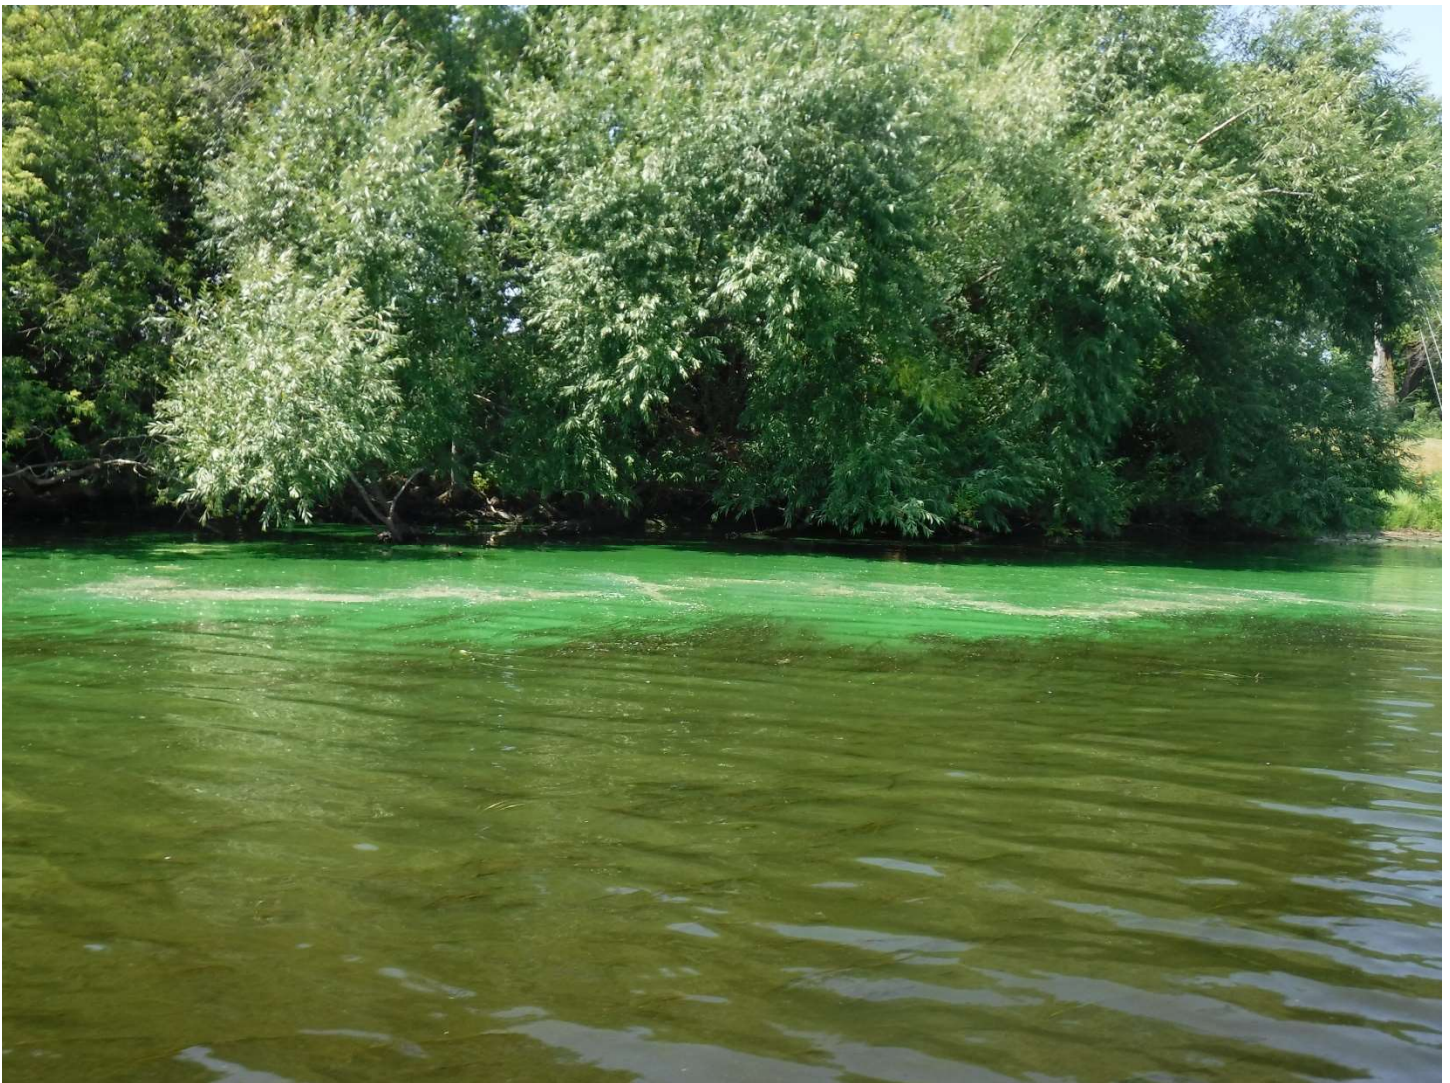
**Photo 1:** Blue-Green algal blooms were present on Cross Lake on 25 July 2024.

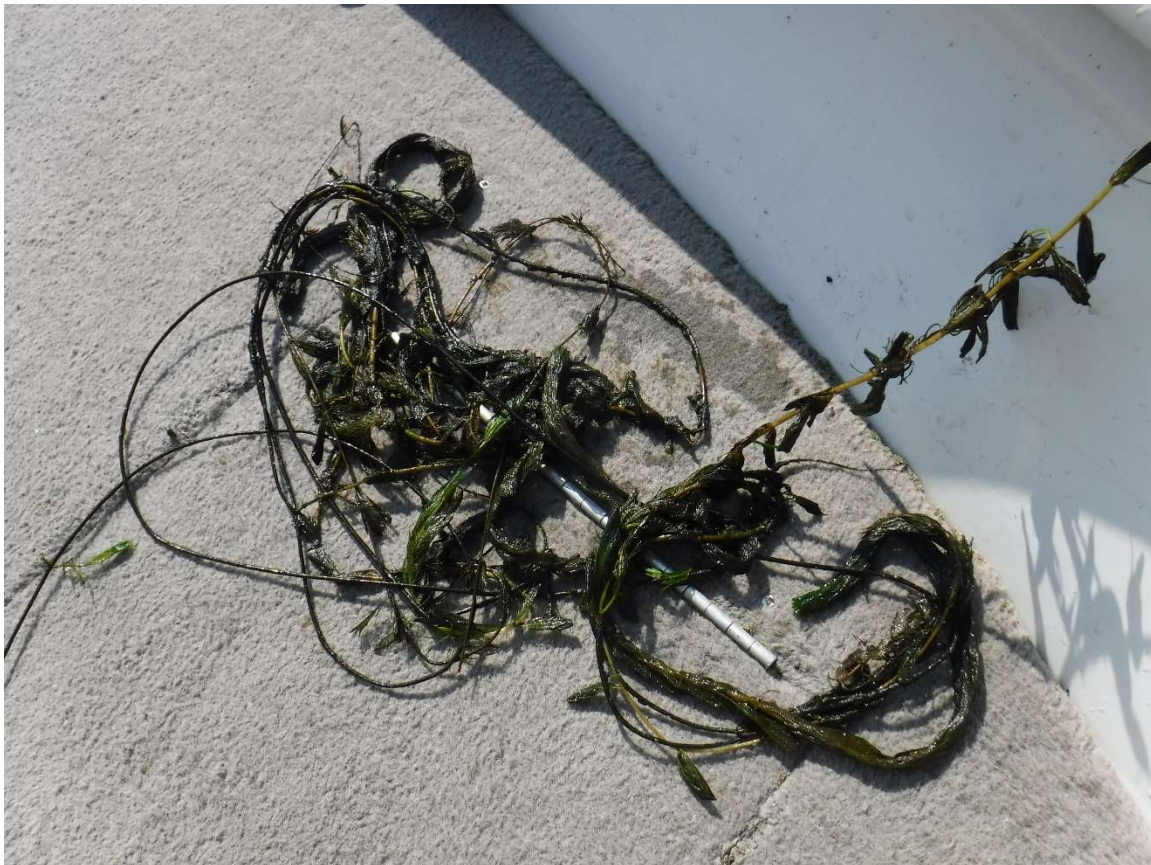
Eurasian watermilfoil was present at sites on the east and north shores. The eastern sites once supported a robust population of curly-leaf pondweed. Photo 2 shows that EWM that was brought to the surface from the eastern sites. When present, the EWM was growing in pure stands with only a few native plants.

**Photo 2. Eurasian watermilfoil from a site on the east side of Cross Lake on 25 July 2024.**

Historical herbicide treatment projects have reduced the populations of both curly-leaf pondweed and Eurasian watermilfoil to manageable areas. Native plants, in contrast, still benefit from nutrient conditions and limnological parameters found in Cross Lake. This was evident during the survey as large beds of coontail (*Ceratophyllum demersum*) and water celery (*Vallisneria spiralis*) were both widespread and common.

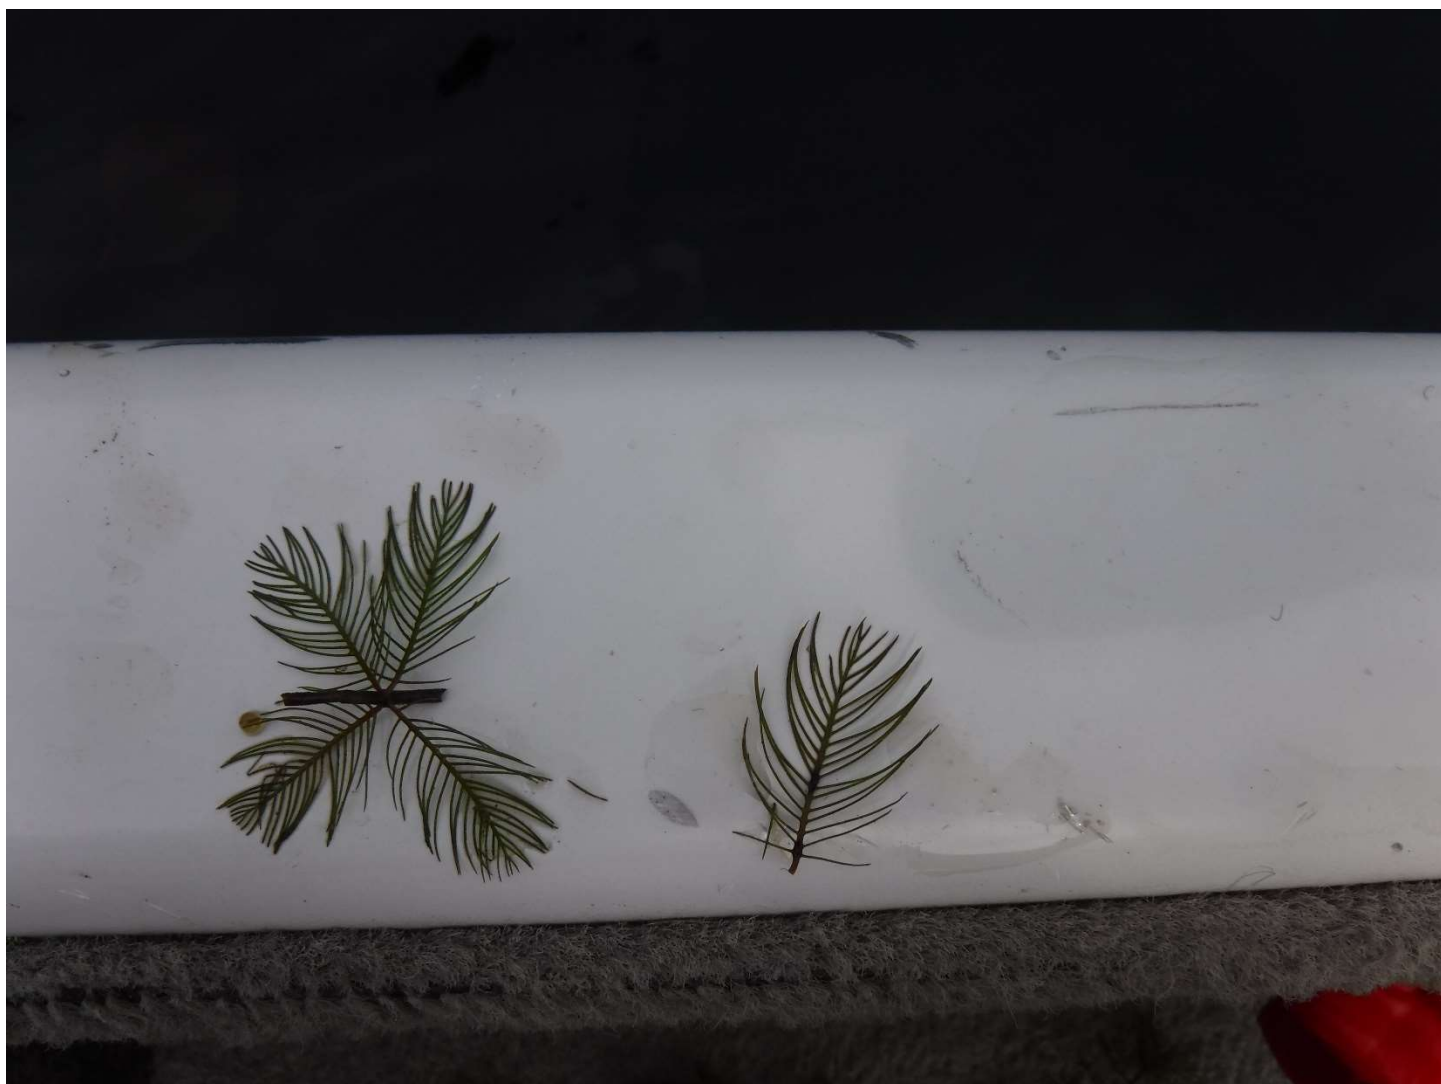
Coontail and Eurasian watermilfoil have similar physical attributes and can be easily mistaken, especially when covered with a coat of algae. Photos 3 and 4 show the differences between the two plants. Surface matting of coontail was common throughout the lake but pronounced on the north side of the lake as shown in photos 5 and 6.

**Photo 3. This photo shows the arrangement of leaflet pairs of Eurasian watermilfoil from Cross Lake on 25 July 2024.**

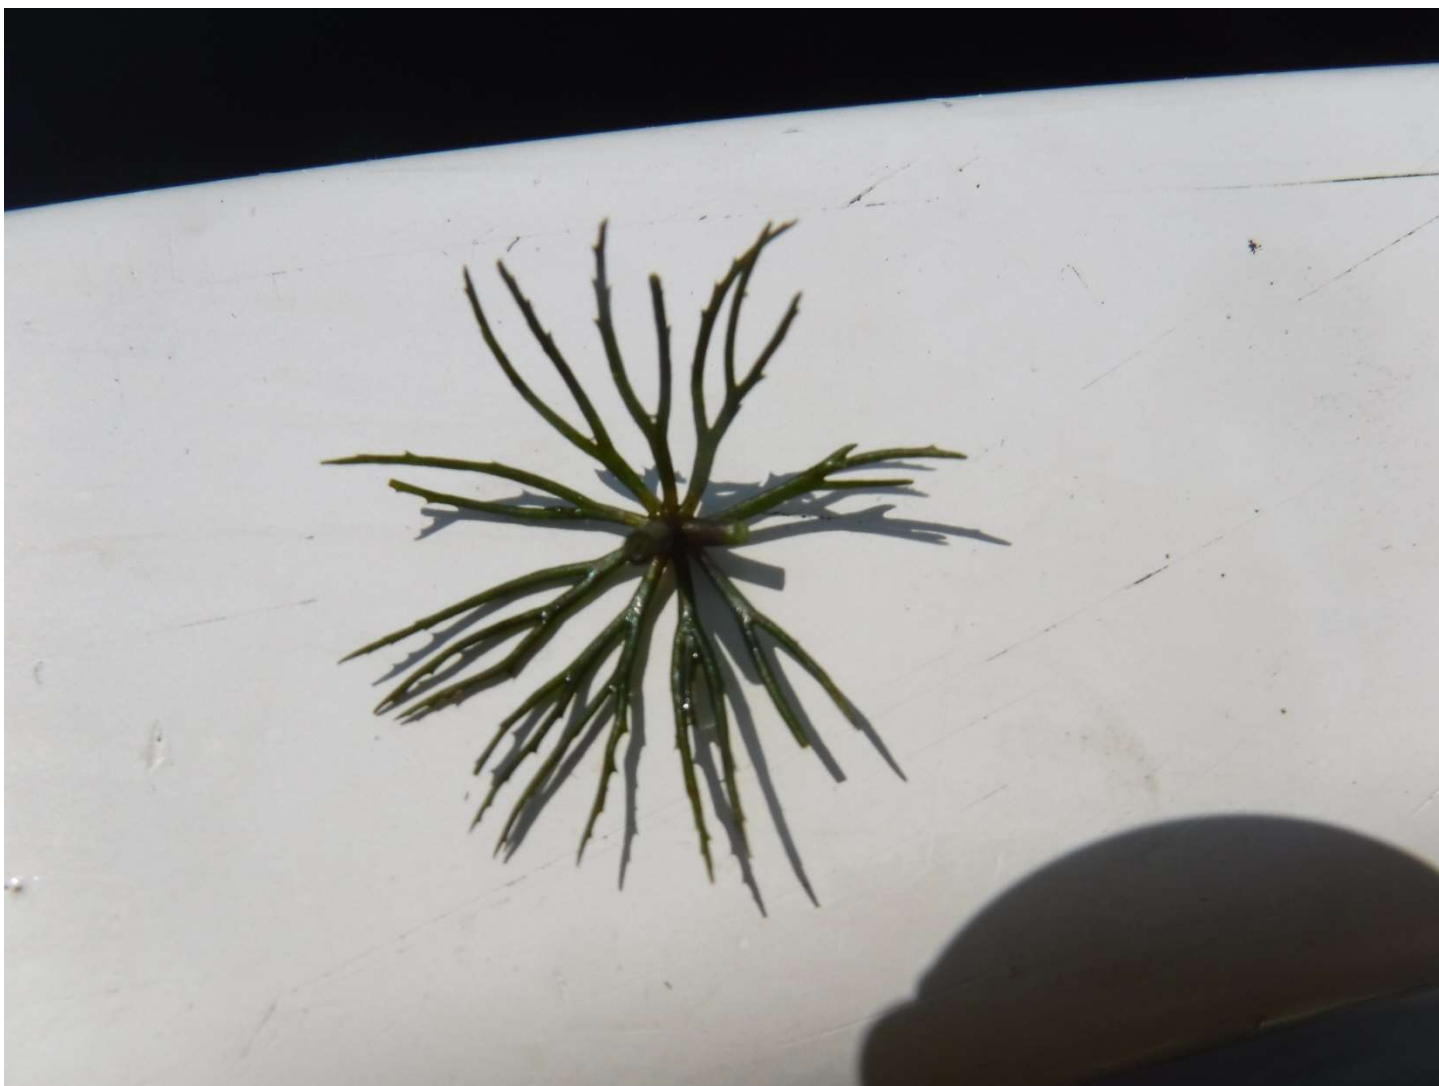
**Photo 4. This photo shows the arrangement of leaflets on a piece of Coontail sampled from Cross Lake on 25 July 2024.**

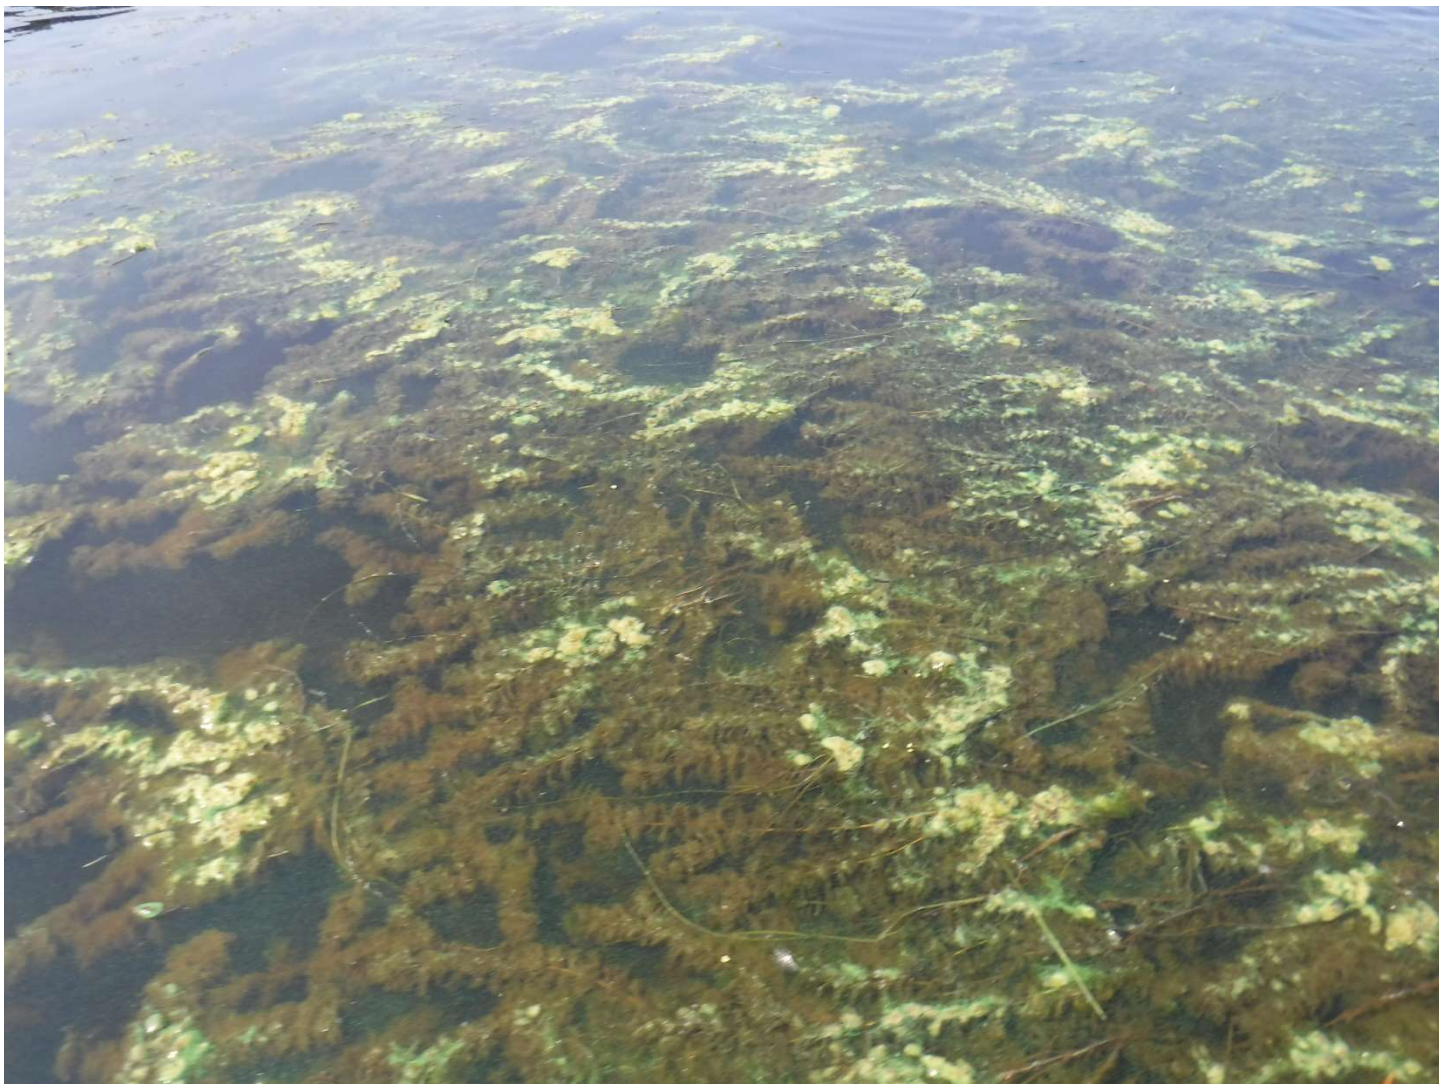
**Photo 5. A large bed of coontail growing in Cross Lake on 25 July 2024.**

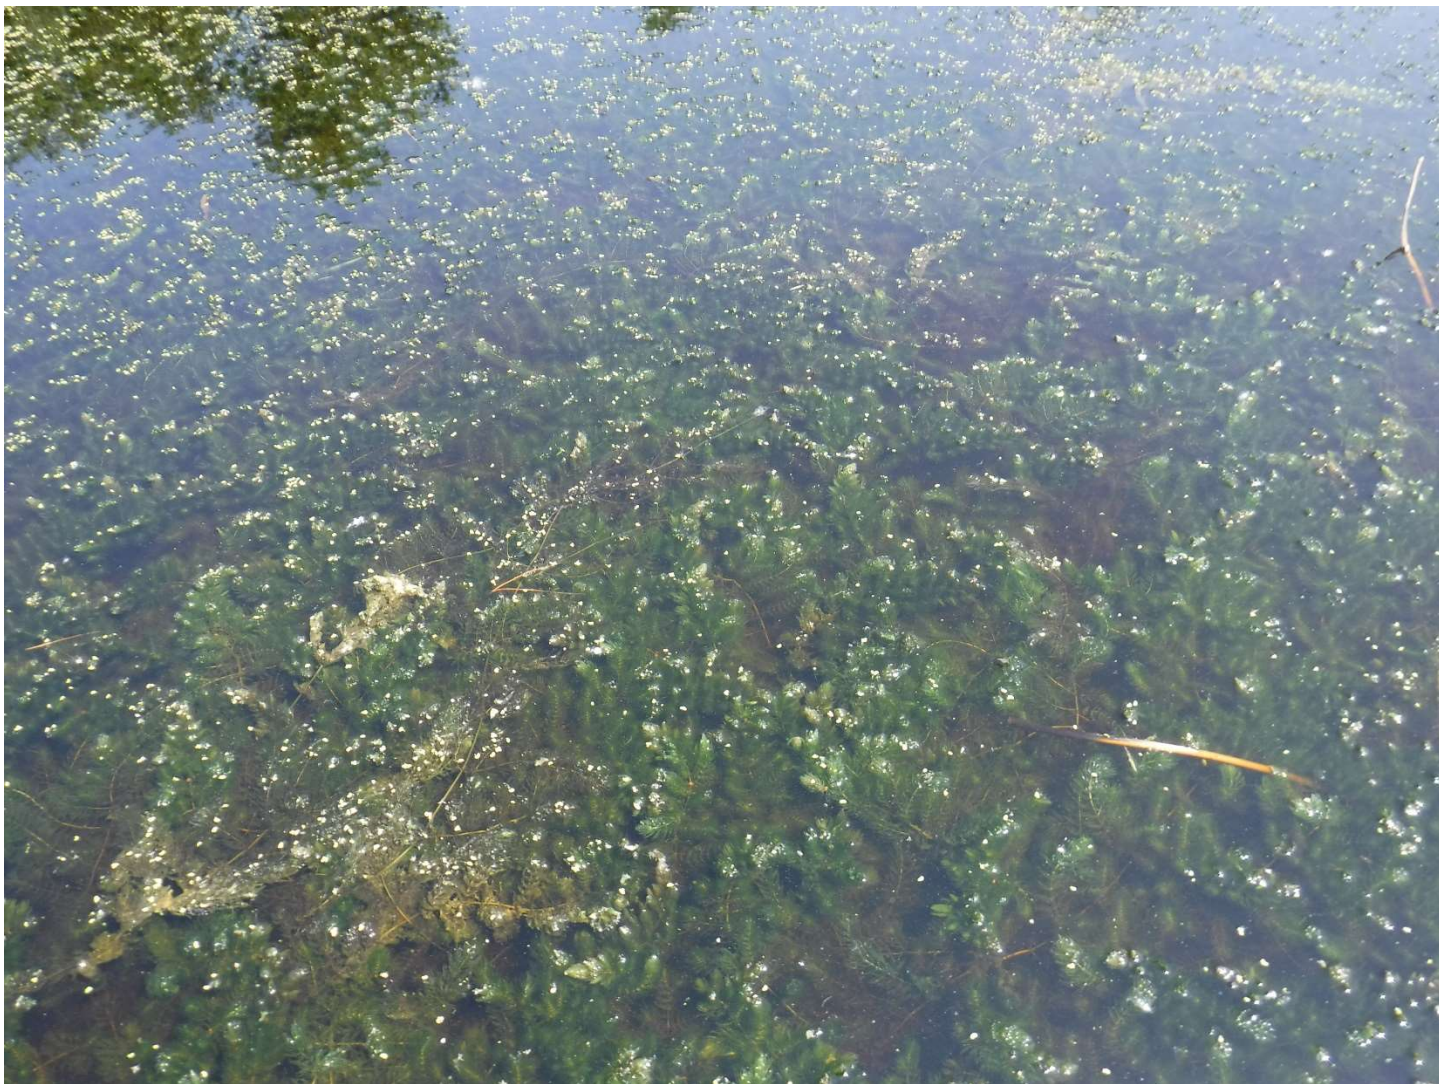
**Photo 6. Another large bed of coontail growing in Cross Lake on 25 July 2024.**
