# Environmental Impact Assessment: Exuma Fund 2 Ltd. Stocking Island, Exuma, The Bahamas

JULY 2025

This Environmental Impact Assessment (EIA) pertains to the proposed resort residential subdivision situated on a privately-owned 34.07-acre sea-to-sea parcel on Stocking Island, Exuma, The Bahamas. An EIA identifies potential environmental impacts based on site investigations and recommends measures for minimizing or mitigating those potential impacts with reference to local legislation, international conventions and/or best practices. This EIA was prepared in accordance with the EIA guidelines of the Department of Environmental Planning and Protection (DEPP) to secure a Certificate of Environmental Clearance (CEC). A CEC is required for full construction activities to commence.

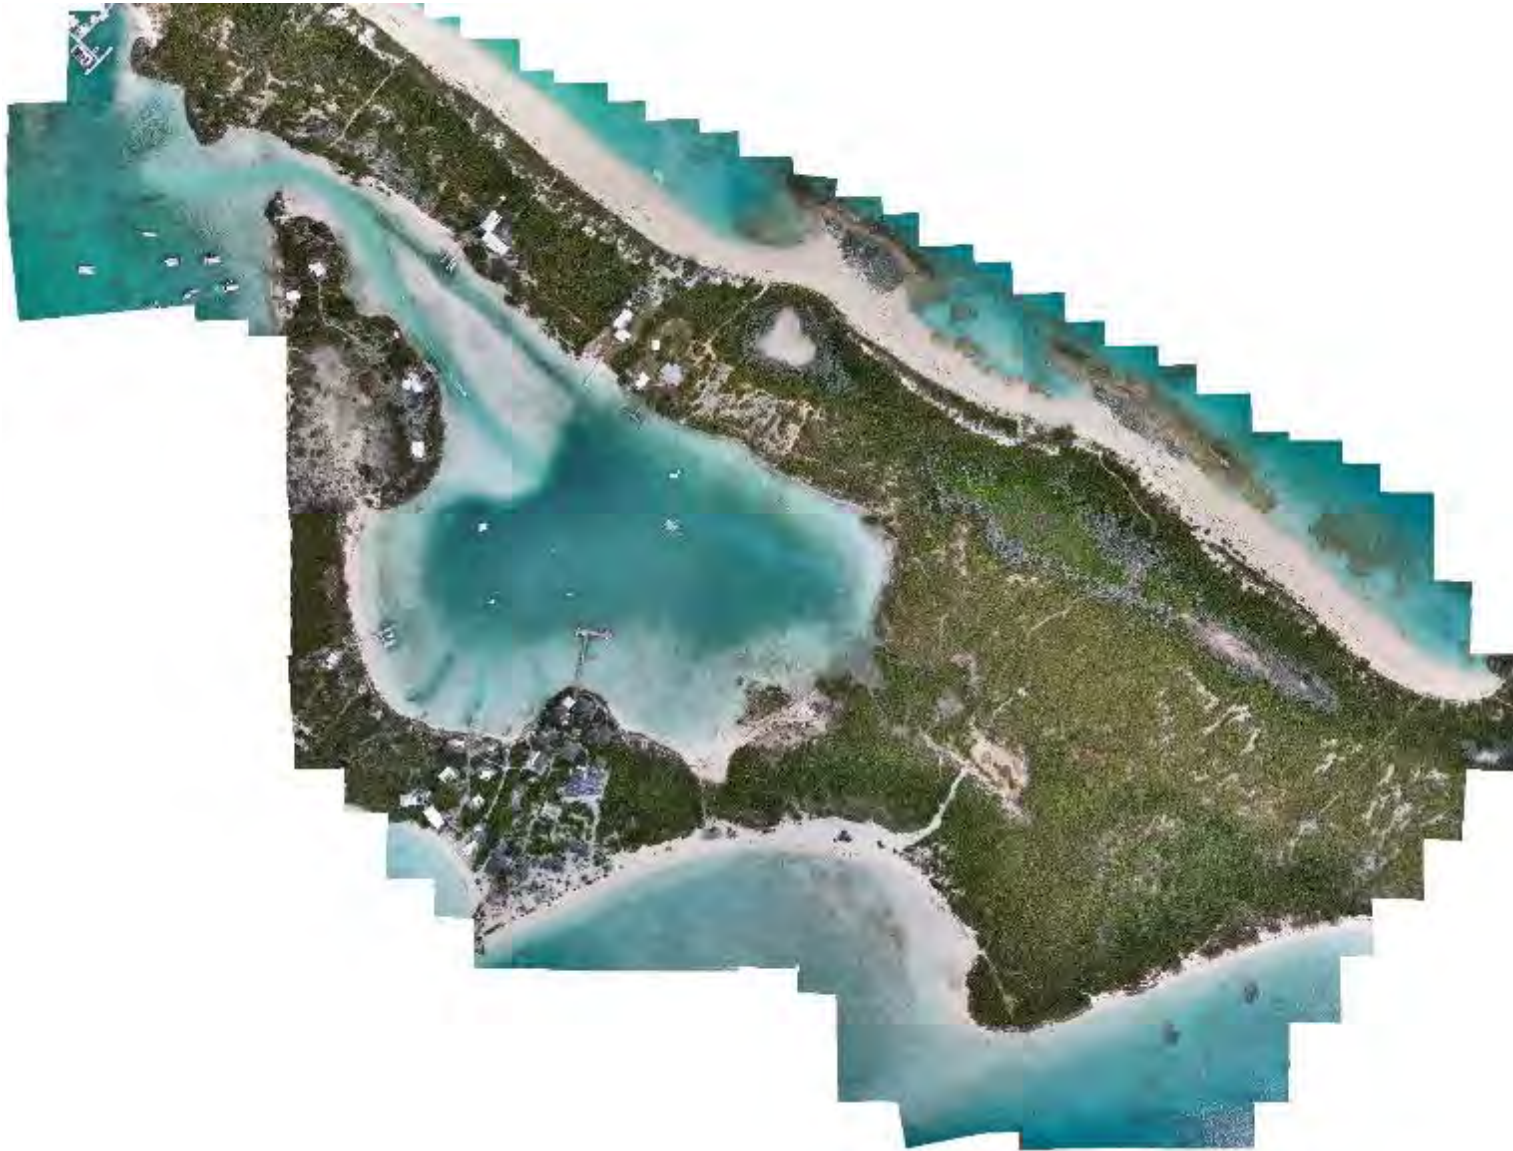
*Figure 3-4 Aerial Drone Image – March 18, 2024*

At present, the ~34-acre parcel is undeveloped and vegetated. A well-maintained nature trail runs from Elizabeth Harbour to Exuma Sound which is frequented by guests aboard anchored and visiting vessels. The lagoon is used as a hurricane hole and by vessels able to navigate the shallow channel as an anchorage.

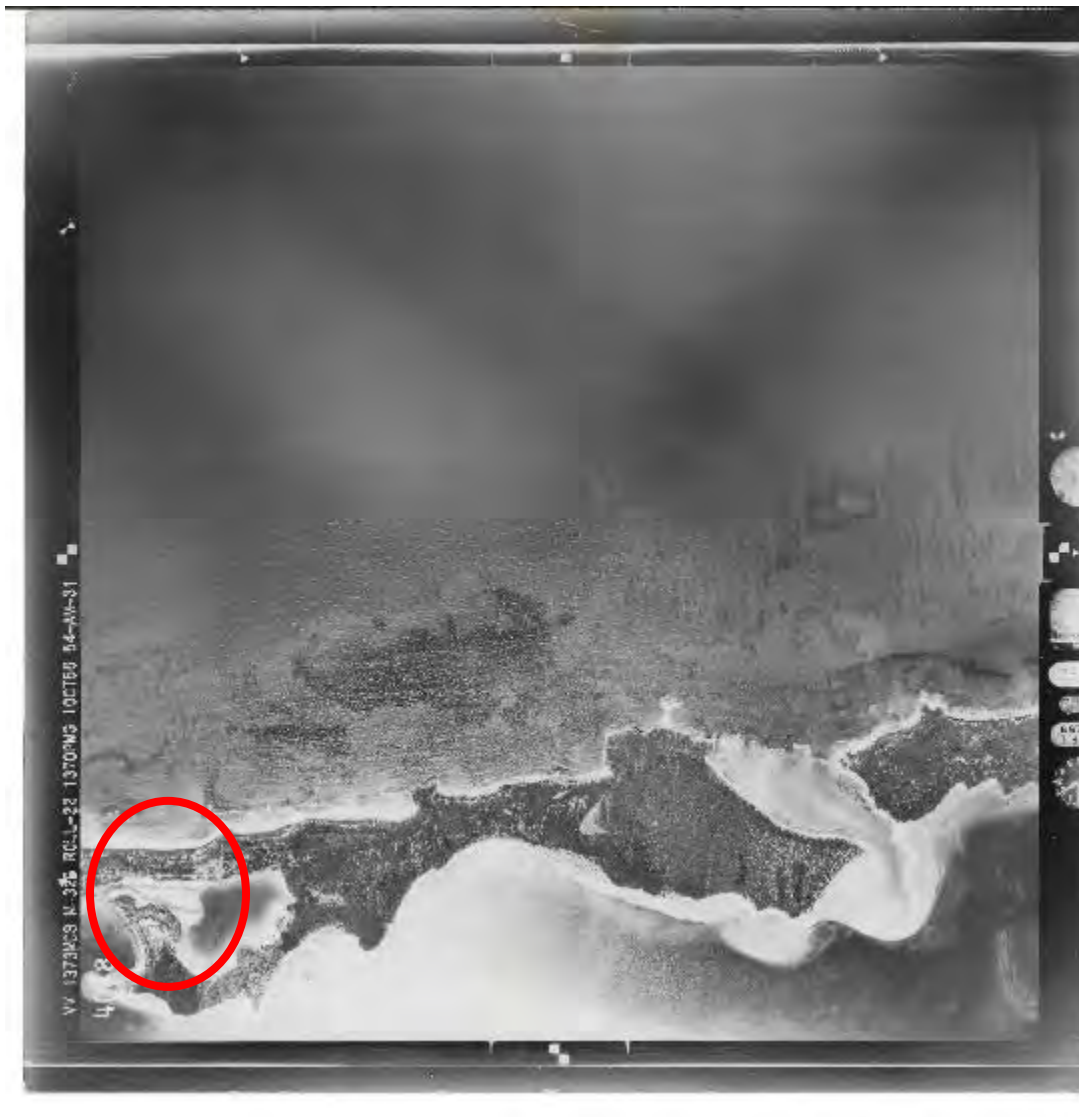
*Figure 3-13 Channel dredging 1956 aerial*

Historical aerial imagery was obtained to identify prior coastal modification including dredging, if any, in the vicinity of the project. Of note, the dual channel to access the interior lagoon was dredged between 1942 and 1956. The channels are noticeably absent on the 1942 aerial and present on the 1956 aerial. The southern channel is marked by buoys but almost impassable at low tide. Please see below for 1956 image which supports the dredging of the channel for maintenance purposes as this has been an active channel for nearly 70 years.

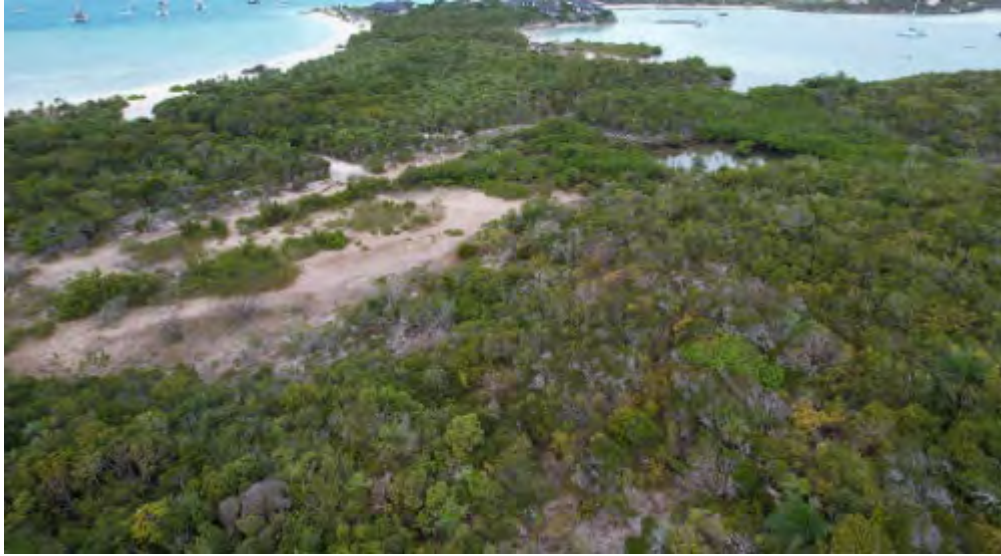
*Figure 6-1 Drone aerial facing northwest across the tidal creek and open flood plain*

The most prominent topographical feature of the property is the eastern facing dune which rises to a crest of 20+ft. above the sea. Relatively narrow in width, the leeward side of the dune vegetated by *Cocothrinax argentata*, precipitously declines until it reaches the silver buttonwood dominated wetland area. An interior limestone ridge formation along a north/south axis separates the buttonwood dominated depression from the tidal creek. Of note, the interior ridge formation has a distinct area of exposed natural limestone rock with no substrate for vegetation to take root.

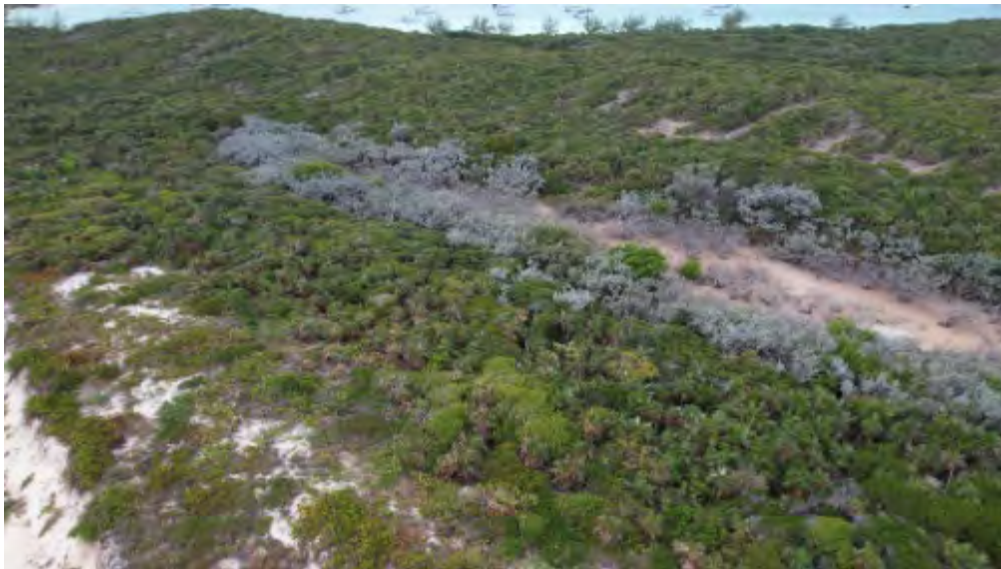
*Figure 6-2 Drone aerial facing southwest showcasing the frontal dune in the foreground and the interior limestone ridge with exposed rock*

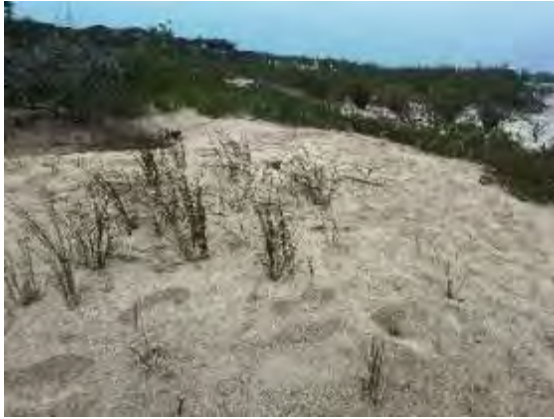
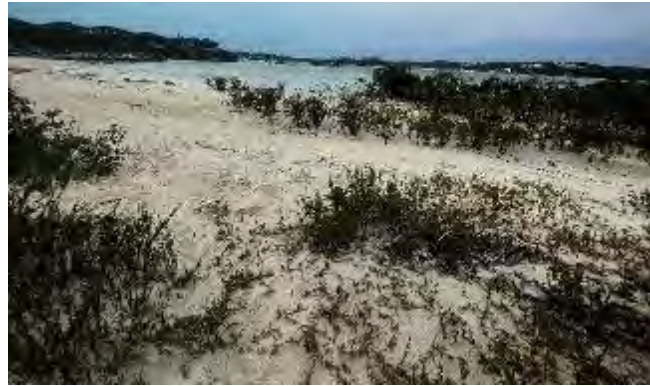
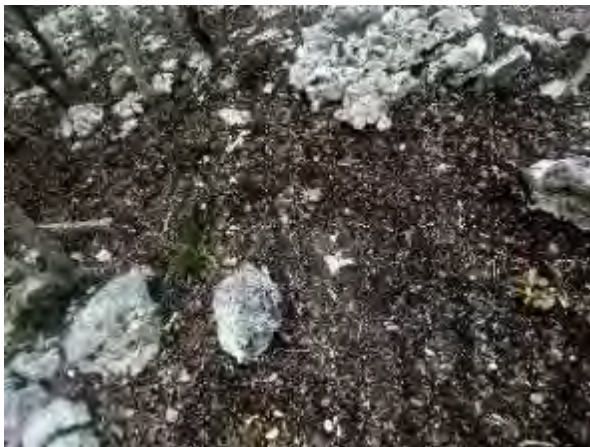
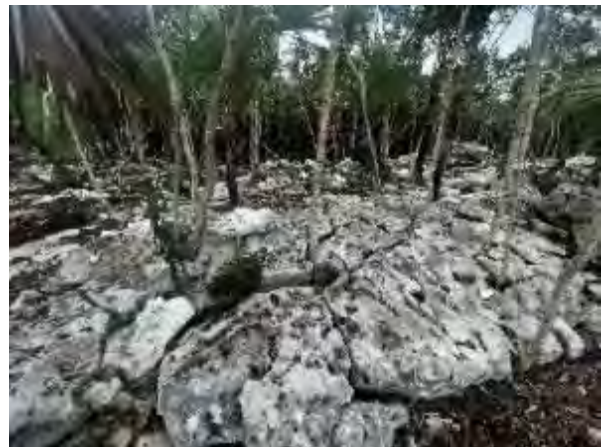
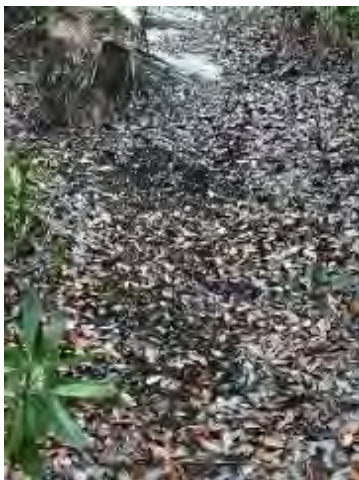
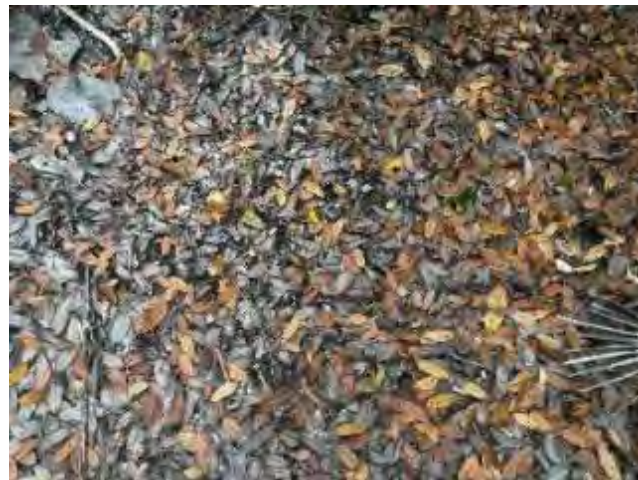
The soil profile of Stocking Island varies depending on the location. Coastal areas are dominated by fine sand whereas inland areas are a mix of loamy and sandy substrates which transitions to a layer of rich hummus over limestone rock in the DBEF.

*Figure 6-3 Soil and terrain comprising a mix of sands, a rich humus layer, or a blend of the two or iron shore rock.*

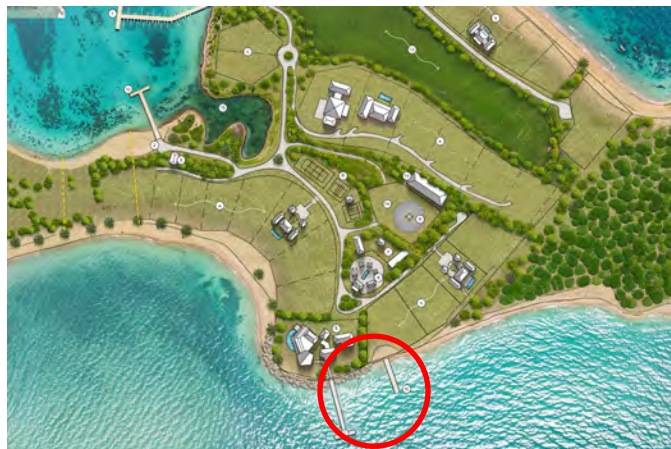
*Figure 6-5 RORO Location*

- **RORO Dredging.** Extending southwest, the proposed RORO location necessitates dredging to -6ft MLLW to accommodate barges laden with construction materials. Dredge volume is estimated at 660 cubic yards. The RORO is located immediately to the south of the site. Please see associated schematic on next page.

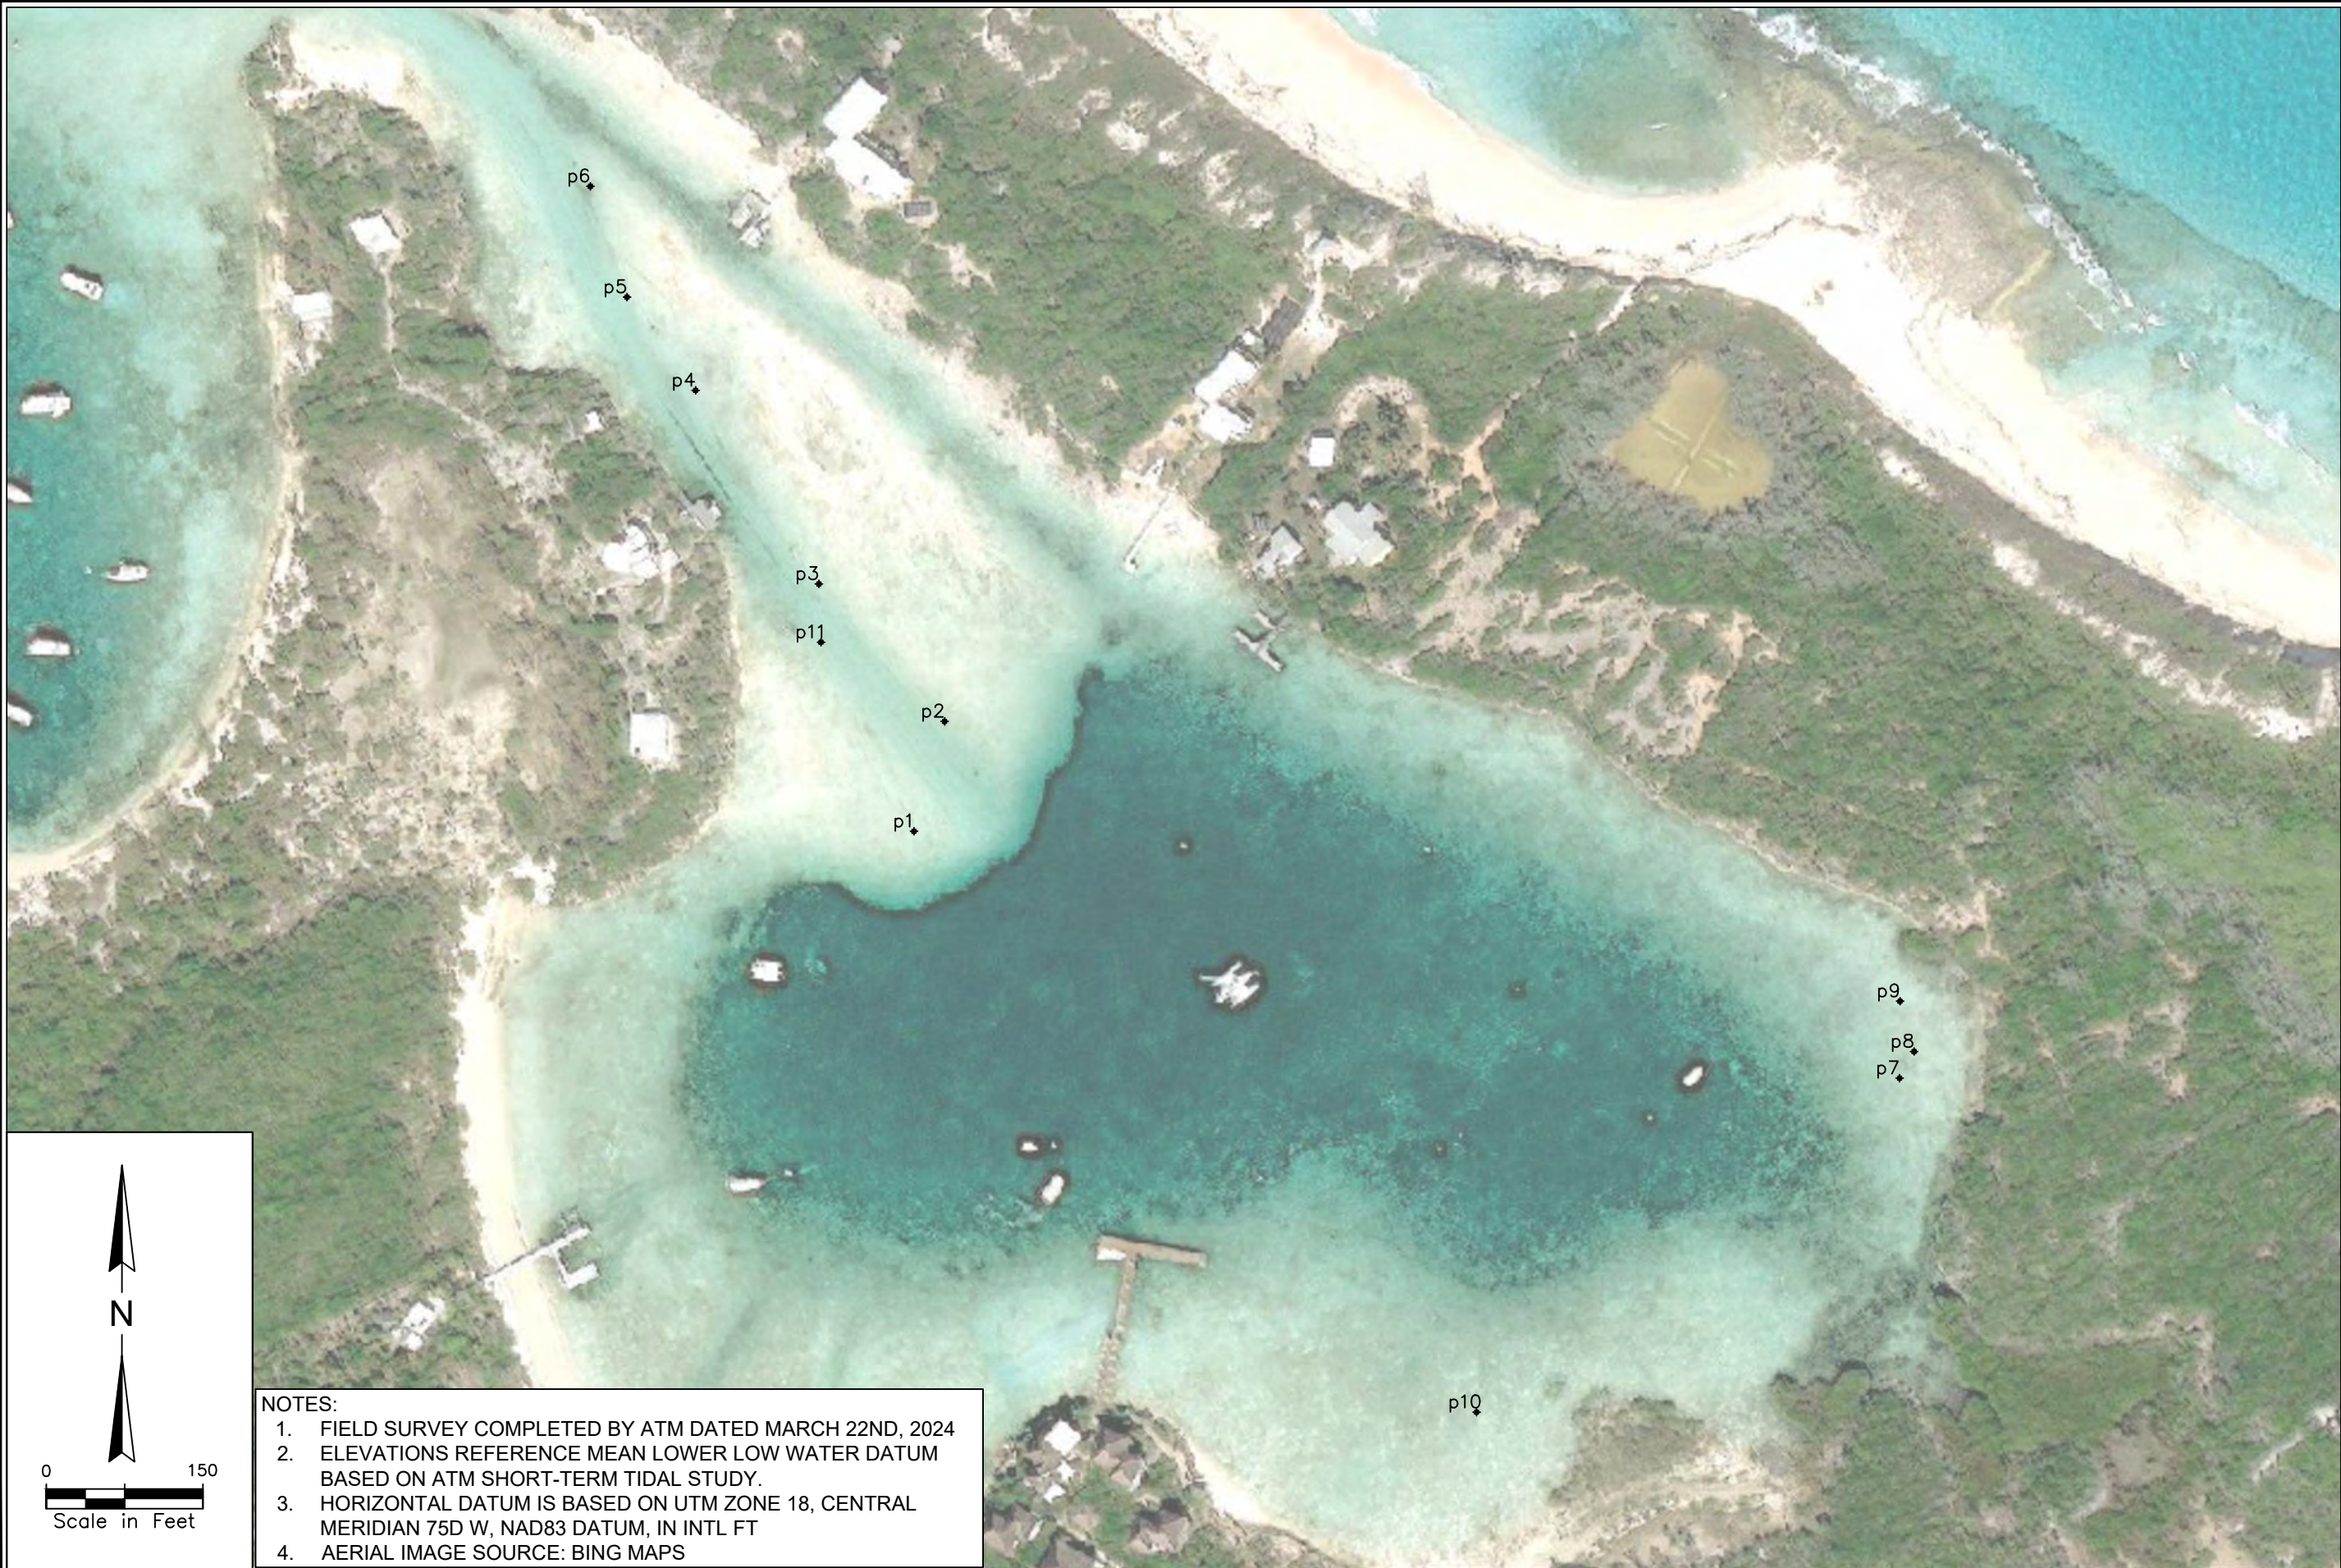
C:\Users\lhan.ross\OneDrive - Geosyntec\Desktop\Exuma Survey\Exuma Survey.dwg Probe 4/4/24

1. FIELD SURVEY COMPLETED BY ATM DATED MARCH 22ND, 2024
2. ELEVATIONS REFERENCE MEAN LOWER LOW WATER DATUM BASED ON ATM SHORT-TERM TIDAL STUDY.
3. HORIZONTAL DATUM IS BASED ON UTM ZONE 18, CENTRAL MERIDIAN 75D W, NAD83 DATUM, IN INTL FT
4. AERIAL IMAGE SOURCE: BING MAPS

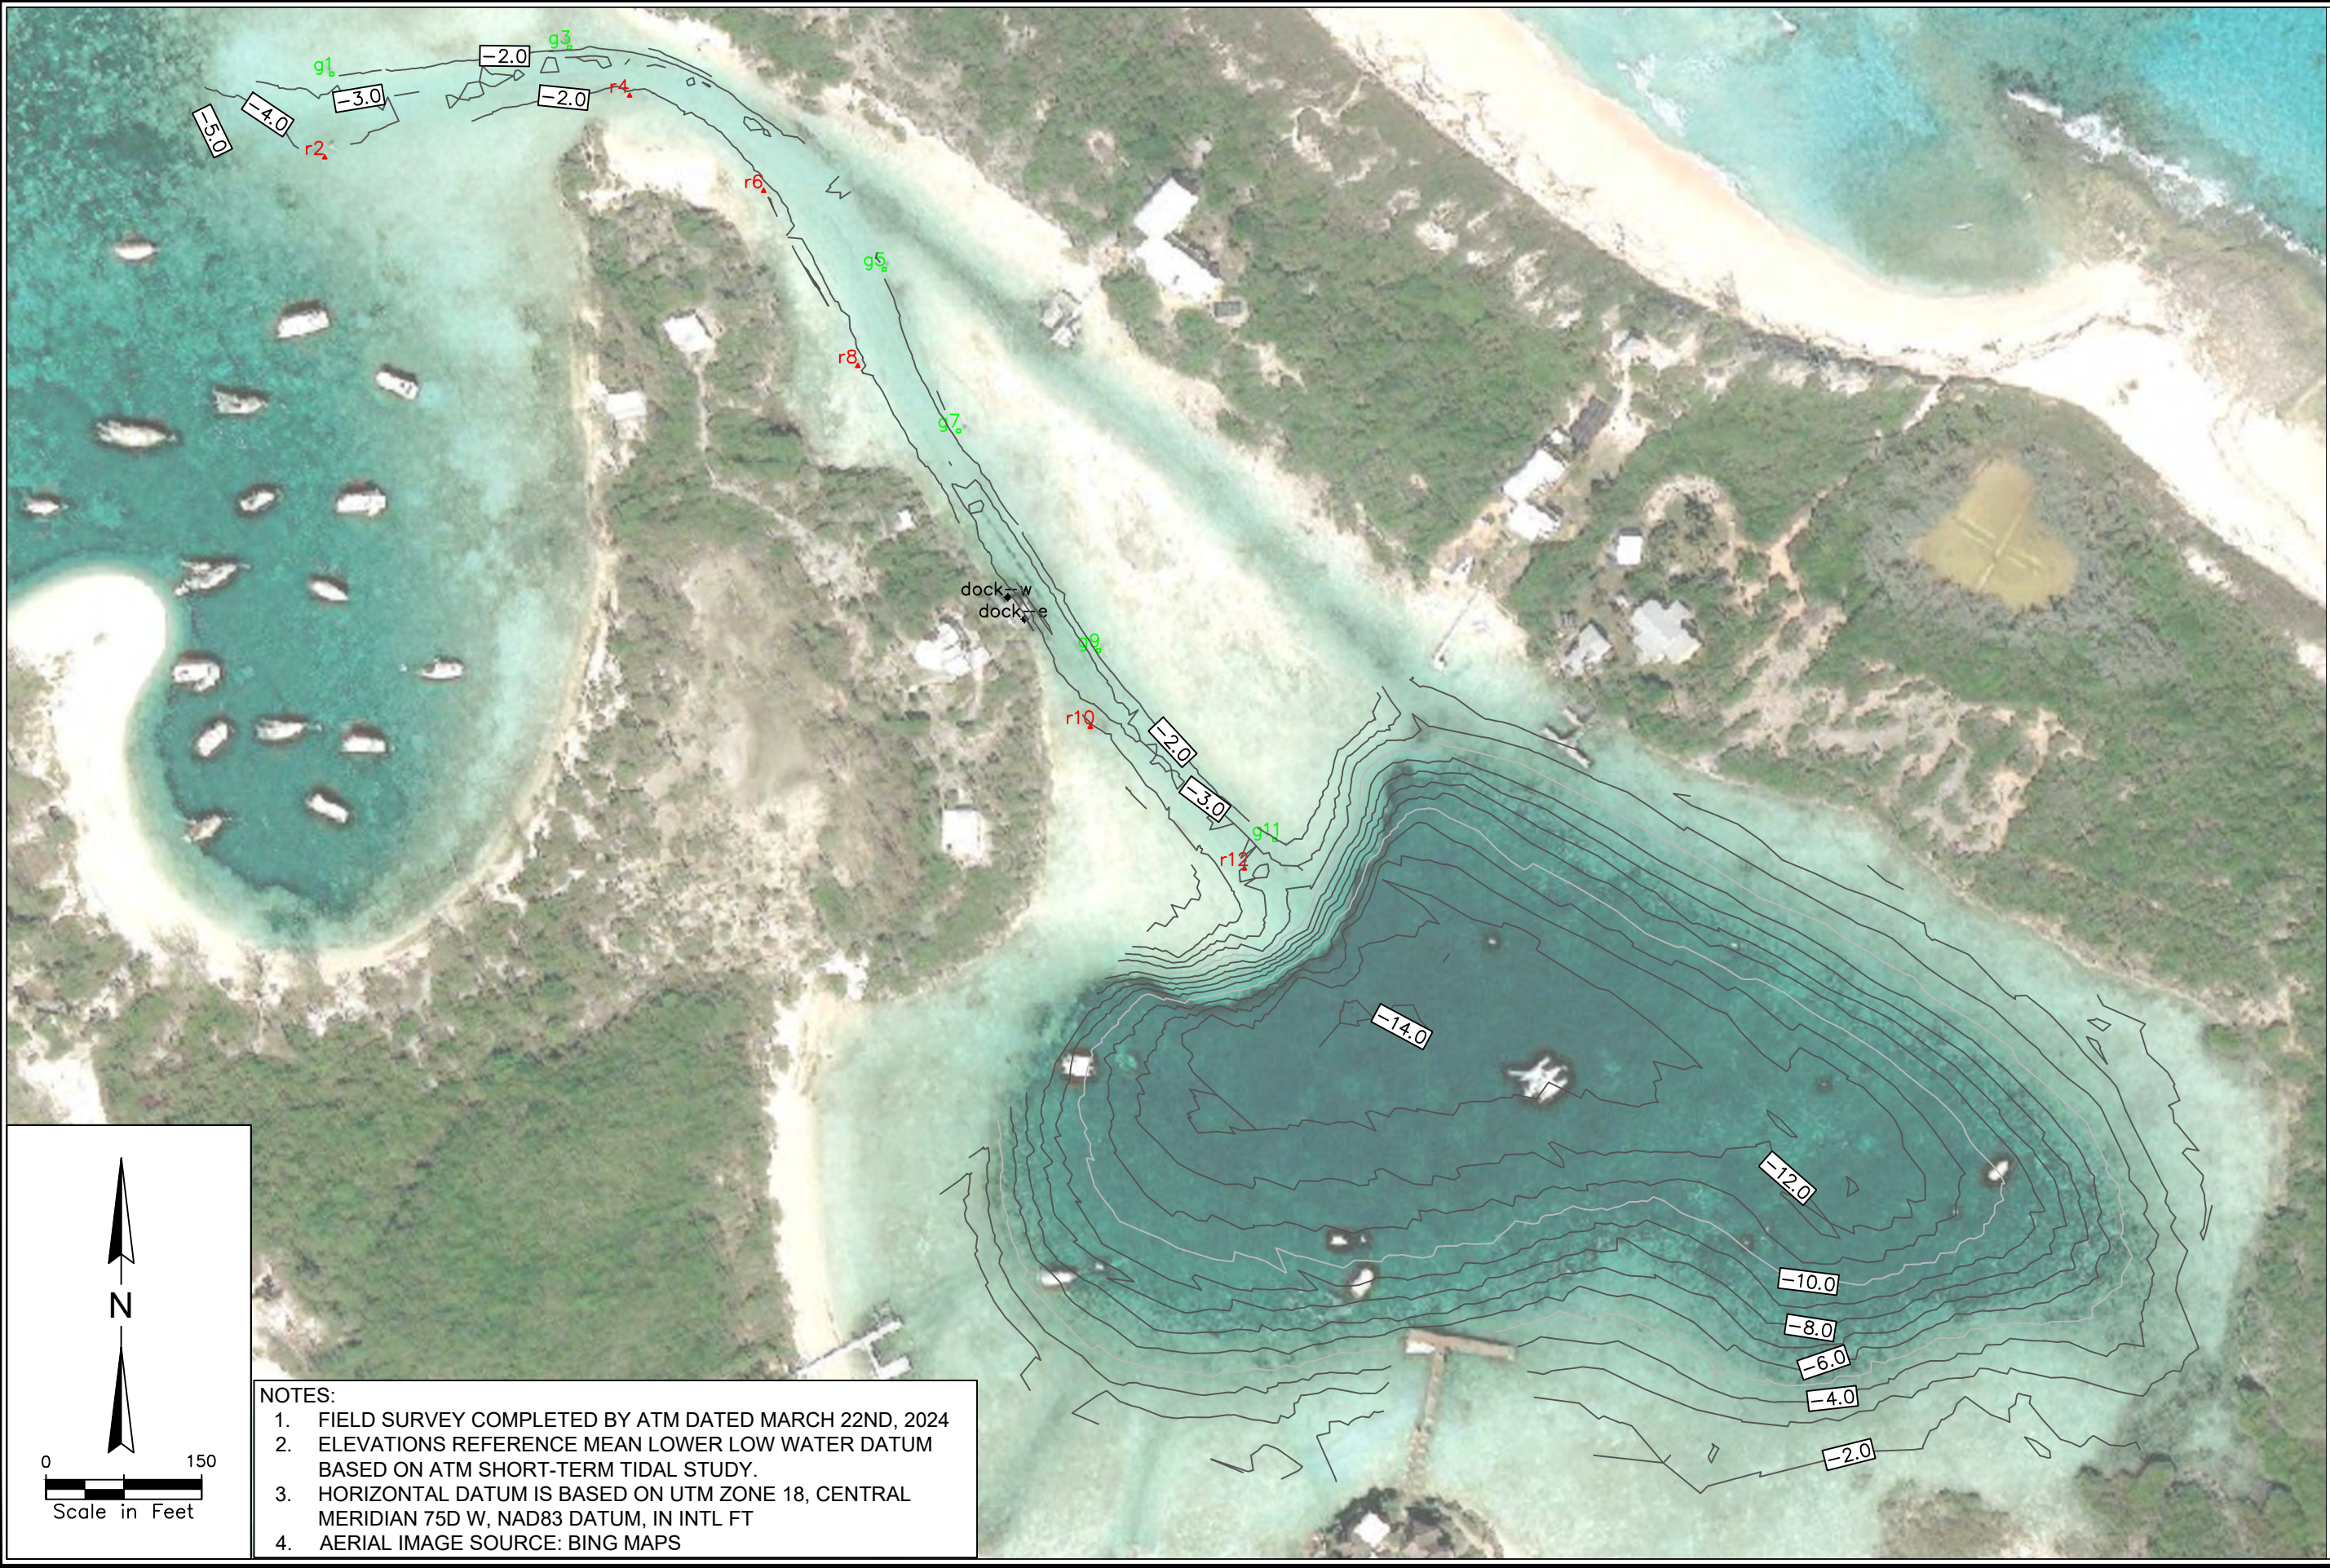
C:\Users\sthan.ross\OneDrive - Geosyntec\Desktop\Exuma Survey\Exuma Survey.dwg SI Contours 4/4/24

1. FIELD SURVEY COMPLETED BY ATM DATED MARCH 22ND, 2024
2. ELEVATIONS REFERENCE MEAN LOWER LOW WATER DATUM BASED ON ATM SHORT-TERM TIDAL STUDY.
3. HORIZONTAL DATUM IS BASED ON UTM ZONE 18, CENTRAL MERIDIAN 75D W, NAD83 DATUM, IN INTL FT
4. AERIAL IMAGE SOURCE: BING MAPS

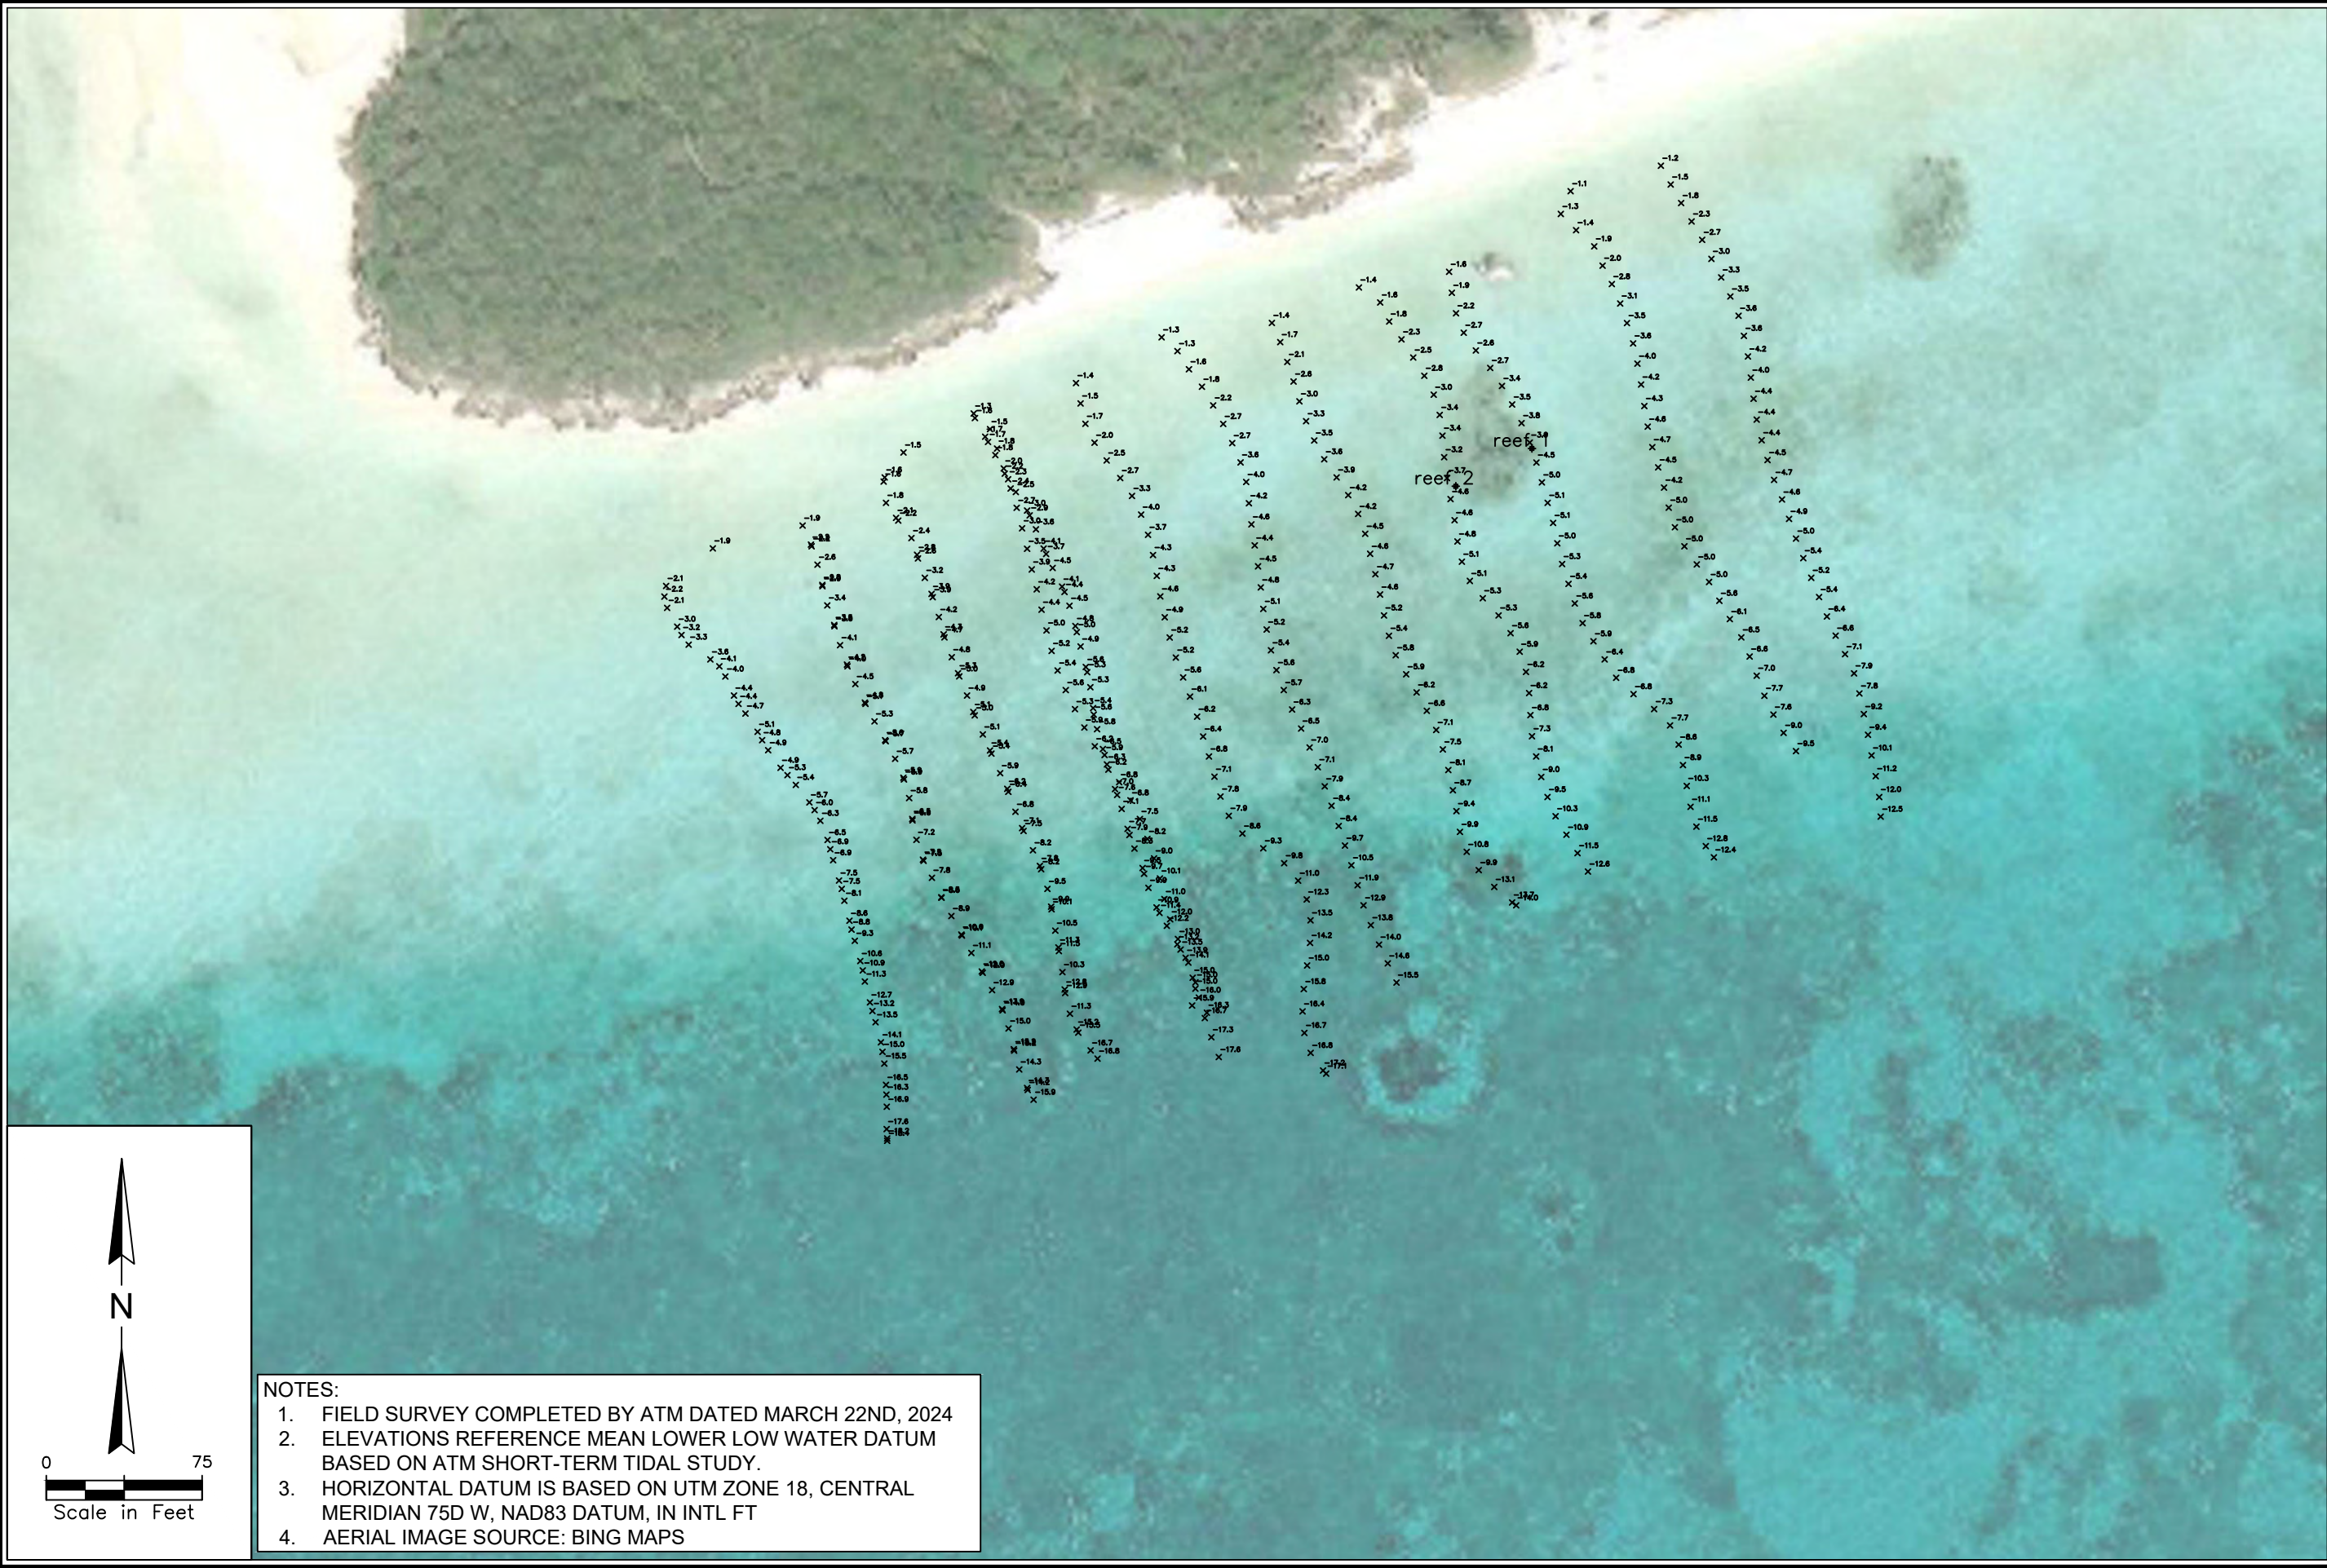
C:\Users\sthan.ross\OneDrive - Geosyntec\Desktop\Exuma Survey\Exuma Survey.dwg St Barge Points 4/4/24

- NOTES:
1. FIELD SURVEY COMPLETED BY ATM DATED MARCH 22ND, 2024
  2. ELEVATIONS REFERENCE MEAN LOWER LOW WATER DATUM BASED ON ATM SHORT-TERM TIDAL STUDY.
  3. HORIZONTAL DATUM IS BASED ON UTM ZONE 18, CENTRAL MERIDIAN 75D W, NAD83 DATUM, IN INTL FT
  4. AERIAL IMAGE SOURCE: BING MAPS

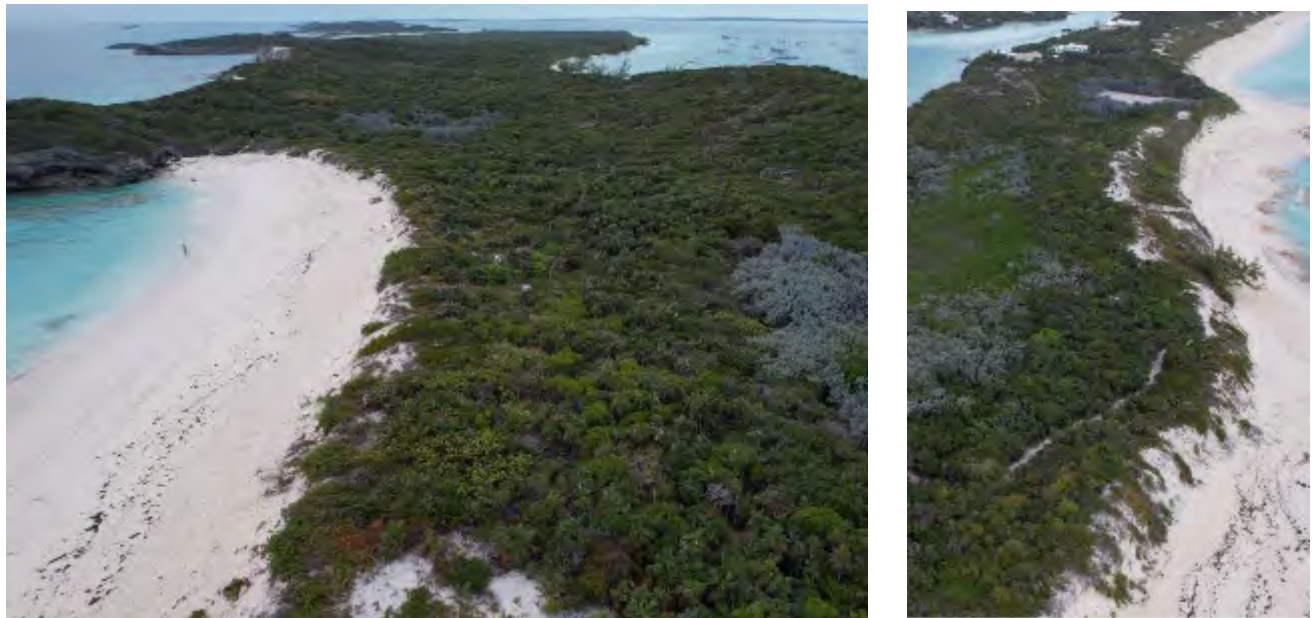
*Figure 6-8 Aerial drone Imagery showcasing the dune system on the ocean side of Stocking Island*

Coastal dune zones are influenced by both marine and terrestrial influences and factors and often act as transitional areas or ecotones. When sufficient natural organic matter accumulates behind an established dune or recently forming dune, vegetation is able to take hold, grow and become established. Coastal vegetation found within dune zones is low growing and shrubby due to low nutrient soil, droughty conditions, and high salt exposure. Additionally, high winds and salt spray often prune the top layers of the trees and shrubs growing on the dunes and result in salt-pruned, windswept canopies, that is typically observed within these habitats. The Coastal Dune zone consists of mainly shrub & vine like species and phase one pioneering vegetation that is highly salt-tolerant, such as succulent annuals, grasses, perennial vines, and a few shrubs.

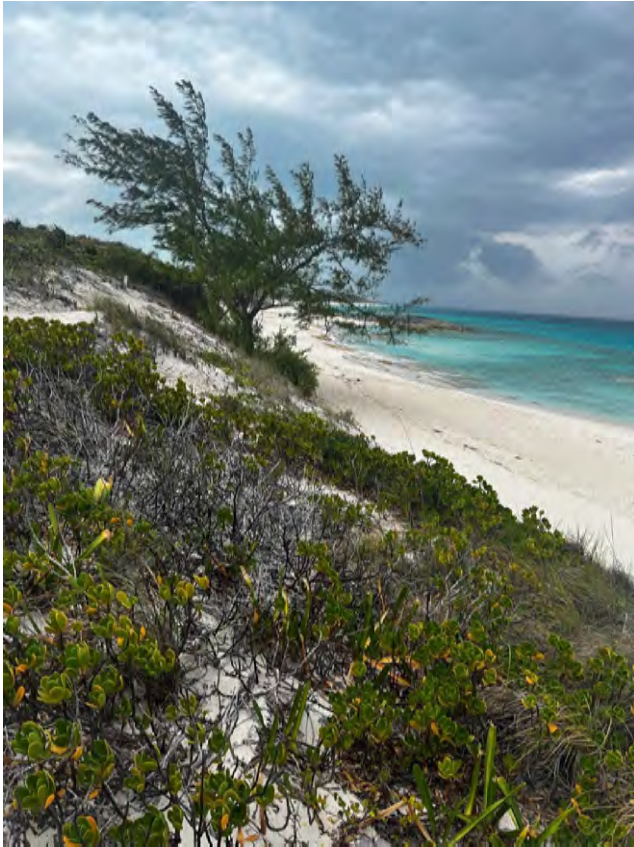
*Figure 6-9 Dune with Invasive Casuarina sp. along Exuma Sound*

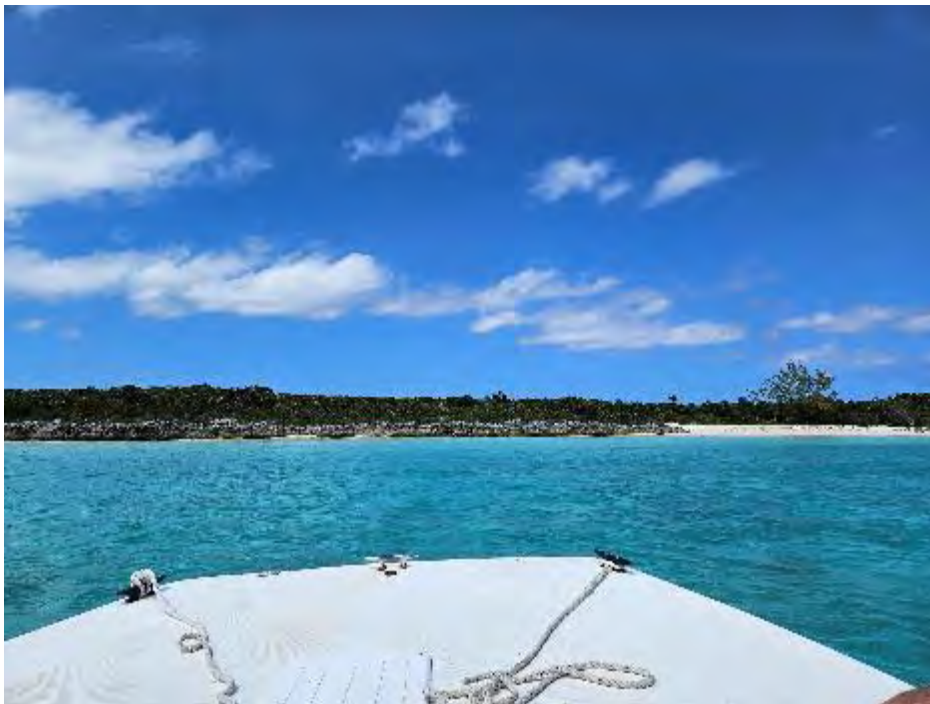
*Figure 6-10 Ironshore location for RORO, leeward side of Stocking Island*

Elsewhere, ironshore protrudes the sandy substrate and is shaped by a combination of rain, wind, acidic rainwater, or eroded by constant wave action. and sea spray into what resemble the jagged like structure that distinguish it.

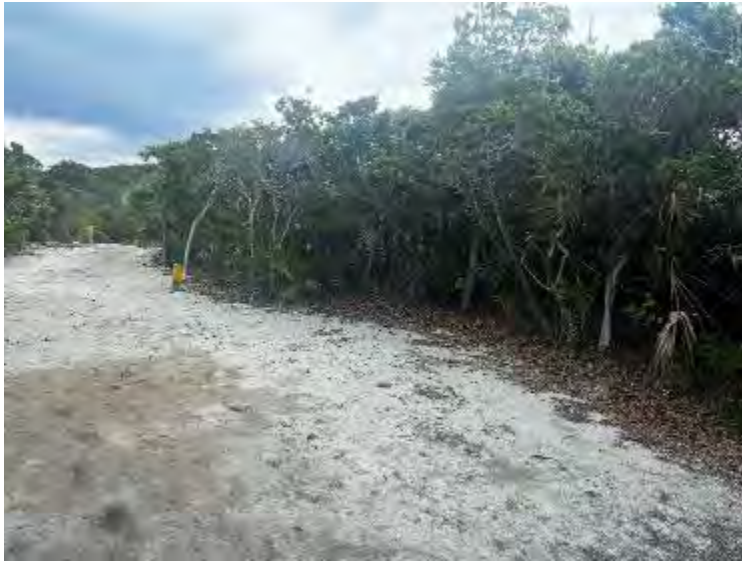
*Figure 6-11 A mix of aerial and on the ground imagery showcasing the current level of upland human impacts within the proposed project area, which consists of a regularly maintained 'nature trail' walk, that is raised in some portions as presented above.*

The "human-altered" refers to areas of land that has been significantly modified or impacted by human activities. The Exuma Fund 2, Ltd. site is relatively undeveloped with the exception of the frequented and well-maintained nature trail.

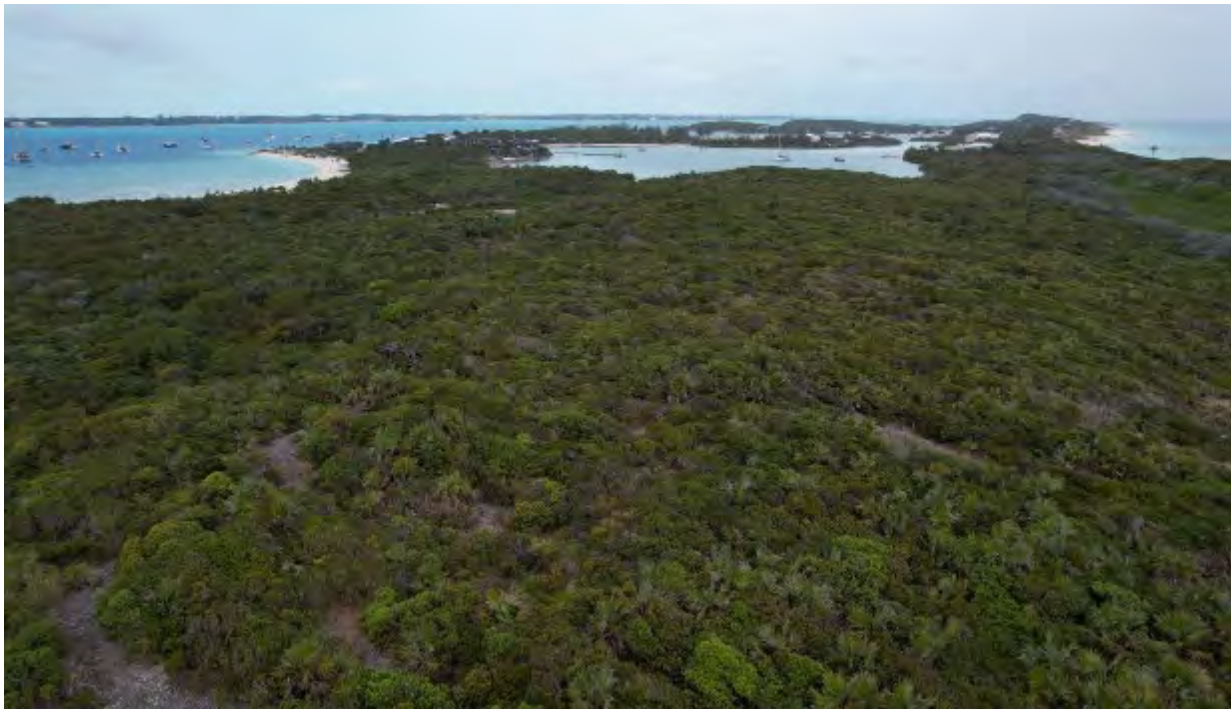
*Figure 6-13 Aerial Images above detailing the typical DBEF forest habitat area observed within the Proposed Project area on Stocking Island.*

DBEF vegetation is comprised of high-density small diameter trees and a dense canopy. The DBEF the most dominant vegetation cover of the property where vegetation reaches an average height of approximately fifteen to twenty feet (15-20 ft). The vegetation in the area exhibits healthy forest crown cover and has good stand class. In some areas the coppice is very dense and diverse with a thick and overgrown understory. The DBEF vegetation class exhibited typical characteristics as can be expected, and showed no signs of stress or diseases, with some more developed trees having a tree trunk diameter of approximately 15-20 inches, and a height of 20-25 feet, which indicates they are approaching the beginning stages of secondary phase growth/ developing into Blackland coppice habitat.

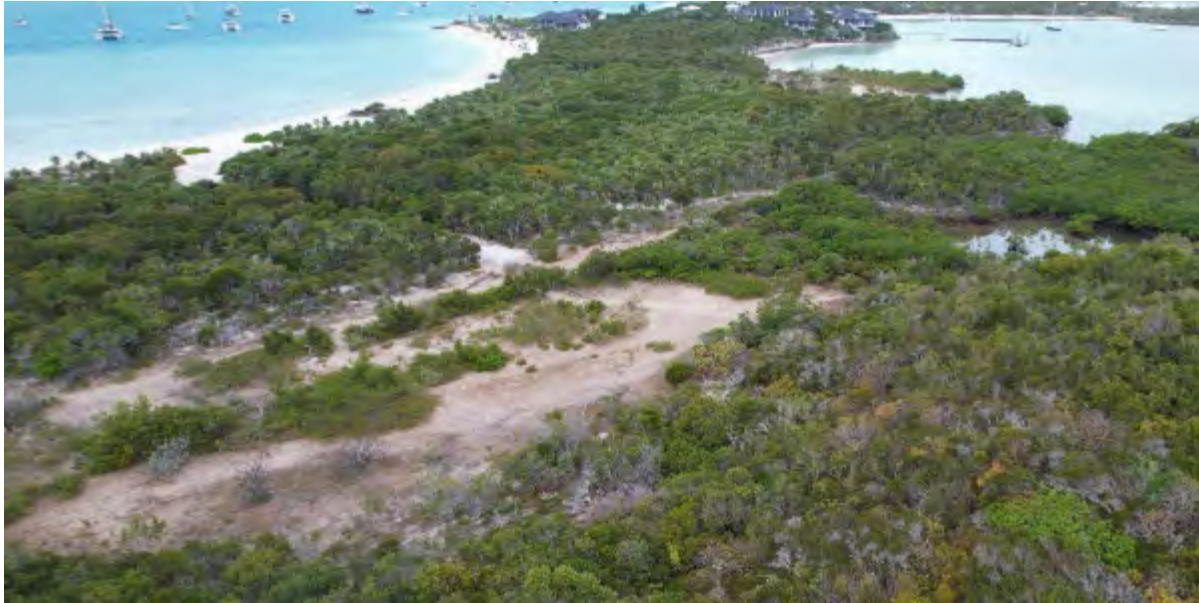
A tidal creek enters the property at the southern portion of the lagoon. Extending south beyond the creek's fringing mangroves is a dry unvegetated open area that appears to be a flood plain and/or drainage basin. This area experiences flooding frequent enough to prevent establishment of upland vegetation.

*Figure 6-14 Open flood plain extending south of tidal creek*
