# Environmental Impact Assessment: Exuma Fund 2 Ltd. Stocking Island, Exuma, The Bahamas

JULY 2025

This Environmental Impact Assessment (EIA) pertains to the proposed resort residential subdivision situated on a privately-owned 34.07-acre sea-to-sea parcel on Stocking Island, Exuma, The Bahamas. An EIA identifies potential environmental impacts based on site investigations and recommends measures for minimizing or mitigating those potential impacts with reference to local legislation, international conventions and/or best practices. This EIA was prepared in accordance with the EIA guidelines of the Department of Environmental Planning and Protection (DEPP) to secure a Certificate of Environmental Clearance (CEC). A CEC is required for full construction activities to commence.

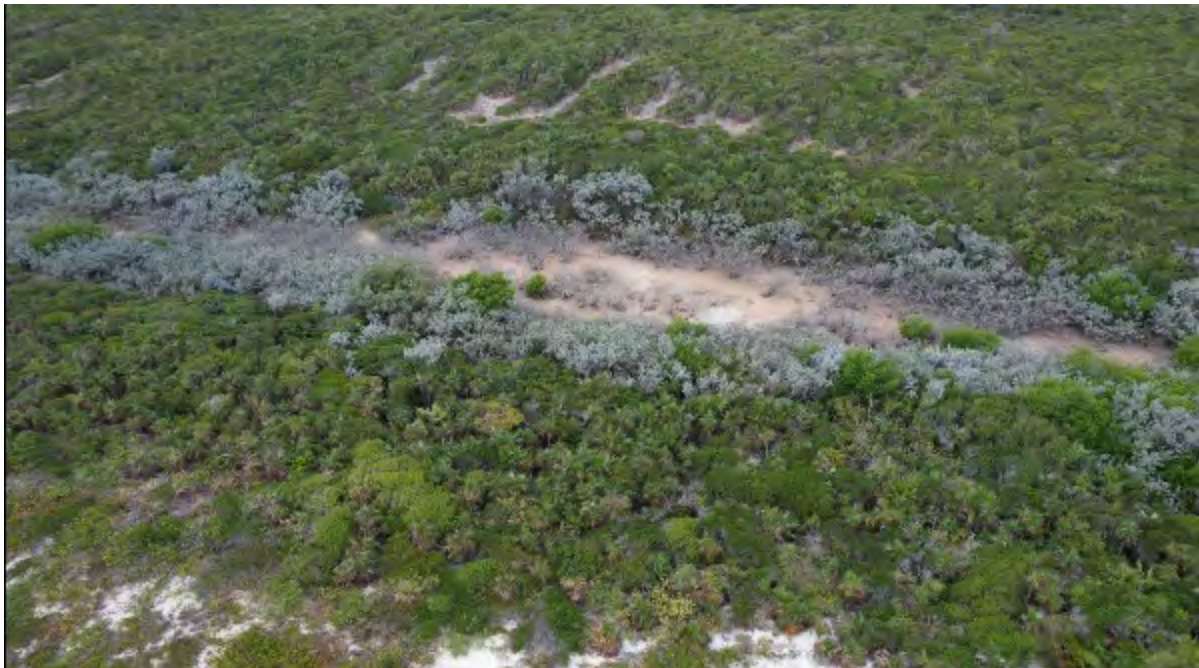
*Figure 6-15 Interior buttonwood formation*

Elsewhere, the buttonwood formation may have been formed by the surface dissolution of bedrock (limestone begins to be eroded away by acid rain which causes cavities, and eventually turn into larger depressions that hold water, and is periodically filled in by sea water or rainwater). This formation exhibits mature silver buttonwoods interspersed by mangrove species easily accessed by a raised wooden platform.

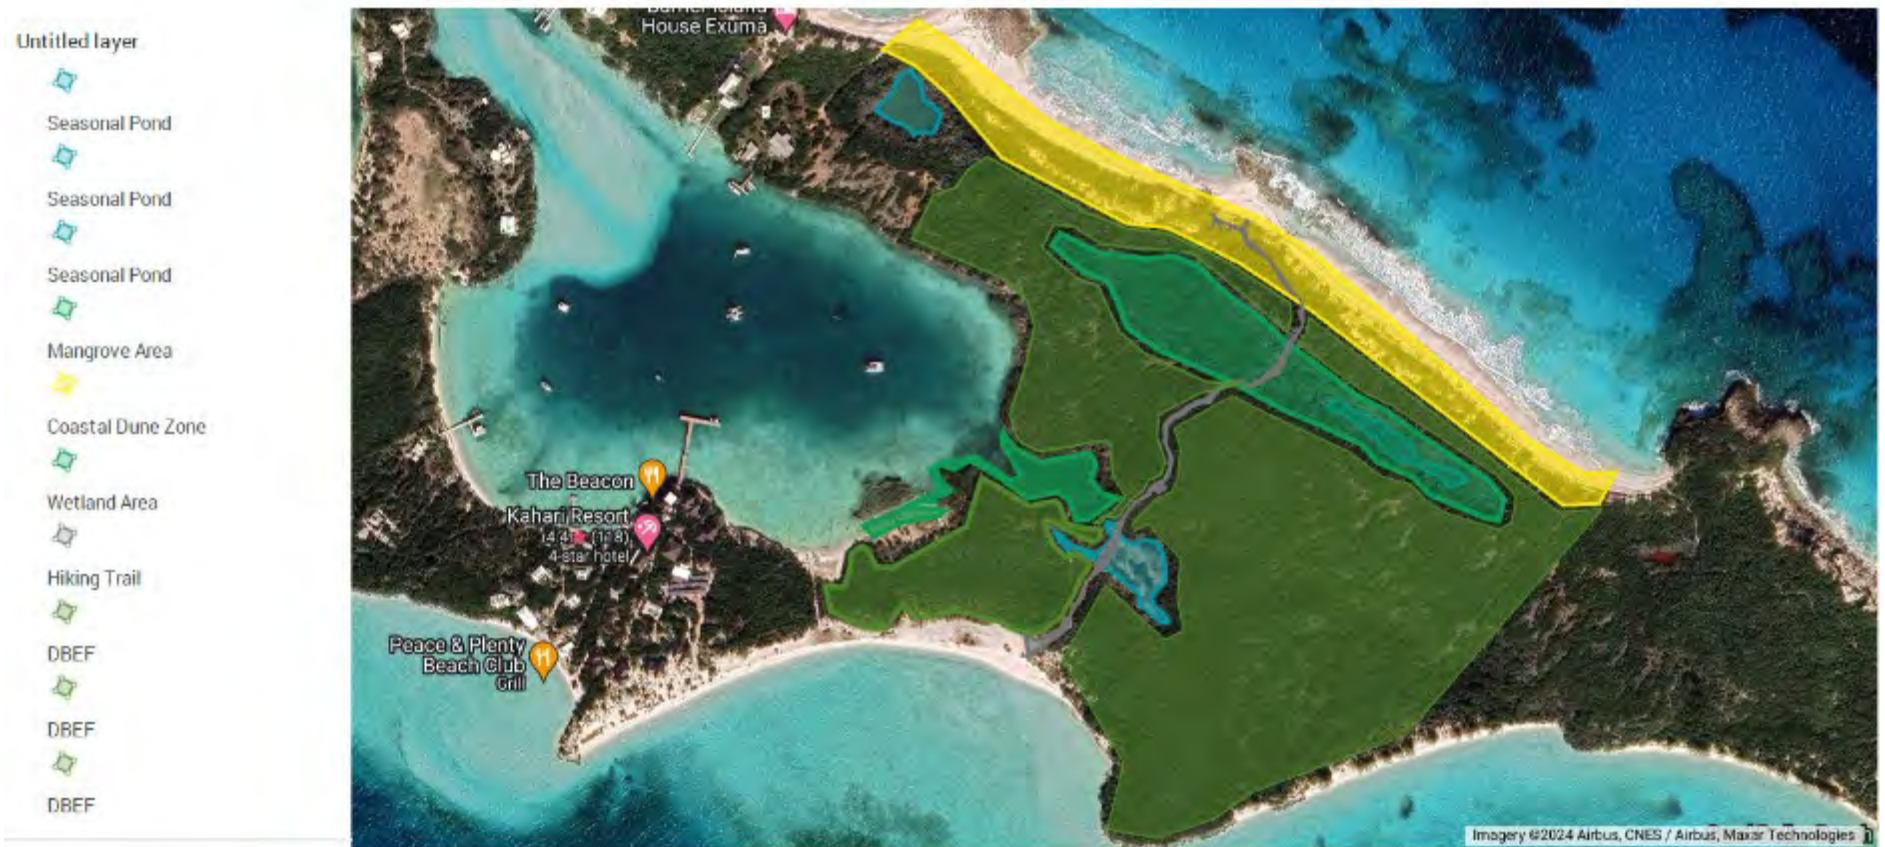
Figure 6-17 Vegetation Map detailing the different vegetative zones identified on Stocking Island as was observed comparable with the Aerial imagery posted below.

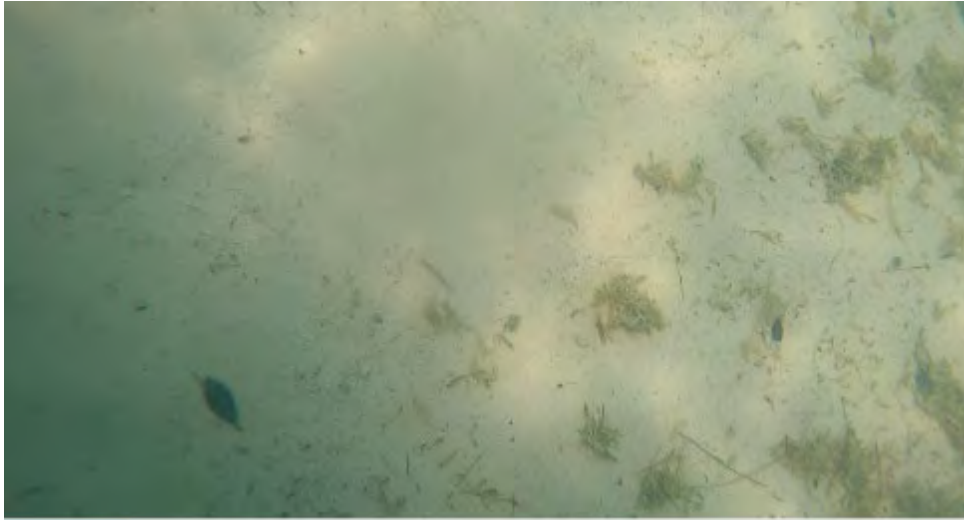
Figure 6-18 The sea floor consist of a fine soft sand, with an estimated two percent mix of Turtle Grass (*Thalassia testudinum*) and Manatee grass (*Syringodium filiforme*)) Coral Conditions

Sandy bottom is the predominant substrate with small patches of Turtle Grass (*Thalassia testudinum*) and Manatee grass (*Syringodium filiforme*); no hard or soft corals were observed within the project area. The assessed area had a limited but notable abundance and diversity of marine flora and fauna.

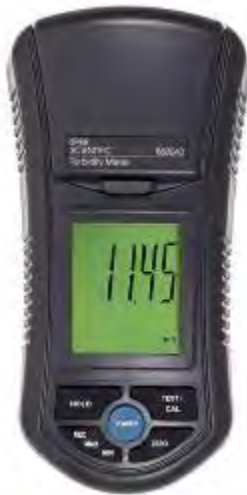
Figure 6-19 Sper Scientific 860040 Turbidity Meter

- Boat
- Drone fly over and review of satellite imagery.
- In situ Marine on foot survey of both the marine and near shore environment.
- Underwater Camera (Go pro)
- Sper Scientific 860040 Turbidity Meter
- Digital 5-in-1 Meter IP67 Waterproof tester for Hydroponics. includes pH, TDS, EC, Salinity%, Salinity ppm, and Temp Turbidity, Ph, Salinity, Electrical Conductivity (Ec) Ms/Cm and Temperature
- Water sample container

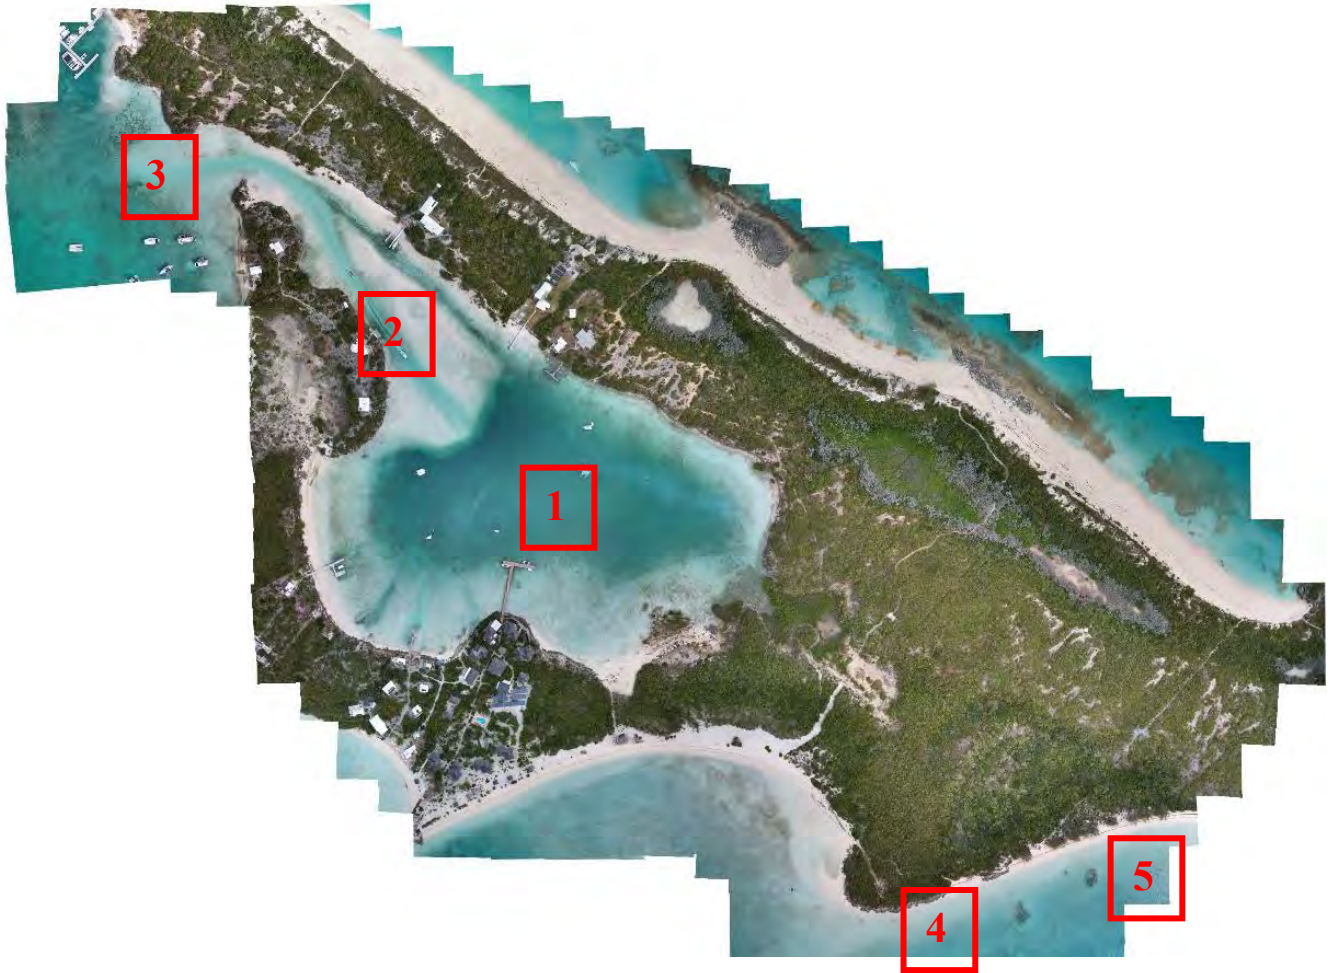
Figure 6-21 Orthomosaic showing five (5) locations where all water samples were collected. Water sample points vary from the proposed dredge location in the lagoon (1-3) to the proposed equipment landing site (4 & 5)

The water quality parameters tested include turbidity, pH salinity, electrical conductivity (Ec) Ms/Cm and temperature. These parameters aid in determining baseline levels to provide a strong indication for the overall conditions of the site.

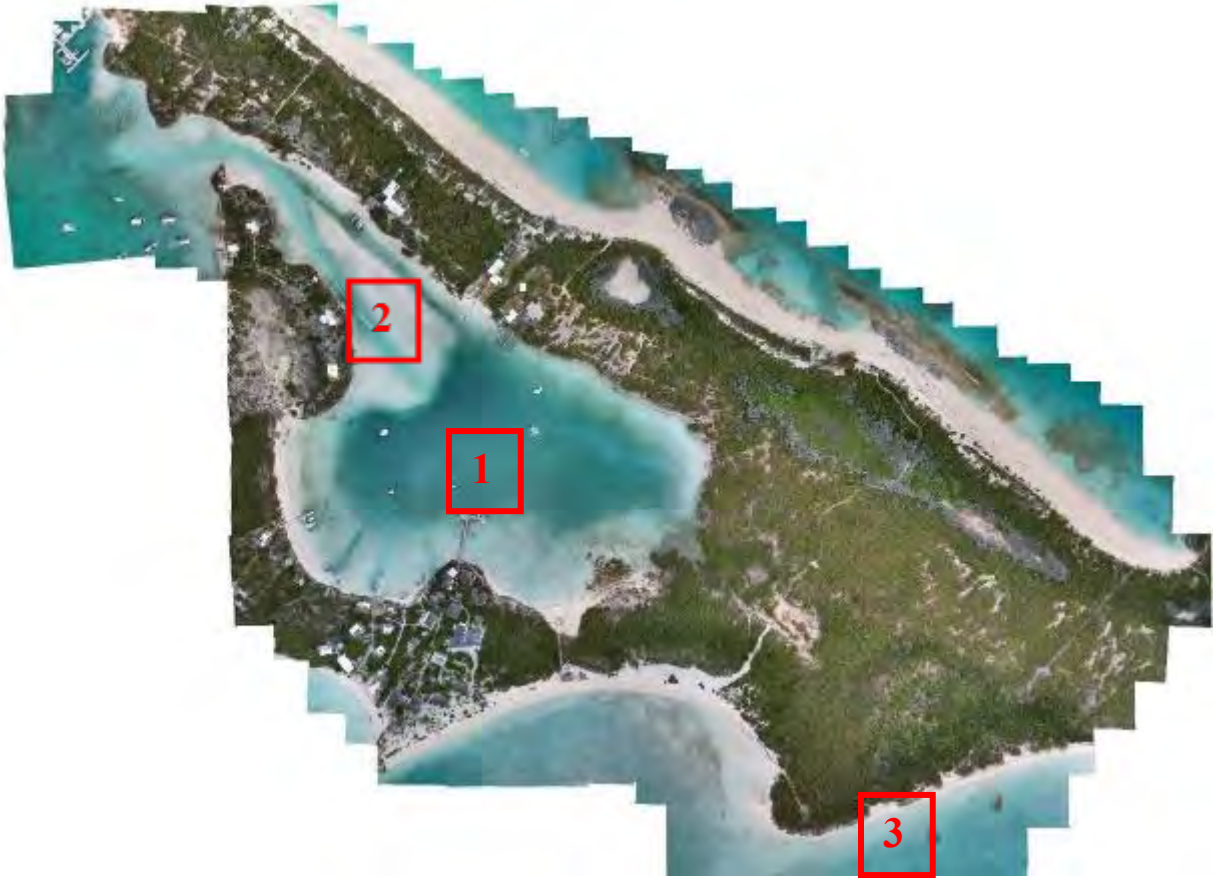
With the seasonal influx of several hundred vessels in Elizabeth Harbour, water quality tests were performed to gauge the presence of total coliforms, fecal coliforms, and *E. coli*. Three (3) samples were taken on March 20<sup>th</sup> by grab: one (1) in the interior lagoon, one (1) in the channel, and one in Elizabeth Harbour. All samples contained total coliforms and *E. coli* with lowest levels measured in the more open waters of Elizabeth Harbour. Samples were kept on ice and transported to ADKA Laboratories on March 21<sup>st</sup>. Zero colonies grew for DEHS, FDEP, and WHO Water Guidelines MCL. The presence of *E. coli* does denote some degradation of existing water quality. Testing locations and results are provided below:

*Figure 6-27 Water Sample Locations, ADKA Test Samples, March 20, 2024*

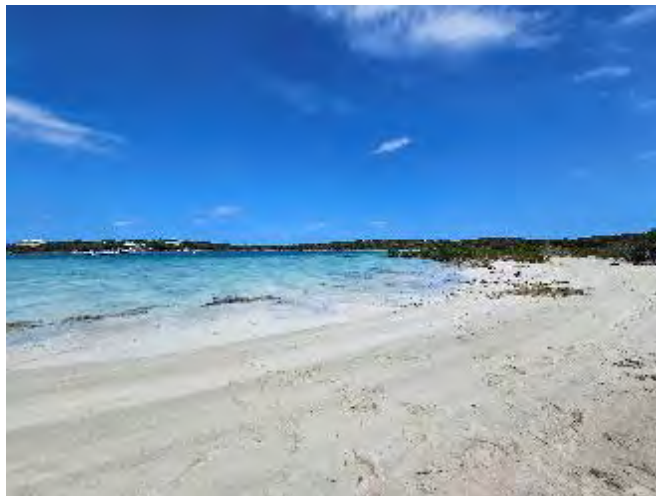
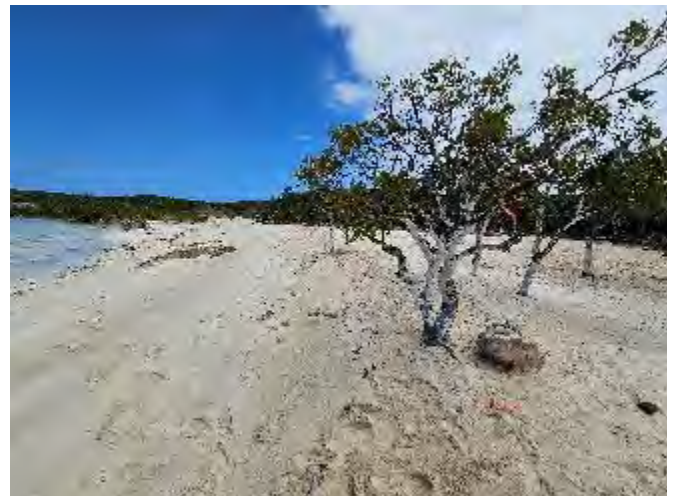
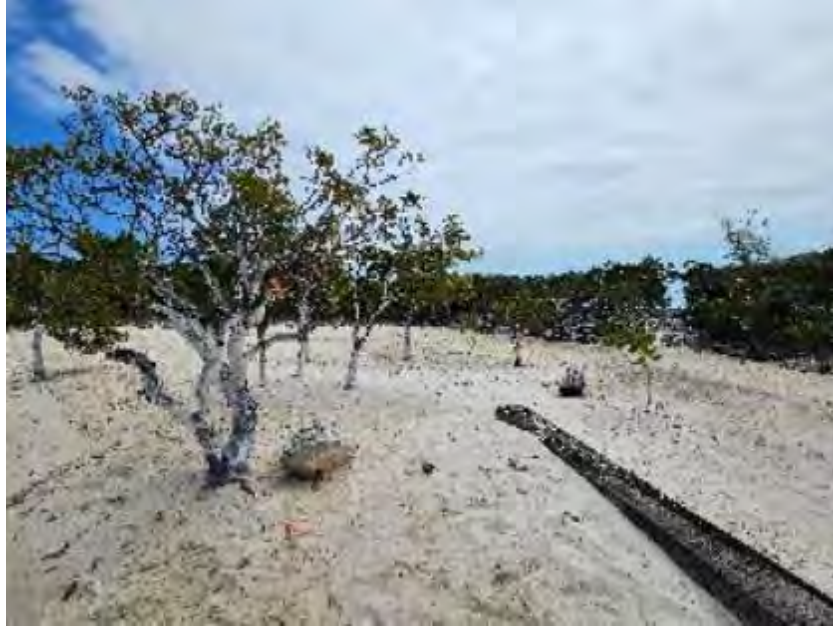
Dredged spoils from the RORO and marina will be used on the property for beach improvements, particularly at the low relief beach within the lagoon. There are no anticipated beach improvements below the high-water mark.

*Figure 9-3 Interior lagoon beach for upland renourishment, March 2024*

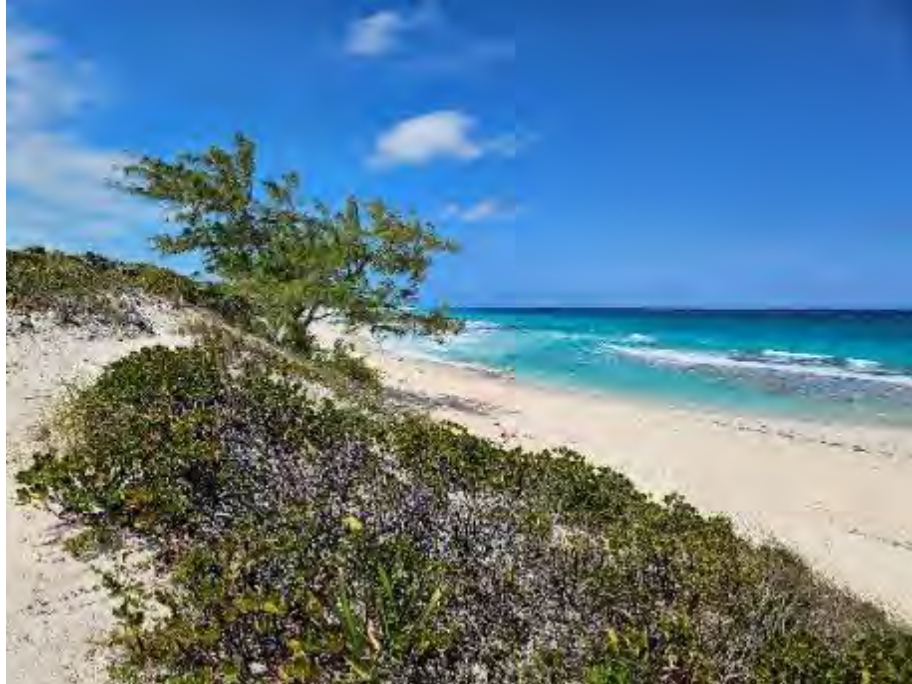
Residences constructed on lots 30 through 34 will be constructed at minimum distance of fifty (50) ft from the crest of the dune. Please refer to the appendix for additional details.

*Figure 9-4 High relief frontal dune facing the Exuma Sound*

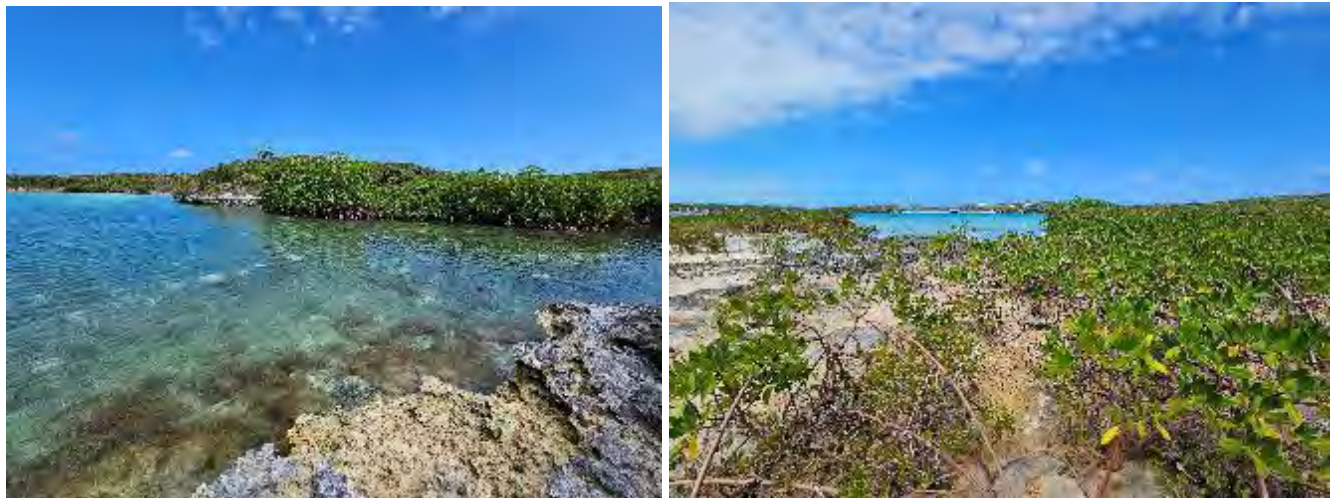
A creek fringed by red mangrove flows into the project from the lagoon. The creek terminates at largely open sand flat largely devoid of vegetation save for mangrove saplings and intermittent grasses. Given the dearth of established vegetation, it is anticipated that this area floods during king tides and/or is a vehicle for drainage flow into the lagoon following a rain event. The developer intends to construct a raised golf cart path in this area and/or the installation of culverts to maintain the naturally existing exchange of water in this area. Non-structural project features such as tennis courts may be constructed on the sand plain pending adequate drainage.

*Figure 9-7 Mangrove fringed creek and area of dwarfed mangrove, March 2024*

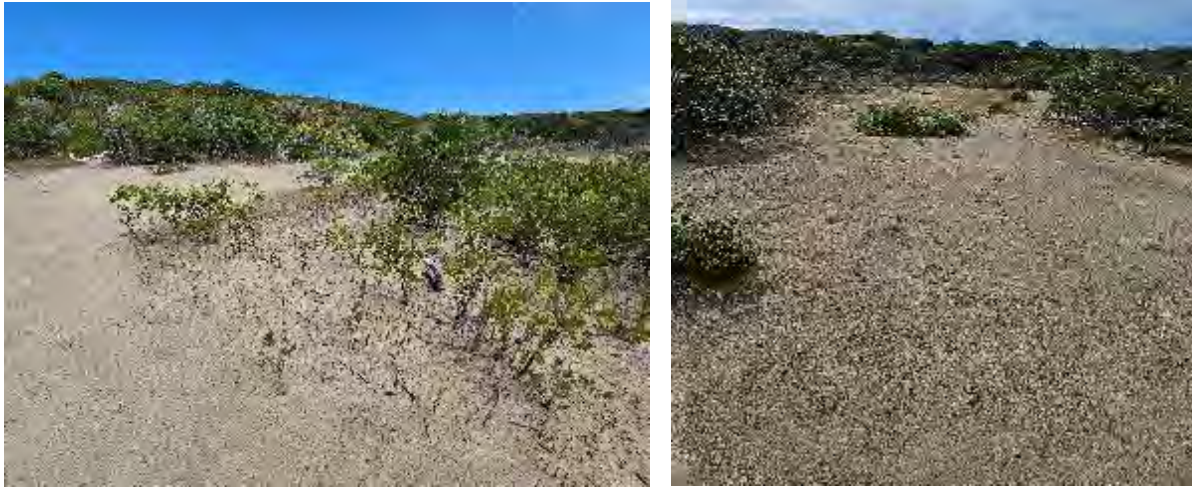
*Figure 9-8 Open sand flat/flood plain with individual mangrove saplings, March 2024*

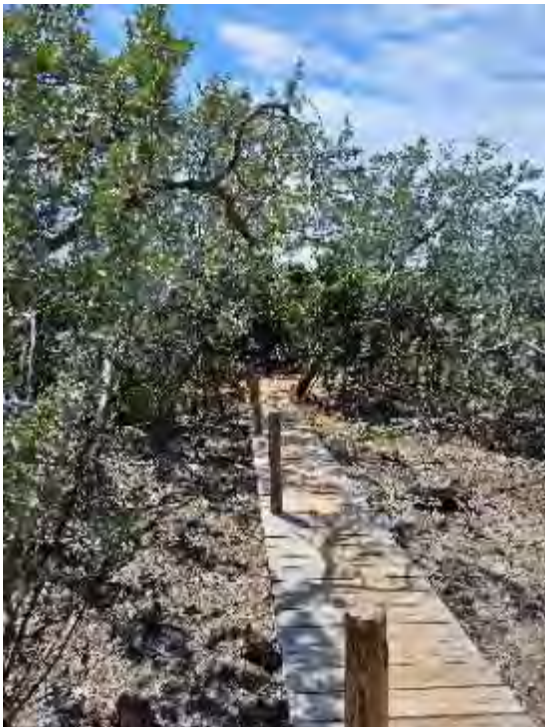
The approximately 4-acre buttonwood formation will be largely avoided save for construction of a roadway around its western perimeter.

*Figure 9-9 Button formation and elevated walkway*

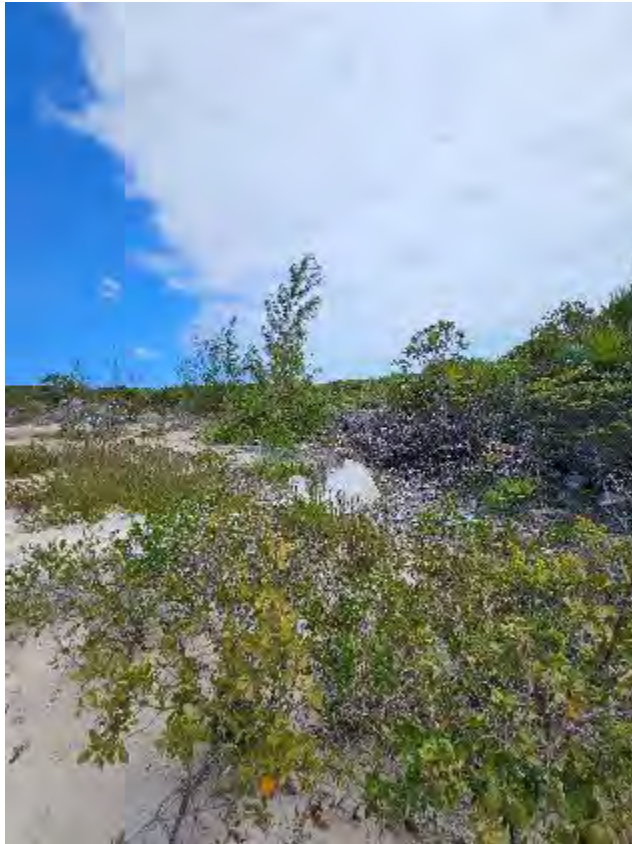
Figure 9-10 Debris and an invasive *Casuarina* sp. along the lagoon perimeter, March 2024

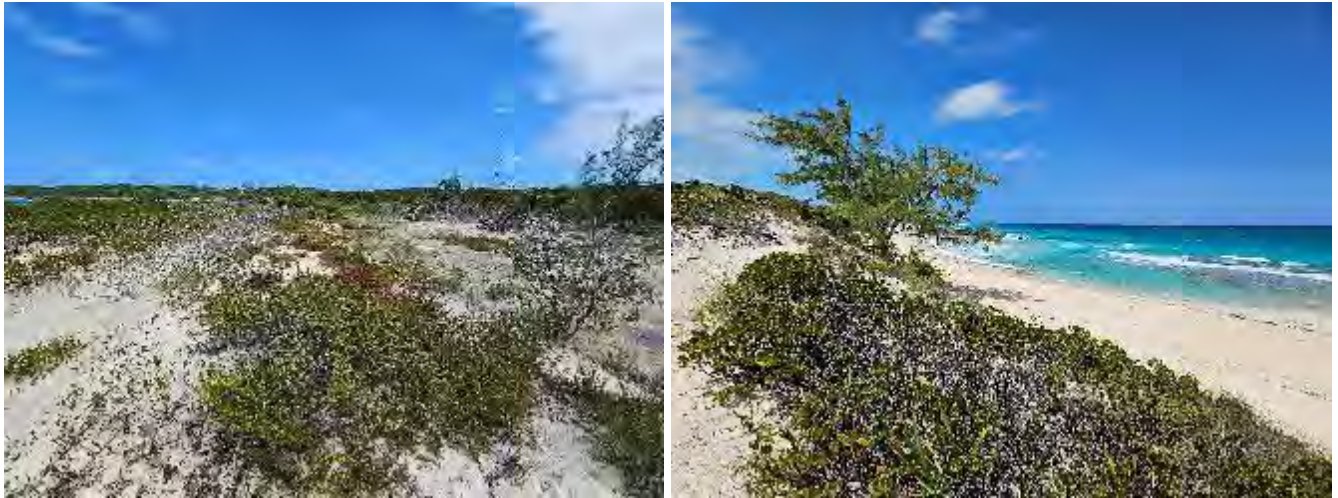
*Casuarina* sp. were infrequently present along the coastal areas (windward and leeward beaches) with some immature trees starting to grow behind the dwarf mangrove flat adjacent to the lagoon and low relief interior beach. The manual removal of seedlings and saplings is strongly recommended, given the size of the trees, if not possible the trees are to be felled using a chain saw. The stumps will then subsequently be treated with an herbicide that can be sprayed or applied to the bottom of the trunk.

Figure 12-1 Left: *Casuarina sp.* coastal lagoon perimeter, Right: *Casuarina sp.* windward dune
