Pond History

SHPOA's pond management strategy (<https://shorewoodhillspoa.org/lake-%26-ponds>) is based on information provided through the years by professionals that the ponds are man-made - meaning their original state was not ponds. Below is information and illustrations that confirm this.

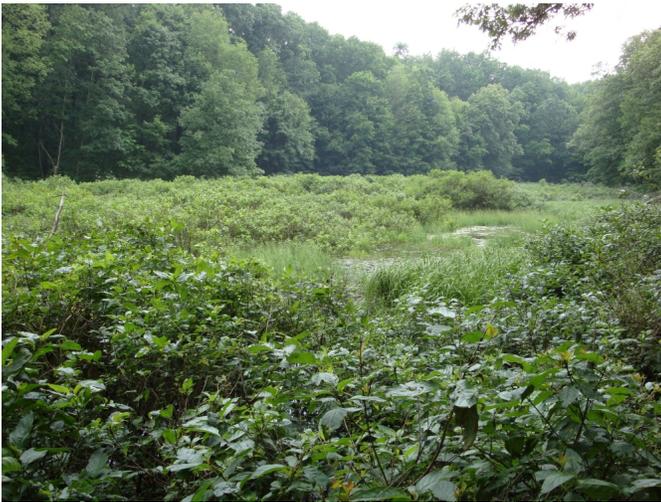
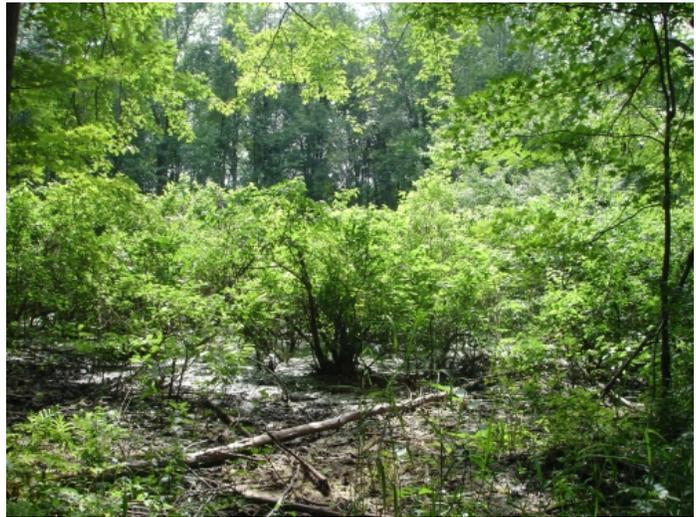
The left side of the screen is information about the historical process, the middle is a present-day map of our neighborhood, the right side is the 'vegetation circa 1800' map.

The 'vegetation circa 1800 map' showing the original state of our "ponds" – a shrub swamp/emergent marsh.

The vegetation map indicates that the ponds were a shrub swamp/emergent marsh. In this type of pond, “Soils are saturated or inundated mucks of variable depth over silty or sandy clay. Water depth varies seasonally and from site to site. The community is dominated by buttonbush.”

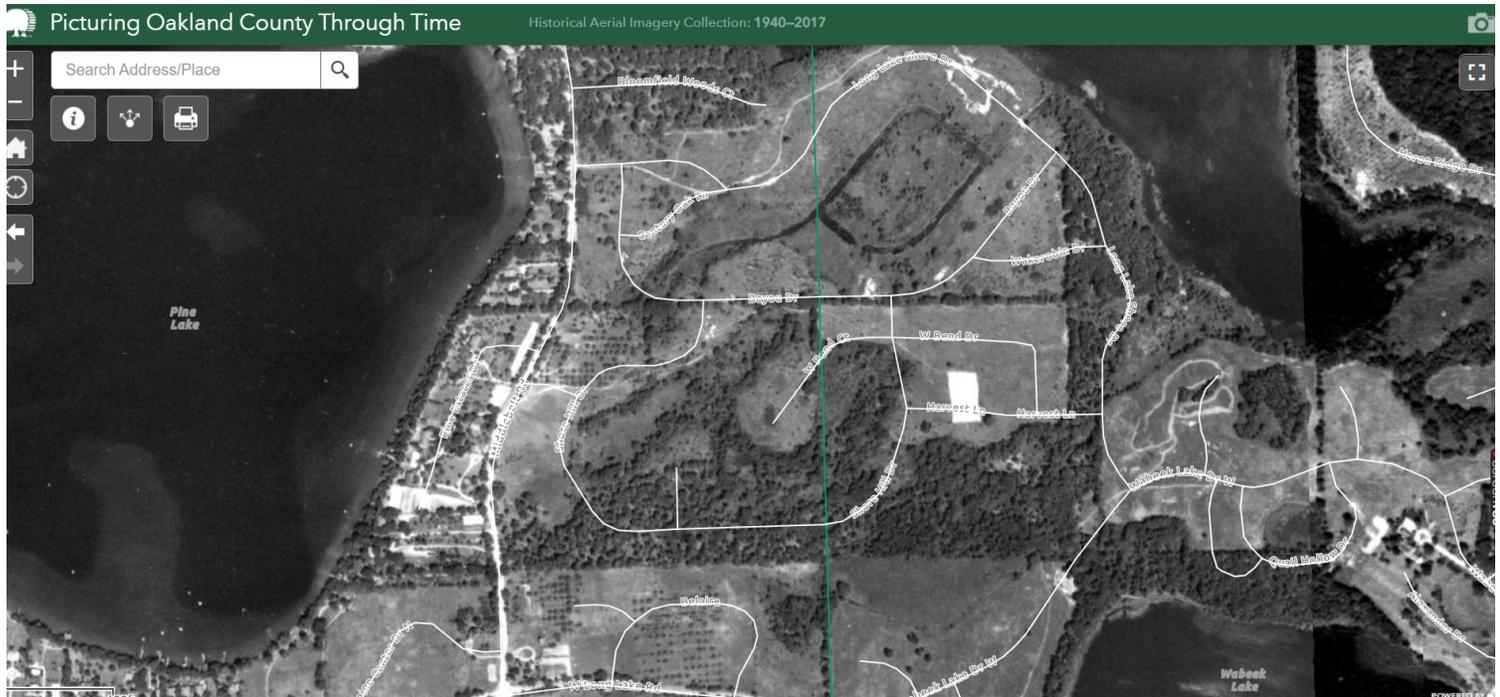
The above photo shows our neighborhood in 1940. Note the water in Pine Lake and the lack of water in our shrub swamp/emergent marsh.

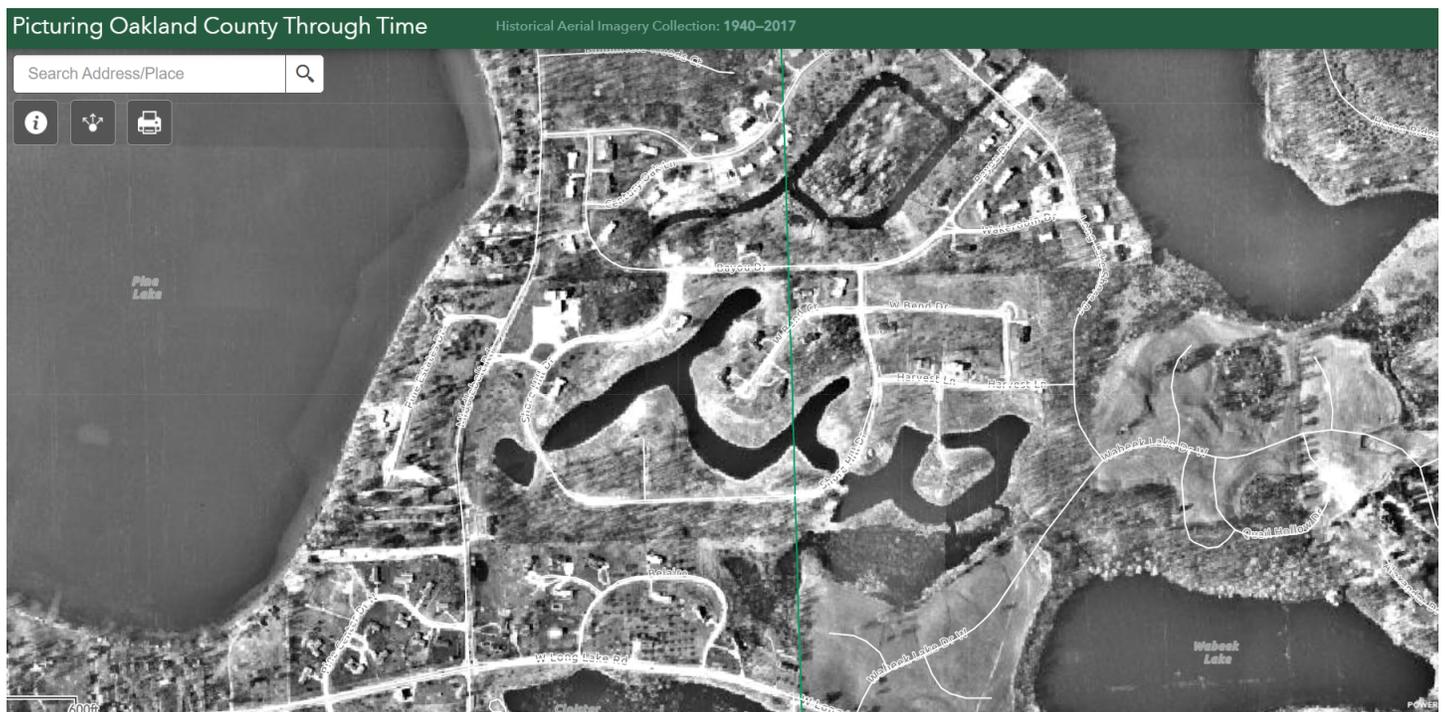
The above photo shows our neighborhood in 1963. Note the water in the ponds. It is highly likely the ponds were dug as part of the storm water collection system when the subdivision was developed. They are essentially retention basins; all road runoff drains into the ponds.
