TECHNICAL MEMORANDUM

To: Kinni Corridor Collaborative
From: Sean Morrison and Marty Melchior, Inter-Fluve
Date: December 29, 2020
Re: Drone based Drawdown Analysis

A drone-based drawdown analysis was conducted on the Powell Falls dam impoundment (Lake Louise) during and after a drawdown of Lake Louise. The drawdown occurred between October 2nd, 2020 and October 16th, 2020. This analysis shows an initial downcutting of the channel and the beginning of lateral migration following a rainfall event of October 12th.

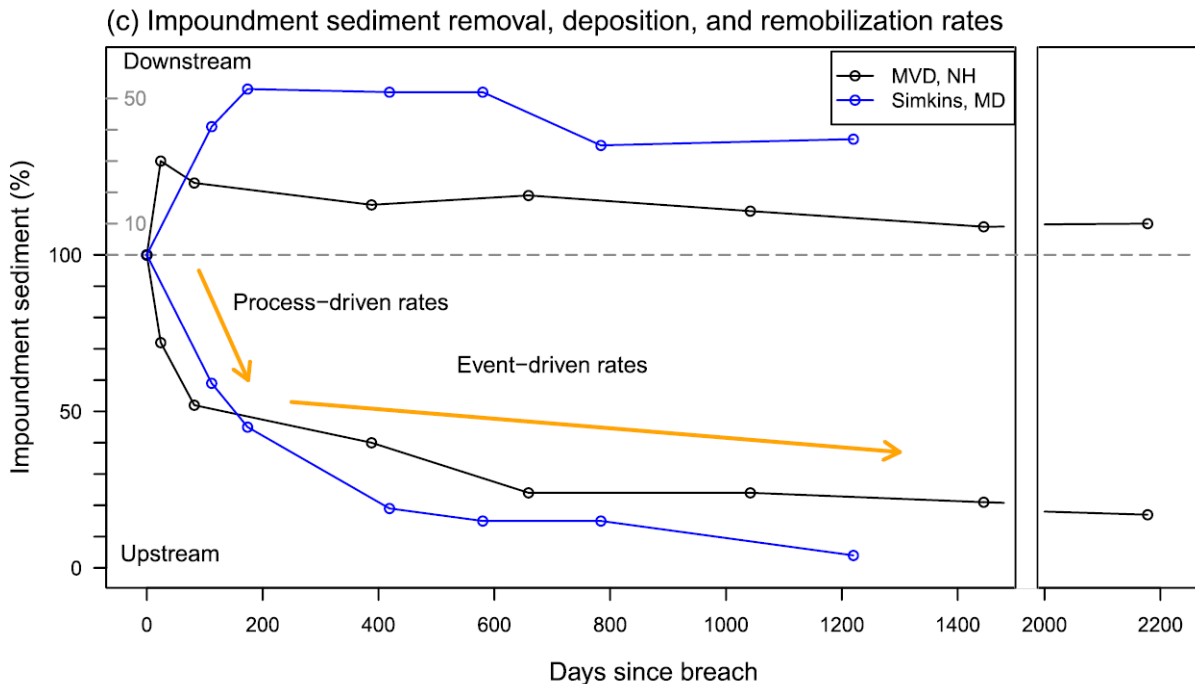
Figure 1: Impoundment sediment erosion and deposition rates for two dam removals (from Collins et al. 2017)

The uncontrolled release of impounded sediments often occurs in two phases: a 'process-driven' and 'event-driven' phase (Figure 1). In the 'process-driven' phase, dam removal results in base level lowering, an increase in the energy gradient and incision through the former impoundment (Doyle et al. 2002, Pearson et al. 2011). Following this phase, during the 'event-driven' phase "larger flood events are necessary to erode impounded sediments more distant from the new channel" (Collins et al. 2017). Typically, 'event-driven' sediment movement requires floods at or larger than the 5-year event. The change from 'process-driven' to 'event-driven' occurs when a stable channel slope is generally reached and the channel is large enough to convey bankfull flows (Collins et al. 2017). In dam removals where downstream sedimentation is a concern, excavation of a pilot channel often sufficiently replicates the 'process-driven' erosion allowing the majority post-construction erosion follow an 'event-driven' trajectory.

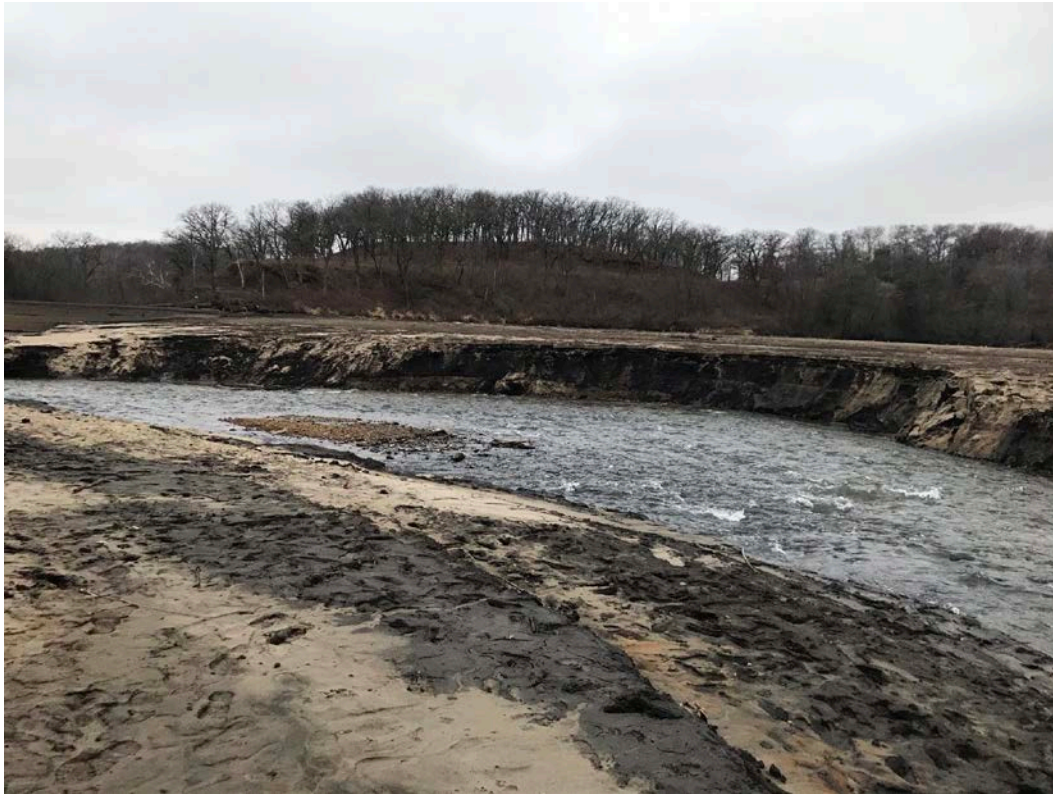
Figure 3: Photo of the channel collected on 11/25.

On the ground photos collected on 11/25 showed near vertical banks which were approximately 12 ft high near the dam and gravels on the channel bottom (Figure 3). Assuming a wedge shape of sediment along the length of the channel between the dam and abandoned sewer crossing with an average width of 39 ft, 10,790 cubic yards of sediment may have been release due to the drawdown. Ayres (2020) estimates that 8,000 cubic yards of sediment may have been released due to the drawdown. Since no bathymetric survey was done before the drawdown occurred, the exact amount of sediment released during the drawdown cannot be accurately quantified. The range provided by the Inter-fluve and Ayres reports provides a reasonable range of the sediment volume released during the drawdown. The most recent sediment volume estimates by Ayres (2020) suggest that 200,000 cubic yards of sediment are currently stored in the impoundment, and that 80,000 cubic yards total is likely to be mobilized if the drawdown continues.

Gravels on the channel bottom may indicate that the channel has reached its pre-dam elevation and initial incision of the channel is nearing completion (Figure 3). However, the gravels may also be unassociated with the pre-dam channel and represent a coarse layer deposited in the impoundment or a coarsening layer caused by the winnowing (removal) of fine-grained sediment. The near vertical banks are unstable and will continue to erode and calve into the channel even under relatively low flow conditions. Immediately downstream of the Powell Falls Dam, several mid-channel bars have developed following the drawdown (Figure 4). These bars are composed primarily of the sand sized sediment eroded during the drawdown as the new channel was excavated. Finer grained sediment was transported further downstream as suggested by the increased turbidity during the drawdown. The deposition immediately downstream of the dam is temporary and larger floods are expected to transport the sediment further downstream and may lead to the burial of gravel riffle substrates, which are the most abundant and beneficial aquatic habitats located downstream of the Powell Falls dam (Inter-Fluve 2020a).

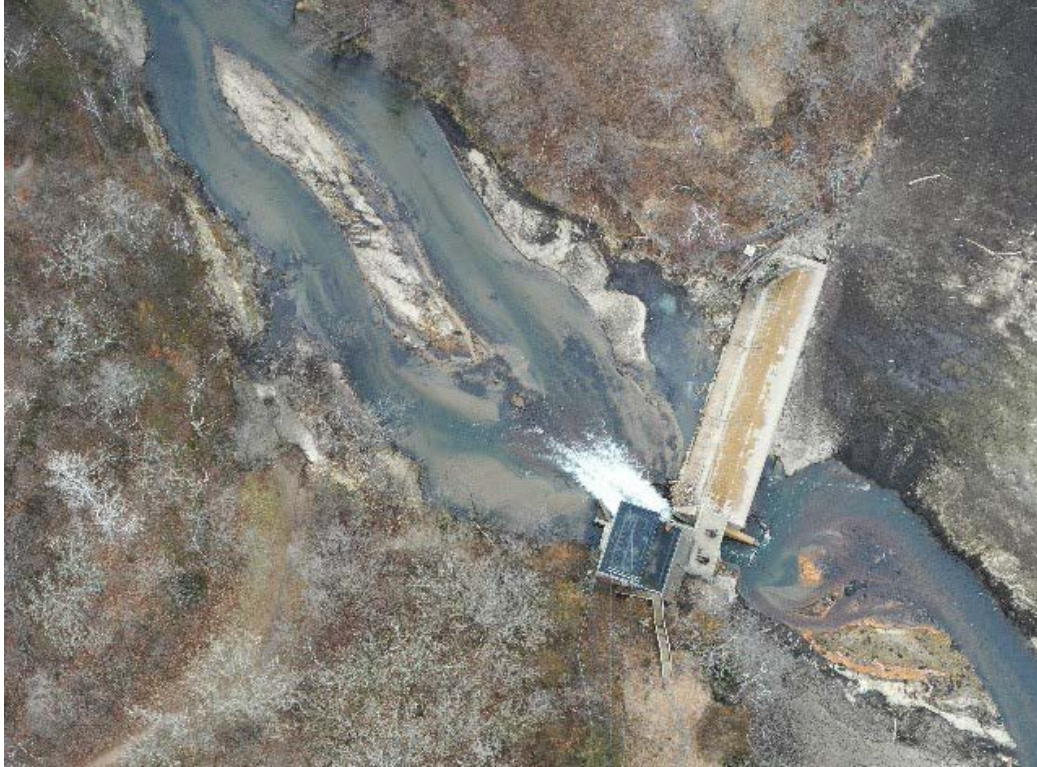
Figure 4: Drone image collected on 12/11 above the Powell Falls dam showing bar development immediately downstream.
