Request List 1704 East 3rd Street Hope Ark

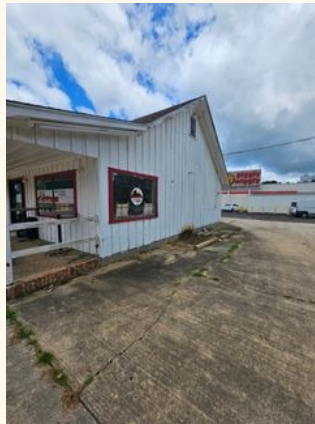
(G-3) Review :

Localized physical damage was noted to the concrete flatwork. Have the builder repair damaged concrete as needed. Concrete repairs could cost between \$3000.00 to \$8000.00.

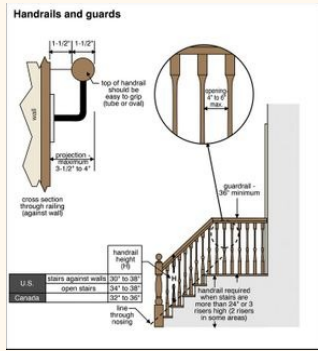
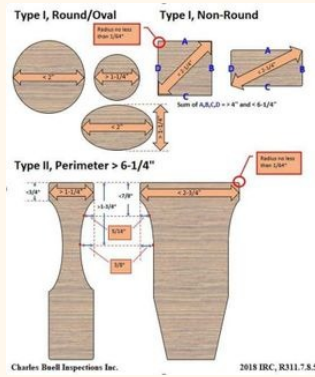
(G-4) Review :

The entry stairs are missing a graspable handrail for safety. This should be a round railing 1 and 1/4 inches - 2 inches in diameter. If the railing is not round it must have a finger groove that is 3/4 of an inch down from the tallest point of the rail. The graspable handrail should also be 1.5 inches from the wall. 2x material is not considered a graspable handrail. Have a qualified contractor build suitable railings to reduce the potential for falls. Repair cost could cost up to \$500 to \$1000.00.

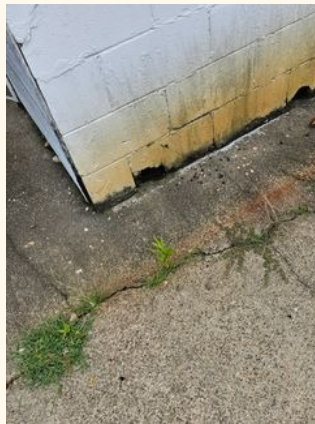
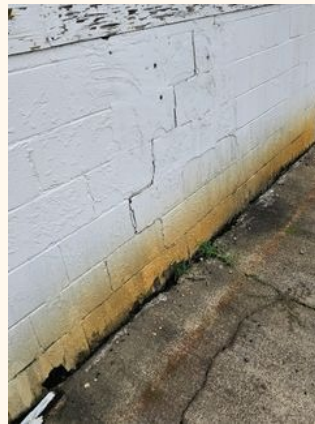
(ED-3) Review :

Cracking noted in the CMU exterior walls. Repair of damage CMU blocking can cost between \$8000 to 10, 000.00.

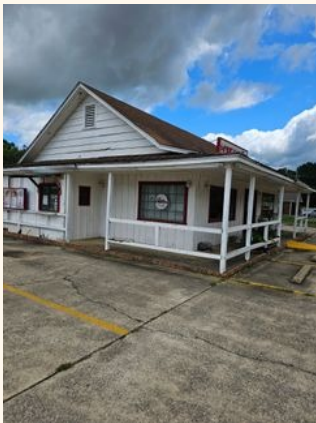
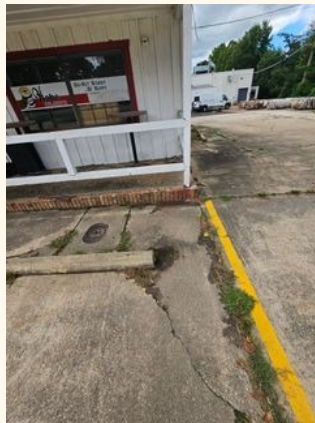
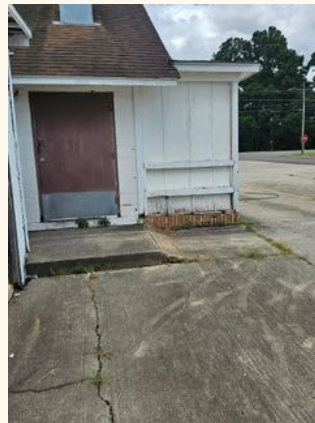
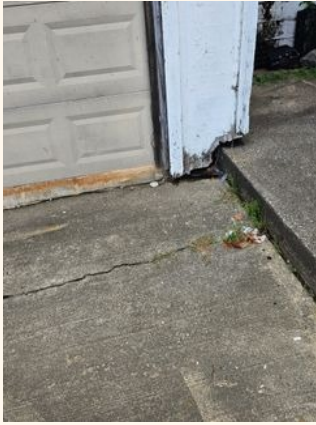
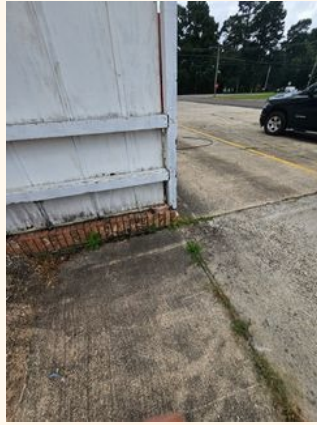
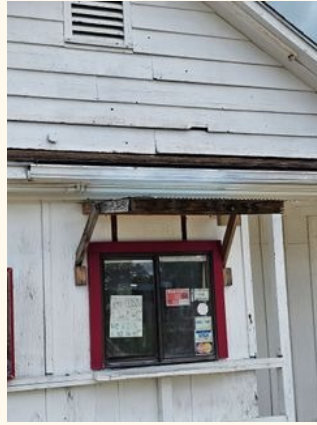
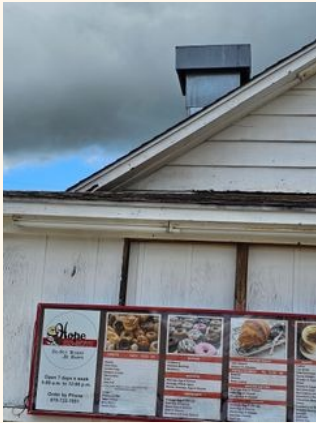
(ED-4) Review :

Exterior of the building shows signs of water damaged. repairs to the building may cost up to 12,000.00 depending on scope of work.

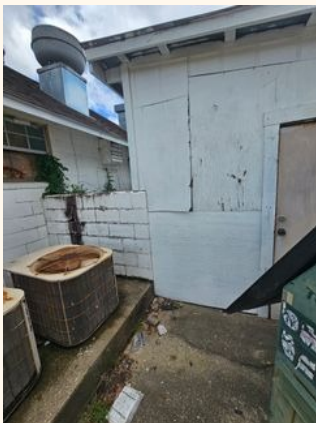
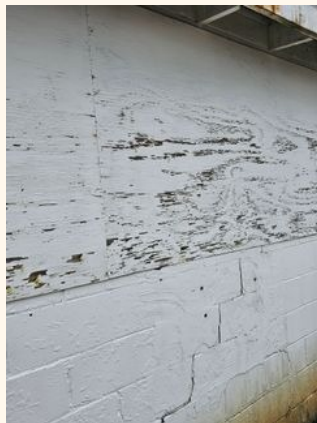
(ED-5) Review :

Siding damaged and decayed in various locations. See above cost estimates.

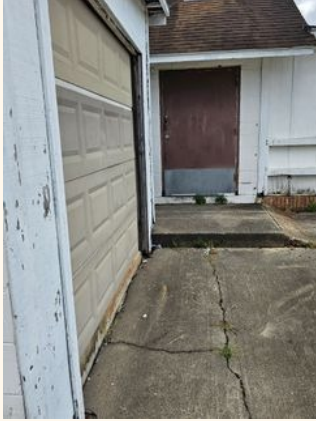
(ED-6) Review :

Exterior doors appear damaged. Repair or replacement of doors could cost between \$1000.00 to \$2000.00 or more depending on the type and style of door.

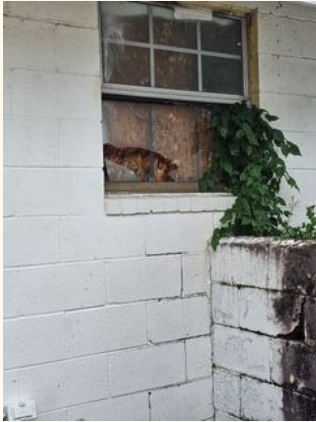
(ED-7) Review :

Windows damaged and missing. REpair or replacement of window could cost between \$500 to 1500.00.

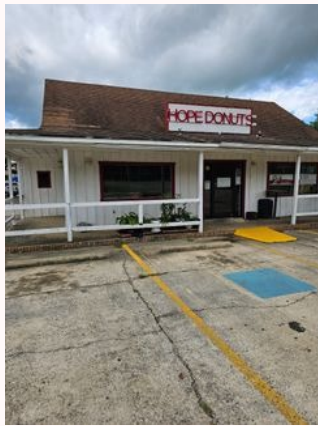
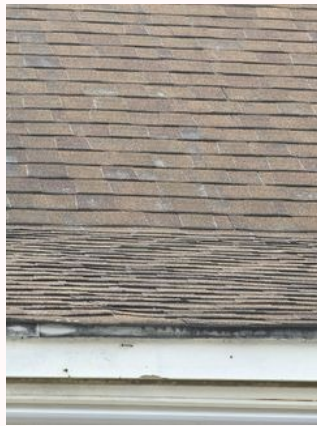
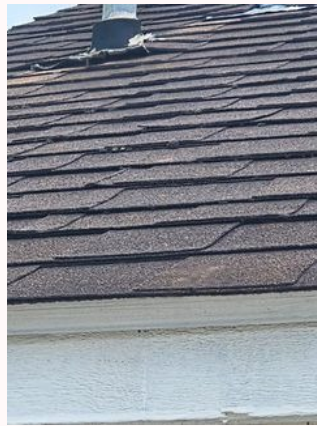
(RCG-2) Major Concern :

This building has an older roofing system that is nearing the end of its useful service life. I would expect the need for regular and on-going maintenance to this roof until it is updated. The roofing material on this building is done in an architectural grade composition shingle. These shingles are often rated as 25-30 year shingles, though I find in practice, as a roof assembly, 18-22 years is more realistic depending on the quality of the installation, the amount of exposure and the pitch of the roof. Please note that roofs are not a shingle, they are an assembly and they require regular maintenance to keep them performing reliably. Examples of observations and repair items noted during inspection include:

Begin gathering estimates and bids for replacement by qualified roofing contractors and update as soon as feasible. Estimate cost could be between 15,000.00 to 23, 000.00.

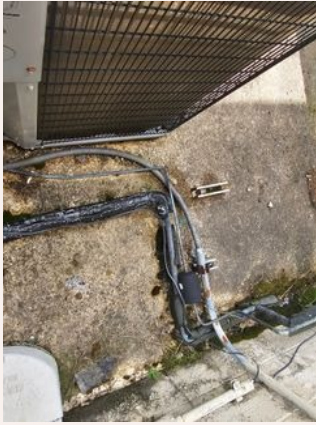
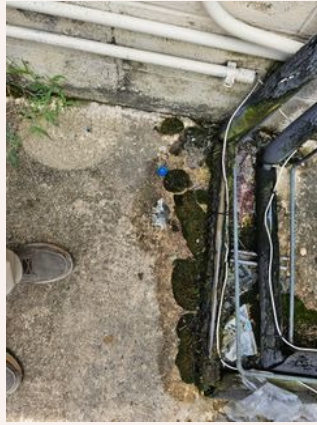
(HCFV-5) Recommended Preventive Maintenance :

Refrigerant line insulation damaged and missing.

Comments: repairs to insulation on lines.
Redemption Value: \$1,500.00

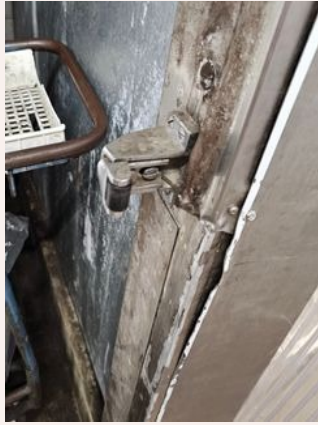
(I-5) Recommended Preventive Maintenance :

Walking cooler metal damaged, rusting, and gapped.

Comments: Repairs to walk in coolers
Redemption Value: \$2,499.99
