Property Inspection Report

**102 Walnut Lane
Delhi, LA 71232**

Date of Inspection
**May 13th, 2022
1:00 PM**

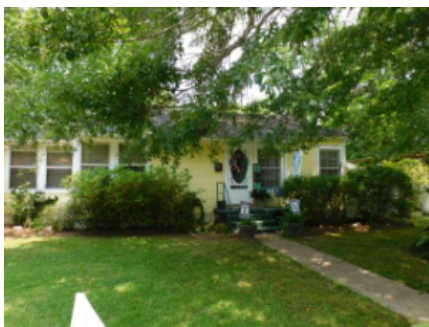
Image 0.1

Plants against the siding limits the Inspector's view and traps moisture against the house siding.

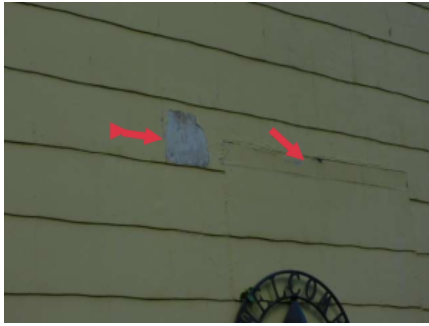
Image 1.3.1

1.3 Exterior Wall Coverings 3 Exterior	Description	<ul style="list-style-type: none"> Fiber Cement
	Condition	<ul style="list-style-type: none"> Paint peeling and stained

Monitor

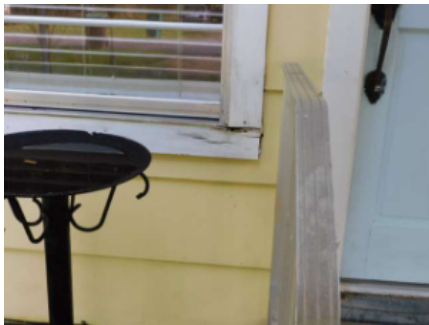
Image 1.4.1

- Wood
- Siding and door trims damaged in various locations.

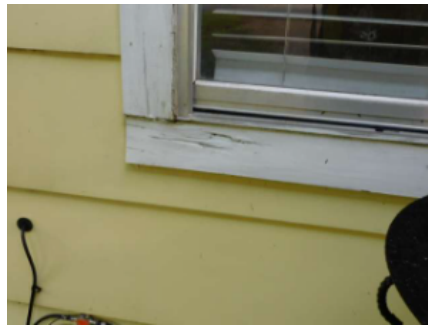
Image 1.4.2 window trim damaged

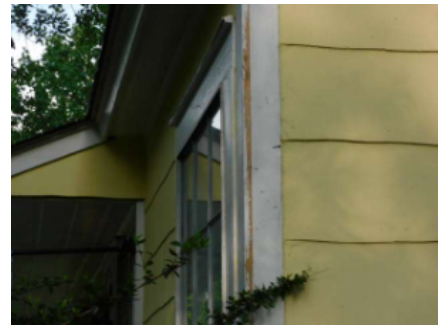
Image 1.4.3 Siding trim damaged

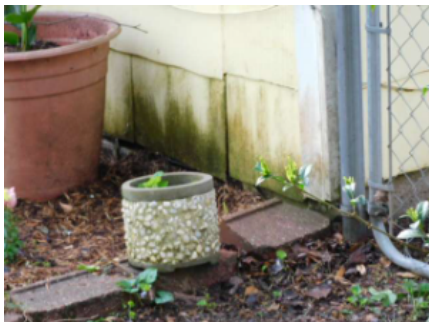
Image 1.4.4 Siding stained/damaged in contact with earth

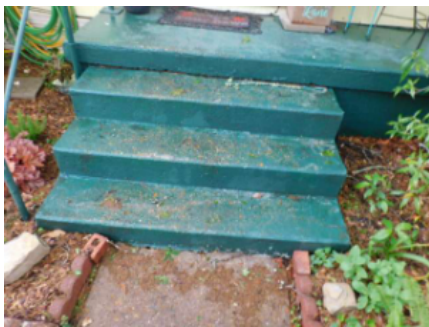
Image 1.5.1

- building standards.
- Uneven steps were noted - refer to the Uniform Building Inspection Report binder in Grounds line 0280 for more information.

Monitor Typical age of home.

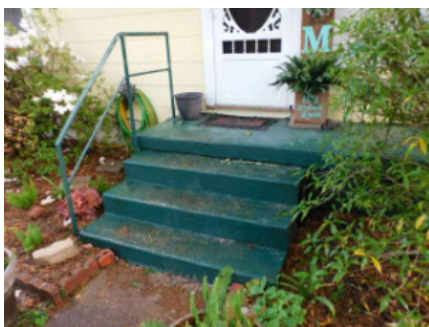
Image 1.6.1

Description	• Concrete	Location	• Front of Home
Condition	• Unsafe	Risk	• fall risk.

Upgrade Hand and guard rail missing. Hand rail on ones side only.
Installed railing dated.

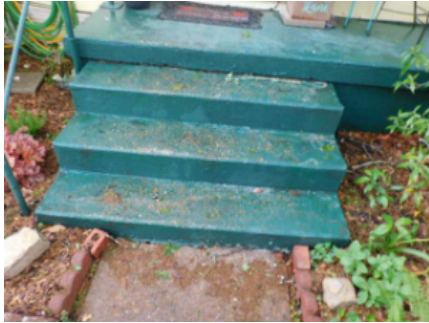
Image 1.7.1

Description	• Metal railings	Location	• Front of Home
Condition	• Incorrect Height	Risk	• Affects Living Condition
	• Not Built to

Upgrade Refer to section 1 Grounds of the Uniform Building Inspection Report Binder in the Grounds section line 0290.

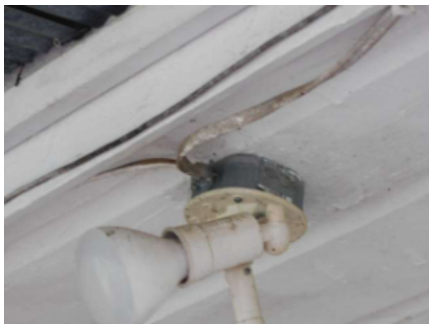
Image 1.9.1

- Exterior

Upgrade

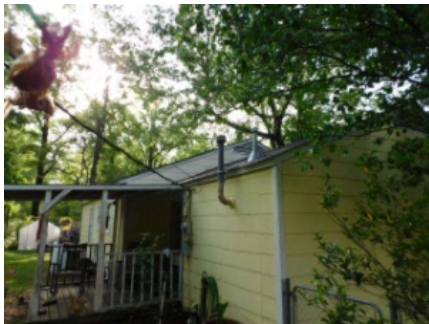
Image 1.10.1

There are tree limbs overgrowing the residence that should be trimmed or monitored, to insure that they do not impact or damage the roof or its components.

We do not evaluate landscaping, but some of the trees need to be trimmed or pruned.

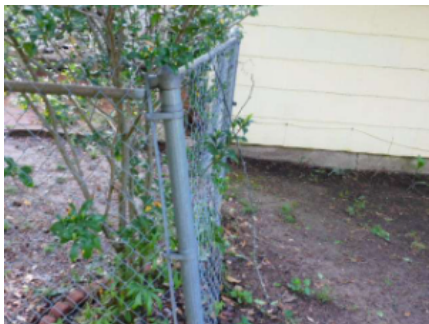
Image 1.18.1

| Condition | • Fence tilted, wood fence damaged.

• Chain link fence damaged/ amiss. |

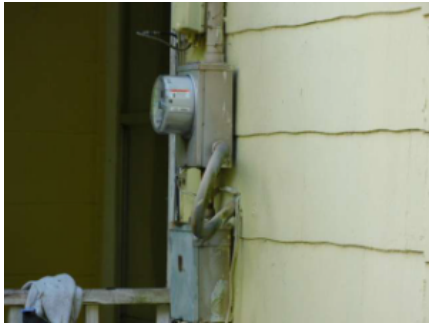
Image 1.19.1

| Description | • Noted on side of home. | Location | • all areas |
| Condition | • Exposed | Risk | • Affects Living Condition |

Dated electrical system

Monitor Power supply 120/240 volt 200 amps

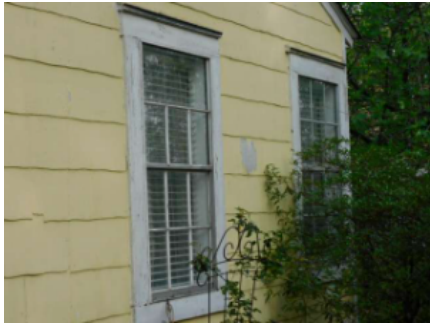
Image 1.21.1

Description	<ul style="list-style-type: none"> • Single glazed metal frame windows. • Single glazed wood frame windows. 	Location	<ul style="list-style-type: none"> • Numerous locations around the home.
Condition	<ul style="list-style-type: none"> • windows appear painted shut.

Evaluation Required

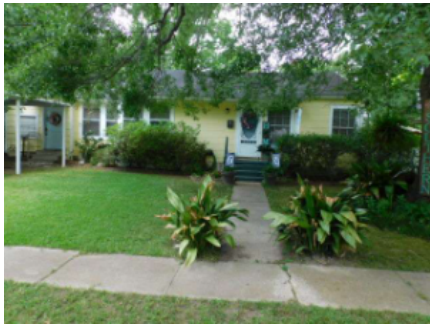
Image 1.L.1

Portions of the fences are obscured by foliage or other material, which prevents a thorough inspection.

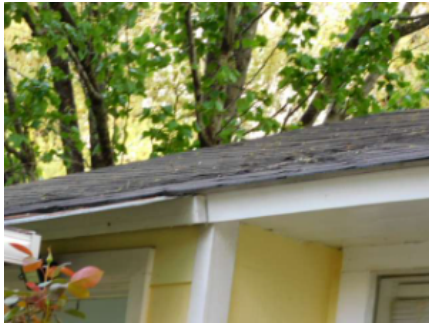
Image 2.2.1

2.2 Roof Type Roofing	Description	<ul style="list-style-type: none"> • Gable 	Location	<ul style="list-style-type: none"> • various locations
	Condition	<ul style="list-style-type: none"> • Shingles show sign of typical age and wear. The attic vent turbin not level. • Sags noted in the roof decking. • Refer to the Uniform Building Inspection Report Binder for more details uner Exterior/Roof line 1000 & 1010. 	Risk	<ul style="list-style-type: none"> • Additional Repair Costs

Repair or Replace - When the roofing is replace it is recommend to have the decking strengthened.: Roof was walked.

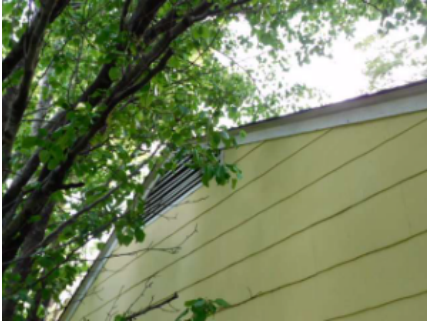
Image 2.4.1

Description	<ul style="list-style-type: none"> • Cut tree limbs to break contact with roof.
Condition	<ul style="list-style-type: none"> • Cut tree limbs to break contact with roofing materials.

Upgrade - Improve for Longevity: Refer to the Uniform Building Inspection Report binder in Exterior/Roof line 1120

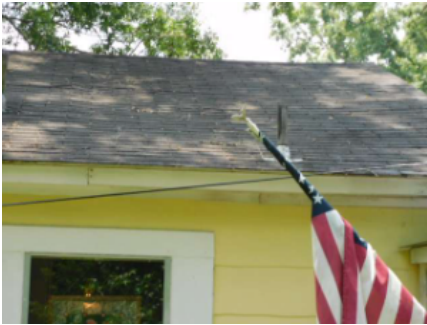
Image 2.L.1

The roof was damp at time of inspection and could not be safely walked on.

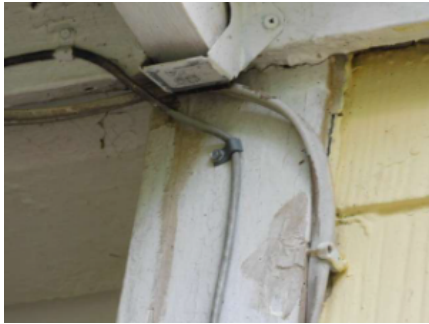
Image 3.7.1

Description	<ul style="list-style-type: none"> • Non-Metallic Shielded Copper 	Location	<ul style="list-style-type: none"> • Various
Condition	<ul style="list-style-type: none"> • Exposed • Wiring exposed in several locations interior and exterior. 	Risk	<ul style="list-style-type: none"> • Electrocutation Hazard

Evaluation Required Wiring exposed in several locations.

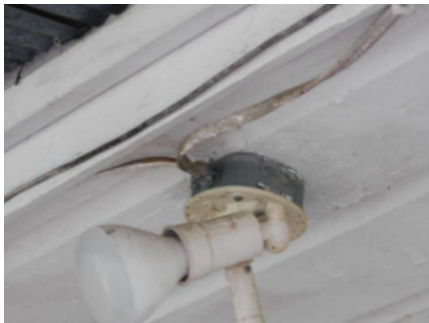
Image 3.12.1

| Description | <ul style="list-style-type: none"> • Exterior light fixture wiring improper | Location | <ul style="list-style-type: none"> • Exterior |
| Condition | <ul style="list-style-type: none"> • Exposed electrical line subject to damage or decay. | | |

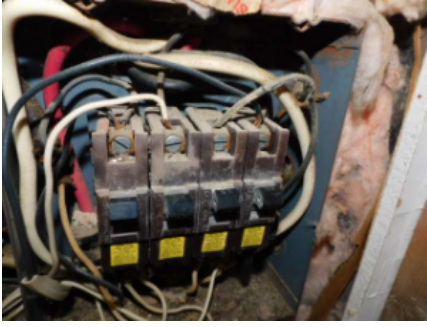
Image 3.L.1

The electrical sub-panel could not be accessed for inspection, and should be made accessible.

Electrical panel in cabinet enclosure behind the washing machine.

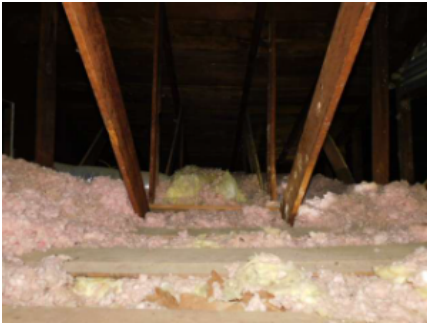
Image 4.3.1

4.3 Cooling Distribution HVAC	Description	<ul style="list-style-type: none"> Attic space not walkways.
	Condition	<ul style="list-style-type: none"> NO signs of moisture barrier visible.

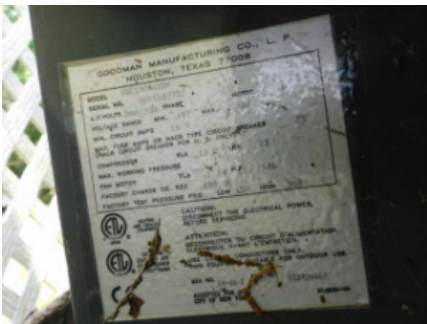
Image 4.L.1

- Ambient Temperature Out of Range for Testing

System appears to operate but under load the Inspector does not know if it will cool.

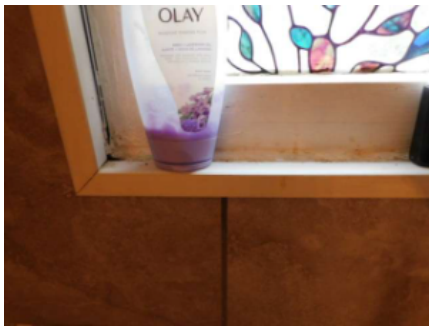
Image 5.9.1

- Description**
- In Tub
- Condition**
- Seal wood window in shower wall
- Location**
- hall bath
- Risk**
- Water Damage
 - Affects Living Condition
 - Not to current codes.

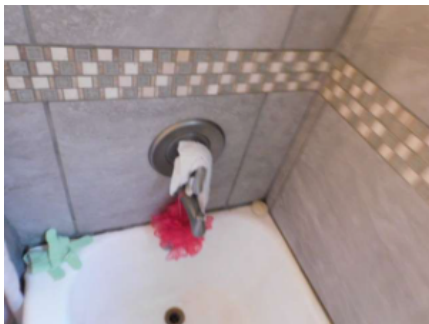
Image 5.10.1

Description • Free Standing **Location** • Hall bath shower
Condition • loose valves

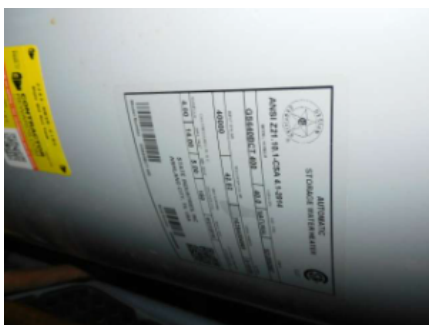
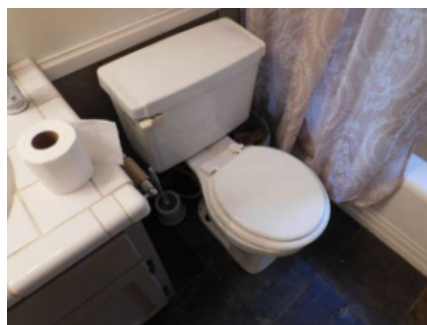
Image 5.11.1

Description • commode seat lose and needs repair **Location** • Hall bath
Condition • Loose

Upgrade

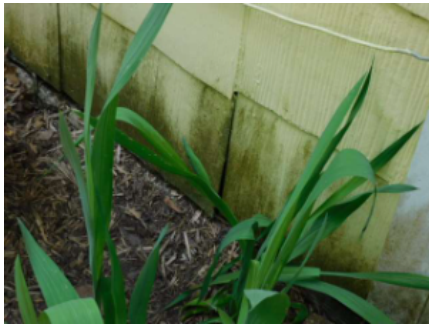
Image 5.L.1

home to low to grade could not access to review the pipes under the

home.

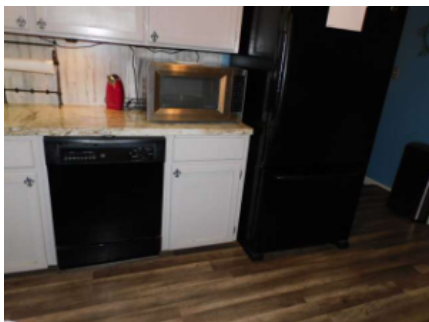
Image 6.2.1

6.2 Kitchen Cabinets Interior	Description	<ul style="list-style-type: none"> Wood
	Condition	<ul style="list-style-type: none"> Dishwasher damaged and needs repair

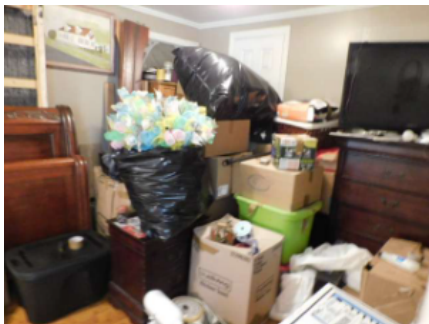
Image 6.L.1

The entry appears to have been remodeled or part of an addition. If so, we recommend that you verify the permit and certificate of occupancy. This is important because our inspection does not tacitly approve, endorse, or guarantee the integrity of any work that was done without a permit, and latent defects could exist.

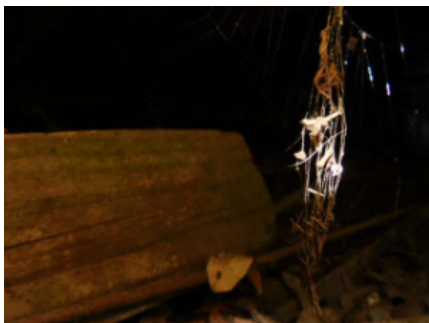
Image 7.1.1

7.1 Crawl Space Inspection Method Structure	Description	<ul style="list-style-type: none"> From Access
	Condition	<ul style="list-style-type: none"> Due to height off grade, the crawlspace was inspected from several points around the structure.

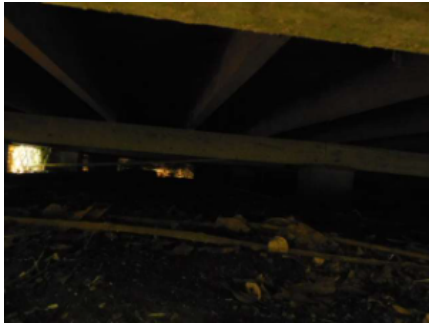
Image 7.2.1

7.2 Foundation Type Structure	Description	<ul style="list-style-type: none"> Piles and Grade Beams
	Condition	<ul style="list-style-type: none"> Limited inspection due to not access to the foundation either in ground or covered.

Water standing under the home.

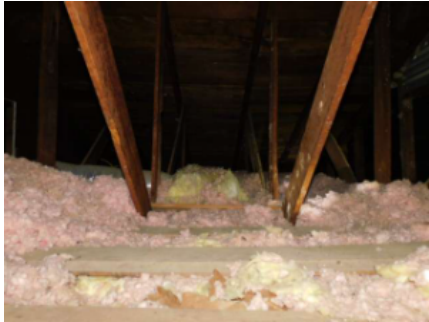
Image 7.6.1

- Inspection limited due to space, design and insulation.

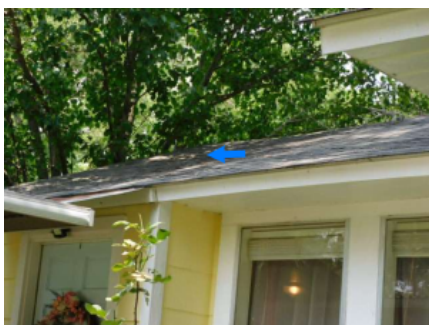
Image 7.8.1

- Sagging noted in roof decking . Sagging noted in rafter.

Repair or Replace Roof plywood appears to sag between rafters.

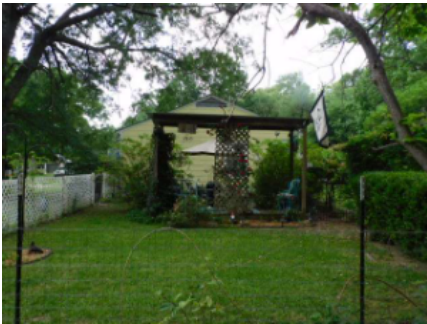
Image 7.L.1

We cannot access all areas of the foundation crawlspace, due to the obstruction of ducts pipes or conduits.

We do not evaluate auxiliary structures as part of our service. However, you should obtain the necessary permits because we do not tacitly endorse any structure that was installed or built without permits, and latent defects could exist.

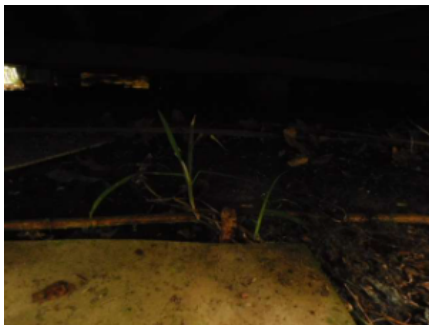
Image 8.1.1

<p>8.1 Foundation Insulation Depth Insulation & Ventilation</p>	<p>Description</p> <ul style="list-style-type: none"> • Could not be determined due clearance under home. • None visible
--	---

NO moisture retarrder noted.

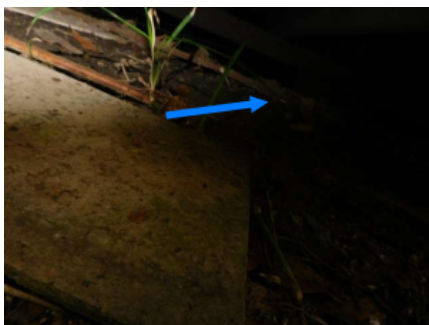
Image 8.6.1

Upgrade No vapor retarder or barrier visible. No insulation noted under home.

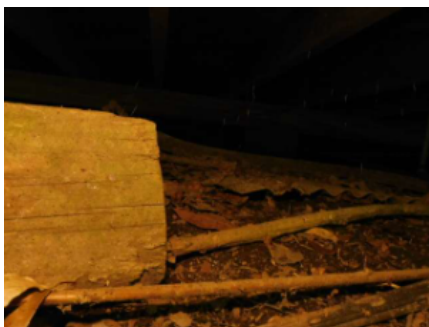
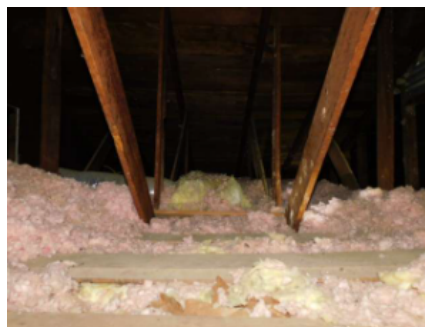
Image 8.L.1

Blown in and possible batt type fiberglass insulation.

No insulation or vapor retarders under home.
