Windstorm Mitigation Report (OIR-B1-1802)

Cypress Run Condominium Association, Inc.

2 Cypress Run, Building 2, Units 21A-26C

As of 11-13-2023 | FPAT File# MUD2321145

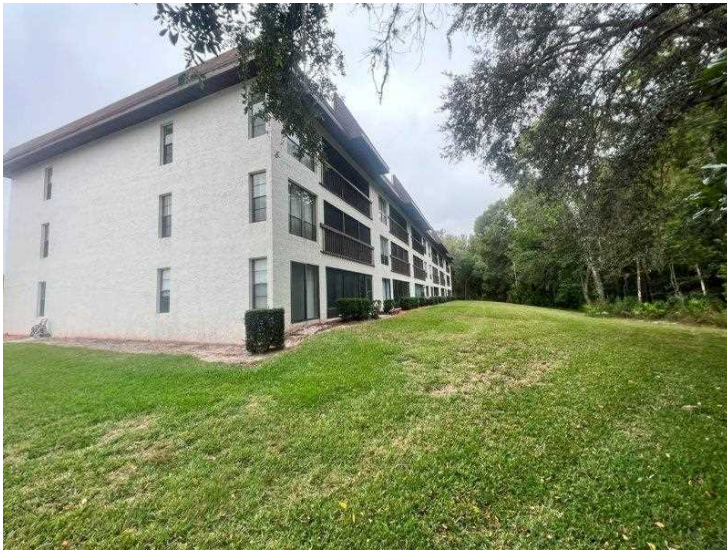
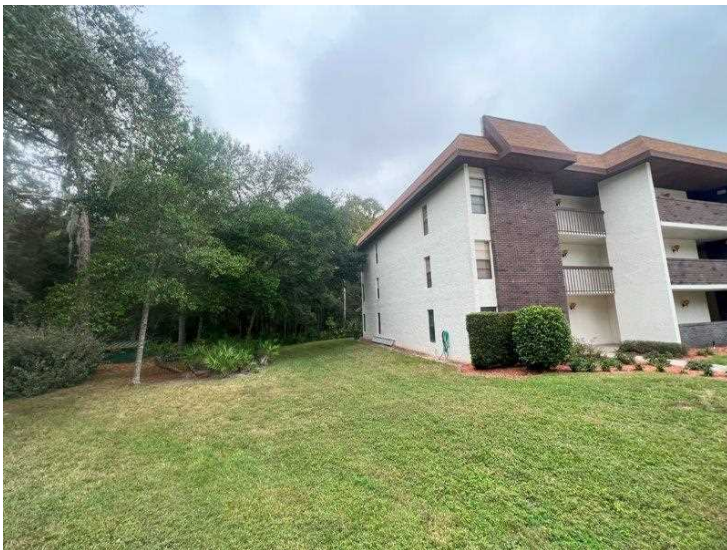
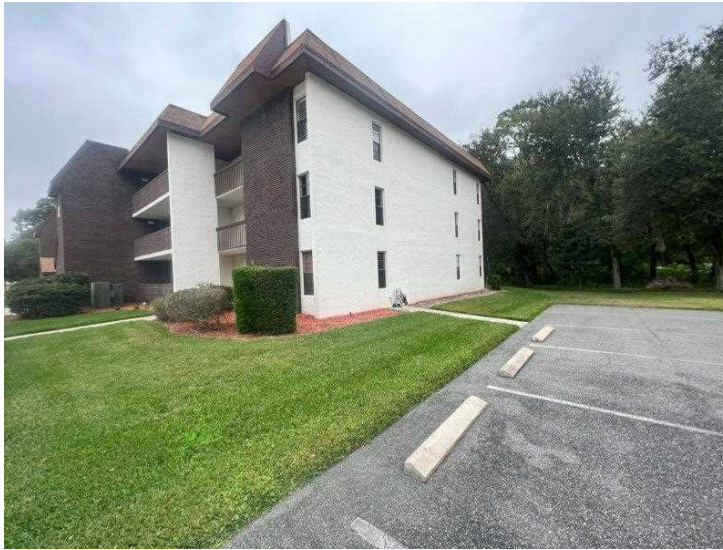
Exterior Elevation

- 5. Roof Geometry:** **Flat Roof**
Comments: Inspection verified a mansard roof shape.
- 6. SWR:** **Unknown or Undetermined**
Comments: Due to limited attic access SWR could not be determined.

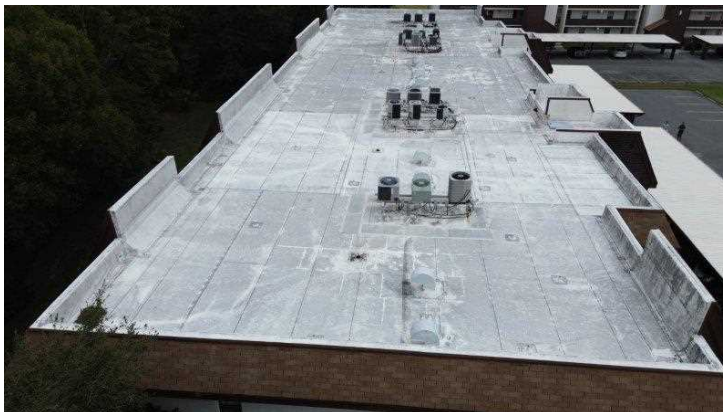
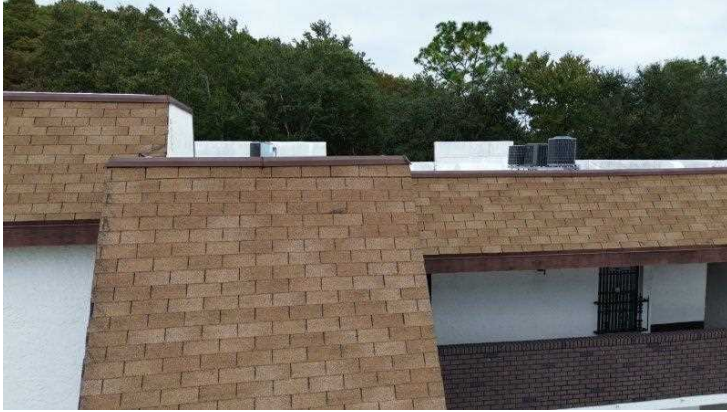
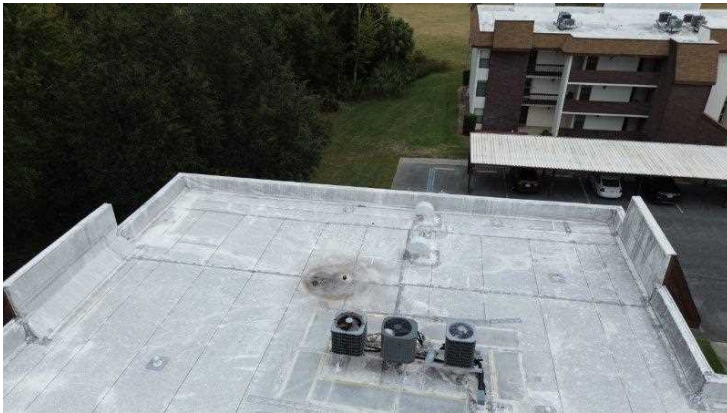
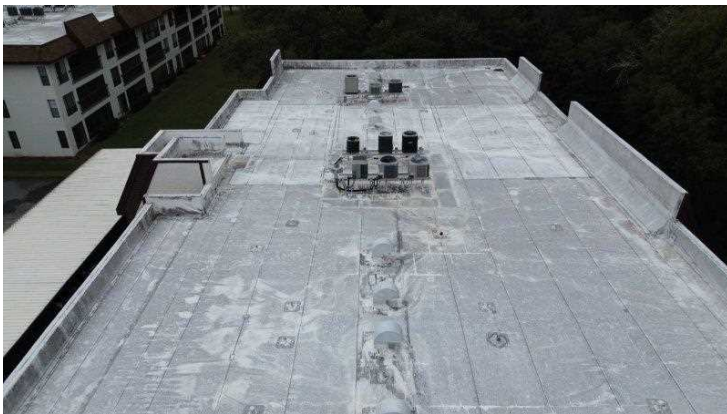
Roof Construction

- 2. Roof Covering:** **FBC Equivalent**
Comments: The roof covering was replaced in 2006. The roof permit was confirmed and the permit number is 200602472. This roof was verified as meeting the building code requirements outlined on the mitigation affidavit.
