COMPOSITE CROSSTIE TEST CYCLIC LOAD

Letter Report No. P-09-003

Prepared for IntegriCo Composites, LLC

by Sirius Roybal, Transportation Technology Center, Inc.

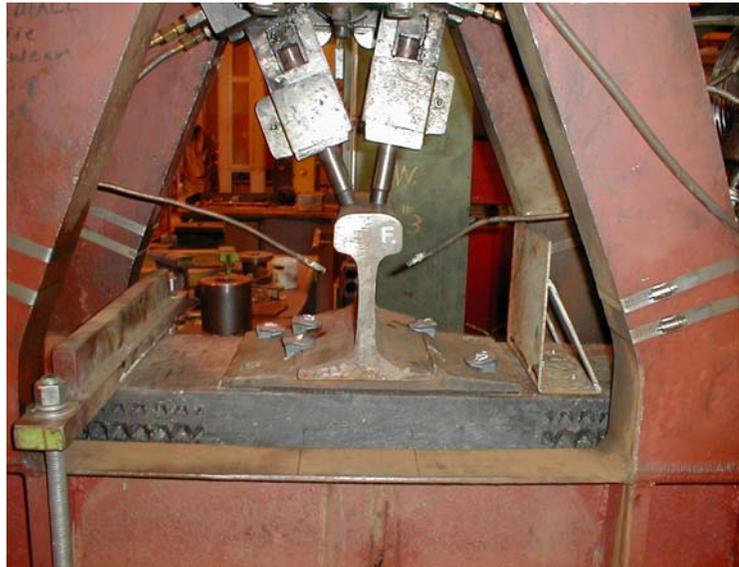
The test sample was fastened to the tie wear machine, as Figure 1 shows. An angular load of 21,000 pounds was applied to the field side and unloaded. Next, an angular load of 21,000 pounds was applied to the gage side of the railhead and unloaded. These two loads represent one cycle. The test was conducted at a rate of approximately 220 cycles per minute. During the 2-million load cycle test, the rail seat area received a constant water drip on each side of the rail base. Per AREMA test requirements, locomotive sand was sprinkled on the entire rail base and tie plate once per day.

Figure 1. Test Setup

The tie plates and rail sections were fastened to the tie using cut spikes, which will also be used in the in-track performance test. The load was applied to the railhead using two load arms. The load arms are set at an angle to apply both a vertical and lateral component to each rail seat. On the gage side, the 21,000 pounds applied through a load pin at an angle of 20.85 degrees resulted in a load distribution of 19,625 pounds for the vertical component and 7,474 pounds for the lateral component (L/V ratio = 0.38).

On the field side for the 21,000 pounds applied through the load pin at an angle of 10.32 degrees resulted in a load distribution of 20,660 pounds for the vertical component and 3,762 pounds for the lateral component (L/V ratio = 0.18). Water and sand were added over the rail seat area to simulate an abrasive environment. Several measurements were taken throughout the test to document tie performance. The dynamic test was carried out for 2-million load cycles. Upon completion of the test, the rail seat assemblies were photographed and examined for any evidence of anomalies, failure, or damage.

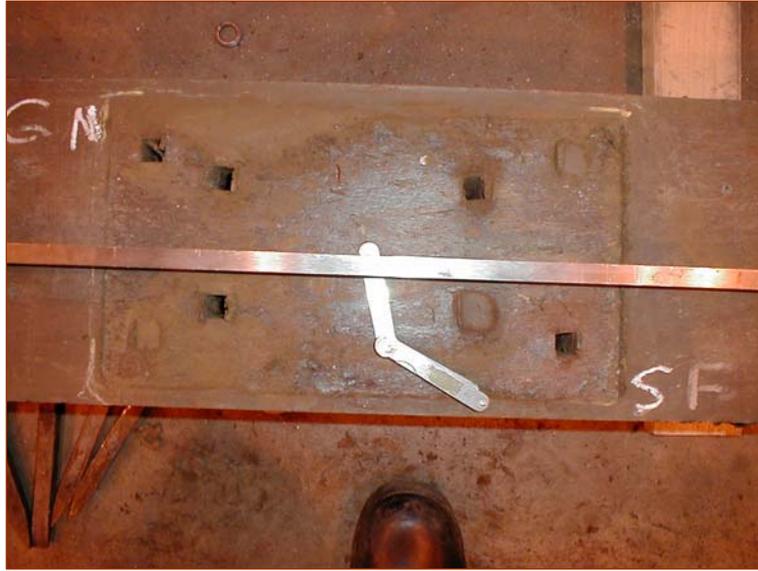
The tie was labeled gage, field, north, and south. A straight edge was placed across tie plate area and the measurements were taken with a feeler gage, as Figure 2 shows. The maximum cutting depth was 0.153 inch at the center field location. All the tie cutting values measured are listed in Table 5. See the appendix for pictures of tie cutting.

Figure 2. Tie Cutting Measurement Setup

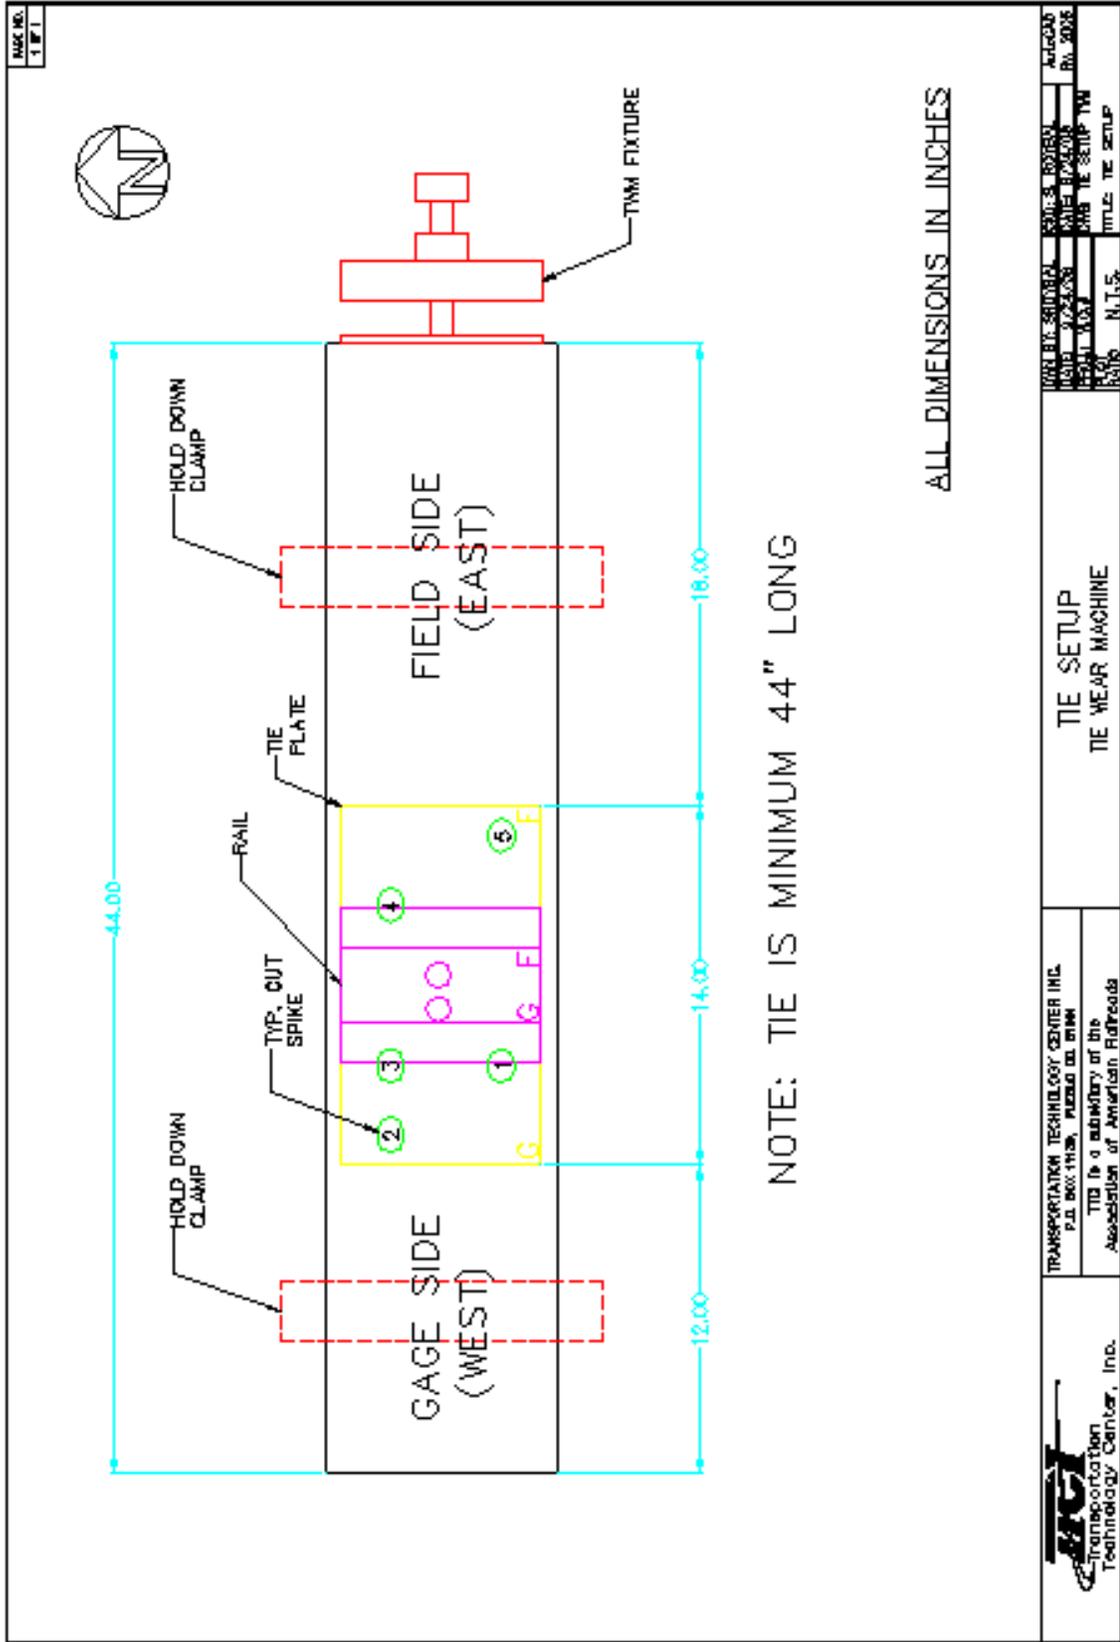
NOTE: TIE IS MINIMUM 44" LONG

Figure A-1. Tie Setup

The test was performed on 1/2 of a composite crosstie, as received from IntegriCo, at an ambient temperature of 70°F. A 14-inch AREMA cut spike tie plate with a short section of rail designed for the test machine was attached to the rail seat end of the tie. Pilot holes measuring 9/16 inch x 5 inch deep were drilled for all five spikes. The spike pattern consisted of two diagonal plate hold-down spikes, two rail hold-down spikes on the gage side, and one rail hold-down spike on

The data indicates that there was a gradual gage spreading with a maximum displacement of 1/8 inch on the north side of the tie plate and a maximum of 3/32 inch on the south side of the tie plate. Table 3 lists the tie plate movement values. See Figure A-1 in the appendix for tie plate orientation.

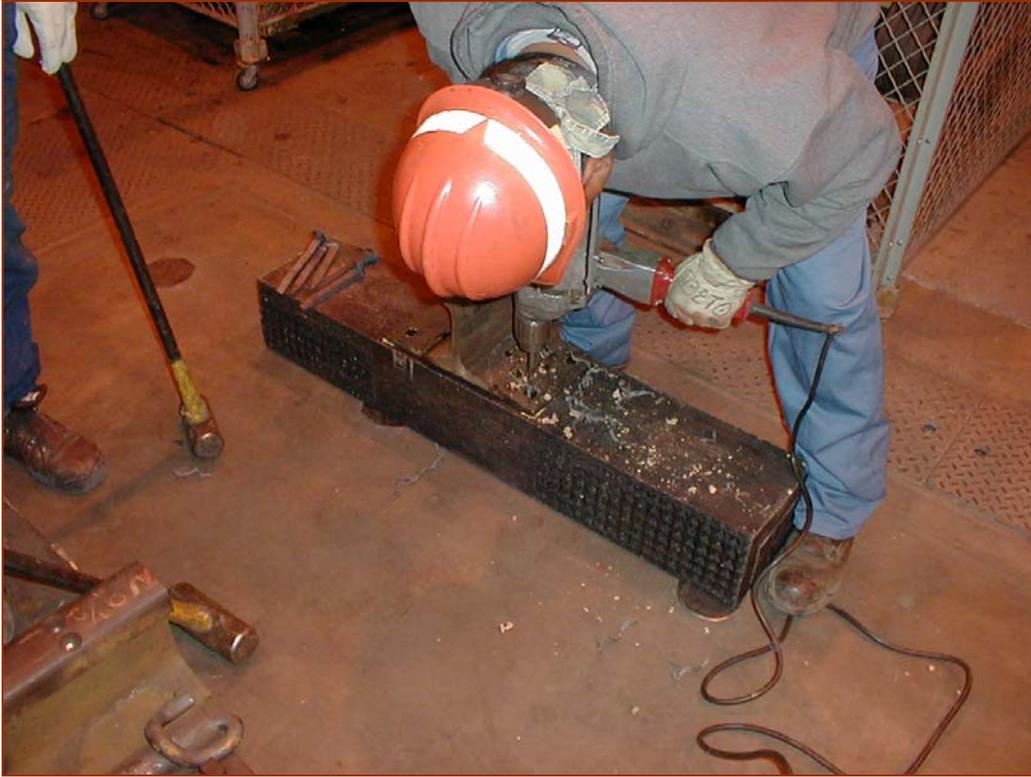
Figure A-2. Predrilling Spike Holes

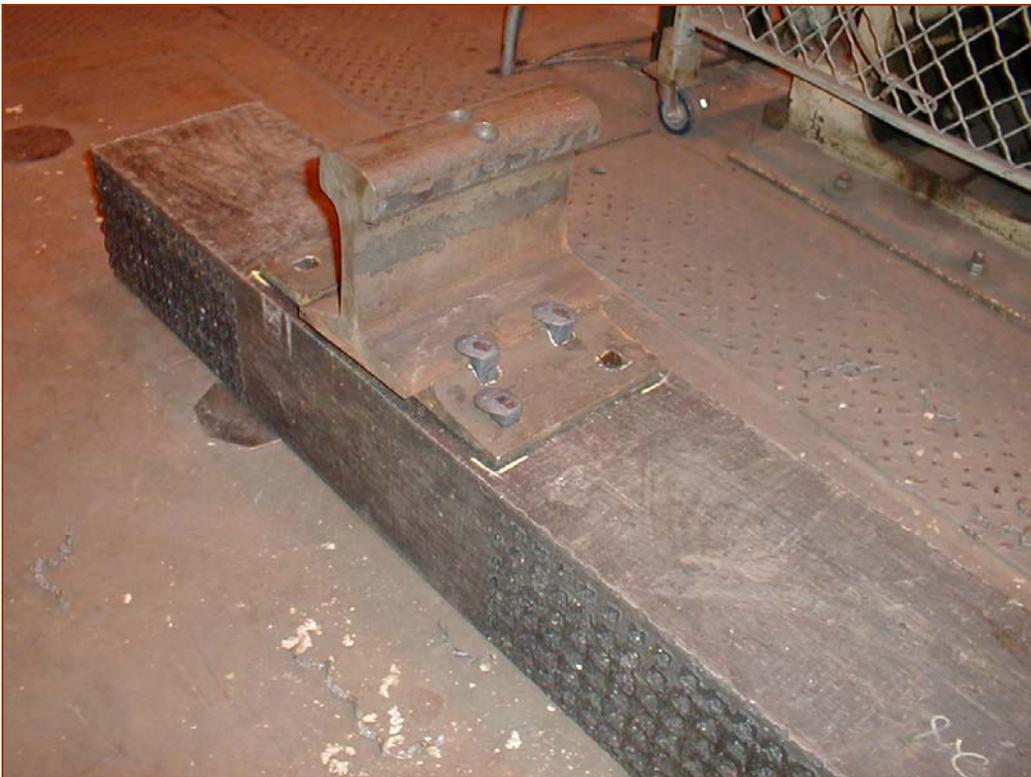
Figure A-3. Tie Plate and Rail Spiked to Tie

the field side. This is a typical spike pattern used in the HTL at FAST. See the appendix for pictures and drawing of tie setup. The test engineer noted that there was a buildup of tie material between the tie plate and the top of the tie after spiking causing a 5/32-inch gap that prevented the tie plate from lying flat on the tie. After several cycles, the tie plate pushed the material down and the plate was reasonably flat. See the appendix for pictures of tie material buildup.

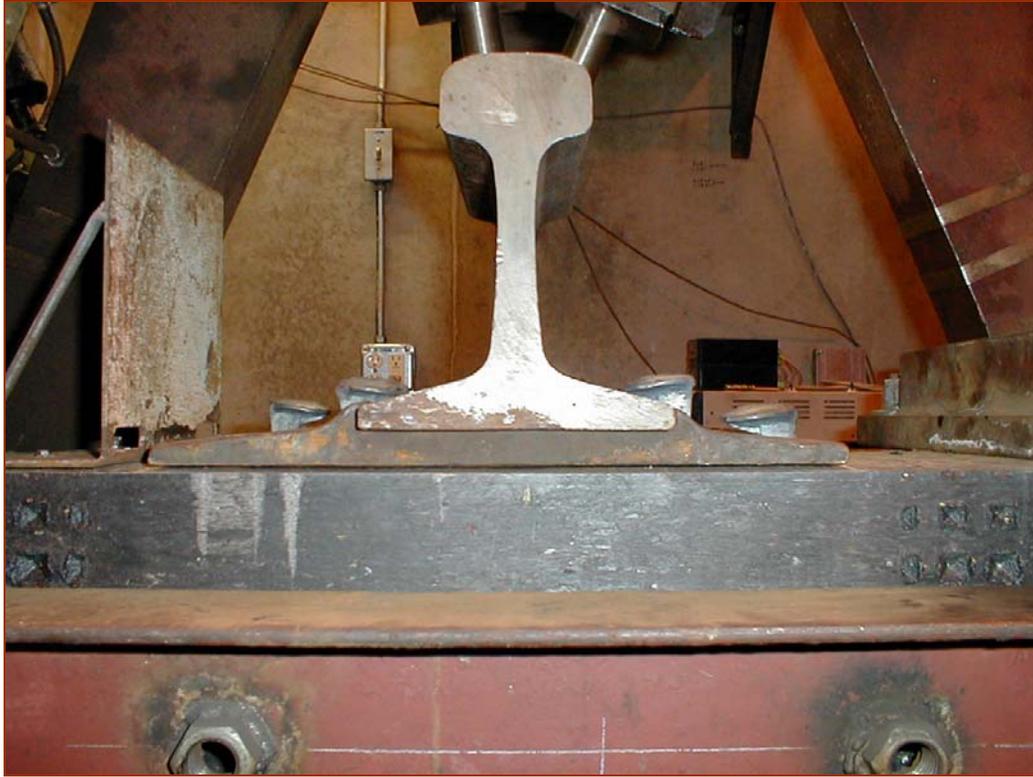
Figure A-4. Gap between Tie Plate and Tie

There was an initial compression caused by the relief of the buildup of tie material between the tie and tie plate. This buildup of tie material was produced when pilot holes were being drilled for spiking. Throughout the remainder of the test, there was no significant plate area compression under load. Table 4 lists the plate area compression values measured.

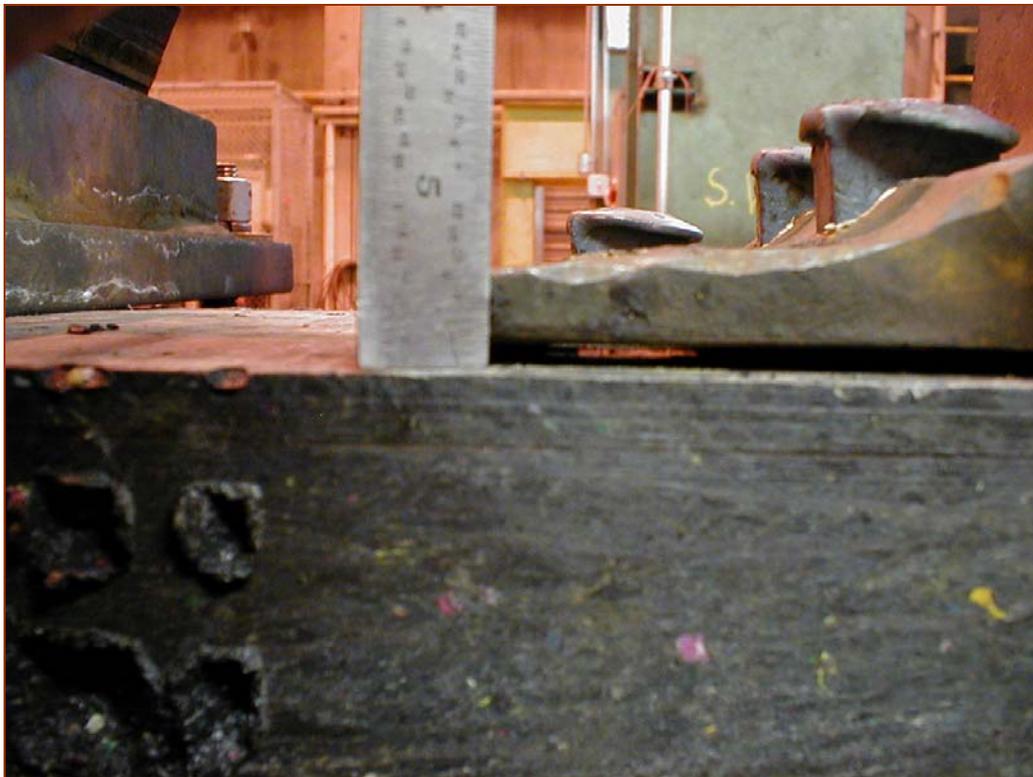
Figure A-5. Close-up Gap between Tie Plate and Tie

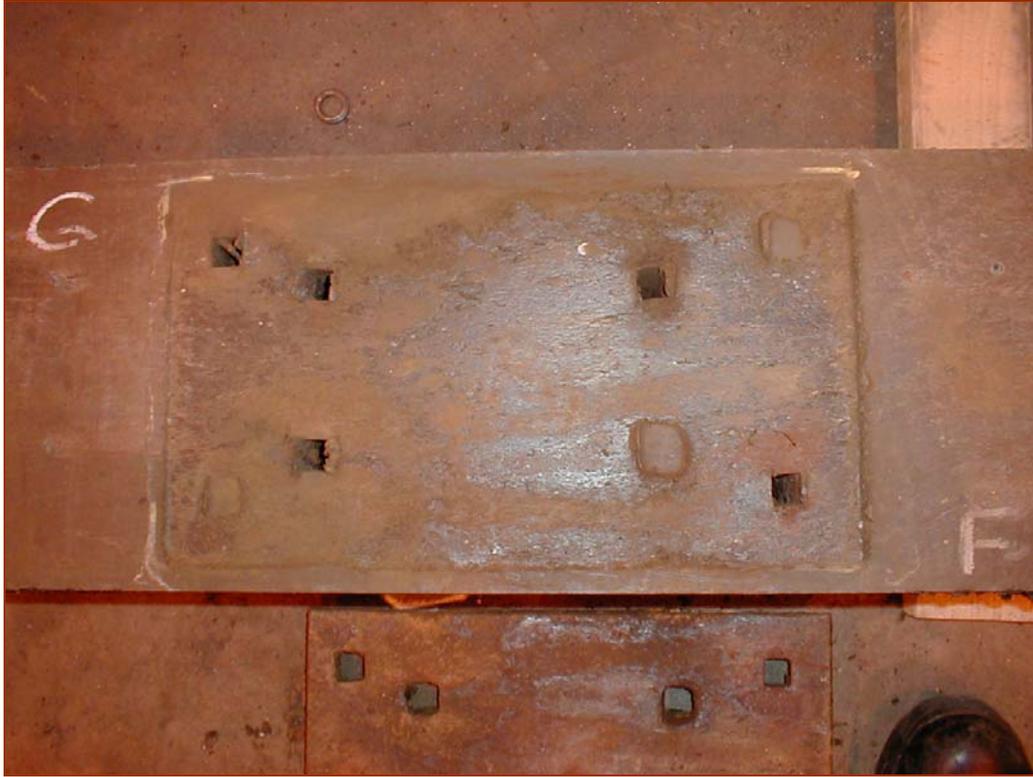
Figure A-6. Tie Plate Cutting

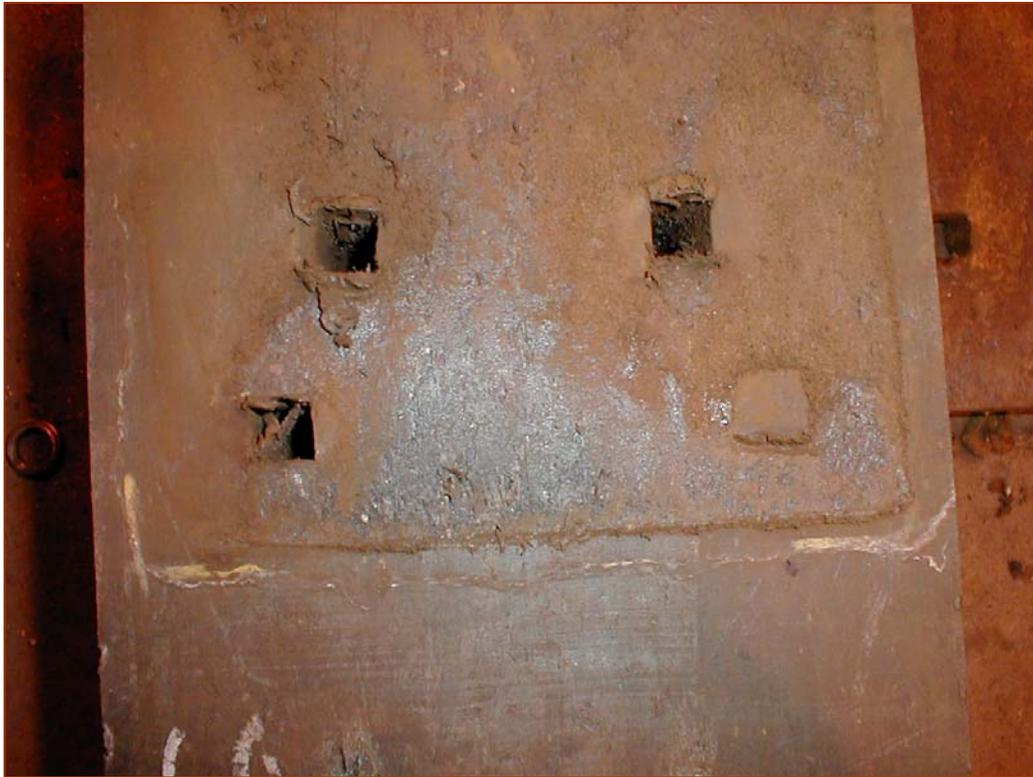
Figure A-7. Close-up tie Plate Cutting Gage Side

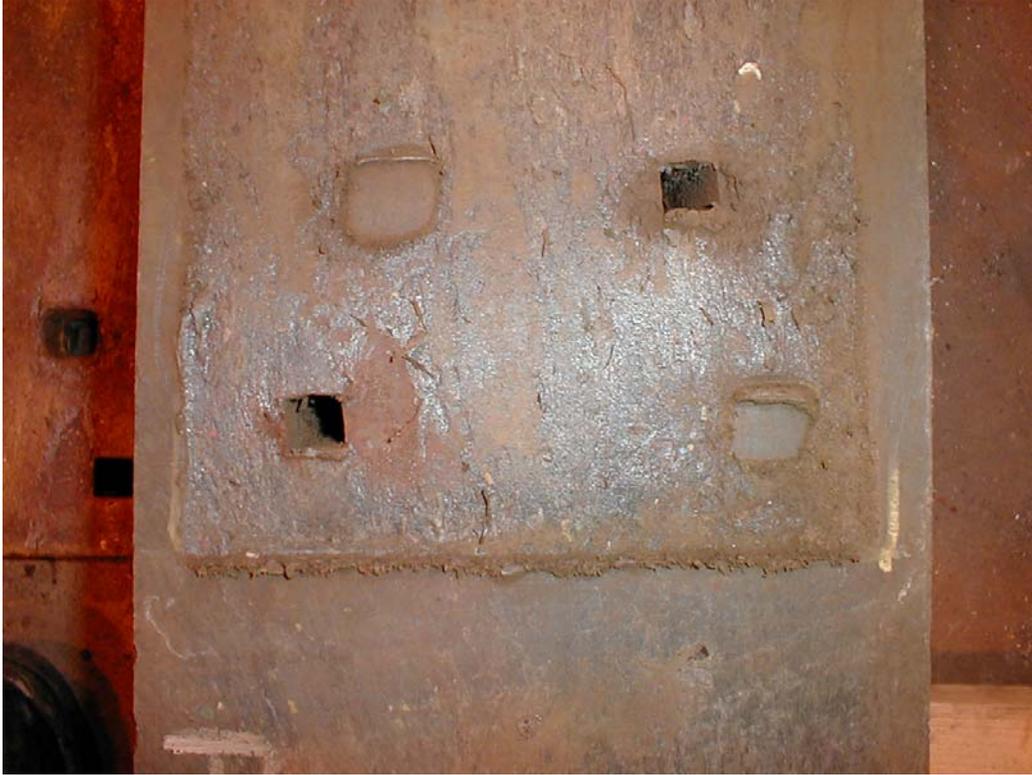
Figure A-8. Close-up Tie Plate Cutting Field Side
