Az Superior Home Inspections

CONFIDENTIAL INSPECTION REPORT

1234 E Sample Lane, Phoenix, Arizona 85050

5/28/2024 7:00 am to 12:00 pm

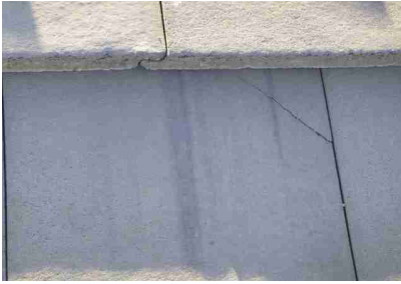
I observed cracked or broken tiles, that may expose the waterproof membrane, which should be serviced or the roof could leak. Lower edge chipped tiles are common, this is the most likely place for a tile to chip, this type of chip does not expose the water proof membrane underneath due to the tile below. E.G.

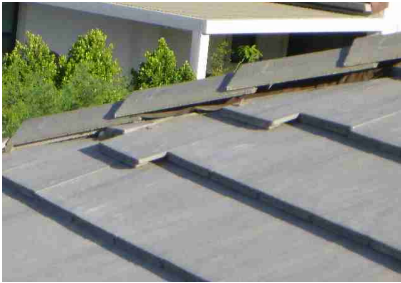
I observed number of slipped tiles that will need service. E.G. South facing roof.

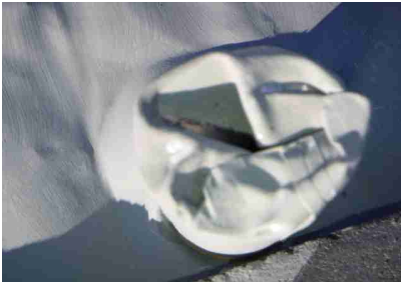
Plumbing vent stack flashing needs wrapped properly. E.G. The flashing is blocking the vent pipe top restricting the venting. South facing roof.

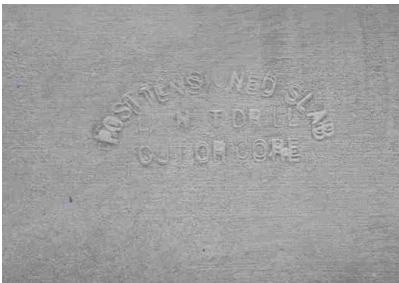
The floor structure consists of a post-tension concrete slab.

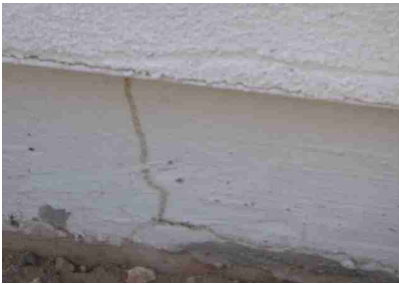
There is evidence of either past or present termites that should be evaluated by a licensed termite inspector. E.G. Termite tubes located at the east exterior stem wall.

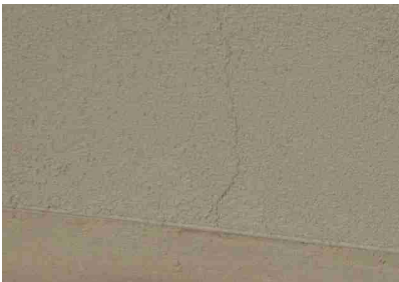
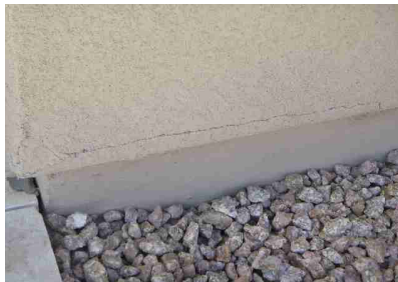
There are typical cracks in the stucco, which you should view for yourself. All cracks result from movement, thermal cycling, and are not structural in that respect, but the vast majority of them have only a cosmetic significance. Most common at corners of windows and doors. E.G. East facing wall.

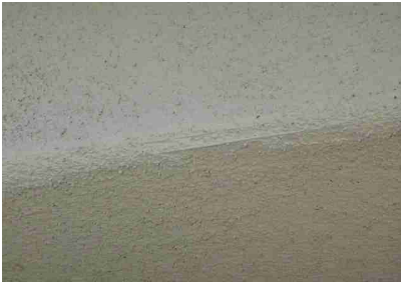
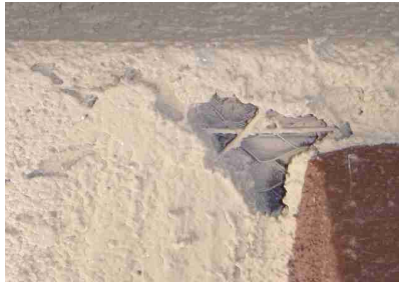
Stucco Lath is exposed - *Continued*

I observed areas where the stucco lath is exposed. Repairs should be made so that the lath does not rust. E.G. Underside of the rear patio. Underside of the front entry.

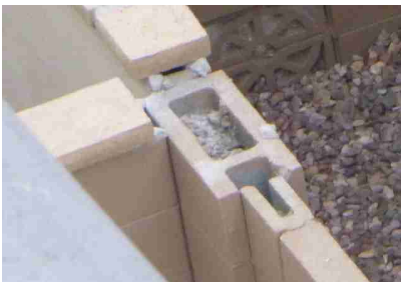
There is a missing cap on the cinder block yard walls, which should be repaired. E.G. South west corner of the yard wall.

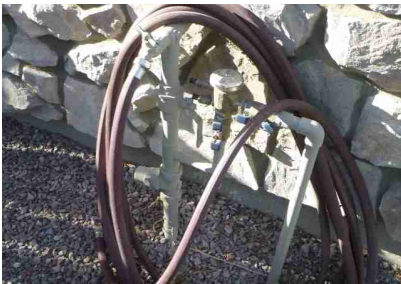
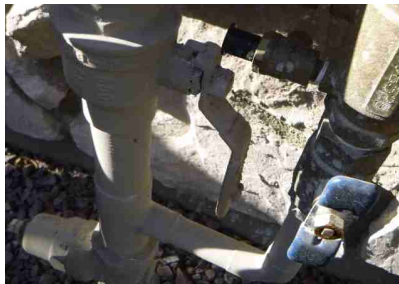
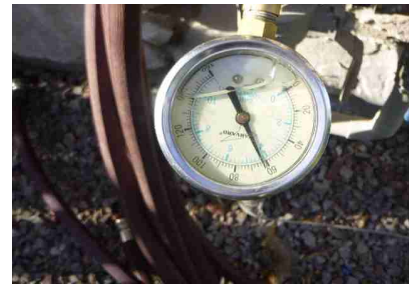
The main water shut-off valve is located at the front of the residence on the west side of the residence. 1- 1/4" copper service. The water pressure at the time of the inspection was at 62 PSI.

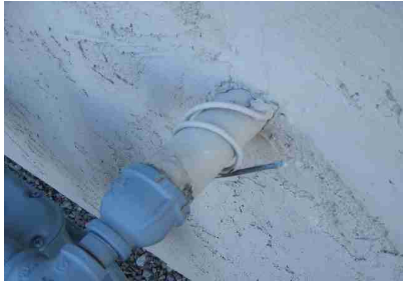
The bonding wire clamp is missing. Bonding is provided primarily to prevent a possible electric shock to people who come in contact with the gas piping and other metal objects connected to the grounding system.

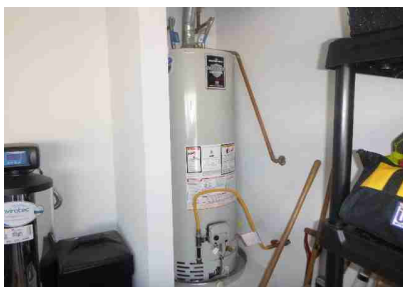
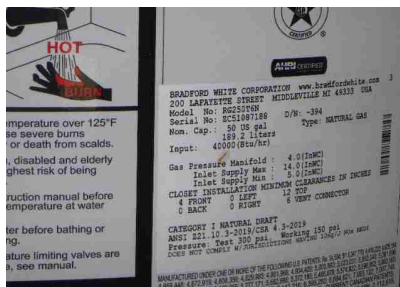
Hot water is provided by a 1 year old, 50 gallon water heater that is located in the garage. This unit is a year 2022.

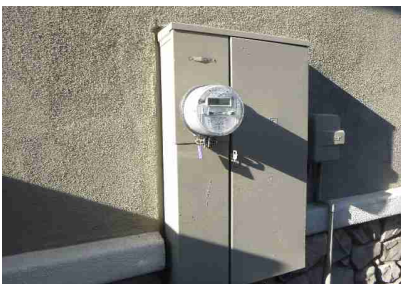
The residence is served by a 200 amp, 240 volt panel, located front east side of the house.

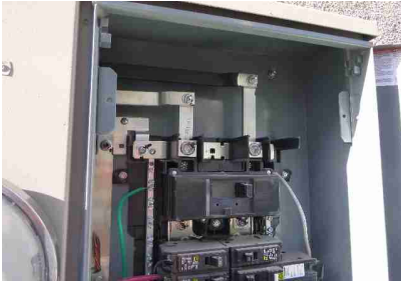
The protective cover for the service entry conductors is missing and will need to be replaced.

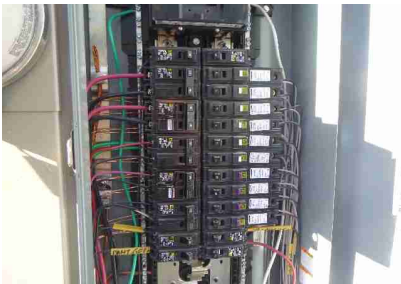
The visible portions of the wiring consists of aluminum 240V and 120V copper branch wiring.

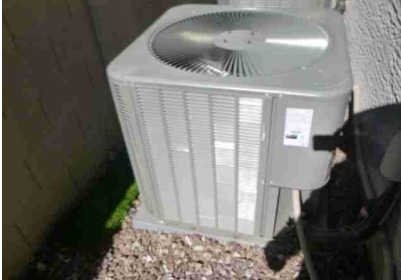
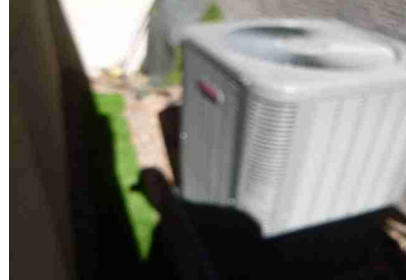
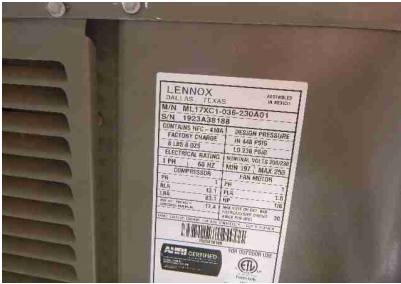
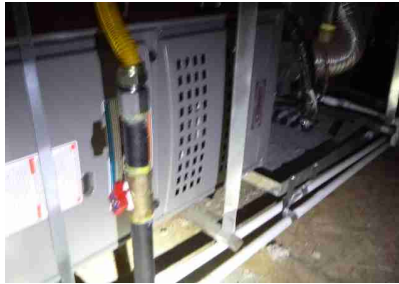
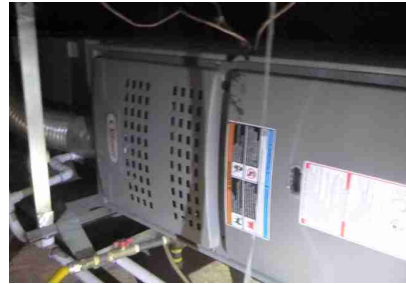
Central heat and air-conditioning are provided by dual systems, consisting of two furnaces with evaporator coils that are located in the attic, and two condensing coils that are located on the east side of residence. Unit one (south unit) is a year 2022, 3.5 ton unit that controls the downstairs. Unit two (north unit) is a year 2023, 3 ton unit that controls the upstairs.

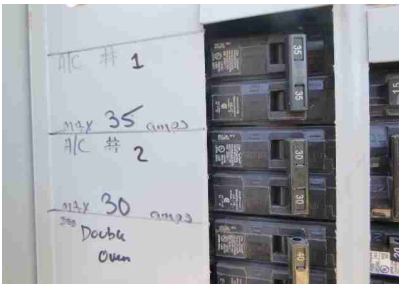
The Maximum Breaker or Fuse Size according to the data plate is 35 & 30 Amps. Breaker Sizes at the Electrical panel are 35 & 30 Amps.

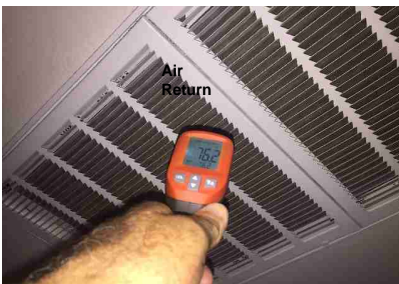
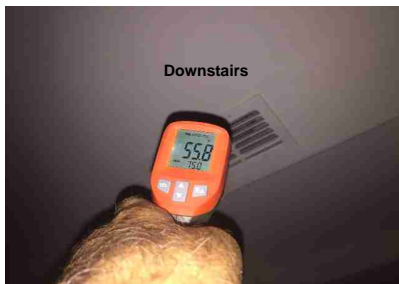
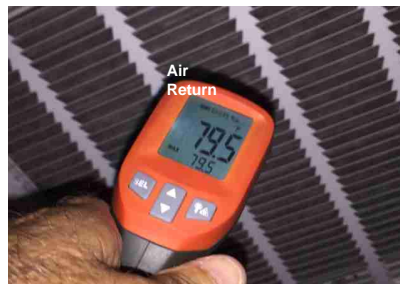
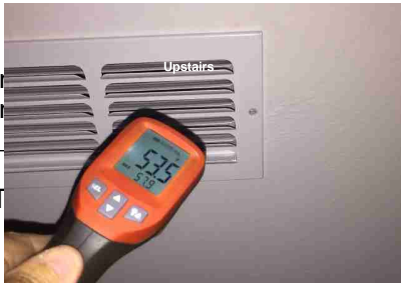
acceptable differential temperature split as indicated within the report - *Continued*

The air-conditioning responded and achieved an acceptable differential temperature split between the air entering the system and that coming out, of fifteen degrees or more. E.G. System one has a 21 degree split. System two has a 26 degree split.

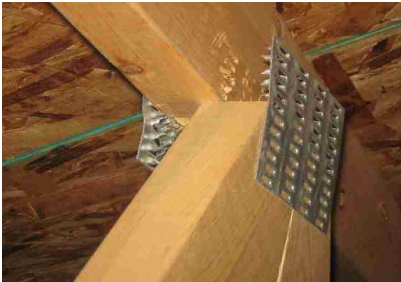
One of the truss members is damaged and should be repaired. I strongly recommend getting a copy of the Truss Repair Design Drawing (TRDD) once repair is completed.

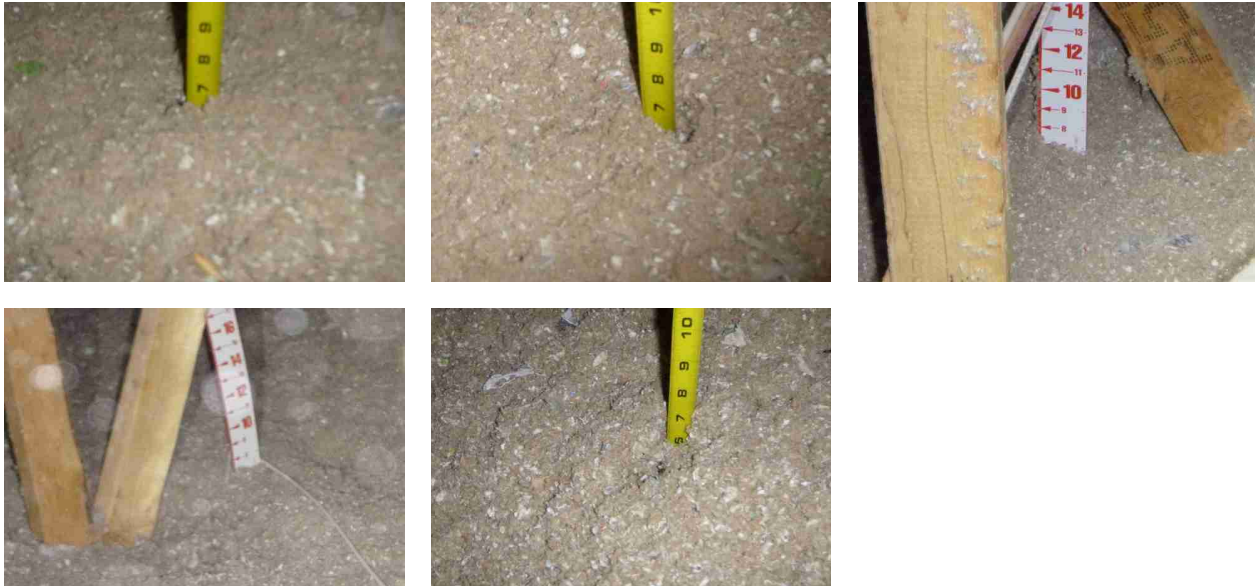
The attic is insulated with less than the standard R30 requirements - *Continued*

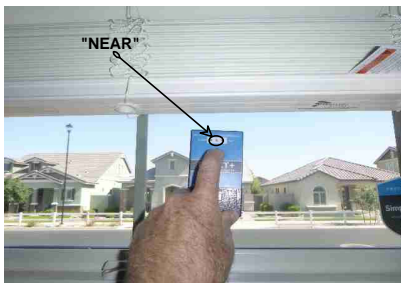
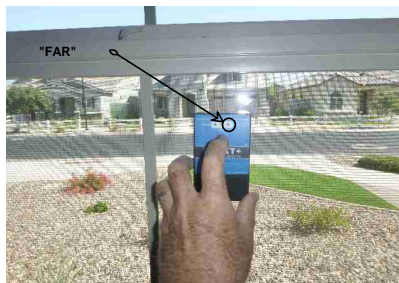
Low E film is inconsistent with one or more of the windows. E.G. All the Windows and Doors tested for the Low E film on the "FAR" side when testing from the interior of the house with the exception of the Downstairs Living room window upper pane. which tested on the "NEAR" side only.

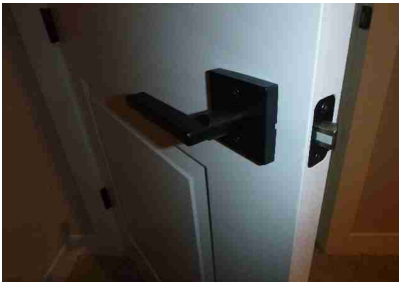
The door does not have a privacy lock for the Master bedroom. E.G. Door handle has no locking device.
