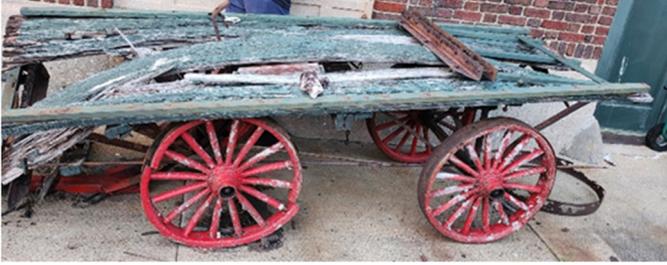
Over the years, since the baggage cart was left outside it had deteriorated into a pile of junk.

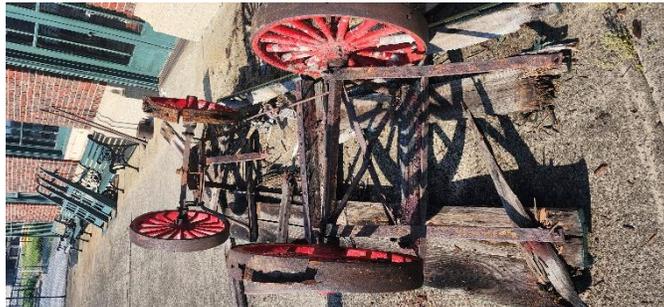
The first thing he did was to turn the cart over and try to measure its original dimensions. He then collected what remained of the cart and brought it to his house.

The first step to restoring the cart was to remove and measure the wheel's diameter. Now that he had the dimensions, he contacted Handsome Wheel and Wagon shop in Letcher, South Dakota to purchase new wheels. Handsome has a line of superior quality wagons, wheels, and equipment.

The next thing Tom did was to disassemble and clean up the remaining metal pieces. This was not an easy task. All of the bolts had over a hundred years of rust and paint and he needed to use a hammer and chisel to get a lot of them out of the frame.

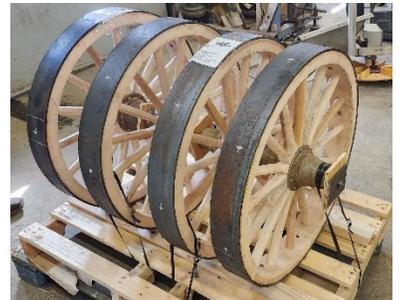
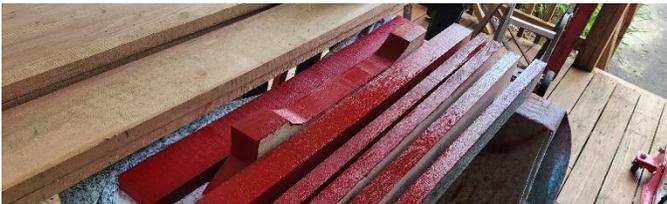
Then came the process of recreating the wooded pieces that would be used on the cart. Red oak was rough cut and sanded down for the deck. Also, several pieces of white oak were cut to match the braces. By accident the red oak ended up being painted green, while the white oak pieces were painted red.

Since Tom wanted to keep at least one piece of the original wood, he decided to save the wooden handle. To do this he needed to come up with some novel solutions to ensure the wooden handle remained serviceable.

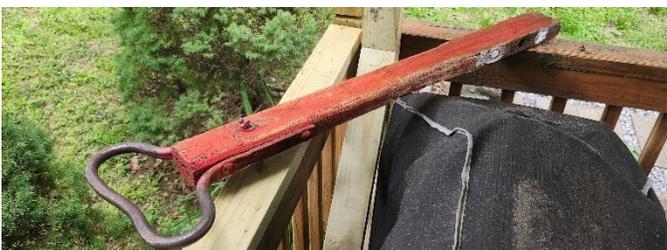
Since he also wanted to use prototypical hardware, this meant using square nuts and bolts instead of the standard hex nuts and bolts. This forced him to special order much of the hardware used on the cart.

After all most everything was painted either red or green it was time to reassemble the cart. The first item that Tom assembled was the center beam brace. He clamped the floor boards together and used 6 inch long, 3/8-inch carriage bolts for the assembly. Unfortunately, it turned out that the thread size of the carriage bolts did not match the thread size of the square nuts. This required Tom to special order square bolts with the correct thread size.

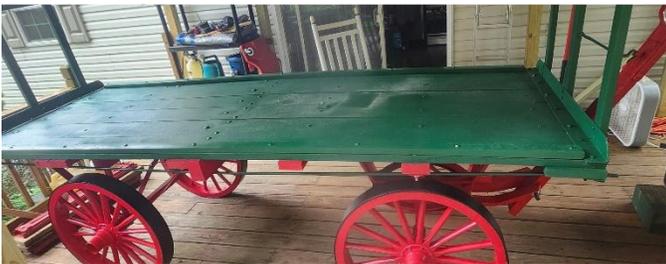
Once the cart was right side up, Tom was able to install the side bumpers that keep the luggage from sliding off the side of the cart. He then jacked up and installed the turning armature and wheels.

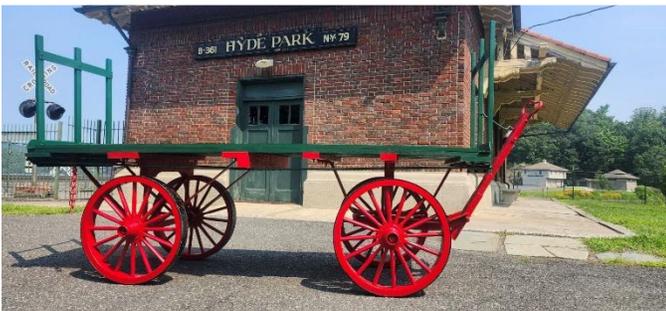
Finally, it was time to move the cart to the Hyde Park station without damaging it. The first attempt to load the cart using Tom's box trailer failed because the cart would not fit. However, with some adjustments, the second attempt using an open trailer worked and the cart was successfully delivered to the Hyde Park station.
