CASE STUDY

This case study concerns a particular canal system in Colorado where shotcrete is widely practiced to reinforce weak banks that are susceptible to serious and rapid erosion if not protected.

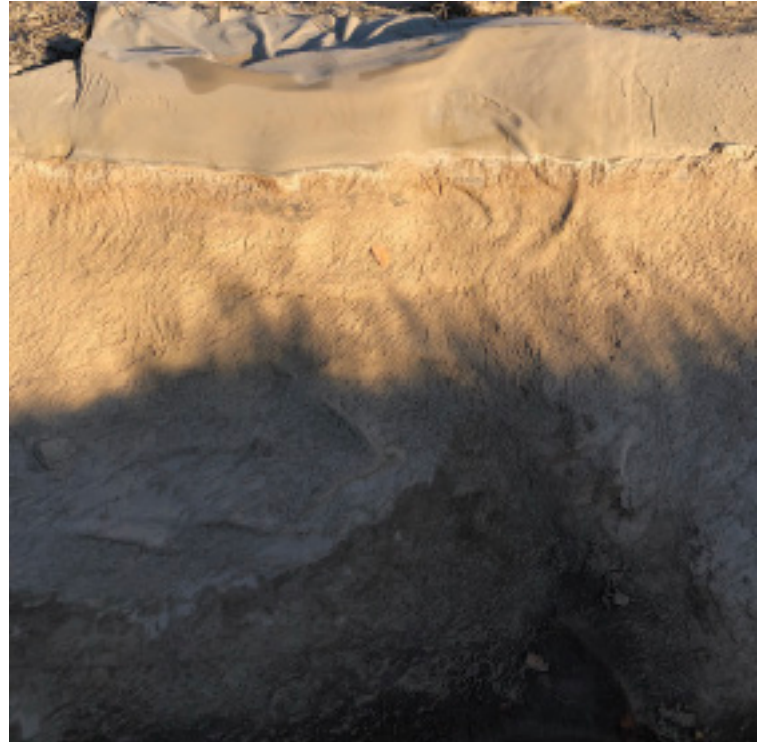
In this case study, a test patch of Castagra's SG1 with geotechnical membrane (fiberglass), had been applied to a previously damaged shotcrete area of the canal 12 months previously. Inspection at the time of the new remedial work, showed it was in perfect condition.

The latest repair work used the same technique as previously applied, including the use of large staples to help it all hold onto the soil substrate. The target area was dried as much as was practicable, Castagra's SG1 was applied over a 4ft. by 4ft. area, and the membrane was immediately pressed into place on the coating. A further coat of SG1 was then applied to completely saturate the membrane.
