CASE STUDY

The United States' canal systems are vast and vital. This case study concerns the Grand Valley irrigation system in Colorado. The water used within the Grand Valley originates in the snowpack of the northern Front Range, Middle Park, Gore Range, Elk Mountains, Grand Mesa, and other smaller ranges in northern and central Colorado. It is a critical source of water for agriculture for crops such as peaches, plums, cherries and wine grapes.

Elite Protective Coatings carried out repair test work three years ago on cracked, shotcreted banks. The shotcrete itself is tough to repair as adhesion is an issue, so it was decided to overcoat it with Castagra's SG1. Recently, those repairs were inspected and photographed to provide evidence for justifying future use of this veggie-plastic.

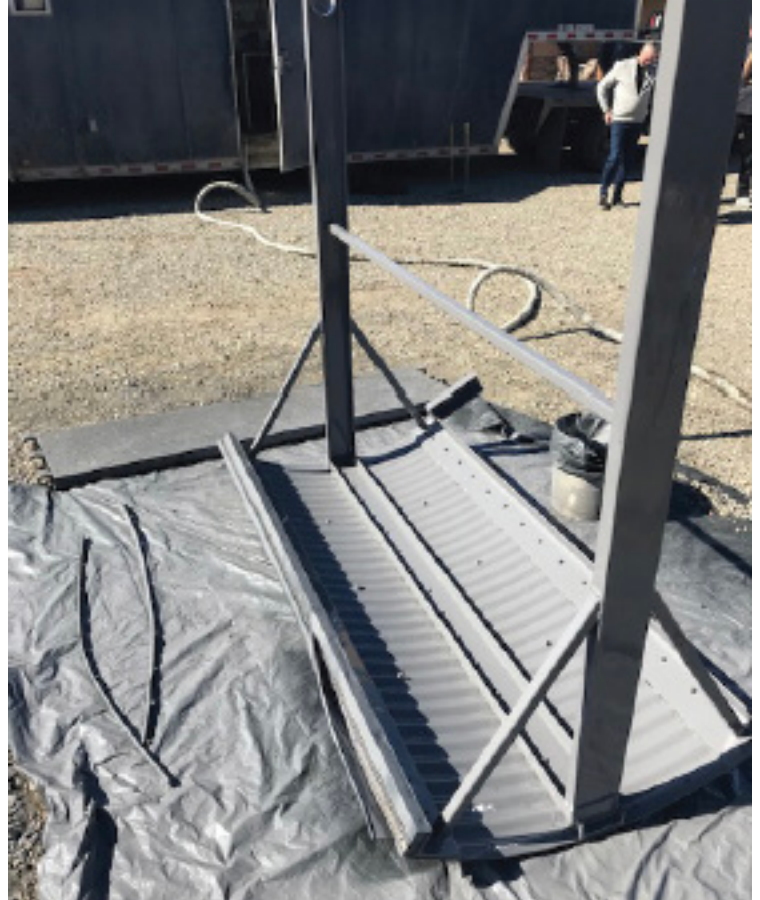
The coated areas on the shotcreted banks appear to be pristine. Careful and close inspection, particularly along edges, showed no anomalies and no touch-ups were required.
