CASE STUDY

This case study concerns an aging 30,000 gallon above ground drinking water steel tank in Placitas, New Mexico, near Albuquerque. Divers had inspected it and found the epoxy coating liner had deteriorated seriously and needed replacing.

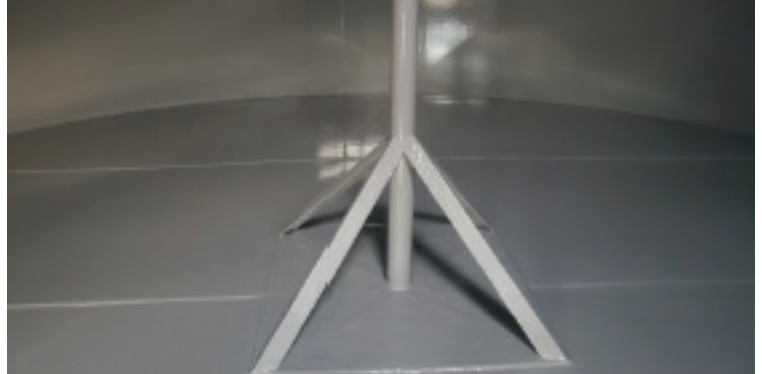
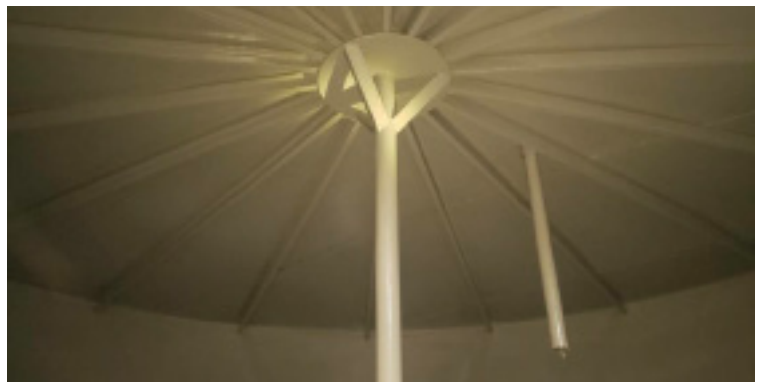
Once drained, the tanks inside walls were sandblasted clear of all epoxy residue, cleaned and then dried with the use of a heater. Ambient temperatures, while working, ranged from a frigid 20 degrees Fahrenheit to 50 degrees. The applicator only sprayed when the temperature was above freezing in this case. Coating depth was estimated at an average of 30 mils. The whole job covered five days.
