RESERVE FUND STUDY

LAKWOOD HOMEOWNERS ASSOCIATION HAMILTON, OHIO

On-site Inspection performed July 16, 2024
Submitted August 2024

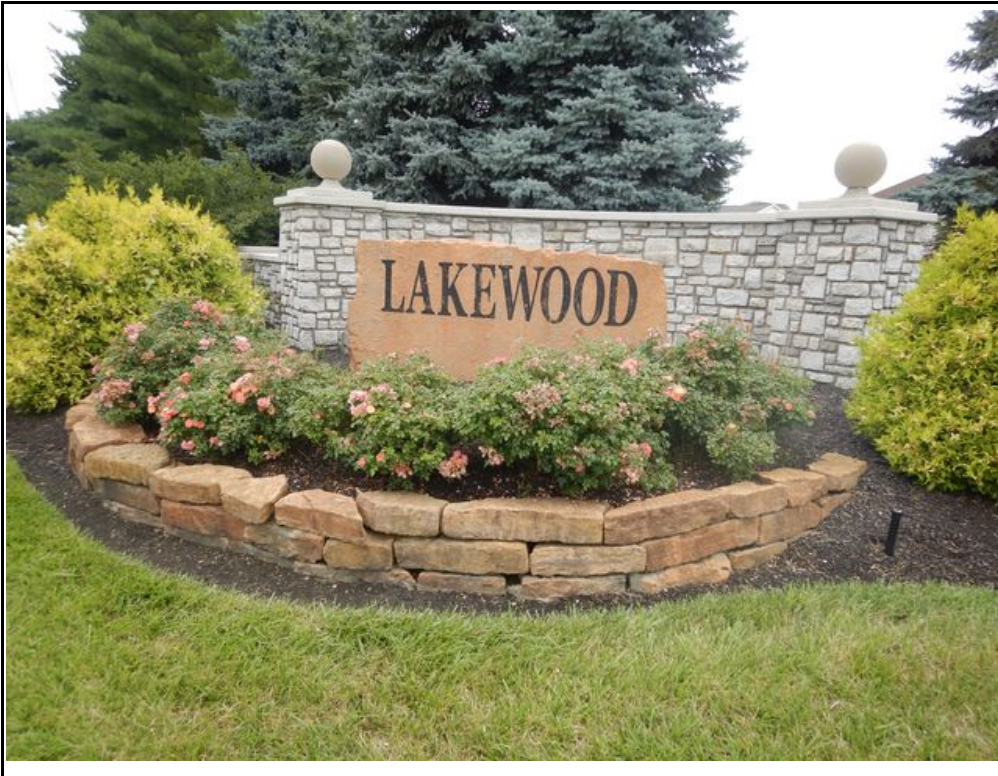
Photo Number
1

Description:
One of two entry signs

Monuments include the 2 stone walls at the community entry and the 3 stone signs. Two of the stone signs are located at the community entrance and one is located at the front of the pool house. The masonry design is long lasting and will be long lasting. We have included an allowance for repairs in future years. The signs are in good condition.

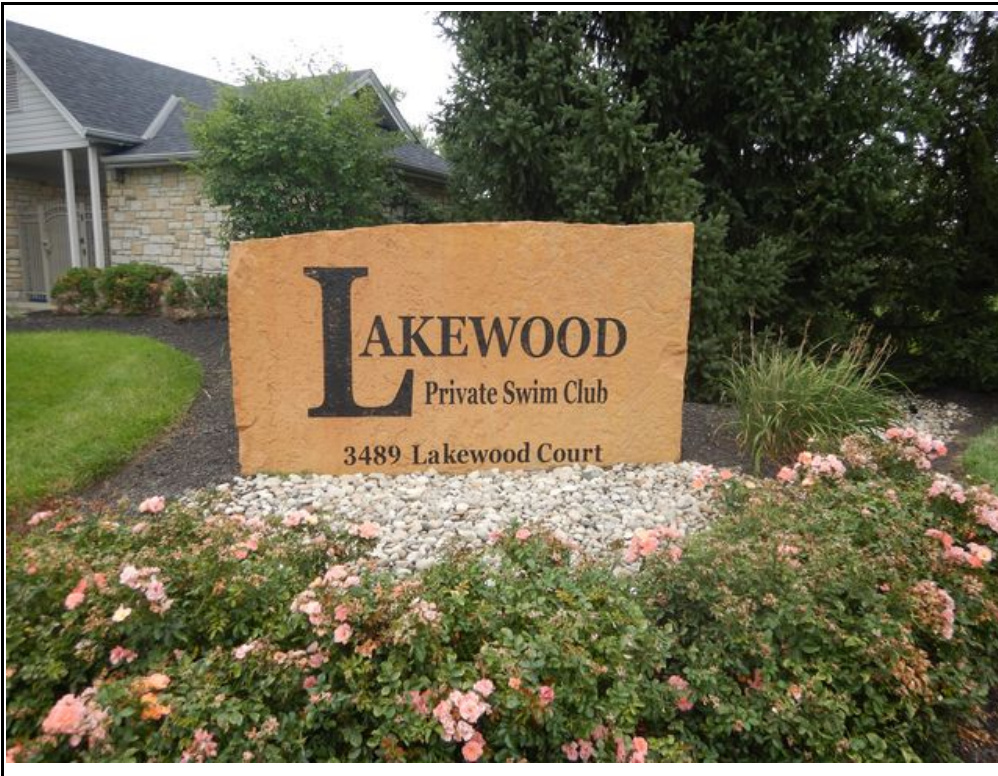
Photo Number
2

Description:
Sign at front of pool house

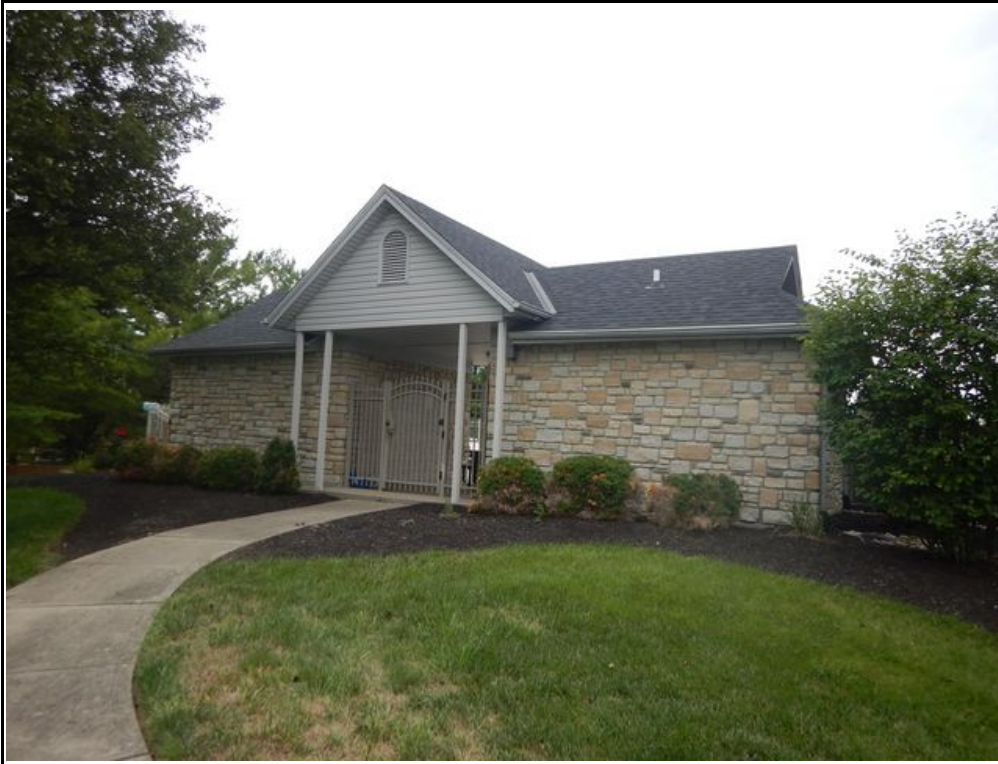
Photo Number
3

Description:
Front of pool house

- **Roof** - The Lakewood HOA pool house is approximately 20 years old and we expect the roof to be replaced in the next couple years. Asphalt composition shingles need replacing about every 20 to 25 years. We recommend removal of the shingles down to the roof deck so that the deck and flashing can be inspected for damage. In the reserve study, we included the cost to remove the old roof layers and install new roofing paper, shingles and flashing. We recommend that the roofs be regularly inspected for nail pops, leaks, lifted shingles and other problems. Correcting these problems as soon as they are found can help prolong the life of the roof and the roof deck.

- **Gutters and downspouts** - Gutters and downspouts have an expected useful life of about 25 to 30 years, although our experience is that they can last much longer. The gutters and downspouts on the pool house are in fair condition at Lakewood HOA.

- **Siding** - There are various siding materials on the pool house at Lakewood HOA. The sidings we have included are the masonry stone veneer and wood trim. The stone siding is a long lasting material that will require some repairs to mortar joints in future years which is typical for masonry veneer siding. We have included an allowance every 20 years for masonry repair.

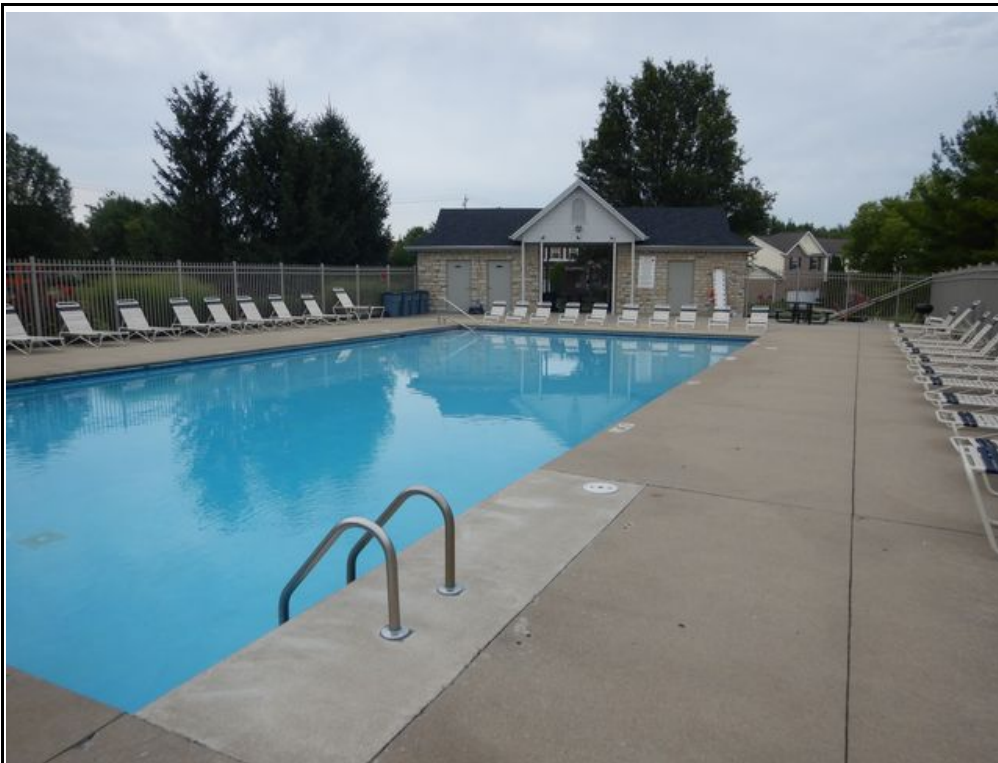
Photo Number
4

Description:
Pool area

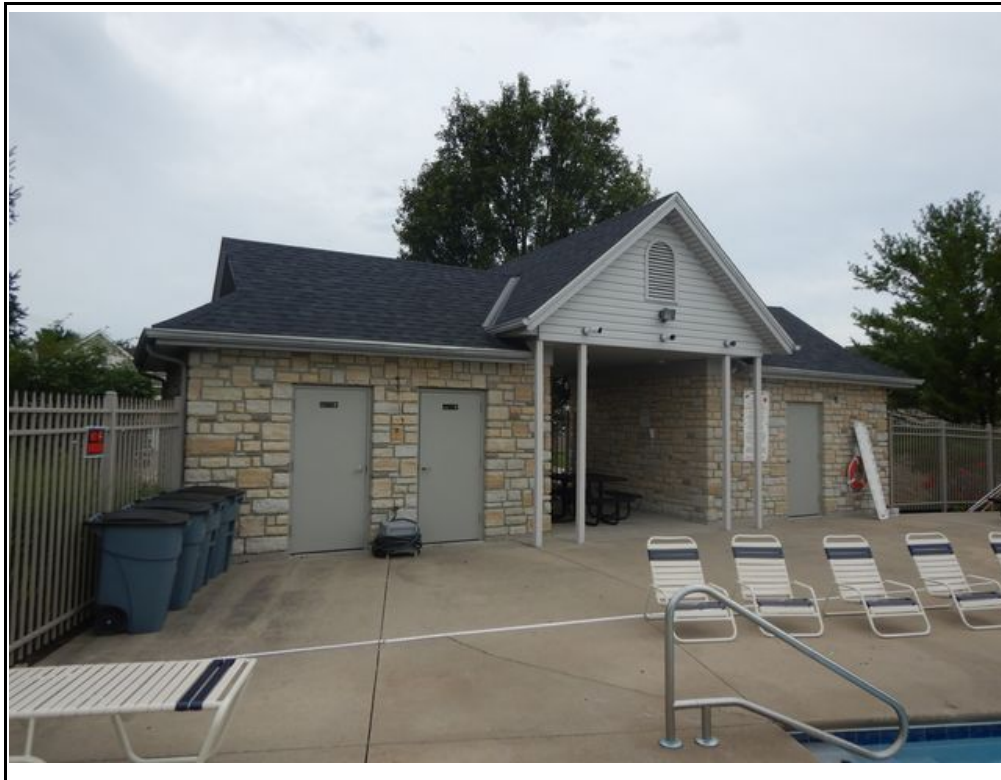
Photo Number
5

Description:
Rear of pool house

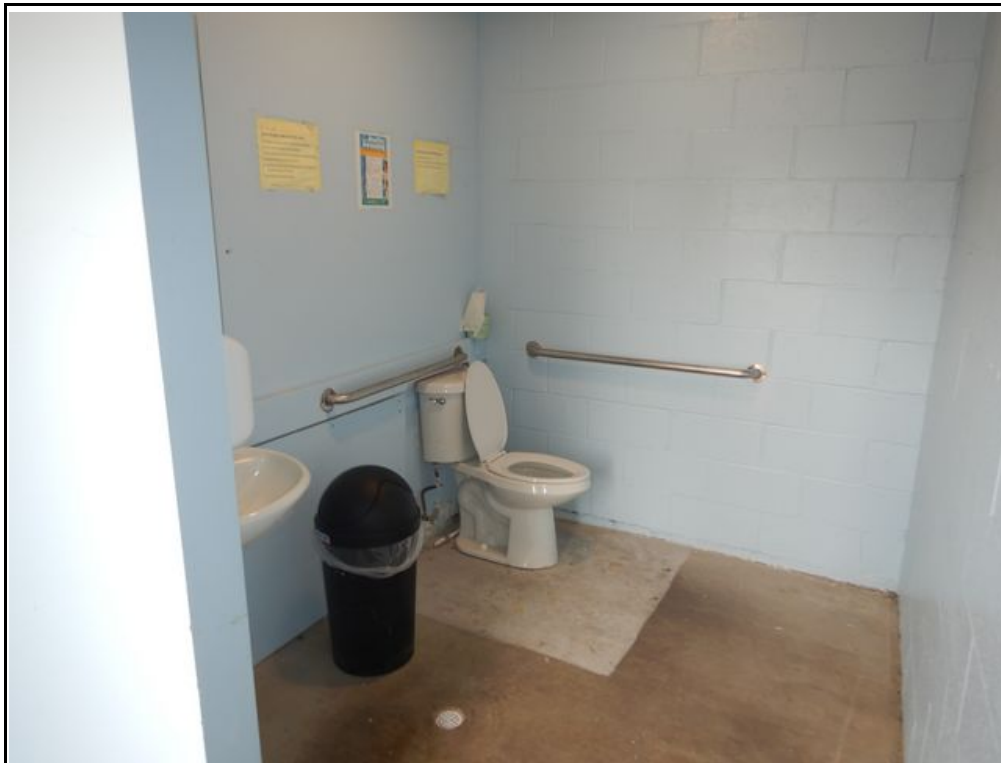
Photo Number
6

Description:
Pool house bathroom

- **Restroom fixtures** - An allowance has been included to replace bathroom fixtures every 20 years.
- **Doors** - We have an allowance to repair or replace the three doors based on a useful life of 40 years. No unusual conditions were noted.

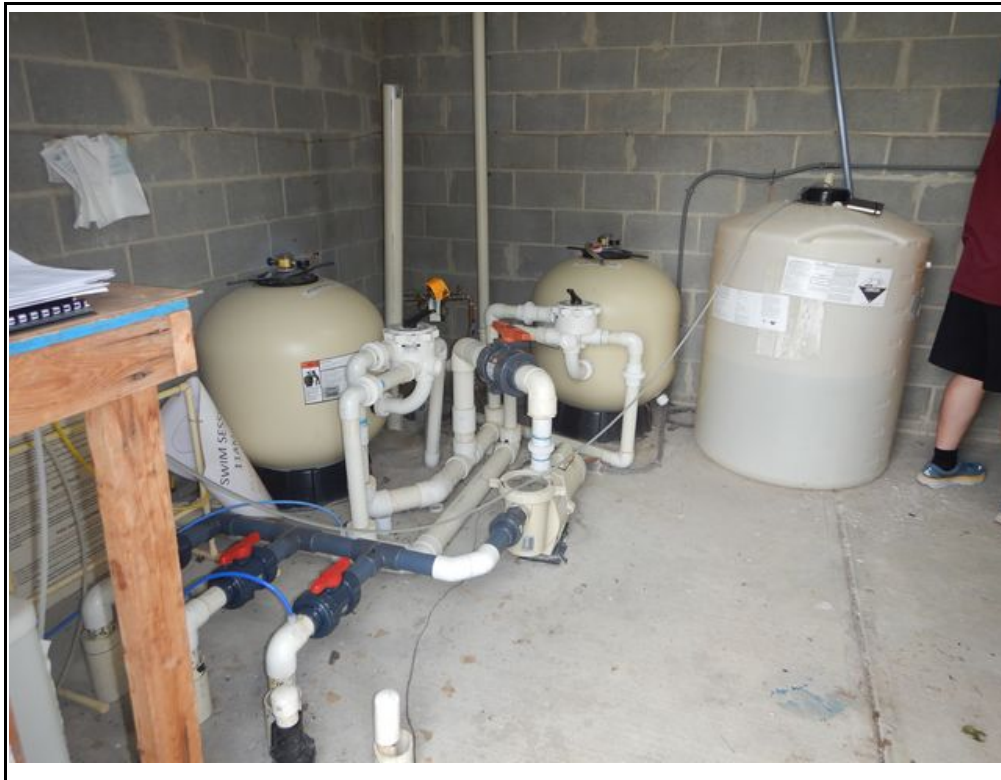
Photo Number
7

Description:
Pool equipment in pool house

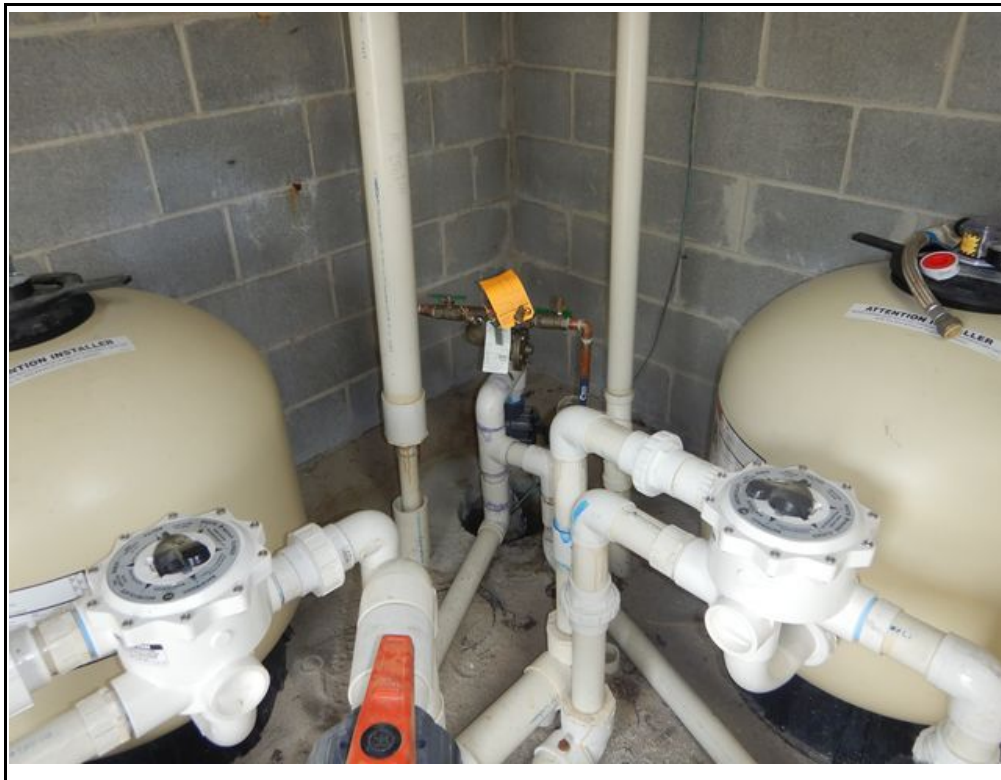
Photo Number
8

Description:
Pool house backflow
preventer and pool filters

- **Filter** - We have included an expenditure to pool filters every 10 years. No unusual conditions were noted in the pool filter.
- **Chemical feed system** - We have included an expenditure to replace the chemical controller every 15 years. No unusual conditions were noted in the pool chemical controller.

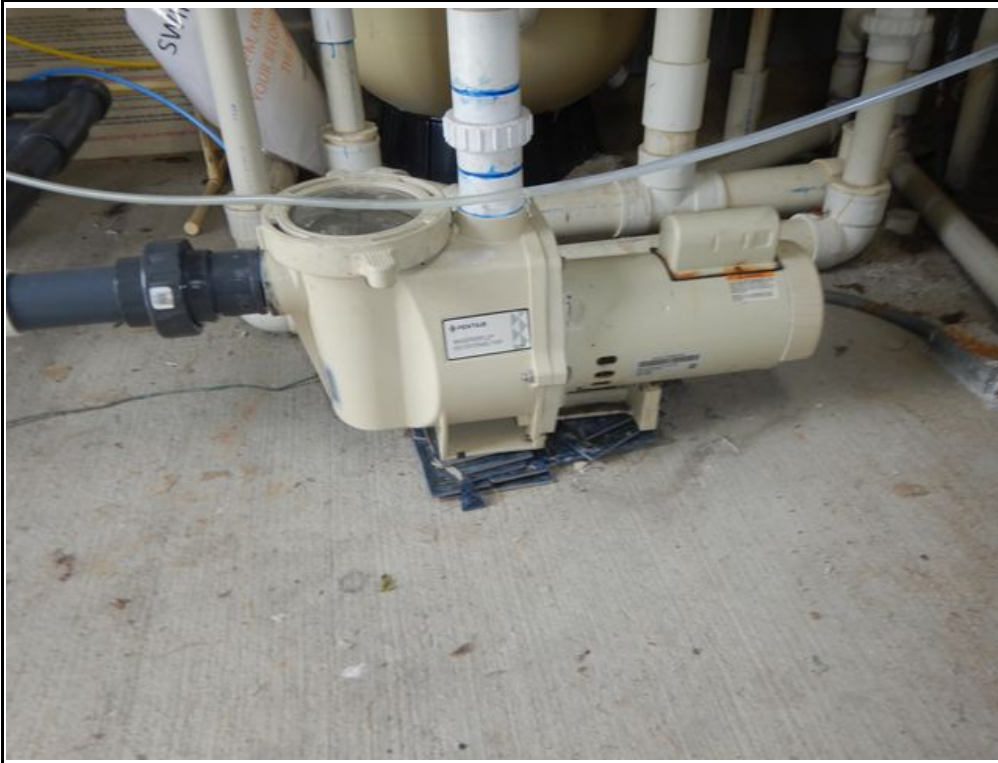
9

Description:
Pool pump

- **Resurface** - We have included an expenditure to resurface the swimming pools every 15 years.
- **Pump** - We have included an expenditure to replace the pool pump every 10 years. No unusual conditions were noted in the pool pump.

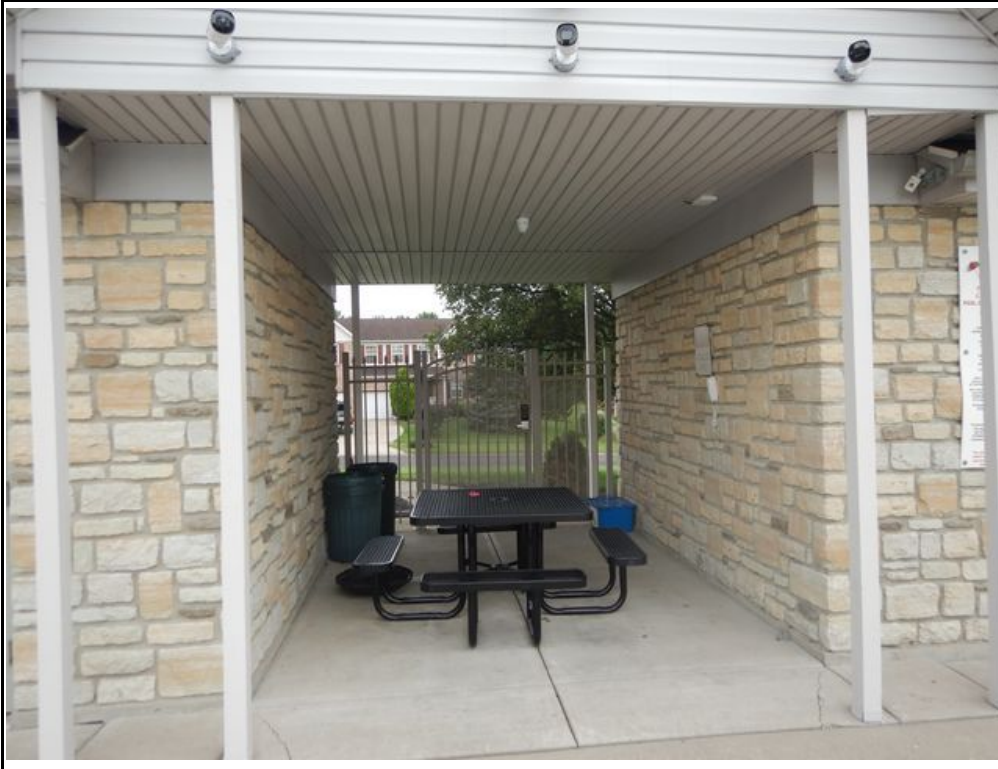
11

Pool house security system

The security system at the pool house includes a fob lock and cameras. The system was installed in 2023 for \$9,500. We have included costs to replace the security system based on a useful life of 15 years. No unusual conditions were noted with the security system.

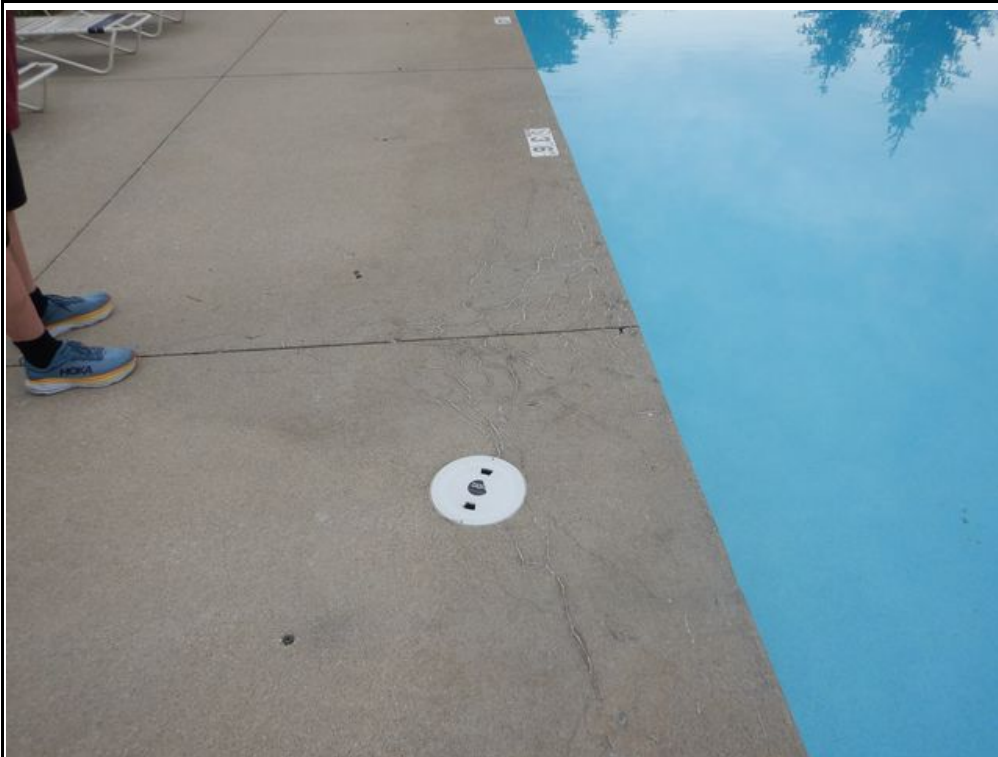
12

Cracks in concrete near pool

The Association's Manager and Board will evaluate concrete periodically and decide when to make needed repairs and the allowance we have used will be adequate to cover those costs. The Association has the option of spending the funded amount each year or let it accumulate for larger replacement projects. The concrete currently is in generally fair condition with areas of poor condition.

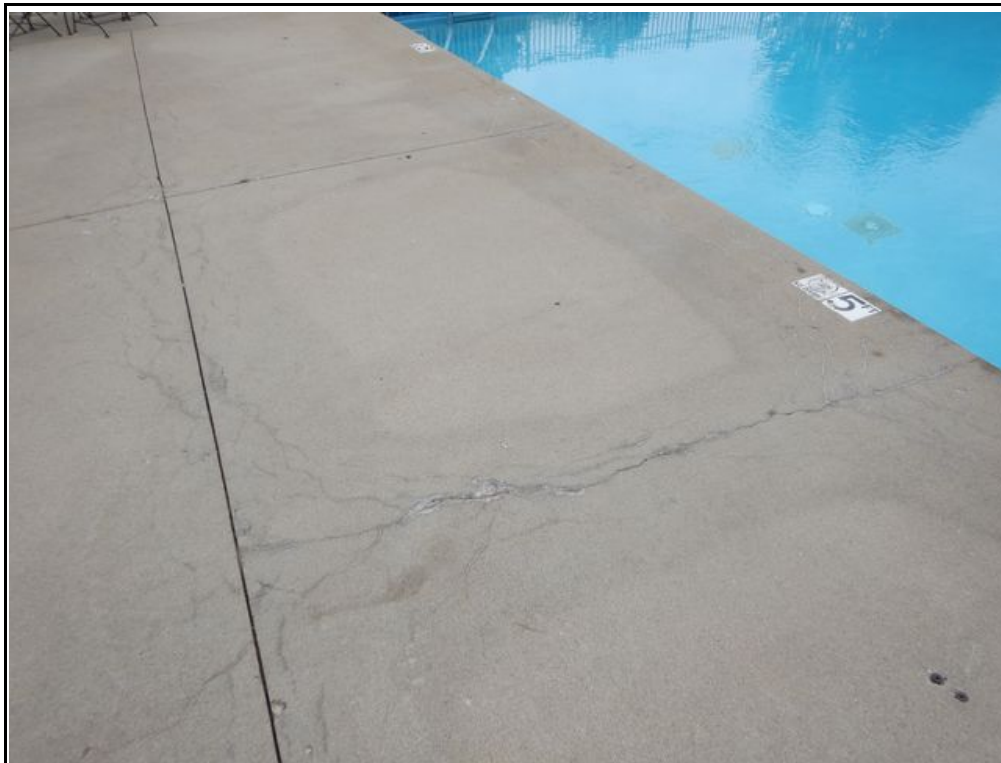
14

Cracks in concrete near pool

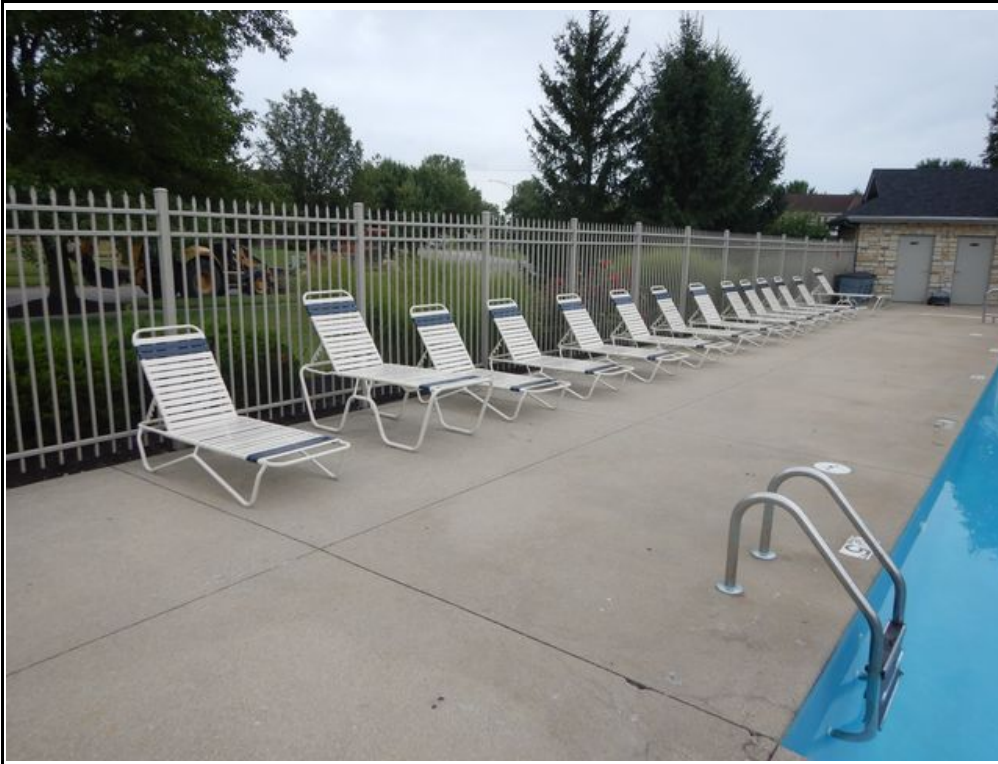
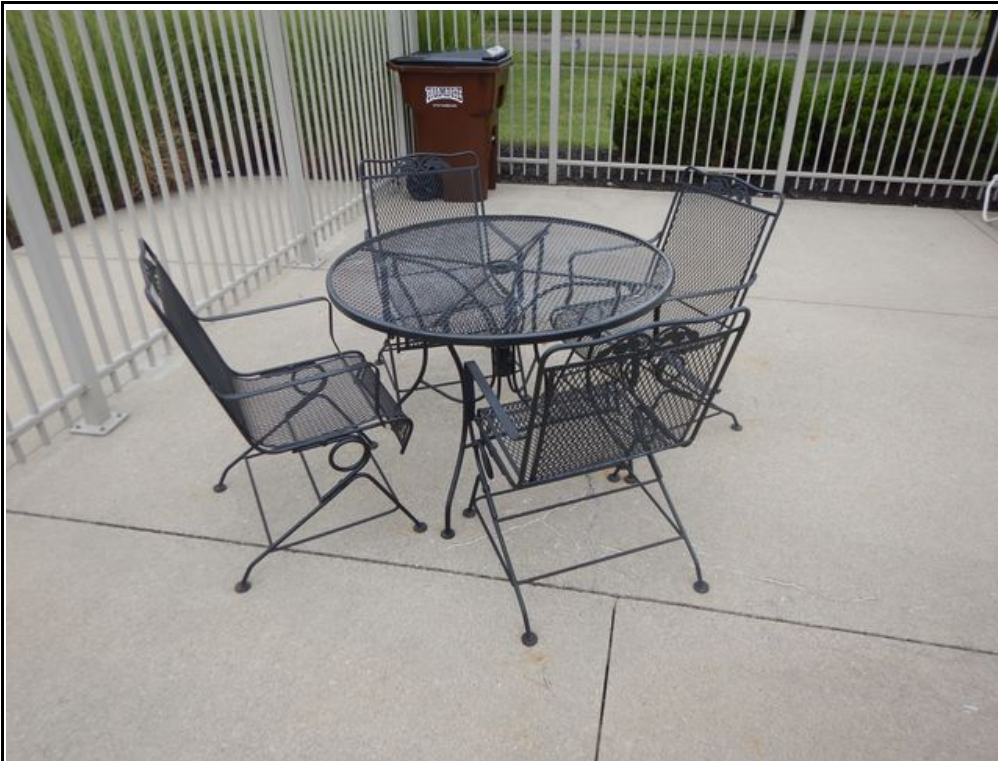
Photo Number
15

Description:
Pool furniture

- **Furniture** - We have included an allowance to replace every 15 years. The pool furniture is in good condition.

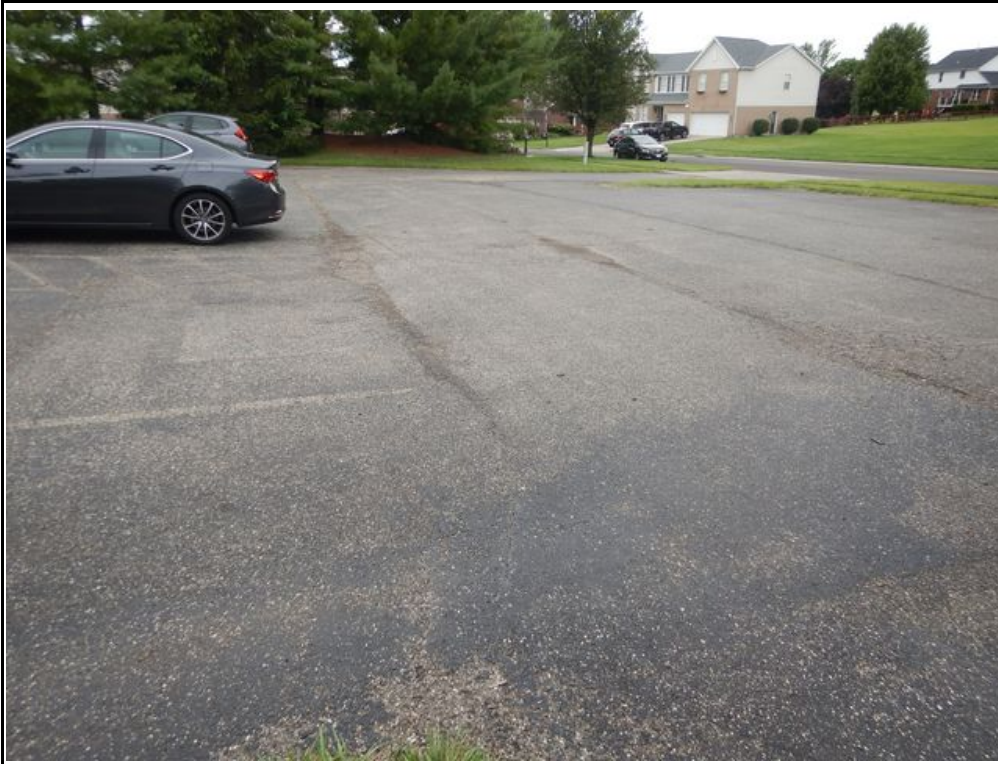
Photo Number
17

Asphalt materials need periodic work. The asphalt parking area at Lakewood HOA should be maintained by periodic sealing and patching. We observed that the asphalt was in only fair condition with some cracks visible. The total asphalt surface we measured was 598 square yards. We have included the cost for the asphalt to be fixed every 5 years with crack patch, seal coat applications. We also have included milling and replacement of the asphalt surface every 20 years.

Description:
Asphalt parking area

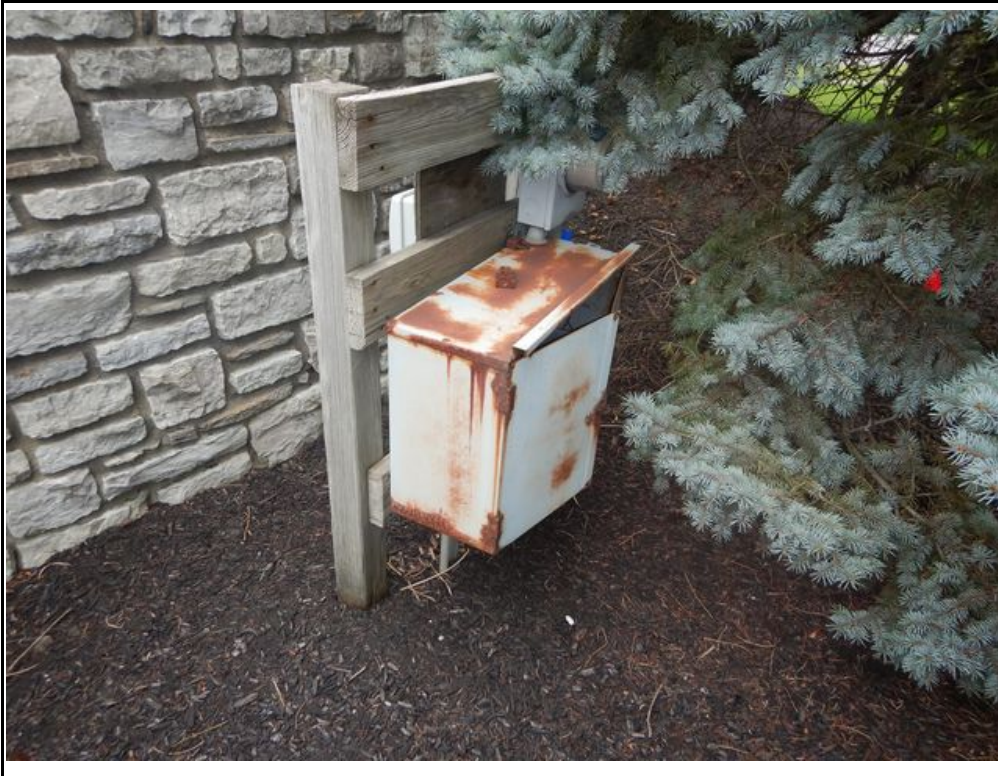
Photo Number
19

Electrical components are present at the entry signs, pool house, and pond. Electrical distribution equipment typically has a useful lifespan of 40 years. The electrical equipment was generally in good condition. We noted a rusted electrical box near the

Description:
rusted electrical box near
entry signs

entry signs. We have included replacement of the rusted box and general replacement of distribution equipment

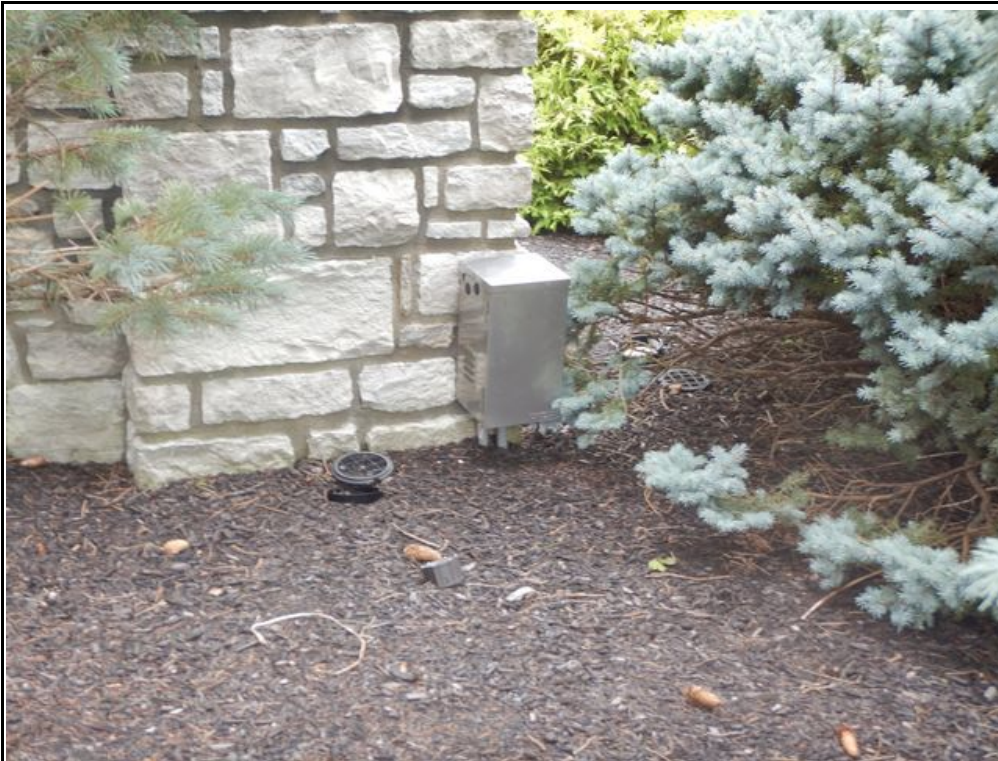
Photo Number
20

There are ground lights for the signs. We have replacement costs with 15 years of useful life.

Description:
site lighting and controls

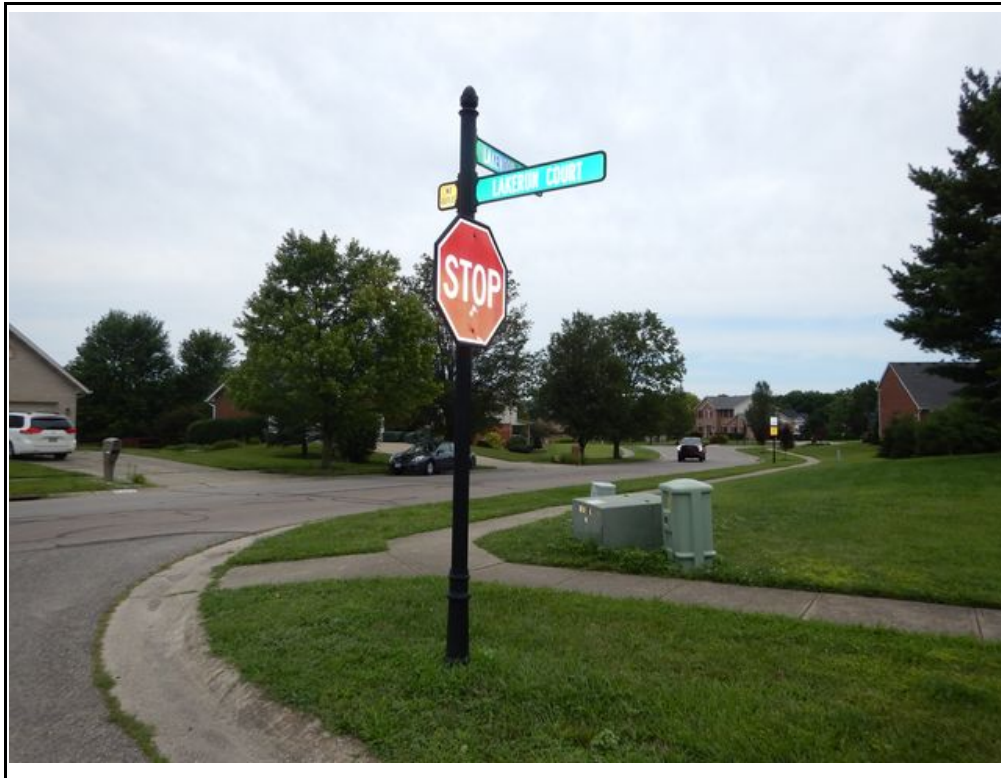
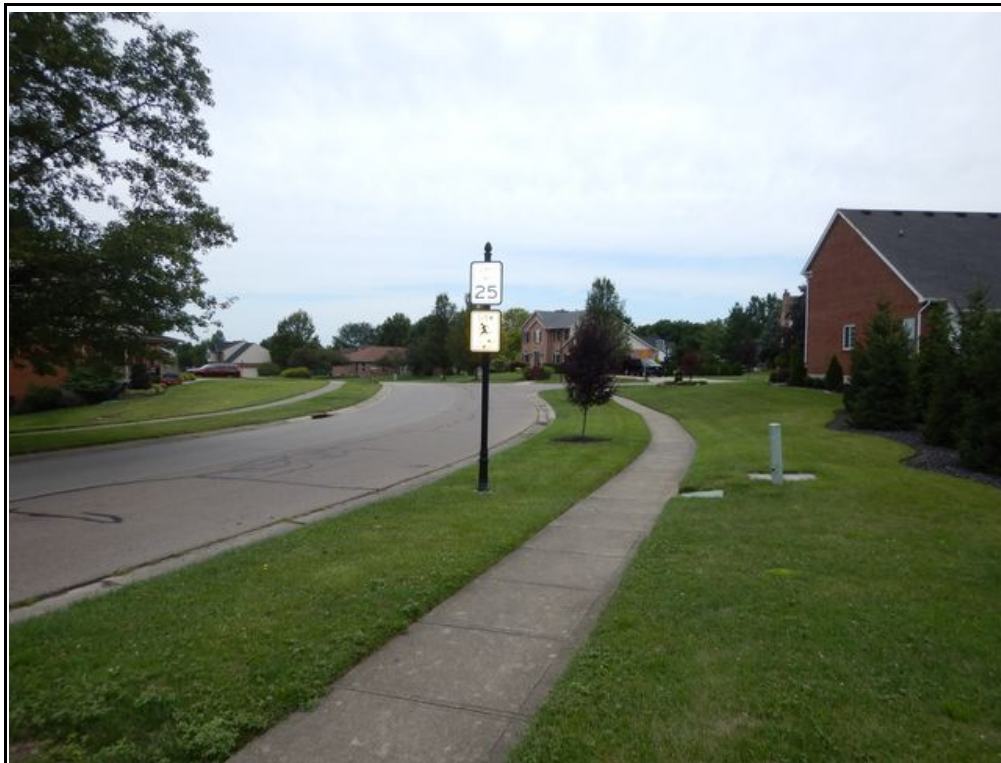
Photo Number
21

The street signs were originally owned by the local municipality. However, the Lakewood community upgraded from to a decorative design that is now the responsibility of the Association. We have included an allowance for street sign replacement based on a useful life of 25 years.

Description:
Street signs

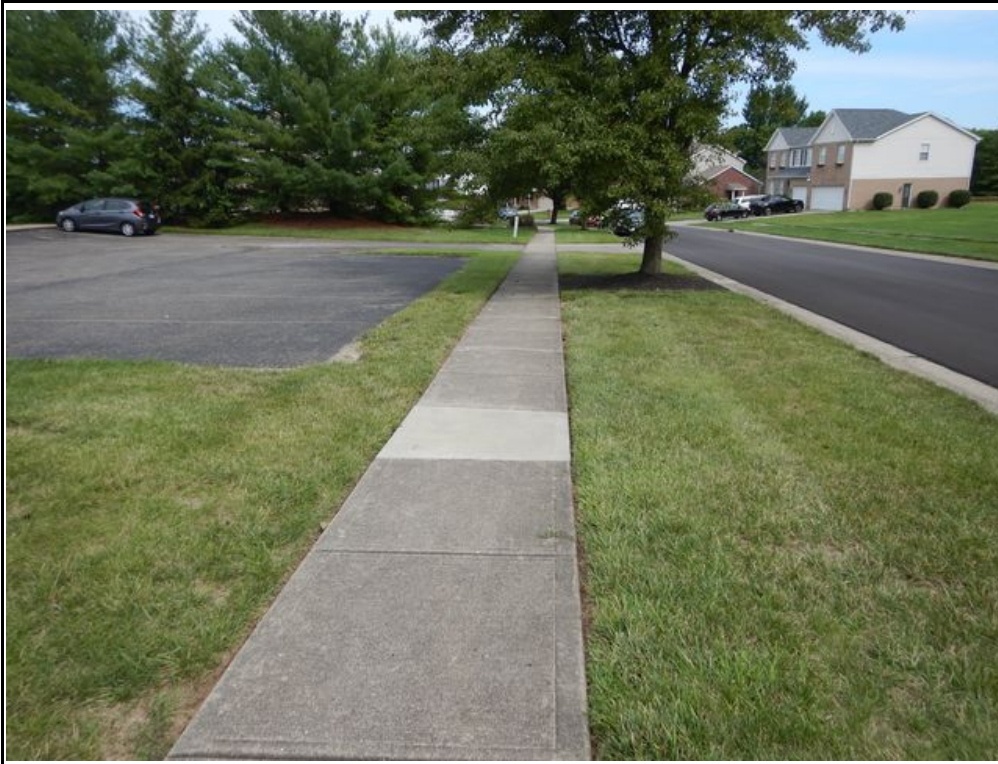
Photo Number
23

Description:
Sidewalk near amenities

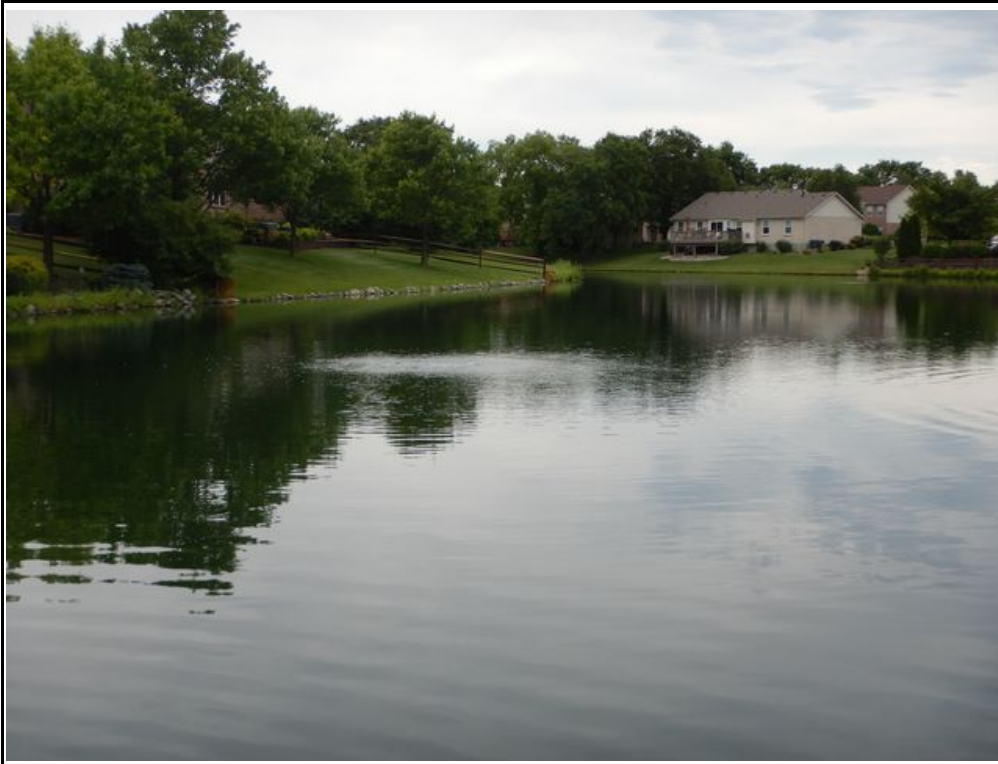
Photo Number
25

Description:
Pond aerator

The pond pictured in Photo 31 has an overflow to maintain a constant level. There are three aerators spaced evenly across the pond and they operate from one aerator pump. We have included replacement costs for the aerators and the aerator pump.

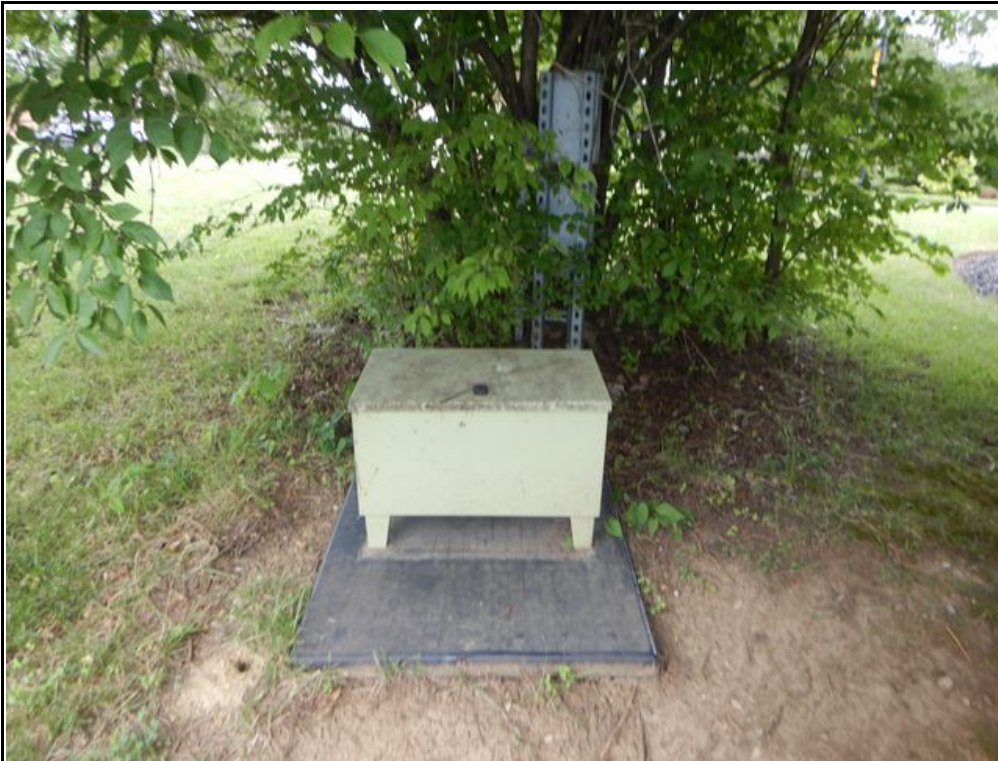
Photo Number
26

Description:
Pond aerator controls and
power

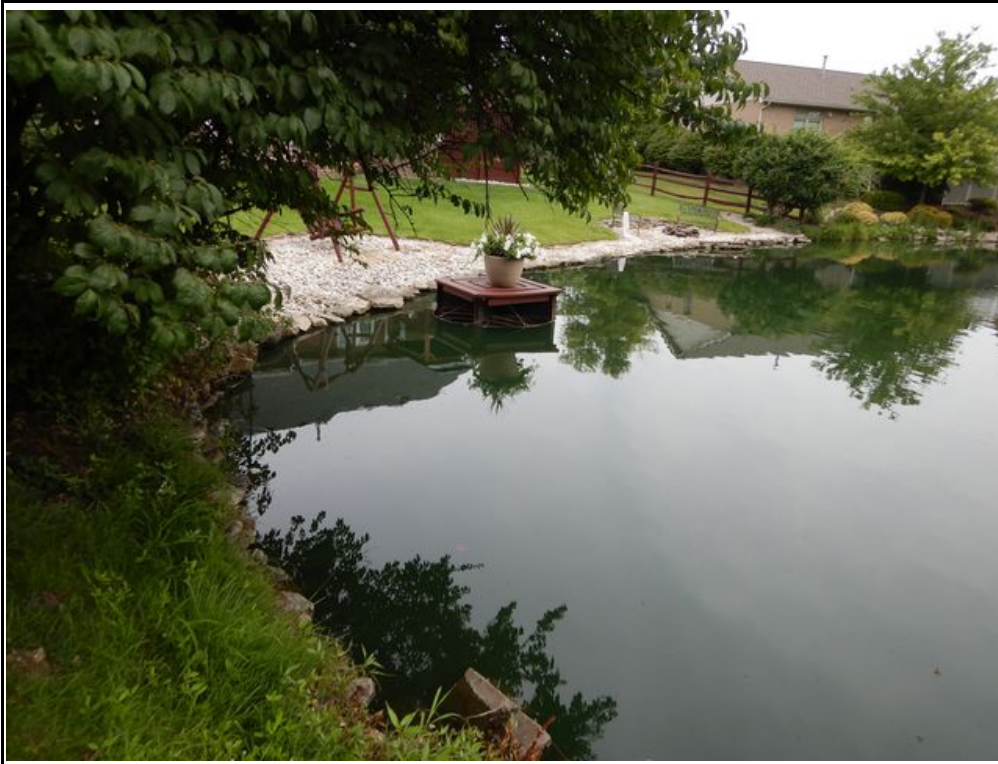
Photo Number
27

Description:
Pond overflow

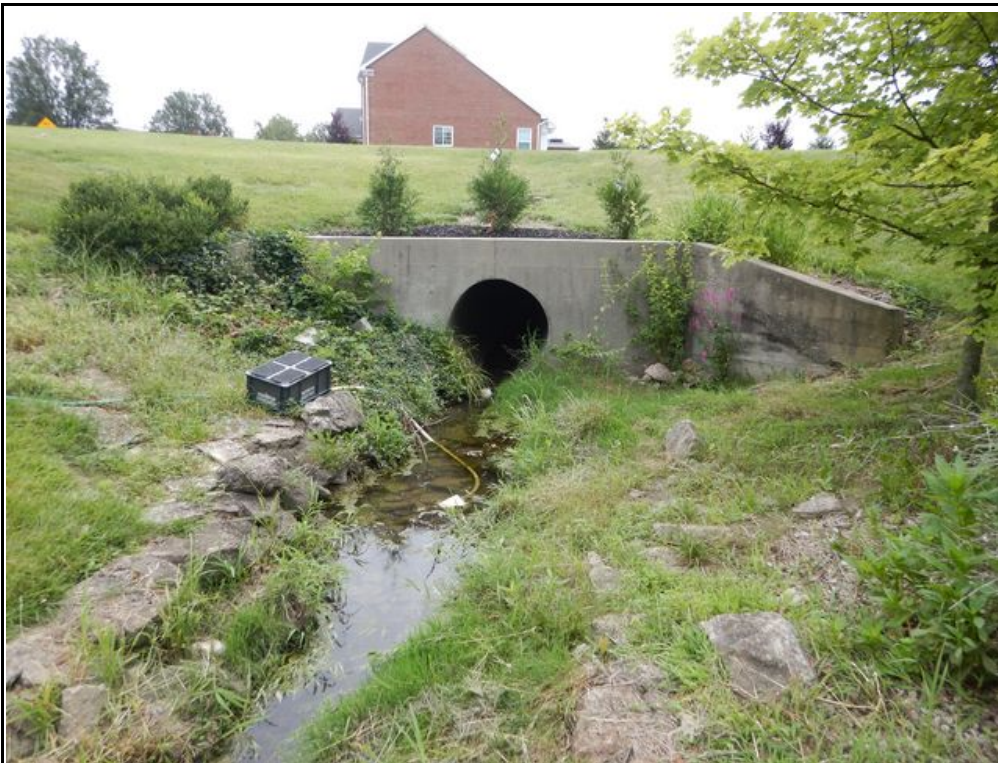
Photo Number
28

drainage includes pond overflow through a corrugated drain below a road. We have included an allowance for future repairs to site drainage. based on a 35 year useful life. Site drainage improvements are commonly required as a community ages. The drainage is in good condition.

Description:
Drainage from pond that runs
below road, corrugated metal.
Concrete retaining wall near
drainage.
