South Loon Lake Road – Lake Shore Homes Road 1A entrance erosion

Proposed Fix

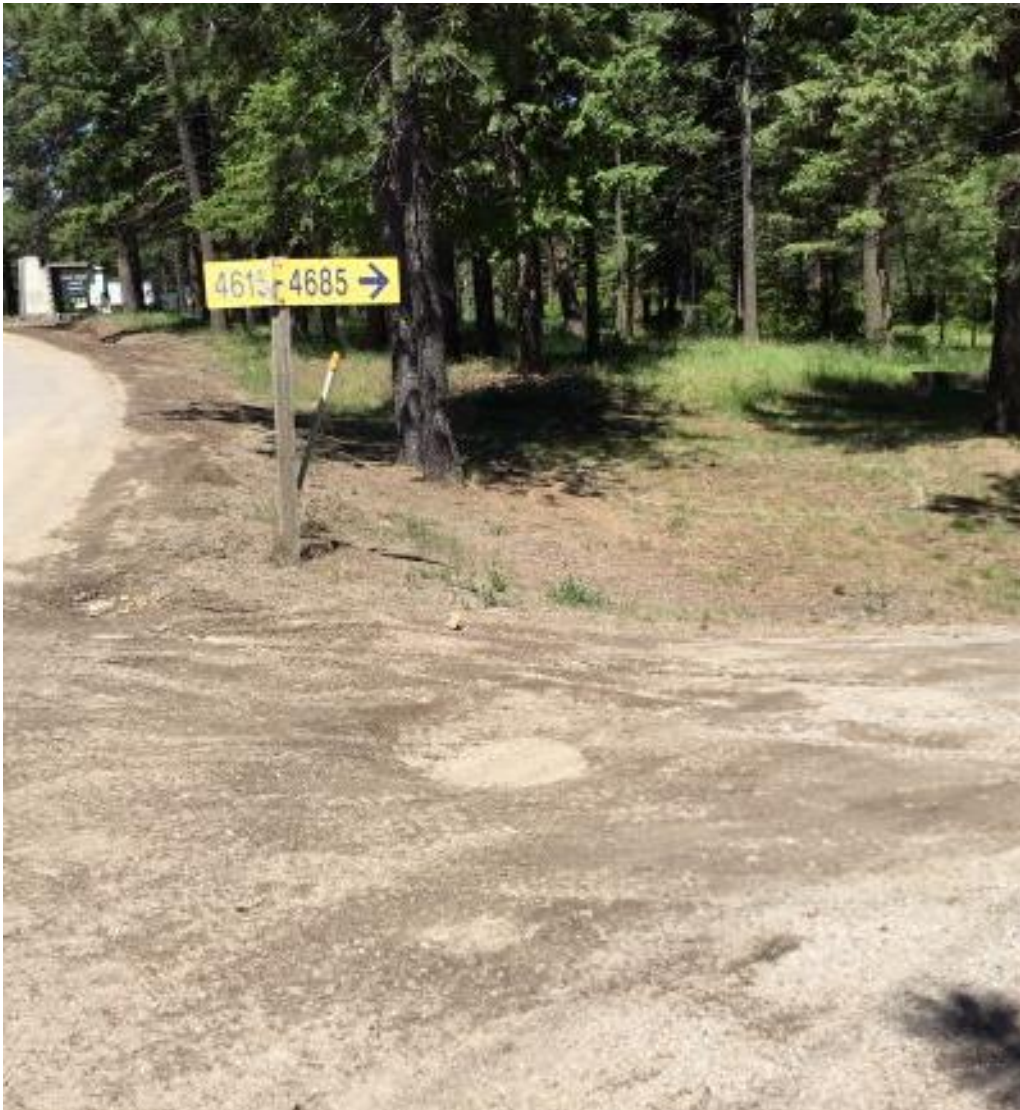
S. Loon Lake Rd – LSH Road 1 Entrance. There is sewer (large circle), gas line and communications lines running down the road

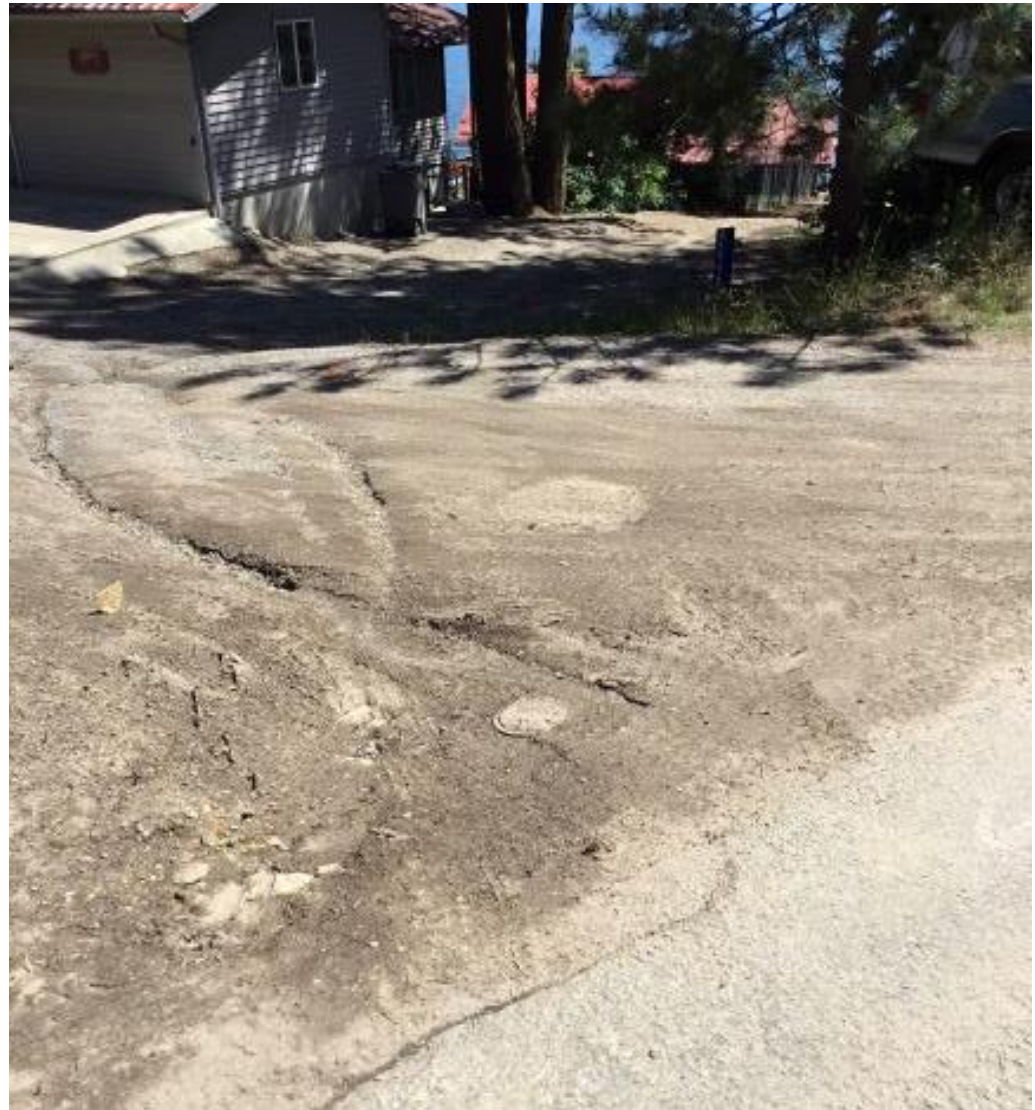
The water damage and erosion caused by the May 30th thunderstorm flowing down road 1 and into the Absolonson's driveway.

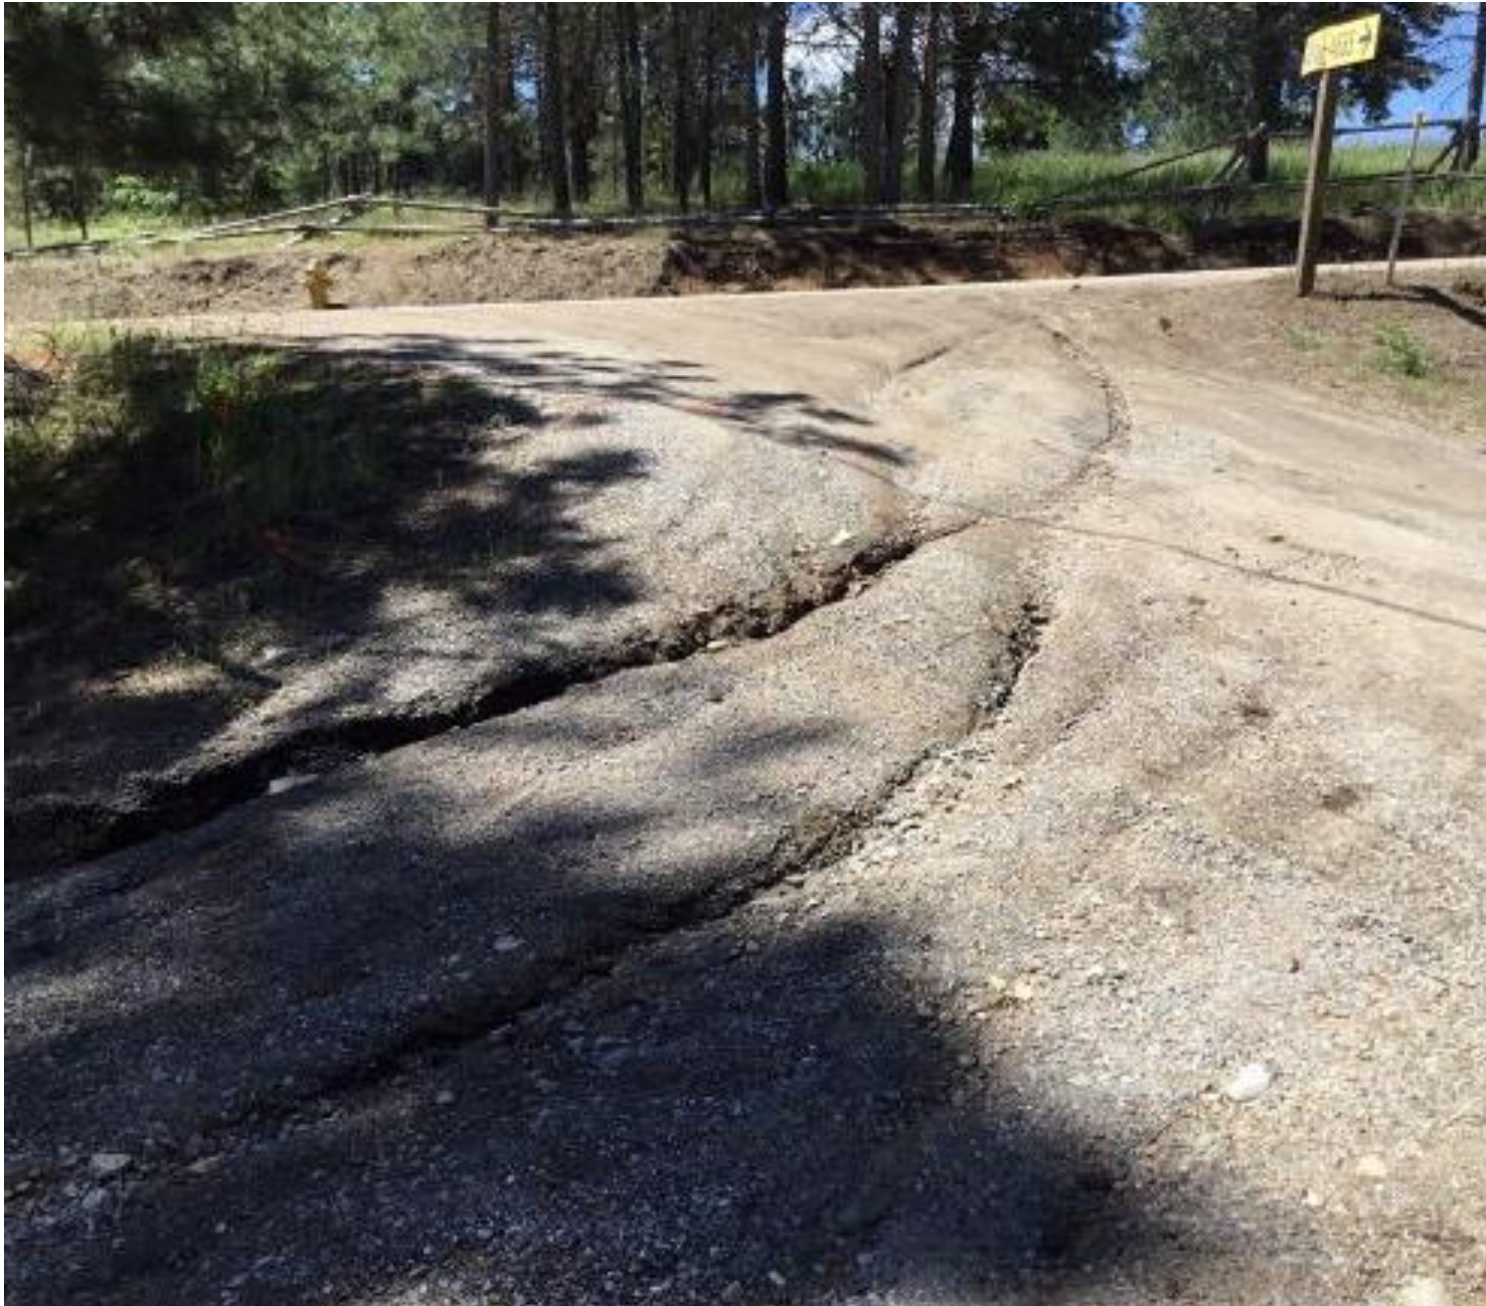
This is a closer look at the erosion damage at the top of the Absolonson's driveway and the entrance of LSH entrance road 1 from S. Loon Lake road. This was caused from the major thunderstorm rainwater that flowed down S. Loon Lake road and into the first entry point the LSH road 1 entrance. Due to a berm along S. Loon Lake road the water could not flow off the road until the entrance to LSH entrance road 1. The water produced a flow of mud down the Absolonson's driveway and onto their lower deck.

- The road 1A entrance was graded, rolled and graveled by Bode's gravel on 6-22-20 .
- The Absolonson's driveway was graded, rolled and gravel applied at owner's expense on 6-22-20.

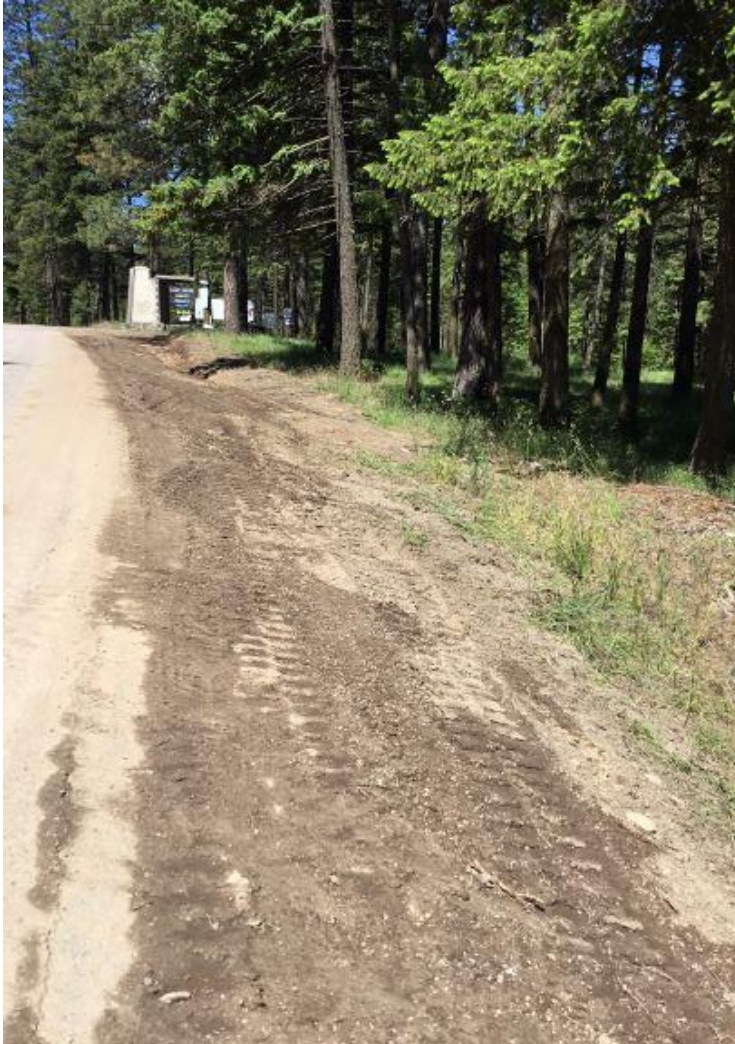
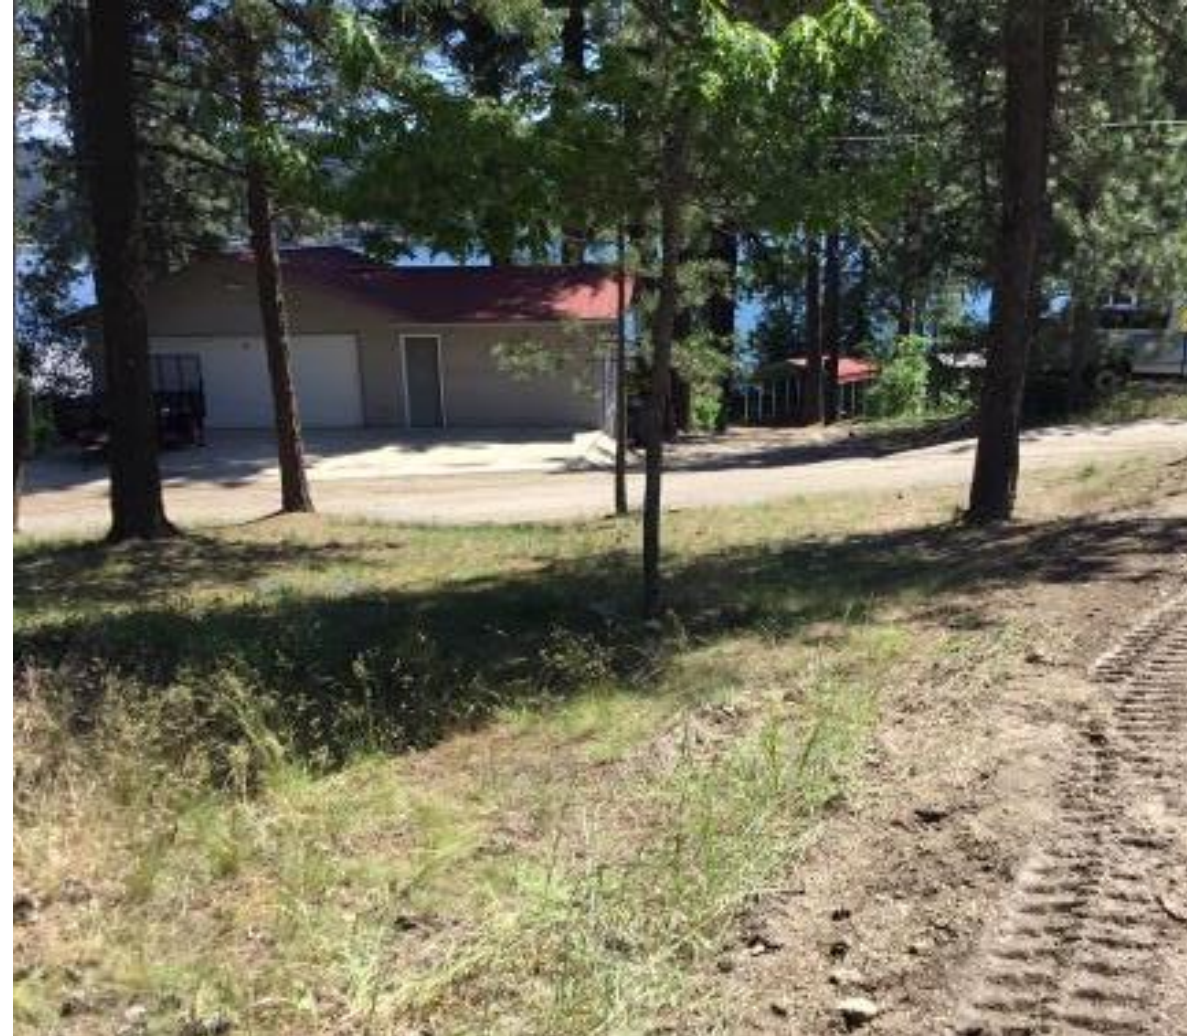
Steven's county road crew removed the berm along S. Loon Lake road from our LSH entrance road 5 slanting the shoulder of the road to allow water run off into the grass all along S. Loon Lake road channeling the water onto the LSH grass area. Picture 1 shows this work

The second picture to the right shows the view from S. Loon Lake road left hand shoulder and the route that water will take away from the road and onto the grass area of the LSH. Grass seed will be planted this fall along the graded area. A drew well will be placed just above rd. 1 and below the LSH water main to catch any water that is not absorbed by the grass area.

- The fix has been completed. Steven's county has brought in their road crew and graded the north shoulder of the road slanting so the water will flow off the road and into the grass area along the road running west from LSH entrance (road 5) to before the LSH road 1A entrance.

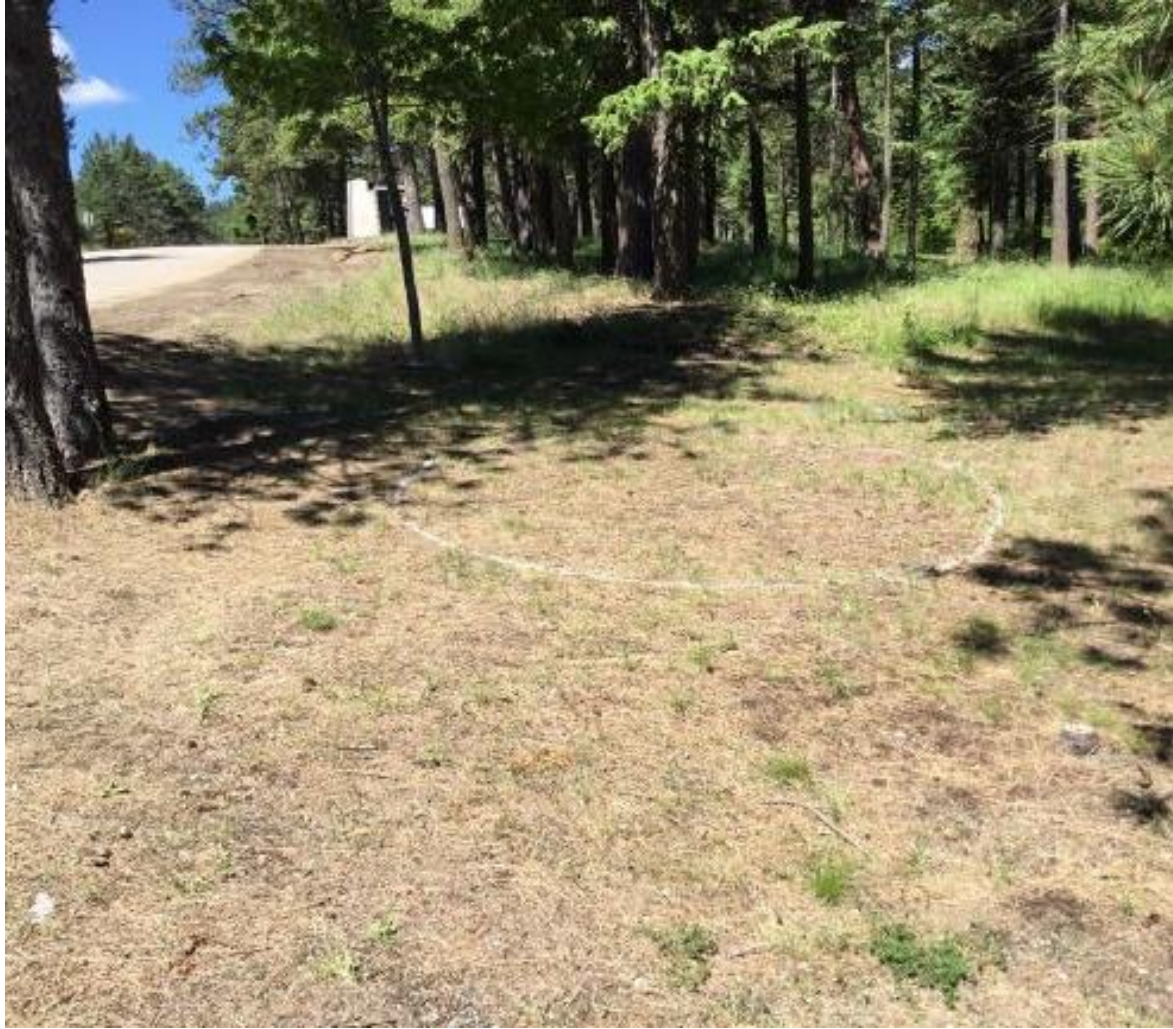
The white circle indicates the location of the dry well. A hole will be dug and filled with rock for drainage.

- A dry well just east of road 1A entrance and below the 5" Loon Lake Water district water main was dug and filled with rock to catch any water that is not absorbed into the grass area from the road preventing water to flow over road 1A and into the Absolonson's driveway or other near by lake homes.

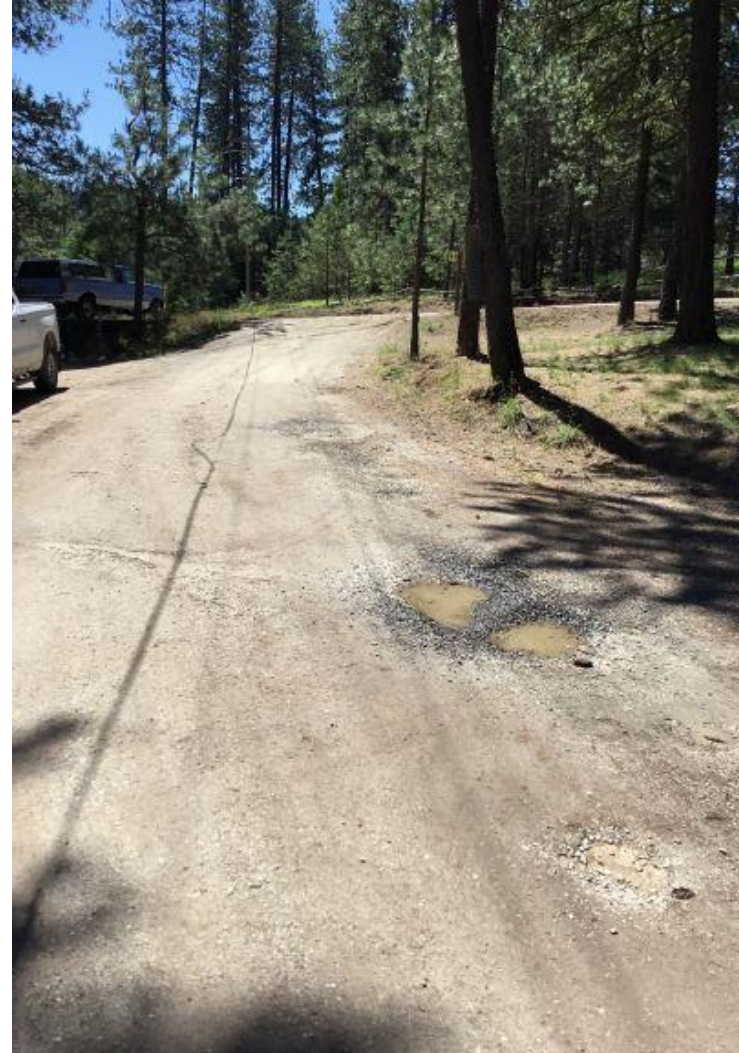
The entrance to road 1 will be graded, rolled and 5/8 " black gravel will be applied for about 200 ft. This will repair the deep ruts at the entrance and potholes that have occurred. This should take care of any maintenance on this part of road 1. There is a lot of traffic on this part of road 1 due to construction as well as there are many homes that use this road.

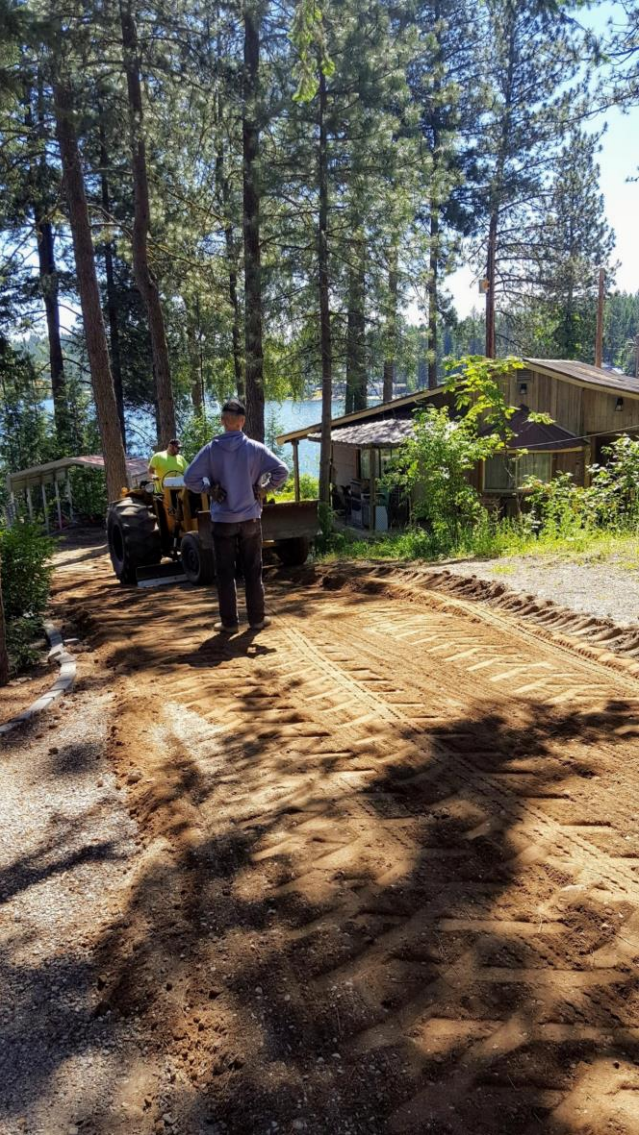
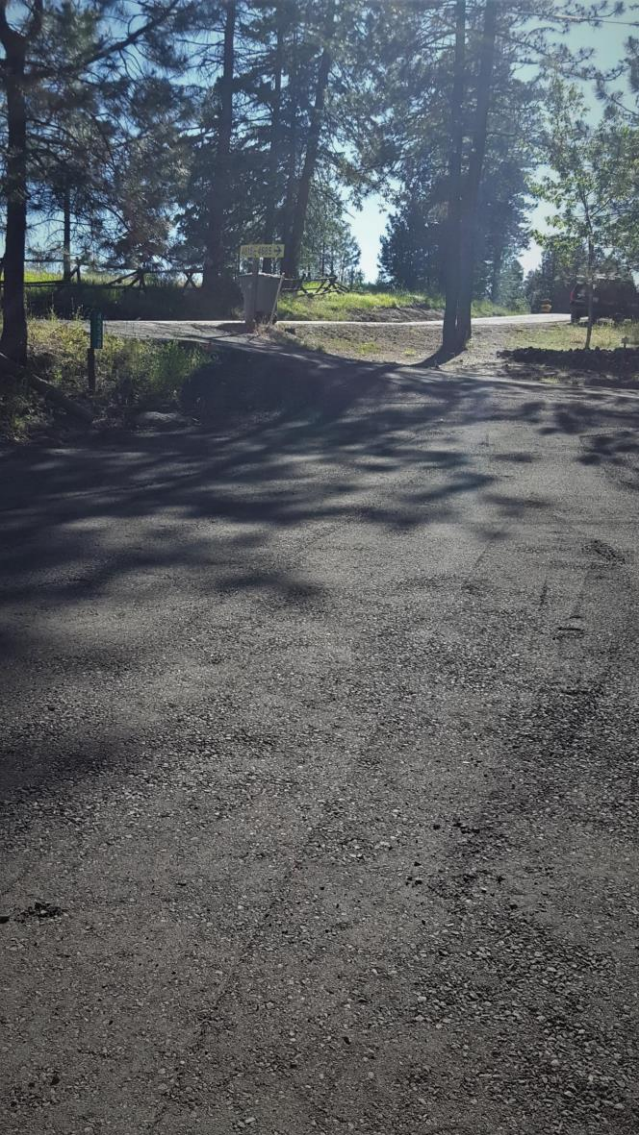
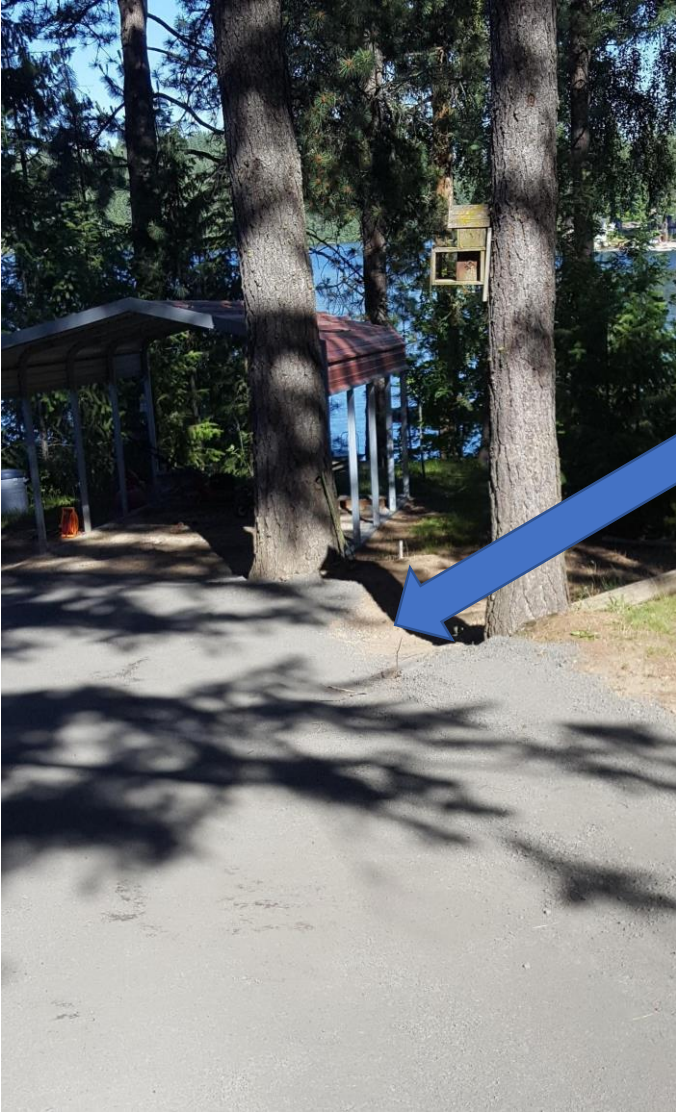
Grading Rolling and Graveling Repair of Gary Absolonson's Driveway

A drainage trench was dug near the end of Gary's driveway to provide a path for water to drain away from his lower patio area.
