The Village of Centertown, MO Drinking Water - Facility Plan

Project No. 19492.001

Bartlett & West

February 2018

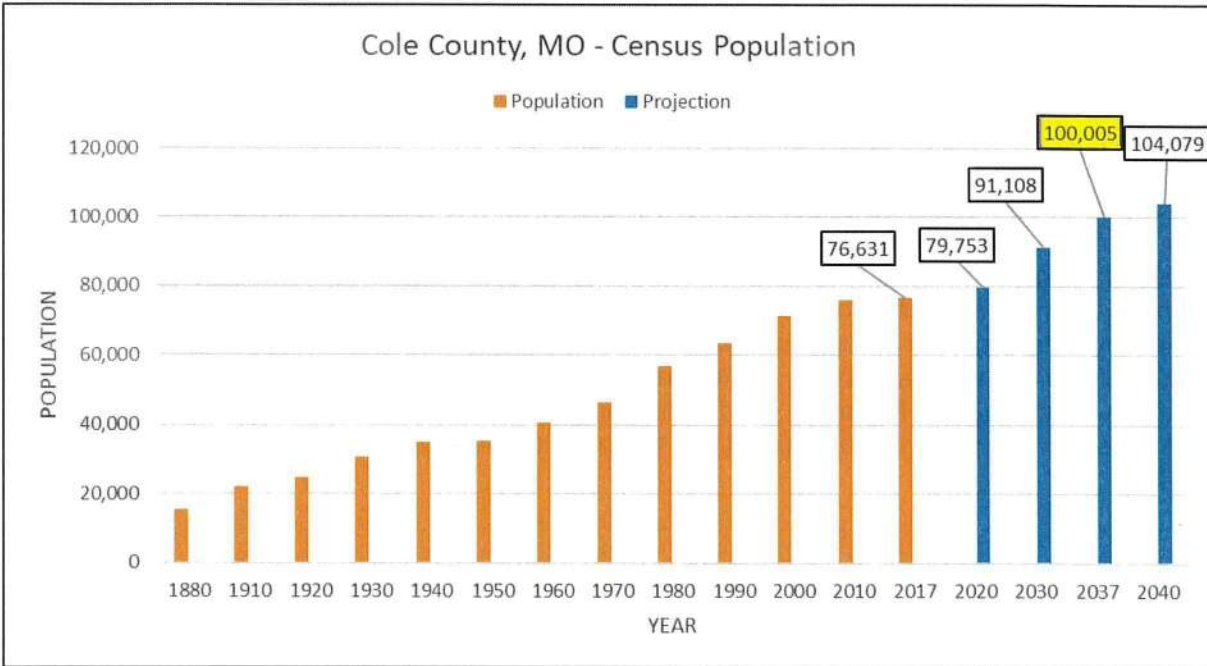
Figure 2- 20 Year Projections for Cole County, MO

From a conservative growth perspective, Cole County's average growth of 1.34% should be used for planning purposes giving Centertown a projected population of **371** in the year 2037 over the 20-year planning period. See **Figure 2** showing the historical population and growth projections of Cole County and **Figure 3** for the historical population and growth projections of Centertown.

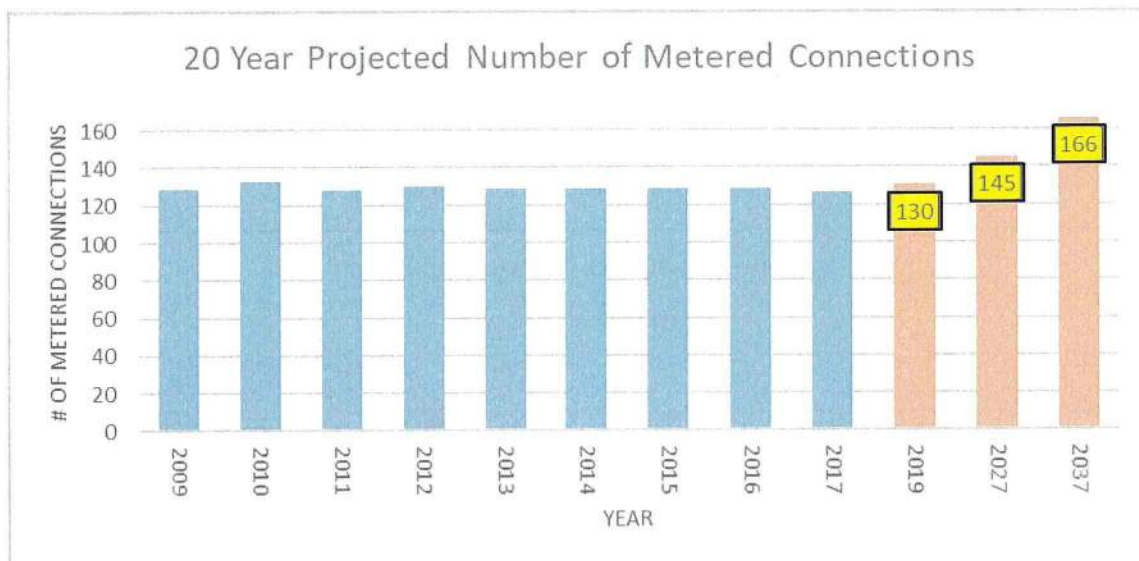
Figure 4- Projected Metered Connections

The 2010 census showed growth of 11 homes and 4 families compared to the 2000 census which also shows evidence of development and growth. It is feasible that with an improvement in water and sewer utilities, there would be an increase in development. Even one new subdivision could increase the number of households by as much as 40-50 homes. For example, there is a subdivision being developed with 60 new lots located just east of Centertown on Highway 50 approximately 4 miles west of the intersection of Business Highway 50 and Henwick Ln. The number of metered connections in 2037 based on projected growth for Centertown is shown in **Figure 4**. For the planning purposes of this report using the same 1.34% growth per year, it is estimated that there will be **166** metered connections in the year 2037.

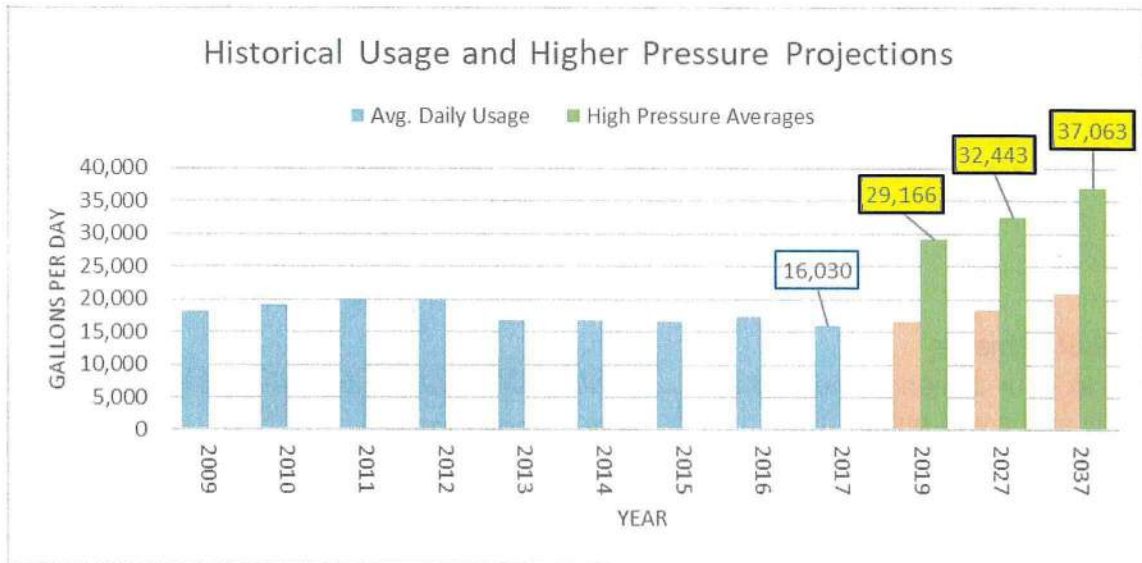
Figure 5- Historical averages and projected future flows with higher pressures assuming 100 gallons/person/day

Figure 5 below shows the historical average daily demands of the Centertown water system, which has been relatively level over the past 5 years. The average daily demand over the past 5 years is **16,763 GPD**. There is an obvious dip in the usage between years 2012 and 2013. The 2013 user rate increase along with the likely associated efficient water usage has probably

played a role in decreasing the average flows. The relatively low usage in Centertown can more importantly be attributed to the low system pressures due to the existing water storage tank that is too low. The current average gallon per person usage is **56.4** gallons per person per day. When the water pressure is corrected with a proposed taller storage tank, customers will have approximately double the water pressure that they currently experience and water usage will increase. For this reason, historical data should not be used. 100 gallons per person per day was used instead to calculate projected future average day demand - see **Figure 5**.

So to summarize, by using the projected 1.3% growth rate, the population would increase to **371** people, roughly **166** metered homes, and an average daily flow of **37,063** gpd.

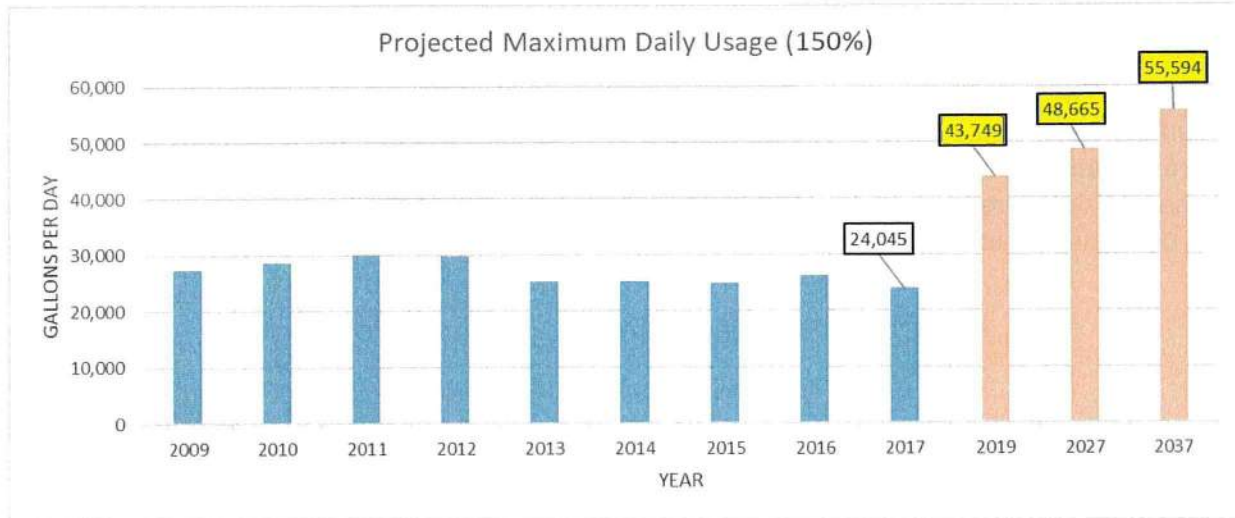
Figure 6-Projected Maximum Daily Usage

Using the Missouri DNR Minimum Design Standards, the maximum daily usage was determined by taking 150% of the average daily flows. **See Figure 6 below**. Based on this standard, the peak day demand would be **55,595** gpd.

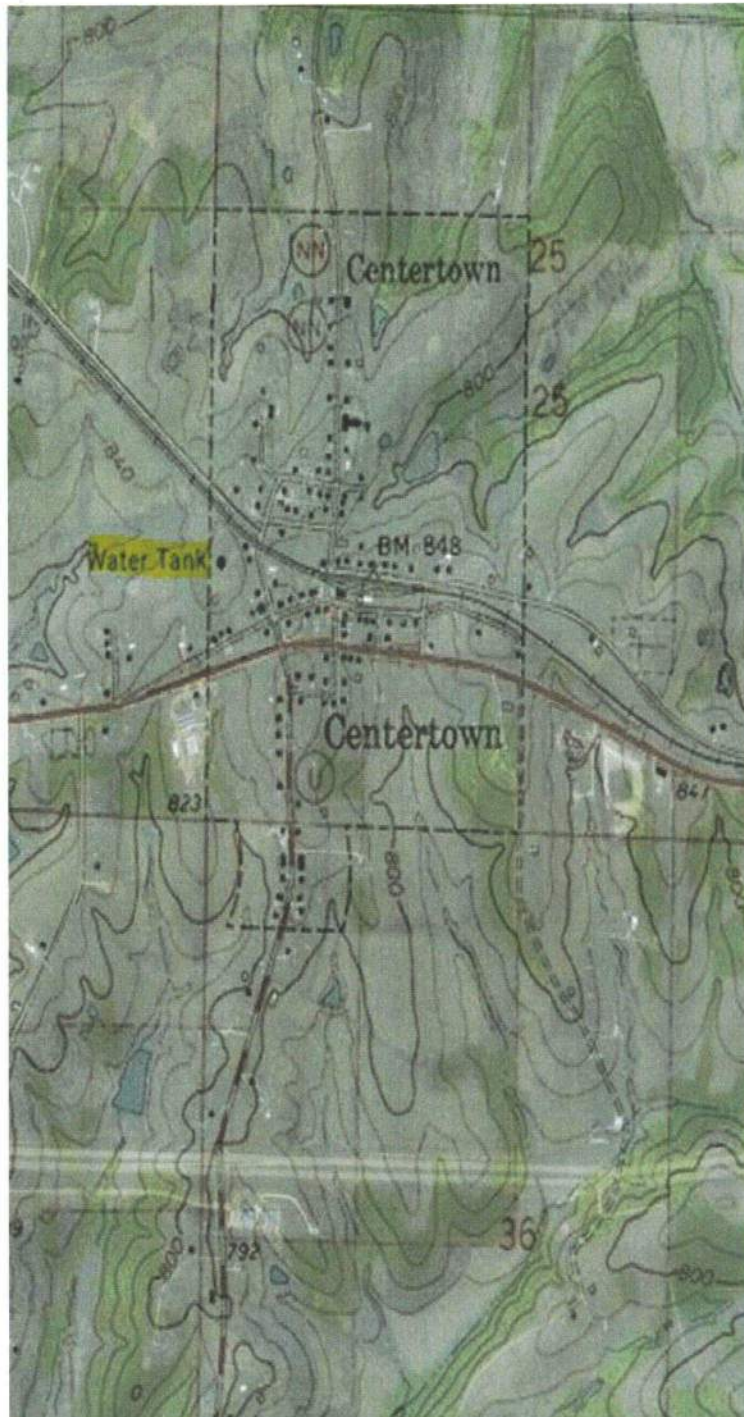
Figure 7 – Topographic Map

As indicated in **Figure 7**, the high points in the system are along the main roads traveling east to west which is where the existing tank is located. Since the existing tank site is at the high elevation area of the village, it is evident that the low system pressures are due to the height of the tank, not the elevation of the existing grade at it's foundation. So that the new tank is built at these high elevations in Centertown and within close proximity to the existing well, the proposed tank should be built on the existing site or adjacent to it. However, the proposed tank should be much taller. The current tank overflow elevation is at 937.5 ft and the residence with the highest

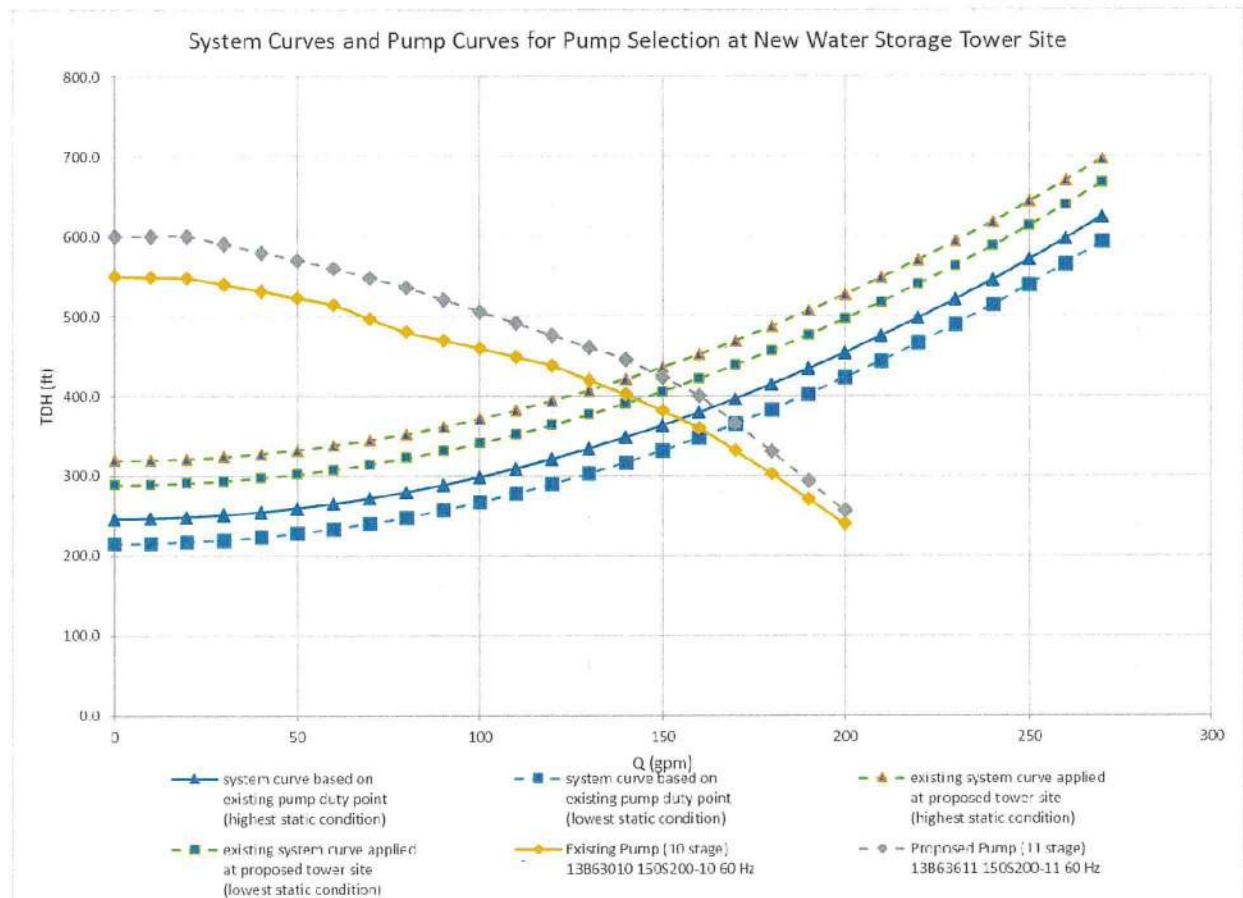
Figure 8 – Estimated System and Pump Curves for Grundfos 10-Stage and 11-Stage Pumps – Existing and Proposed Sites

A recent pump reading suggested the duty point of the existing pump is **158 gpm at 360 ft** of total dynamic head (TDH). Given that duty point and an average static head of the current

condition derived from the water surface elevation of the well to the high and low water elevations of the existing tower, the system head loss “k” value was calculated. Using this same “k” value but with the increased static head anticipated with the new taller storage tank, the duty point of the existing 10 stage Grundfos pump was calculated. If the existing 10 stage Grundfos pump used for the proposed storage tank, the capacity range would be approximately **133 to 142 gpm** and would not meet the peak 20-year design capacity of **167 gpm**. If an additional stage was added to the existing pump for an 11 stage configuration, the capacity range with the proposed storage tank would be approximately **148 gpm to 155 gpm**. While this doesn’t quite meet the 167 gpm peak hour design goal, this will satisfy projected demand for at least 12 years (see Table 1), probably longer since 167 gpm should be considered the peak instantaneous flow rate. Therefore, the 11 stage Grundfos pump is recommended for the proposed pump configuration when the proposed storage tank is constructed.

The Grundfos pump data and curves of the existing 10-stage pump and proposed 11-stage pump can be found in **Appendix C**.

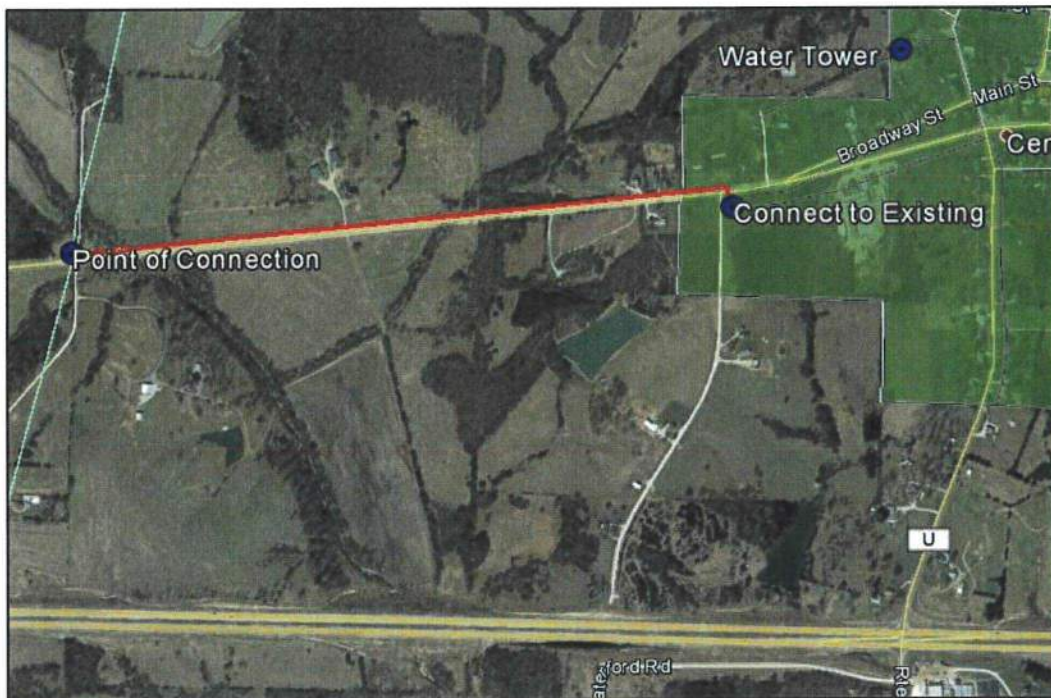
Figure 9- Point of Connection Map

Creating a connection between the two systems creates redundancy in the two water systems providing backup water sources to each community. The proposed connection point can be seen in **Figure 9**. Building a new well and well house would not be a cost-effective solution given the proximity of the Moniteau system, especially considering the long term maintenance costs of that additional facility.

Currently the largest water line in the Centertown distribution system is a 6-inch line. It is proposed to match that water line size for the connecting water main between the two systems. The 6-inch line will experience a 9 psi headloss at the future peak demand flow. A 4-inch line has too high of headloss during typically demands in Centertown for it to be considered for the connection between the two systems.

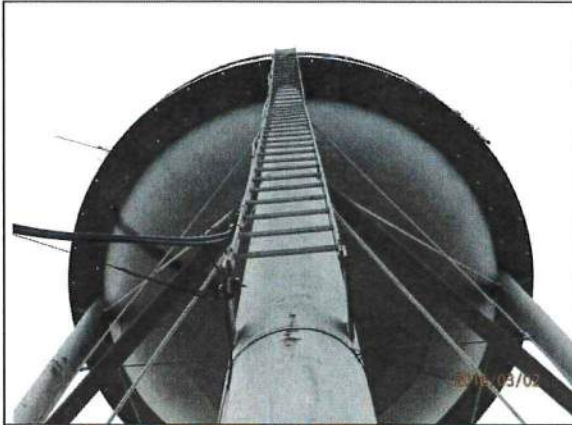
Photo #: 1
Date/Time Taken: 03/02/16 at approx. 1238 hours
By: Richard Morrow
Program: PDW Unit
File: 3.200
Facility: Centertown
Location: Water Tower
Description: There was no safety climbing device provided on the exterior access ladder and cables and antennae have been attached to the balcony's railing.

7. Cables and antennae have been attached to the balcony's railing. The system should contact their engineering firm to have an analysis conducted to assure that the railing is structurally capable of supporting the additional weight and stress subject in high wind conditions.

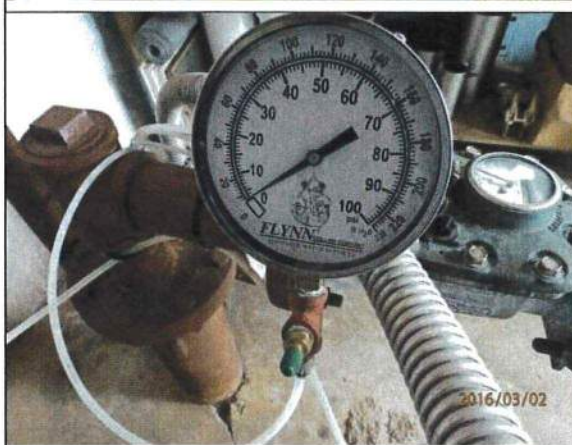
Photo #: 3
Date/Time Taken: 03/02/16 at approx. 1238 hours
By: Richard Morrow
Program: PDW Unit
File: 3.200
Facility: Centertown
Location: Well #4 Well house
Description: This is a picture of the drawdown gauge and airline. Draw down, yield, and static water level tests should be performed and recorded once every month on the well.

1. Draw down, yield, and static water level tests should be performed and recorded once every month on the well. These tests are necessary to determine if the well and its pump are operating properly. The tests will alert an operator to pump problems or low water levels in the well before the pump fails or the well completely quits and leaves the system out of water.

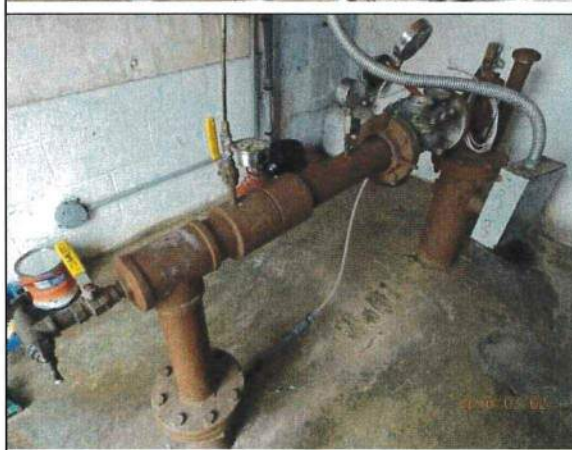
Photo #: 4
Date/Time Taken: 03/02/16 at approx. 1238 hours
By: Richard Morrow
Program: PDW Unit
File: 3.200
Facility: Centertown
Location: Well house
Description: This is a picture of the well house.
