"Of the 170 Fish Habitat Enhancement Structures that were built on Canmore Creek in 1997 and 1998, all of them were still intact in the summer of 2008!"

Over a two years period, Canmore Creek underwent a major fish habitat enhancement make over! The small stream is located in the Town of Canmore, Alberta and it is a small tributary to the Bow River. At its headwaters, there is a seep collection gallery and culvert below the Rundle Canal that provides a consistent annual flow in the creek. The Rundle Canal is part of a hydro generating operation in the Town that diverts a large volume of water from the Spry Lakes down to a power facility in Canmore.

## MILLENNIUM CREEK PROJECT 2004-2008

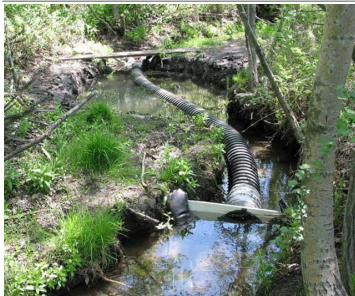
Above: A flow by-pass pipe is placed into the stream channel to isolate the work area and allow clean water to be diverted around the pool excavation site.

To minimize the impacts of silt loading downstream of a construction site, a flow bypass pipe is used to isolate the work area, during pool excavation. The flange secured to the upstream end of the pipe dams off the channel and results in the entire volume of flow being passed thru the corrugated plastic pipe. Sand bags are used to achieve this goal and they are also used to dam around the discharge end of the pipe.

There is a roughness factor which slows the velocity of flow in the pipe, which helps minimize the effects of erosion on the downstream end. The 10 inch pipe in the photo to the left weighs in at approximately 15 kg, so it is easily moved by hand to the various pool sites.

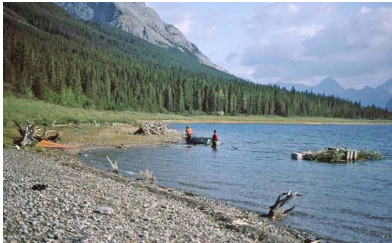
### Submerging over 300 Root Balls in Spray Lakes

In 1998, BVHD was contracted by TransAlta Corporation to finish a fish reef project that was started but not finished by another organization. The project involved submerging over 300 tree stumps that had been collected in piles, at a number of locations around the west side of the reservoir. Some anchors had been built by the group that first attempted to complete the job, but not nearly enough for the task at hand!

Some anchors had 4 holes and others had 6 holes so that more woody debris could be added!
