"Local Trout Stream News and Information"

This is the second issue of Stream Tender Magazine!

Storm Water Discharge Threatens Small Trout Stream!

Ranch House Spring Creek
Town of Cochrane (Tributary to the Bighill Creek SE 10.264.W5)
Report Prepared by : Guy Woods January 2012
Impacts of Storm Drain Discharge on the Trout Fishery and Riparian Zone

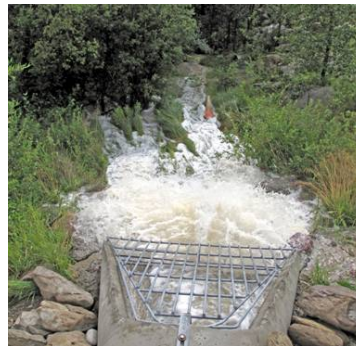
This photo shows the volume of discharge from the existing development, into the small trout stream. The proposed new second stage, Phase Two Sun Ridge Development, to the existing Phase One development, will more than double this volume of flow, if the storm water systems are tied into the same discharge pipe.

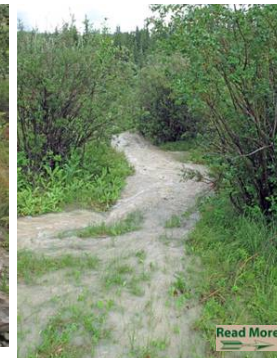
This photo shows how the volume of discharge from the storm drain system is too high for the present stream channel to manage. The end result will be erosion problems, "further down the road!"

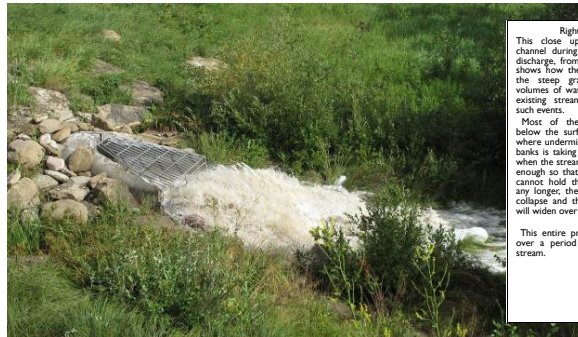
Above: This photo shows the volume of flow added by the storm drain from Sun Ridge in August of 2010. This volume of flow is approximately 10 times what the natural channel can handle.

Right Photo:
This close up of the stream channel during the high volume discharge, from the storm drain, shows how the turbulence from the steep gradient and large volumes of water, can scour the existing stream channel during such events.
Most of the erosion occurs below the surface of the water, where undermining of the stream banks is taking place. Over time, when the stream bank is undercut enough so that the root systems cannot hold the banks together any longer, the stream bank will collapse and the stream channel will widen over time.
This entire process takes place over a period of years on the stream.

I have prepared a draft design of a remediation plan to divert flows in the storm drain into a nearby wetland that will be enhanced by the additional volumes of water that it presently is sustained by. This wetland option would also allow for a stage two pre-treatment of the stream channel and the sensitive riparian habitat into the Bighill Creek system.

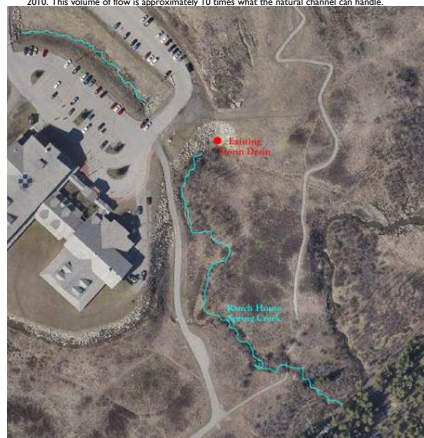
Above: This is a map of the Ranch House Spring Creek and the storm drain outflow

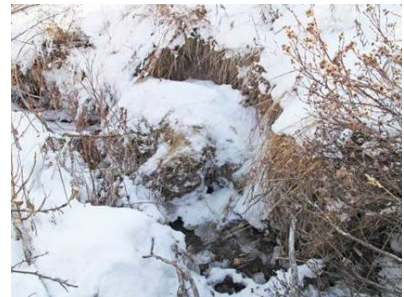
Above: This January 2012 photo shows the collapsed stream bank that occurred in 2011 on Ranch House Spring Creek, approximately 60 metres downstream of the storm drain outflow.

Over time, the existing storm water discharge into the Ranch House Spring Creek will eventually destroy the sensitive riparian habitat along its narrow banks. The invertebrate populations that are present in the creek will be disturbed and this will result in a less productive food supply for juvenile trout that depend on them for a rapid growth.
During the spring of 2011, the first signs of major bank erosion were noted along the streams lower channel, and this erosion is expected to continue and be increased over time. The erosion that occurs in the spring creek will have negative impacts to the reproductive process for spawning trout in the main stem of the Bighill Creek. Silt loading from erosion on Ranch House Spring Creek will be transferred downstream and onto one of the known key spawning habitats, located just below the confluence.

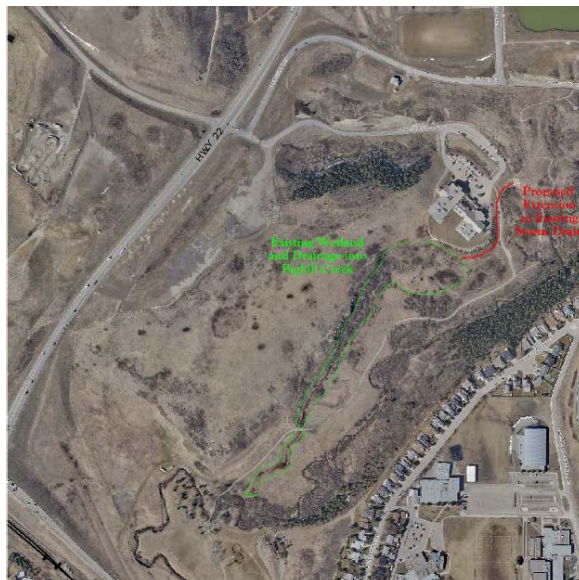
Above: This is a draft plan for a remediation project to divert flows from the storm water drainage. The plan would involve the extension of the existing outflow location.

The Red Line shows an extension that could be added to the existing discharge outflow. The extension would divert flow into a wetland area that is approximately 100 metres away from the present outflow pipe.

The wetland is outlined in green!

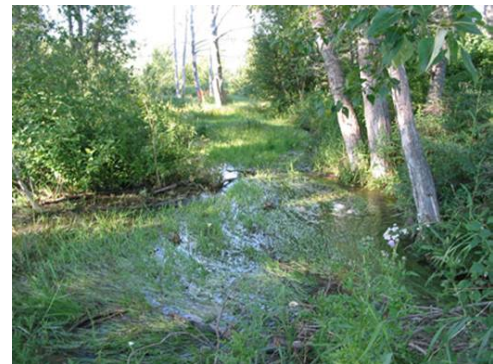
Above: This is a 2004 photo of a section of the lower creek, near the mouth of the Bighill Creek. The wetted perimeter of this reach averaged approximately 4 metres in width. Shallow flowing water moved downstream thru aquatic sedge and grasses with no defined stream channel. Years of silt loading had caused this problem!

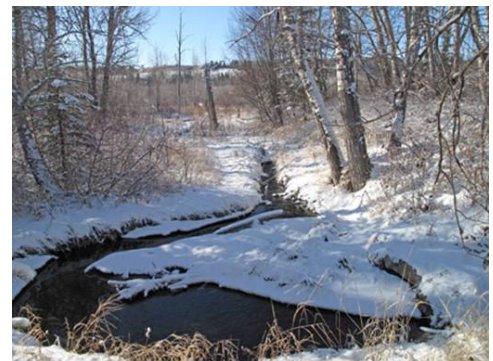
Above: This February 2012 photo shows the new stream channel that was cut thru this section of the stream in 2005. Now there is a defined narrow channel that supports a resident trout population. Over time, the willows that were planted along the channel downstream, will hide much of this reach of stream channel, but the plants will help maintain stability in the stream banks!

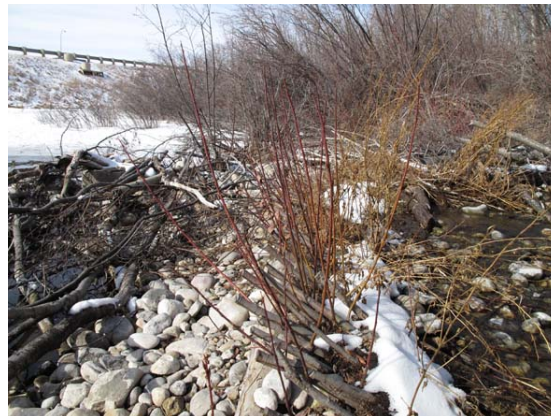
Above: Willows were planted in August of 2010 to create a natural fence to keep ducks from the spring pond out of the spawning channel area. The willows in the photo show how well they are growing!

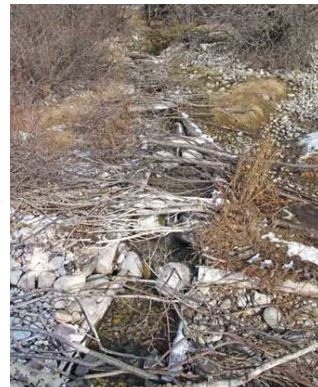
Right Photo: This is a photo of the spawning channel, taken from a downstream position looking upstream over the area where brook trout spawn in the fall of every year.

The branches were placed over the channel to provide some overhead cover, until the willows grow tall enough to do the same job. Brook trout spawn all the way up this channel in the fall. They utilize every bit of spawning habitat that was created!

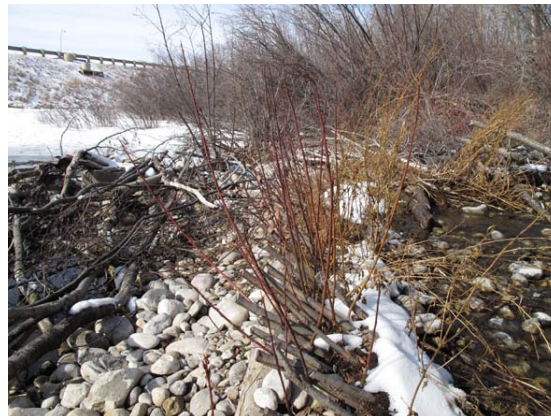
Above: Willows were planted in August of 2010 to create a natural fence to keep ducks from the spring pond out of the spawning channel area. The willows in the photo show how well they are growing!

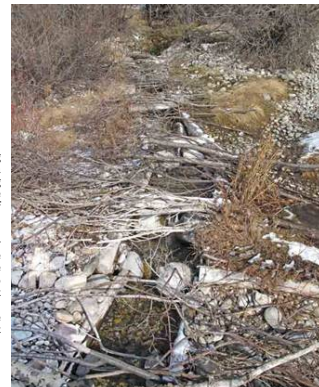
This is a photo of the spawning channel, taken from a downstream position looking upstream over the area where brook trout spawn in the fall of every year.

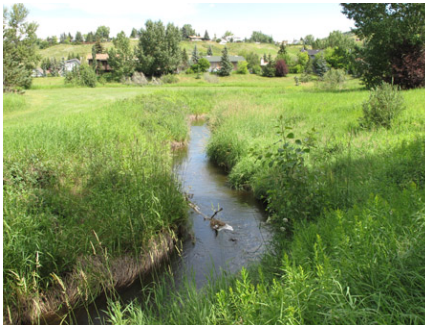
Above: This is a typical reach of the Bighill Creek that is in need of some riparian enhancement work! The site is one of many, located within the Town of Cochrane.

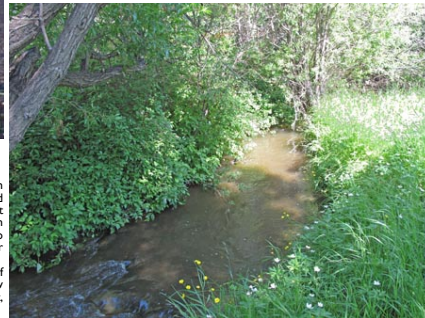
Above: This is one of the existing healthy riparian zones on Bighill Creek. Note how the Red Osier Dogwood has grown right down overtop of the stream channel, providing a great habitat for the resident trout in the stream!

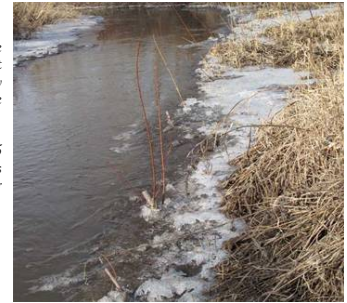
This photo was taken along the creek on March 19th, 2012. It shows some of last year's willow plants, now growing along the Bighill Creek.

It will take approximately 5 more years before these willows stand out above the high summer grasses along the creek!

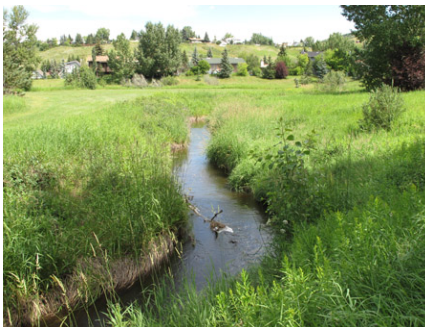
Above: This is a typical reach of the Bighill Creek that is in need of some riparian enhancement work! The site is one of many, located within the Town of Cochrane.

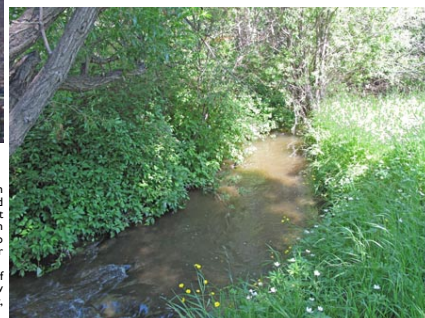
Above: This is one of the existing healthy riparian zones on Bighill Creek. Note how the Red Osier Dogwood has grown right down overtop of the stream channel, providing a great habitat for the resident trout in the stream!

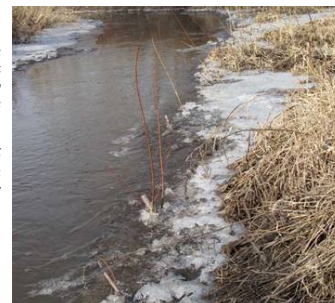
This photo was taken along the creek on March 19th, 2012. It shows some of last year's willow plants, now growing along the Bighill Creek.

It will take approximately 5 more years before these willows stand out above the high summer grasses along the creek!
