# Stream Tender Magazine

September Issue 2013

## The 2013—Post Flood Fisheries Report, for the Bow River in the Town of Cochrane, Alberta

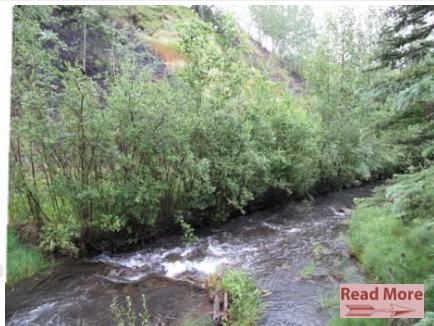
**Above:** This 2013 photo shows the log wall and willow/tree plants on Canmore Creek, 15 years after it was constructed. The willow and poplar trees are getting very tall now, and the lower limbs help to hide the logs used in the log wall construction. The substrate in the creek channel below the log wall is now clean and free from mine tailings. The creek looks really good this year!

In the late 1990's, and as part of the Canmore Creek Fish Habitat Enhancement Program, a major bank stabilization project was completed on the lower reach of Canmore Creek. The objective of the project was to help stabilize a slope that was loading mine tailing into the stream channel.

The steep slope above the creek consisted of tailings from the Canmore Mines #1 and #2 mine shafts, located just upstream of the stabilization site. The historic mine site was never reclaimed after it ceased operating in the early 1900's.

It was determined that the best way to deal with the site was to create a bench at the base of the slope, to prevent toe erosion and any further slippage of tailings.

To do this, a rather long log wall would be constructed at the base of the slope. Then a riparian crop of native plants would be established on the bench. Over time, the riparian growth would cover the log wall and a stable root mass could creep up the slope and re-vegetate the area.

The long term benefits would become apparent in the streambed substrate, which would clean itself of mine tailings below the log wall and downstream of the site, over time. The overhead cover created by the re-vegetated bench, would provide fish habitat for the resident trout in the stream.

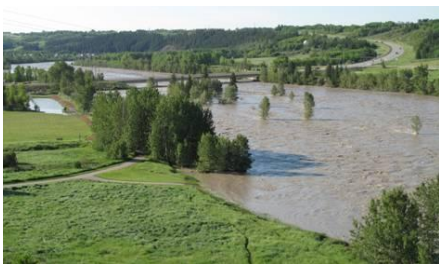
**Above:** This photo shows the flow elevations on the Bow River in the Town of Cochrane, during the peak of the 2013 flood event. The photo was taken just upstream of the highway 22 bridge. The last major flood event that occurred on the Bow River, was in 2005. That previous flood did not impact the fishery in a negative way!

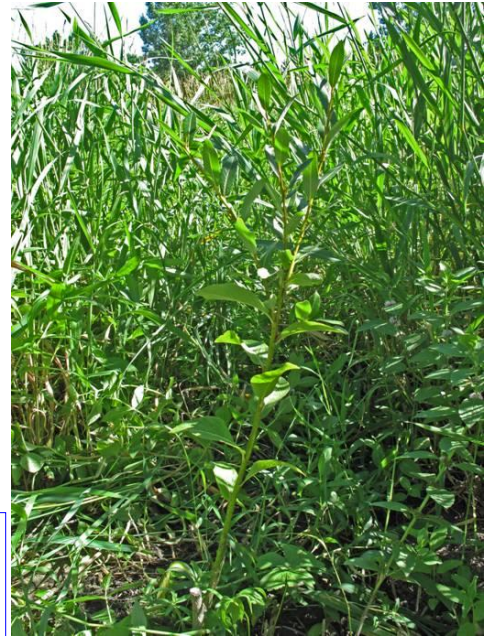
*This photo of one of the ATCO Pipelines Stage Two plants was taken on August 22nd of this summer. You can see that the plant is doing very well and by the end of next year's growing season, it should be noticeable above the tall grass of August.*

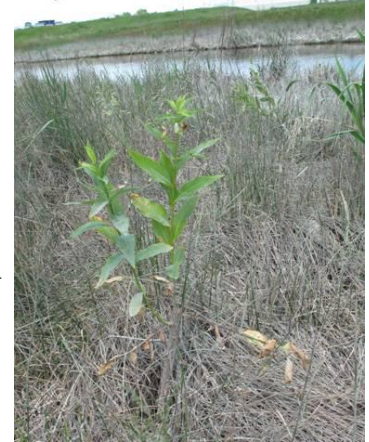
**Above:** When the water levels from the flood receded, a white powder was left on the new willows and shoreline grasses and sedges. This could be from the high PH levels in the creek's water or possibly salinity from farm fields upstream. On many young willow plants, the powder coated their leaves.

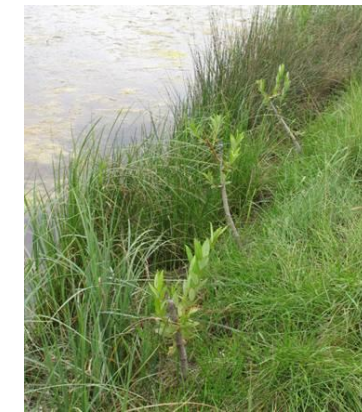
**Above:** This is a photo of some of the Stage One plants along the water's edge on Nose Creek. The photo was taken in mid-August of this year. By now, the root systems are well established with plenty of moisture available from the water table, next to the surface of the creek.

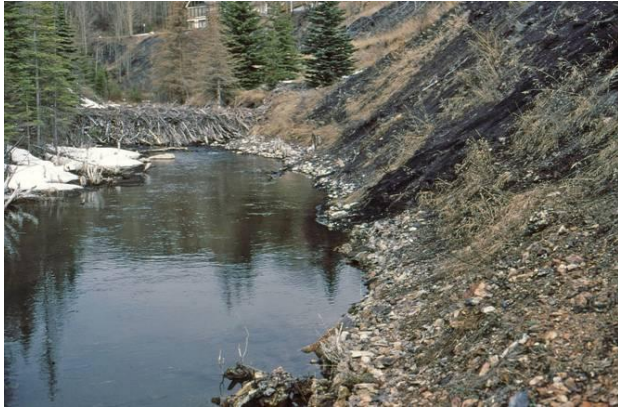
As you can see from the photo on the left, mine tailings were sliding down the slope and entering the stream channel on Canmore Creek. These tailings were smothering the natural cobble and gravel that had once existed as the stream's substrate.

Mine Tailings on Canmore Creek Were Sliding into the Stream Channel Prior to 1998!

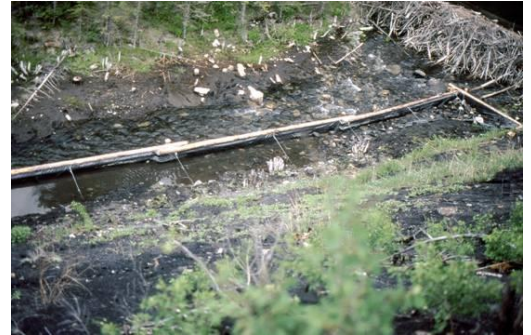
**Above:** This 1998 photo was taken from the top of the valley, looking down on the newly constructed log wall, at the base of the slope. There are anchor cables above and below the geo-textile liner, to insure the long term stability of the log wall. This photo was taken just before the back-filling on the bench.

In 1998, BVHD Constructed a Log Wall at the Base of the Slope

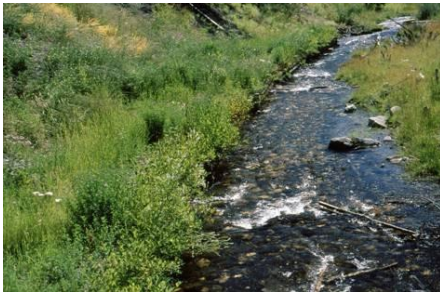
**Below:** The photo below was taken from the same position as the one above, but the one below is a shot from this year, which is 15 years after the log wall was constructed!

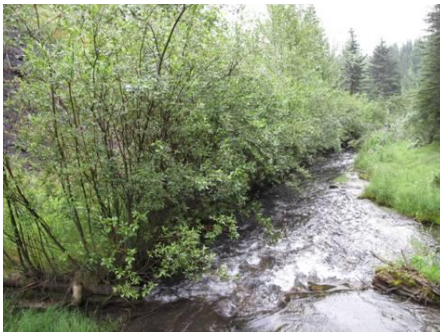
This photo was taken in 2000, two years after the log wall project was completed. The photo was taken from an upstream position, looking downstream along the log wall.

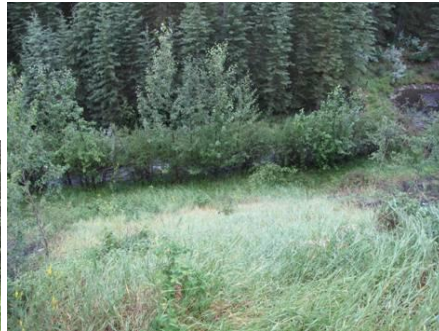
**Above:** This 2013 photo was taken from the top of the valley, looking down the slope to the log wall. You can see that the willows and poplar trees have grown considerably, and the slope is now covered with native grasses. Also noted: the willows and trees are starting to sucker up the slope and I expect that in the next ten years or so, the slope will have willows and tree cover to further stabilize it.

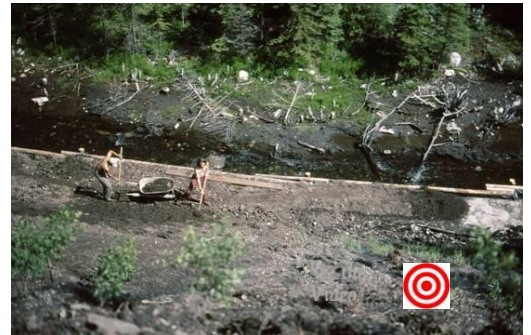
**Above:** In this photo, BVHD team members spread the back-fill over the geo-textile and create an earthen bench that is level with the top of the log wall. The next phase was to plant native willows, trees and grasses on the bench.

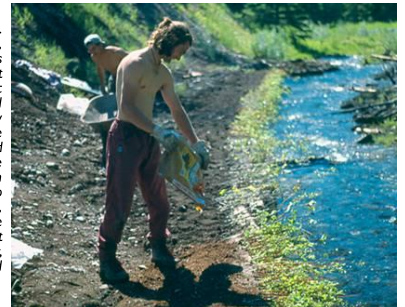
Fish Habitat Tech. Duncan McCall, along with fisheries biologist (background), Eric Ladizable, finished the log wall by planting native willows, trees and grasses on top of the bench. The team worked very hard to complete this project, but having the opportunity to re-visit the site years later, makes all of the hard work worth it!

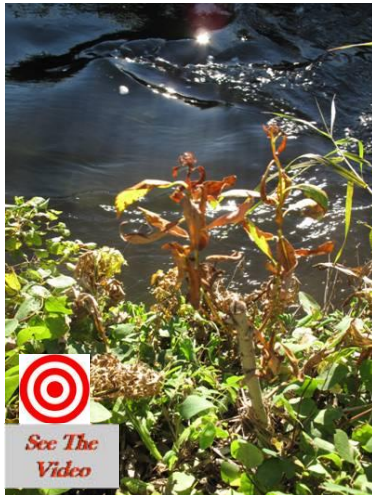
**Above:** This Stage One Willow Plant was one of approximately 12 plants that fell victim to thistle spray this year. Although the number of lost plants was low, in comparison to the number of plants that went into the ground, it is still a "hard pill to swallow", knowing that you have lost a few plants this way! Bow Valley Habitat Development has talked to contacts in the thistle spraying program, and hopefully this won't happen again.

I have since found out that my earlier request for a 5 metre spray free zone was somehow miss communicated between the right people involved in the thistle spraying program. Fortunately the losses were quite low!

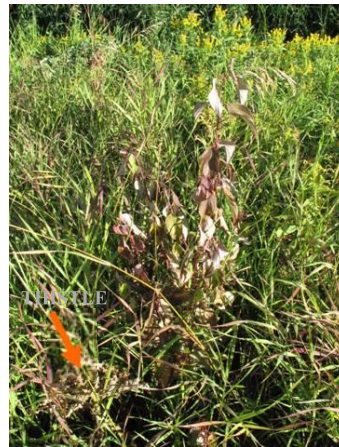
**Above:** This Red Osier Dogwood, which was planted by volunteers on a previous planting program. It also fell victim to herbicide! You can see one dead thistle, right next to the willow. So was it worth killing one willow plant for one thistle?

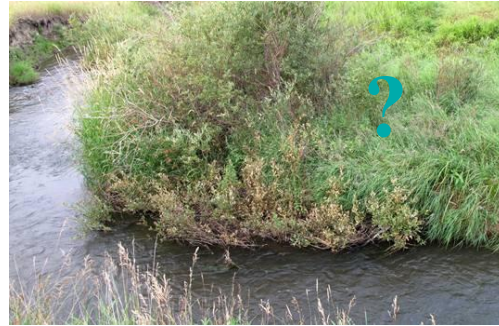
The willow tree in this photo was sprayed with thistle herbicide, during a spraying program along this trout stream. You can see the dead leaves on the plant. Also, you will notice that the plant is located right over and in the water of the creek, so it is a puzzle to me why anyone would spray this plant with herbicide.

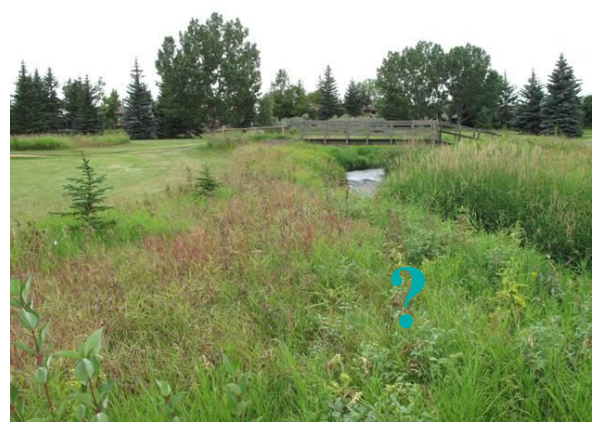
**Above:** In this photo, you can tell where the herbicide was sprayed, the grass color has turned reddish in color. The top of the red osier dogwood that is shown in the bottom left side of this photo, was lucky that it did not get sprayed. Other willow plants that have been planted were not so lucky! You can also see how close to the creek that the broadcast spraying of herbicide was done.

" Hopefully the issue of how close to the water's edge that herbicides can be sprayed will be addressed by the Province or the Department of Fisheries and Oceans! There are a lot of groups and organizations that plant thousands of native willow and tree plants along our flowing streams each year, and it is a shame to know that some of those plants will be lost to chemical sprays. Also, how are we expected to complete riparian recovery programs when both natural recruitment of plants and those that are planted by humans – are Killed! "

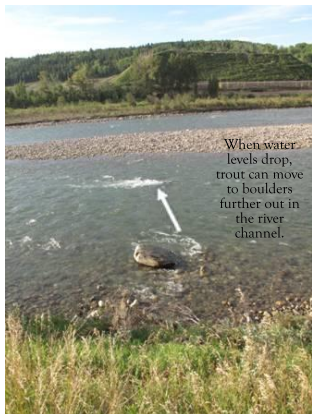
When water levels drop, trout can move further out in the river channel.

Further out in the river channel, you can see a submerged boulder that is disrupting the flow in the channel. Trout and whitefish like to hold just downstream of these boulders, where the current has been slowed down. See the video links to the right. They will show how trout and whitefish

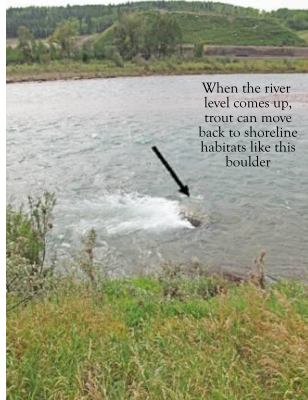
When the river level comes up, trout can move back to shoreline habitats like this boulder

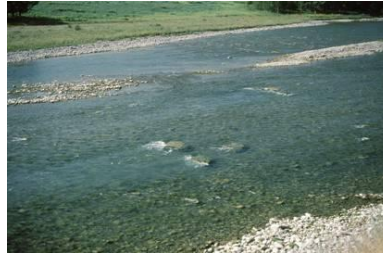
**Above:** This is what one of the triple rock placements looked like in 1996, just after the project for that year was completed. Note the pocket pool area just below the three rocks. This provides great low water fish habitat!

Large flood events benefit the fishery in a river or stream by creating new habitats for the fish that reside in their waters. The scouring effects of a flood also enhance invertebrate habitats for the long term!
