September 2016 Issue

Stream Tender Magazine

| Stream Bank Stabilization | Page 4 |

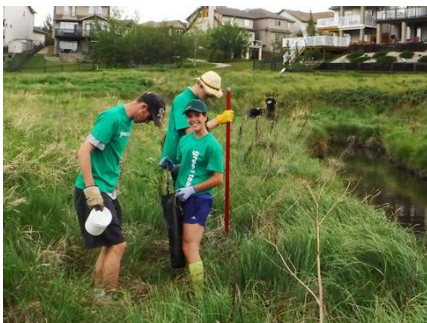
Above: A hole is punched into the soft ground along the stream and then the Stage Two plant is placed into the hole. A good watering and tamping of the soil completes the job. Working in teams of three allows for a high degree of efficiency. Plant spacing is approximately 1 metre.

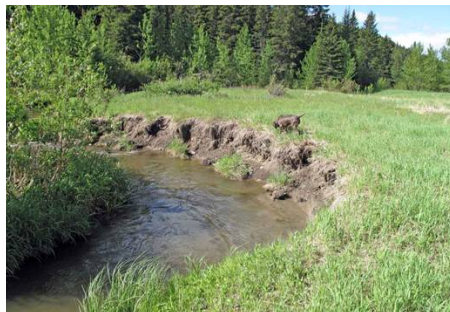
Above: This 2010 photo shows the eroding stream bank on Bighill Creek, before planting.

The site received its first planting treatment in 2012. The willow growth is slow at this site, but the results are quite evident. This stabilization project has greatly reduce silt loading into the stream channel.

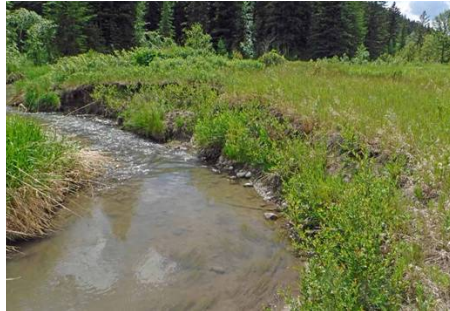
Above: This is a photo of the same eroding stream bank taken four years later, in 2016.

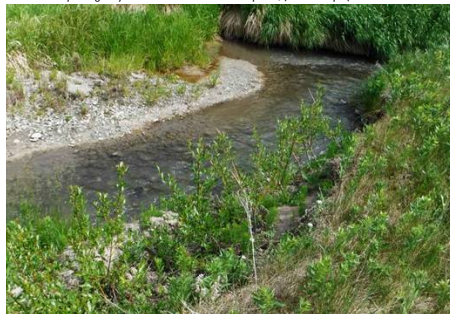
Below: This photo gives you a closer look at the willow plants, from the top of the bank.

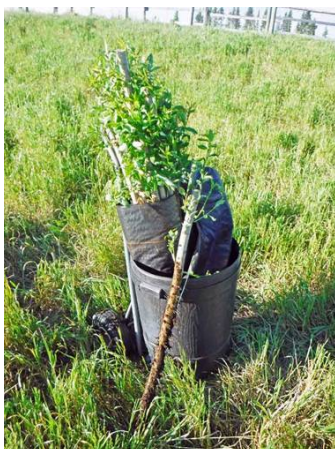
Above: This is one of the large diameter cuttings that was planted.

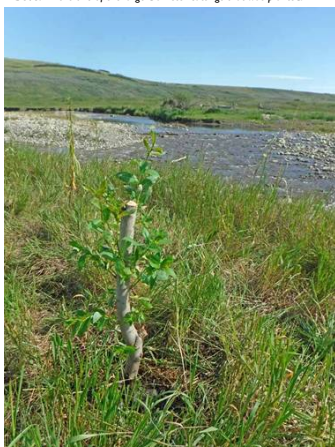
Above: This photo shows what the large diameter plants look like, just after they have been planted. Because of the stream bank elevation, the deep planting of approximately 4 feet would help get the roots down to a moister soil, close to the stream's water level.

Standard willow cuttings that are only planted around 19 inches in depth would have been too shallow for a good chance at survival.

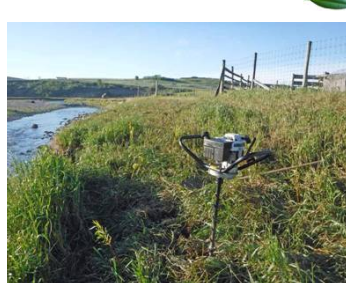
Above: This gas powered earth augur was the best choice of equipment for the task at hand. Although the ground was very dry and hard, a power augur worked best for creating a hole down to the proper depth. Hand tools would have made the job very difficult for this part of the planting.

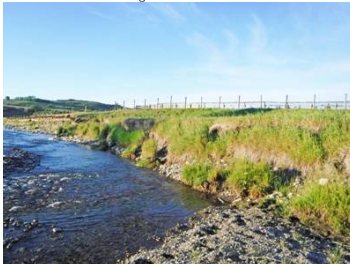
Above: This photo was taken from stream level and it shows the erosion occurring on the stream bank. You can see the corals in the background that are under threat of being damaged in the long term, by continued stream bank erosion at the site.

The large diameter cuttings were chosen as the best option for this particular stream bank. The cuttings are planted deep into the ground to insure moist soil will maintain the root systems on the plants. Small diameter cuttings would die off, when planted so off from the stream channel and at an elevated planting site.

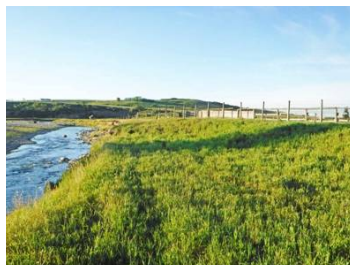
Above: This photo was taken on the top of the eroding stream bank, looking downstream on the Jumpingpound Creek. You can see how close the corals are located to the eroding stream bank. A few major floods would definitely undermine the fence and corals on the south side, along the creek.

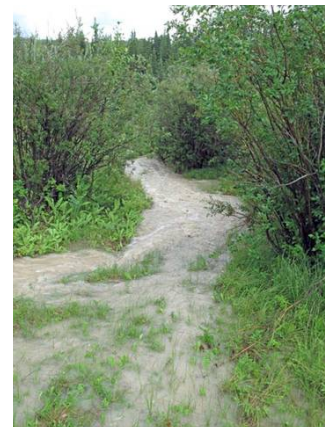
Above: The storm drain causes the flooding of the RHS Creek channel during rain, hail or melting snow events on a nearby development.

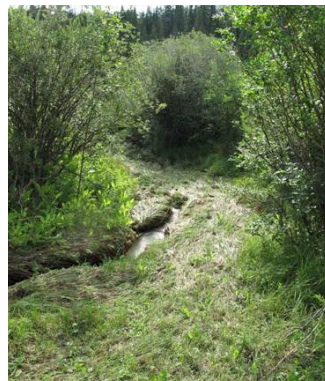
Above: This photo shows the normal stream channel after a recent flood created by the storm drain upstream.
