# **ONSITE HOME INSPECTION**

# TREC REI 7-6

1234 Main Street Denver CO 80210

# PROPERTY INSPECTION REPORT FORM

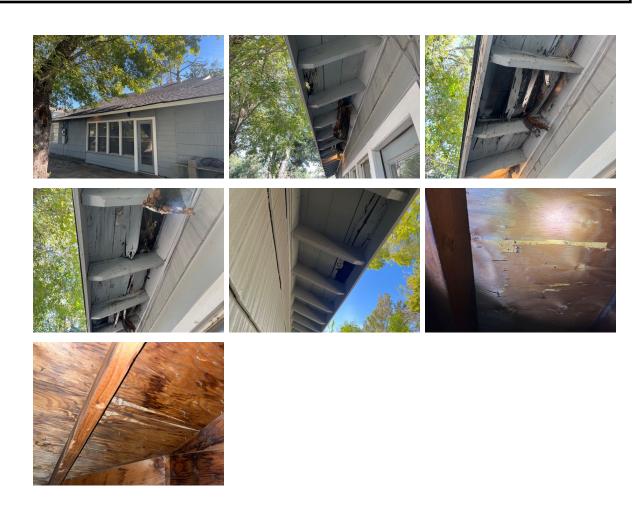
# 2: Deteriorated Sheathing - Water Intrusion

Multiple Locations

The roof has significant damage to sheathing. There is a significant area of damage to the rear of the roof that runs several feet up the roof and approximately 75% of the length (left to right) of the home. There are several other locations found in the attic of minor damage, possibly from leakage, hauler or limb strikes. Client may consider major repairs or possibly complete roof replacement since the roof could be nearing the end of useful service life.

Recommendation: Contact a qualified professional.

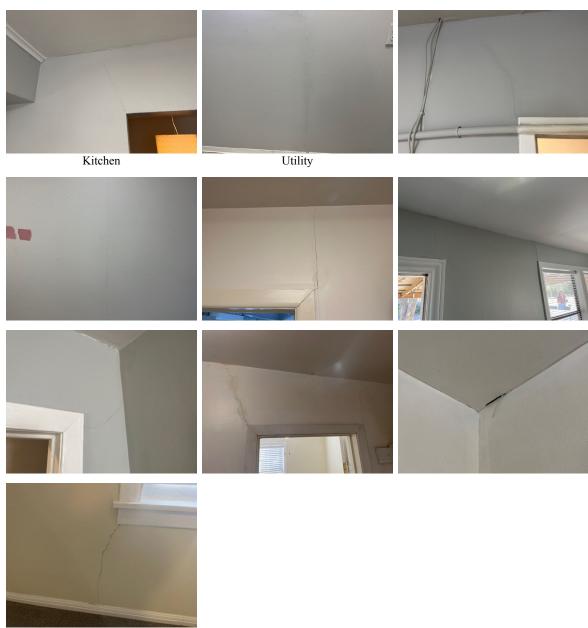
1: Cracks - Minor

Multiple

Minor cracking was observed in wall structure. This is common as homes age. Recommend monitoring for signs that cracks are widening.

Recommendation: Recommend monitoring.

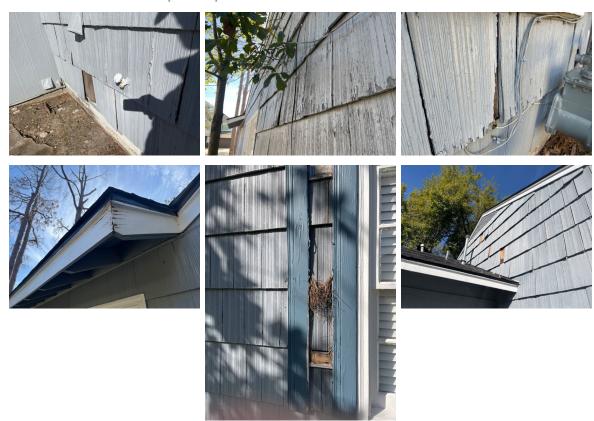
# 3: Deteriorated Siding/Trim/Fascia

# Recommendation Multiple Locations

At least 60% (or more) of the siding, trim, and fascia was observed to be deteriorated due to rot and decay or otherwise damaged. Complete replacement of siding, trim, fascia, sheathing, and moisture barrier should be considered. Recommend a qualified contractor evaluate and replace.

Recommendation: Contact a qualified professional.

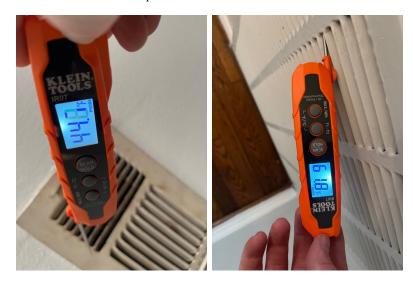
Comments:
Produced Cold Air. Temp Differential -13F
