Yeti Armor™

The World's Most Amazing Cementitious Repair and Overlay Product!

What Sets Yeti Armor™ Apart From Every Other Repair and Overlay Mortar in the Industry?

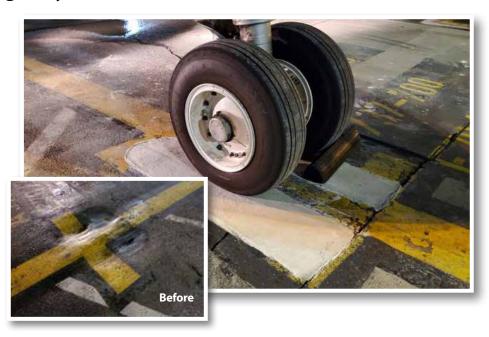
Street Repair - City of Sebastopol, CA

It is no longer necessary to follow traditional *Remove and Replace* methods of repair for failing concrete roadways, walkways, driveways etc... By significantly reducing the time of repair, a new lifecycle can be achieved with minimal environmental impact. This will also reduce repair costs by as much as 75%. Eliminates the environmental impact of waste to the landfill.

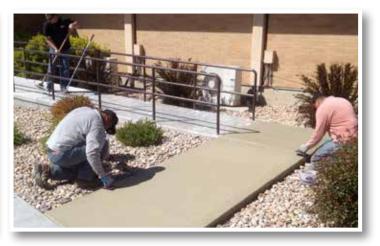
Post Office ADA Ramp Resurfacing - Salem, OR

Overlay being finished using traditional finishing tools.

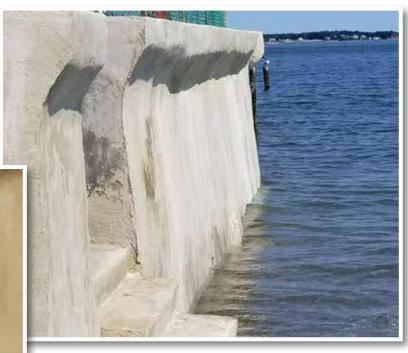
Sea Wall Repair - New London, CT

Removal of loose debris, pressure washing, and steel remediation are part of the reconstruction of this sea wall. Proper preparation before **Yeti** Armor™ is installed will ensure longevity and lessen future degradation. Workers were able to reconstruct without any deconstruction by applying the **Yeti** Armor™ in 2″ lifts, eliminating the use of forms. **Yeti** Armor™ was applied with trowels and then rolled into place. The final finish was achieved with smooth rollers*. Because **Yeti** Armor™ can be rolled on instead of troweled, considerable labor savings are attained. This method of reconstruction drastically reduced the overall cost of the project, in comparison to deconstruction and rebuild.

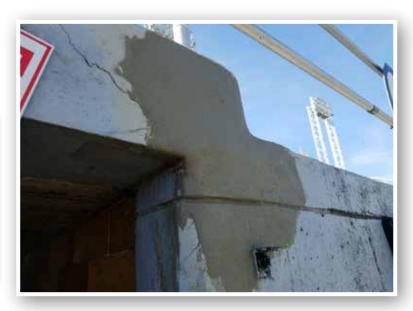
Hershey Park Stadium - Hershey, PA

Yeti Armor™ for vertical repair in preexisting structures eliminates traditional
