Water System Asset Management Plan

PILLSBURY LAKE VILLAGE DISTRICT
WATER SYSTEM ASSET MANAGEMENT PLAN
WEBSTER, NH

WRIGHT-PIERCE

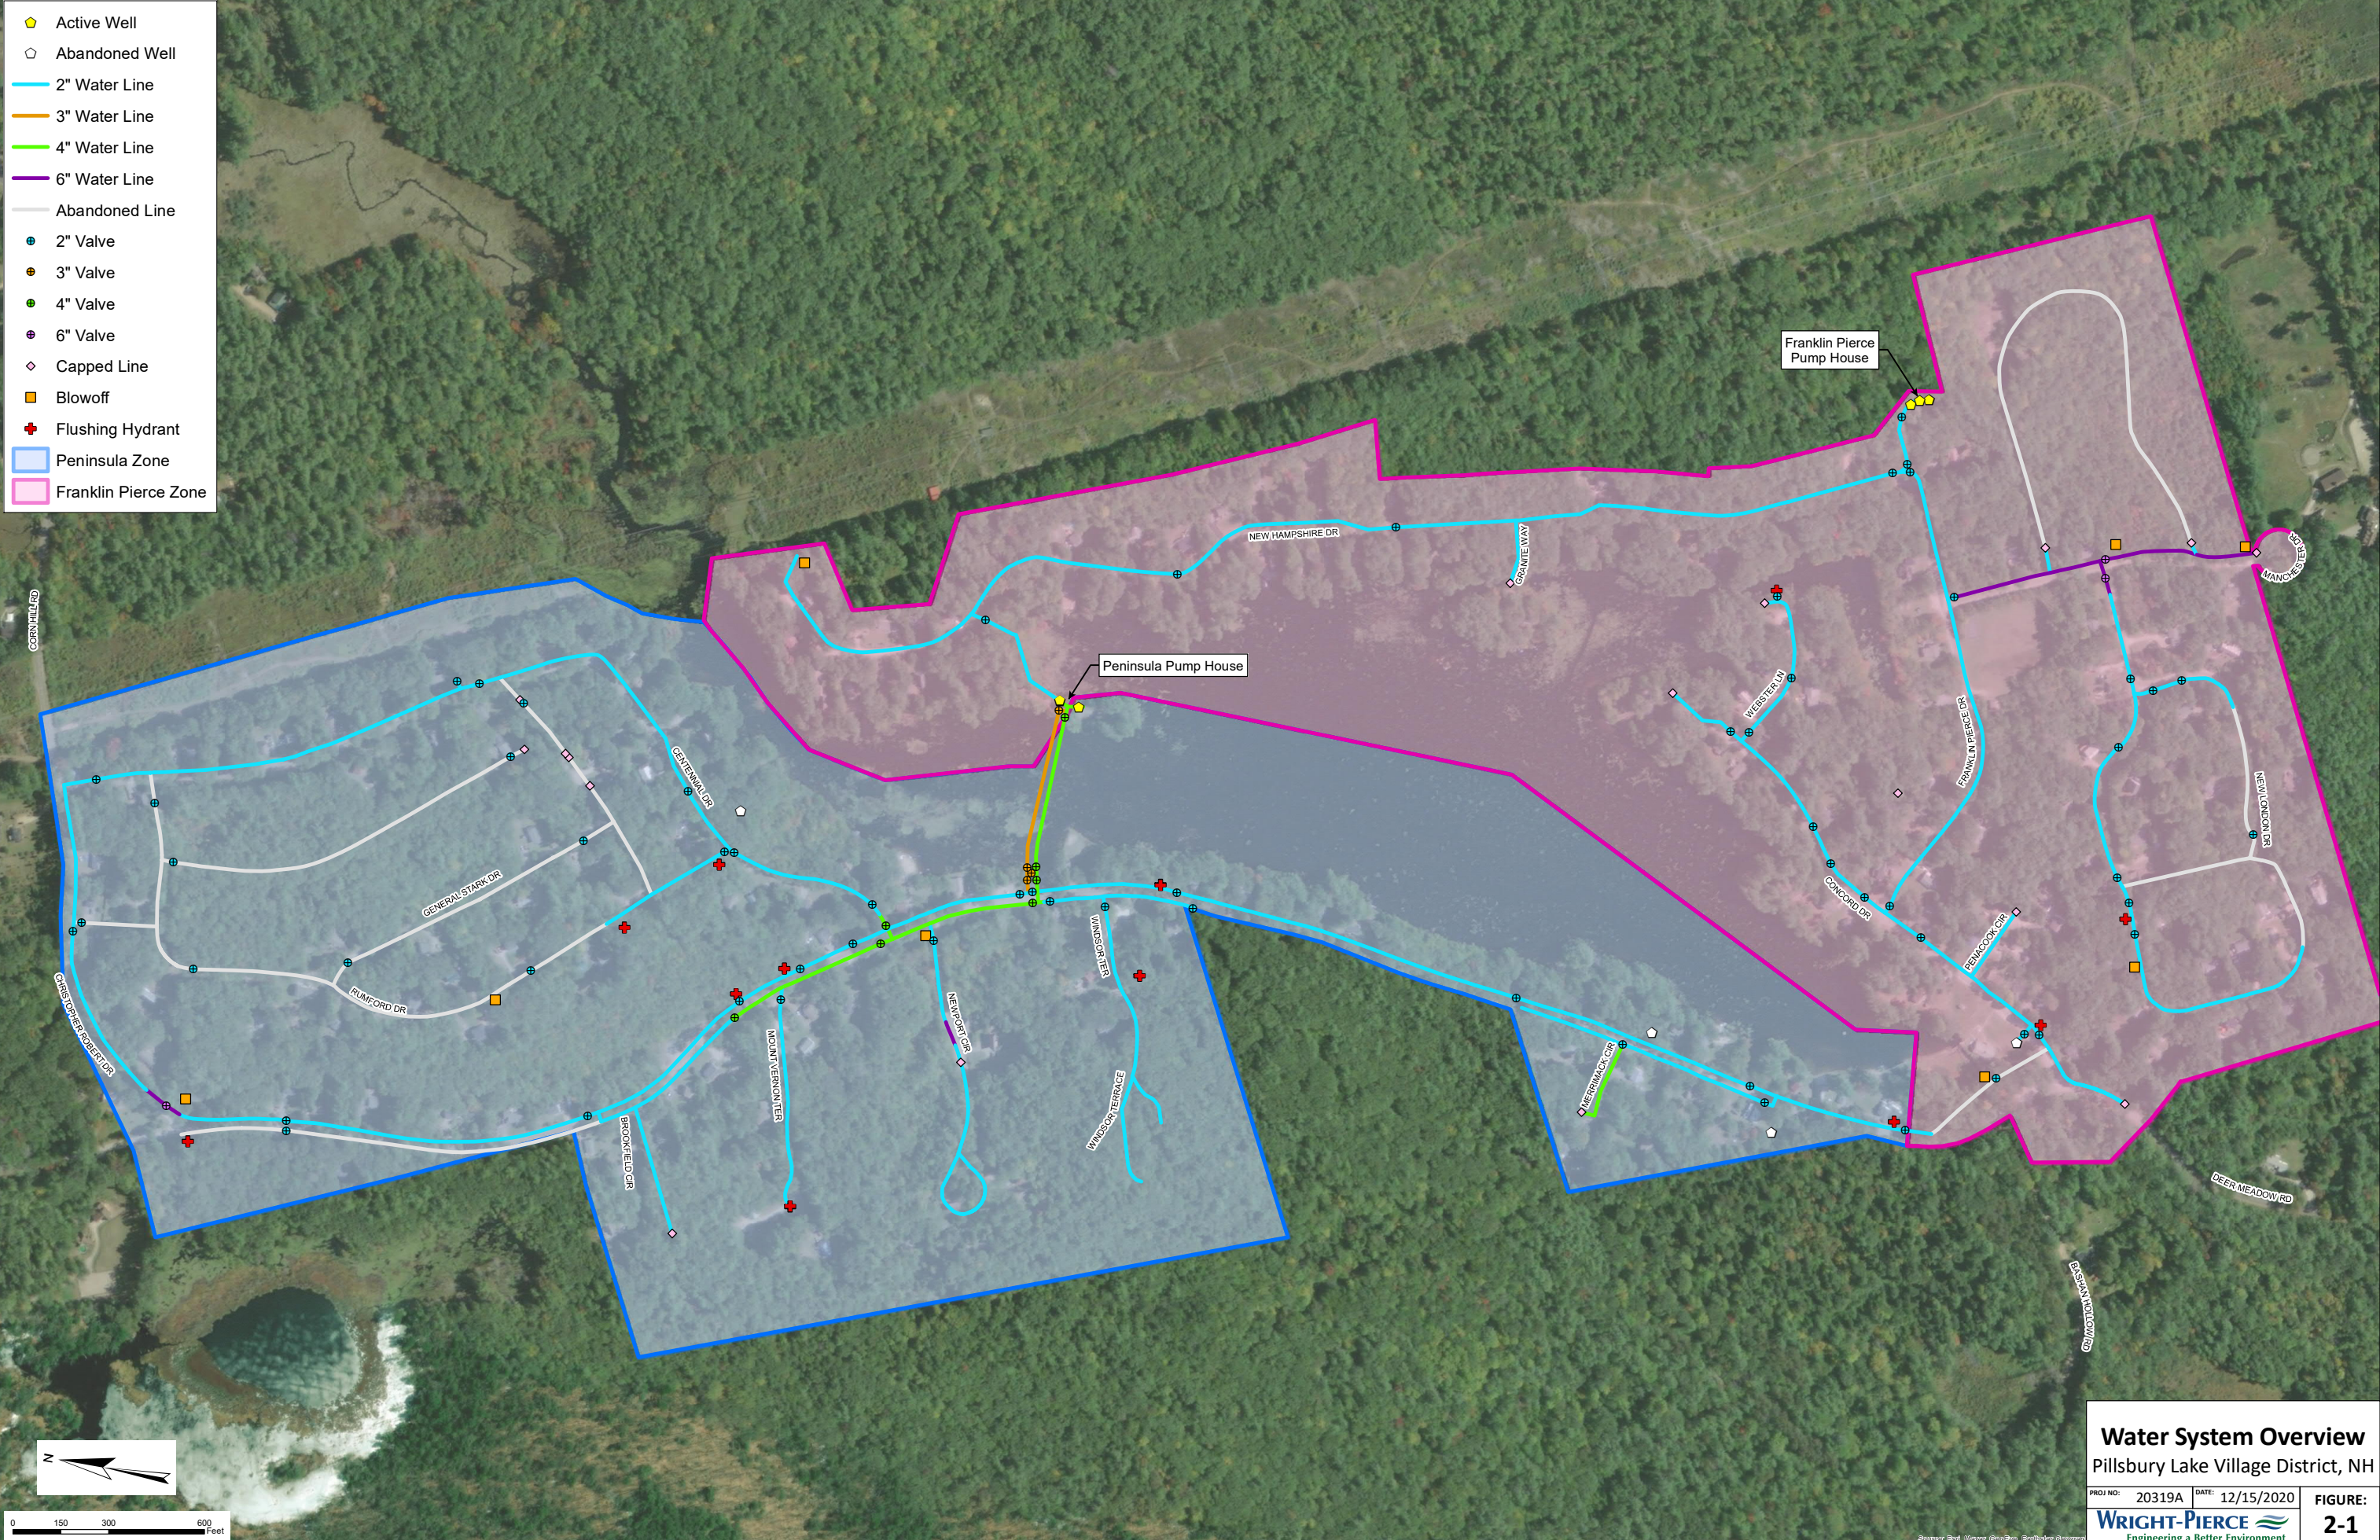
PROJ NO: 20319A	DATE: 12/15/2020	FIGURE: 2-1
-----------------	------------------	-------------

Water System Overview
 Pillsbury Lake Village District, NH

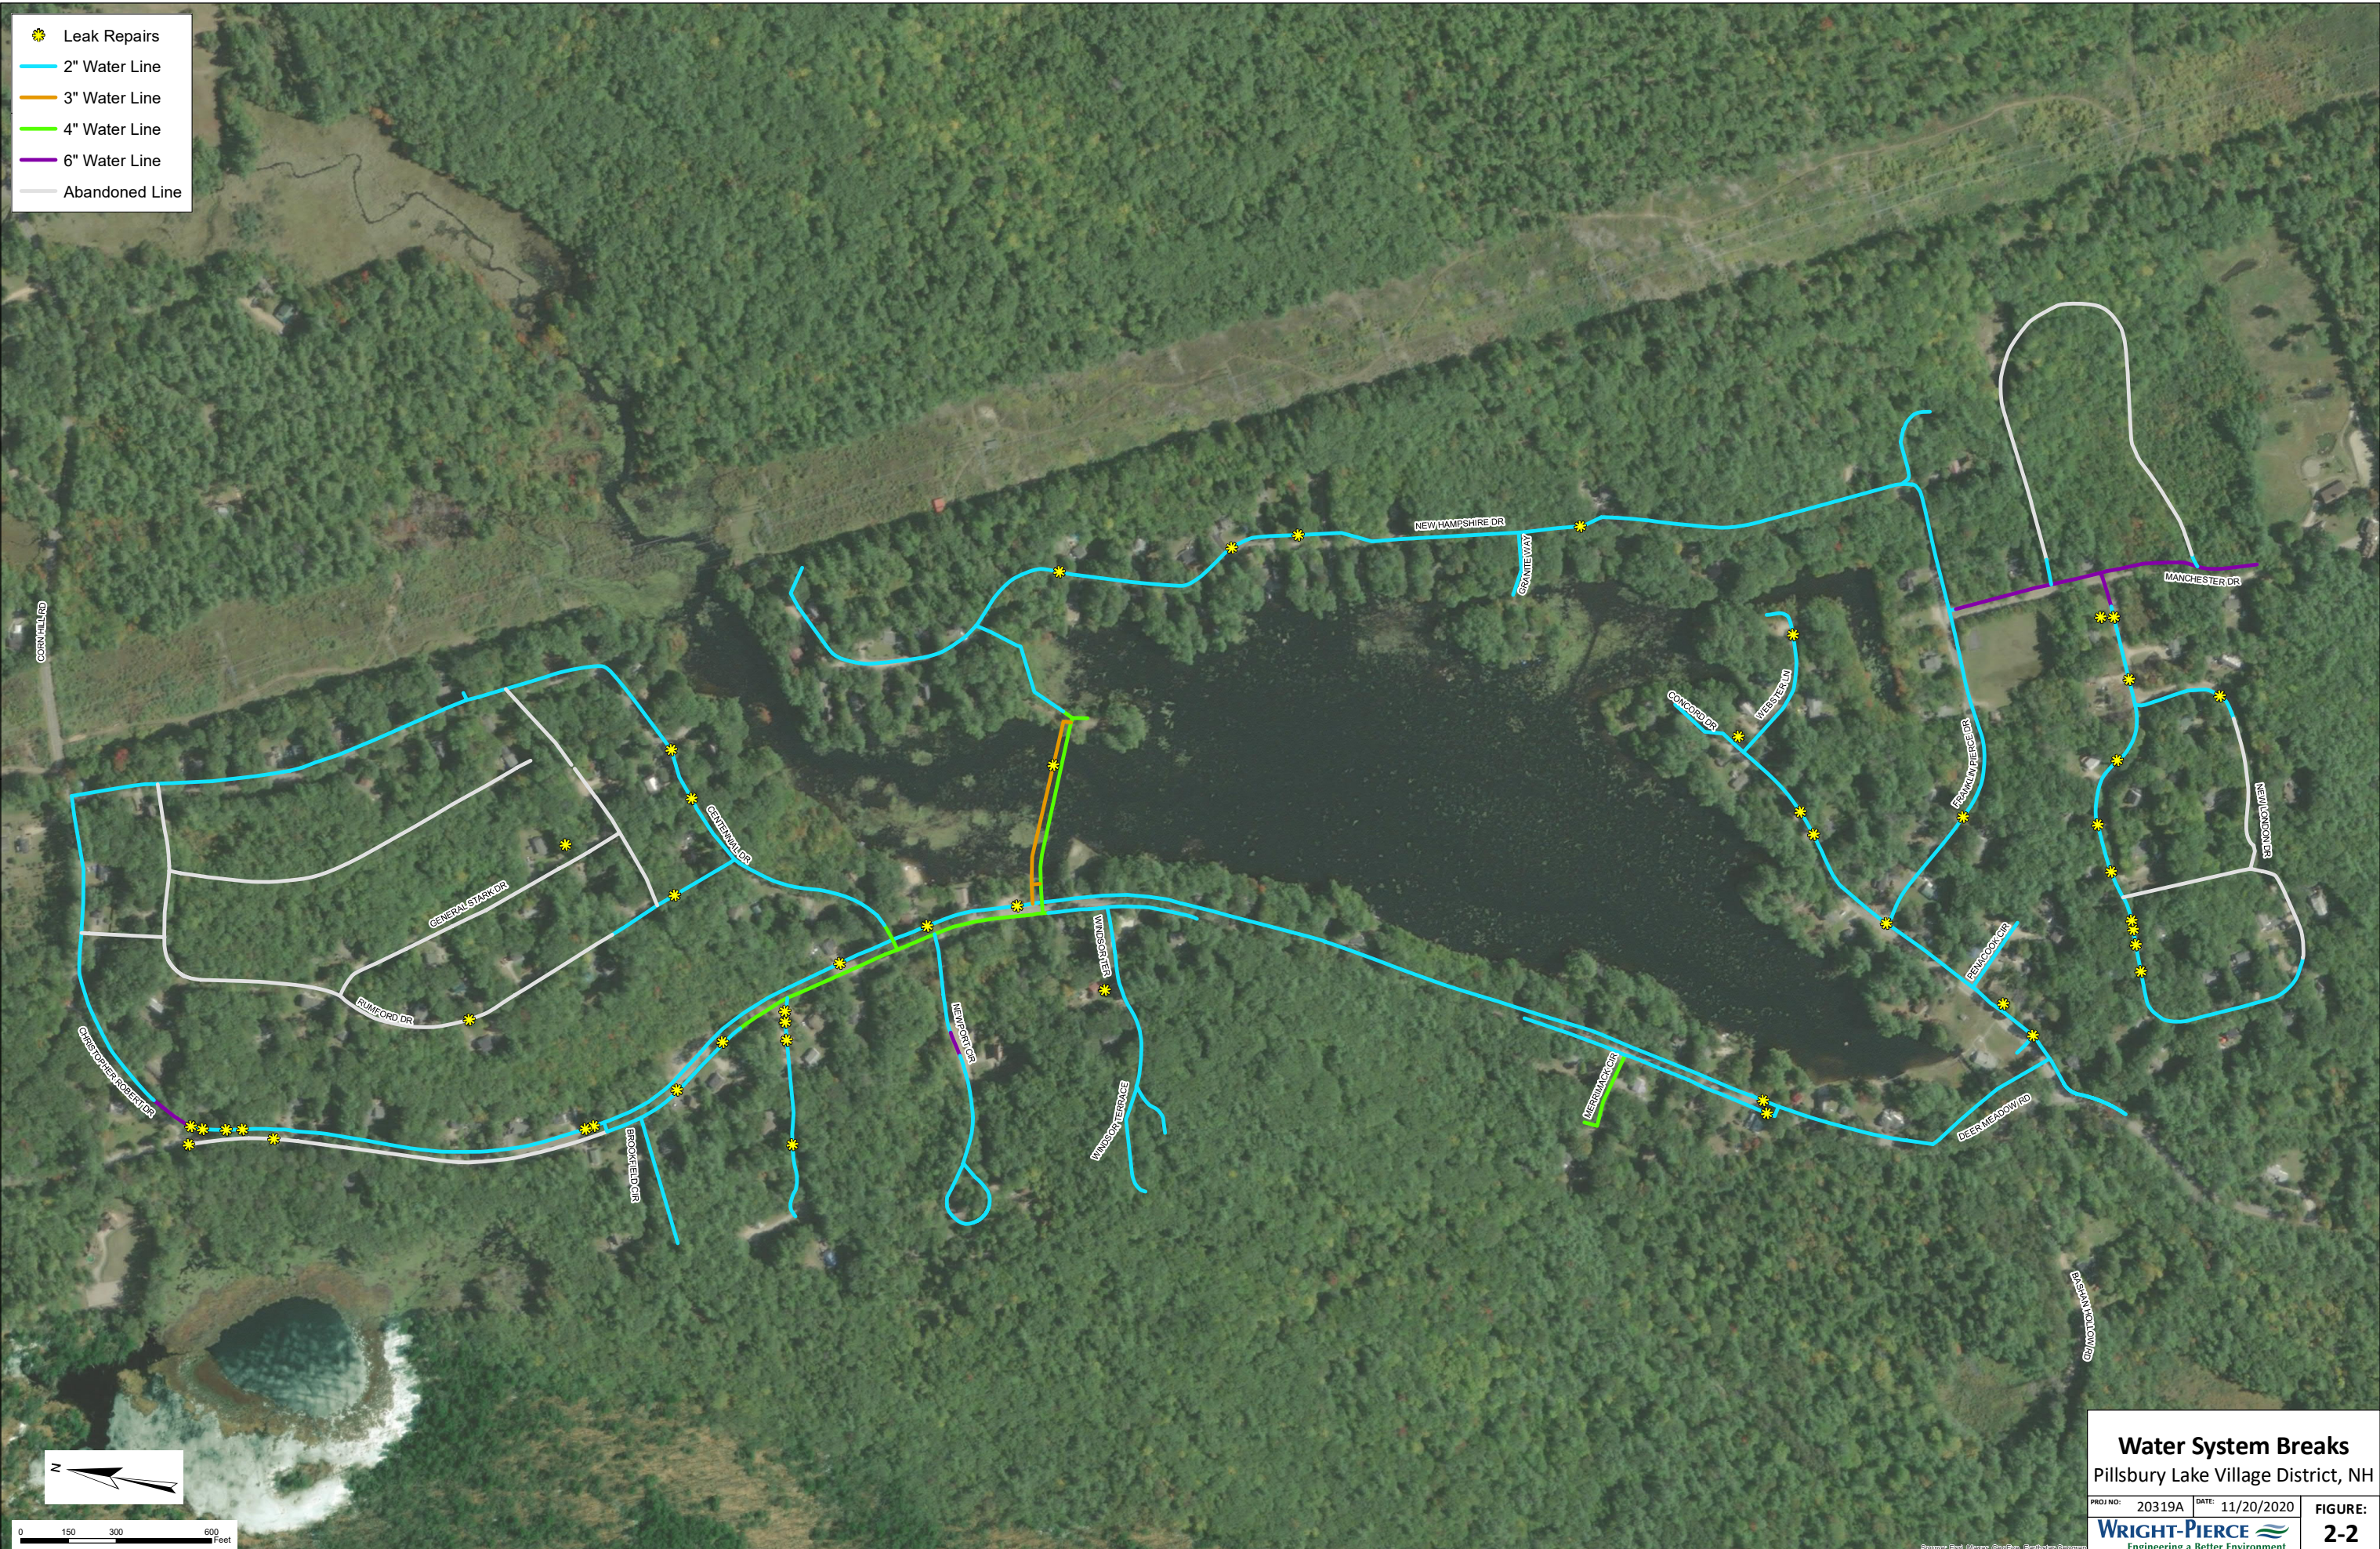
Water System Breaks		
Pillsbury Lake Village District, NH		
PROJ NO: 20319A	DATE: 11/20/2020	FIGURE: 2-2
 WRIGHT-PIERCE Engineering a Better Environment

A major component of PLVD's past struggles to meet system demands can be attributed to water main and service leaks in the distribution system. Over the past 5 years, the water system has experienced approximately 50 leaks. However, water loss associated with these leaks was not estimated until May 2020. **Figure 2-2** depicts the general location of these leak repairs.

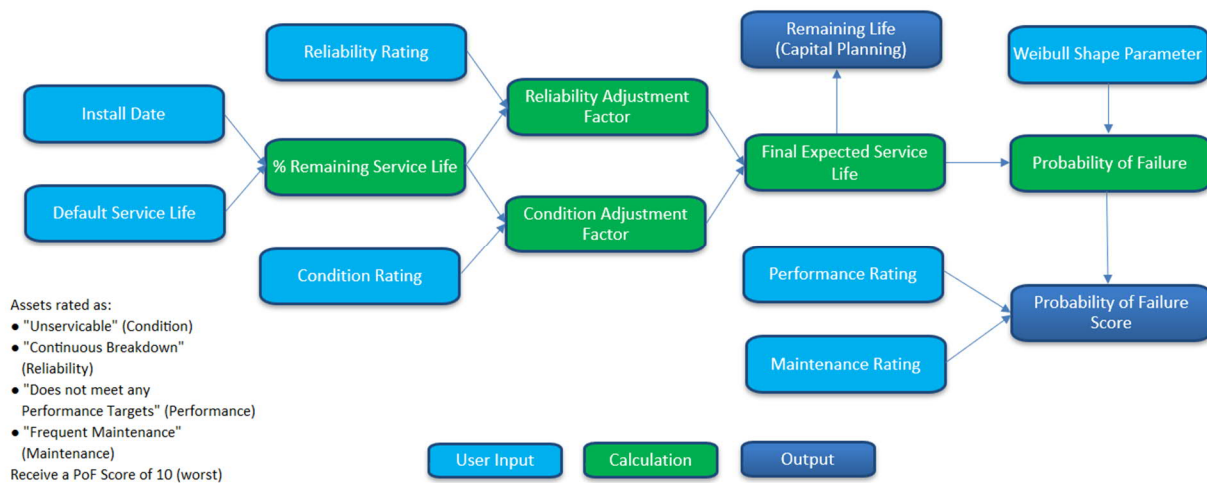
**FIGURE 3-2
PROBABILITY OF FAILURE SCORE CALCULATION**

Figure 3-2 provides a visual depiction of how inputted factors contribute to PoF score calculation.

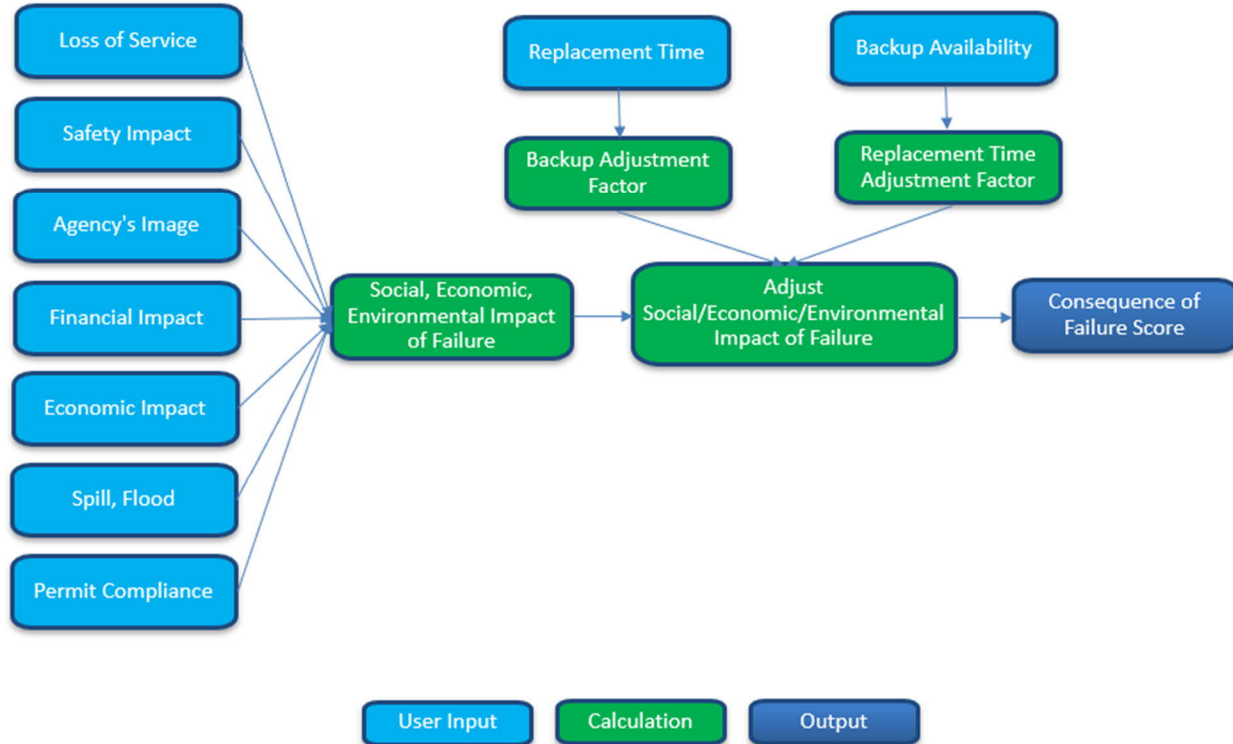
**FIGURE 3-3
CONSEQUENCE OF FAILURE SCORE CALCULATION**

Figure 3-3 provides a visual depiction of how inputted factors contribute to CoF score calculation.

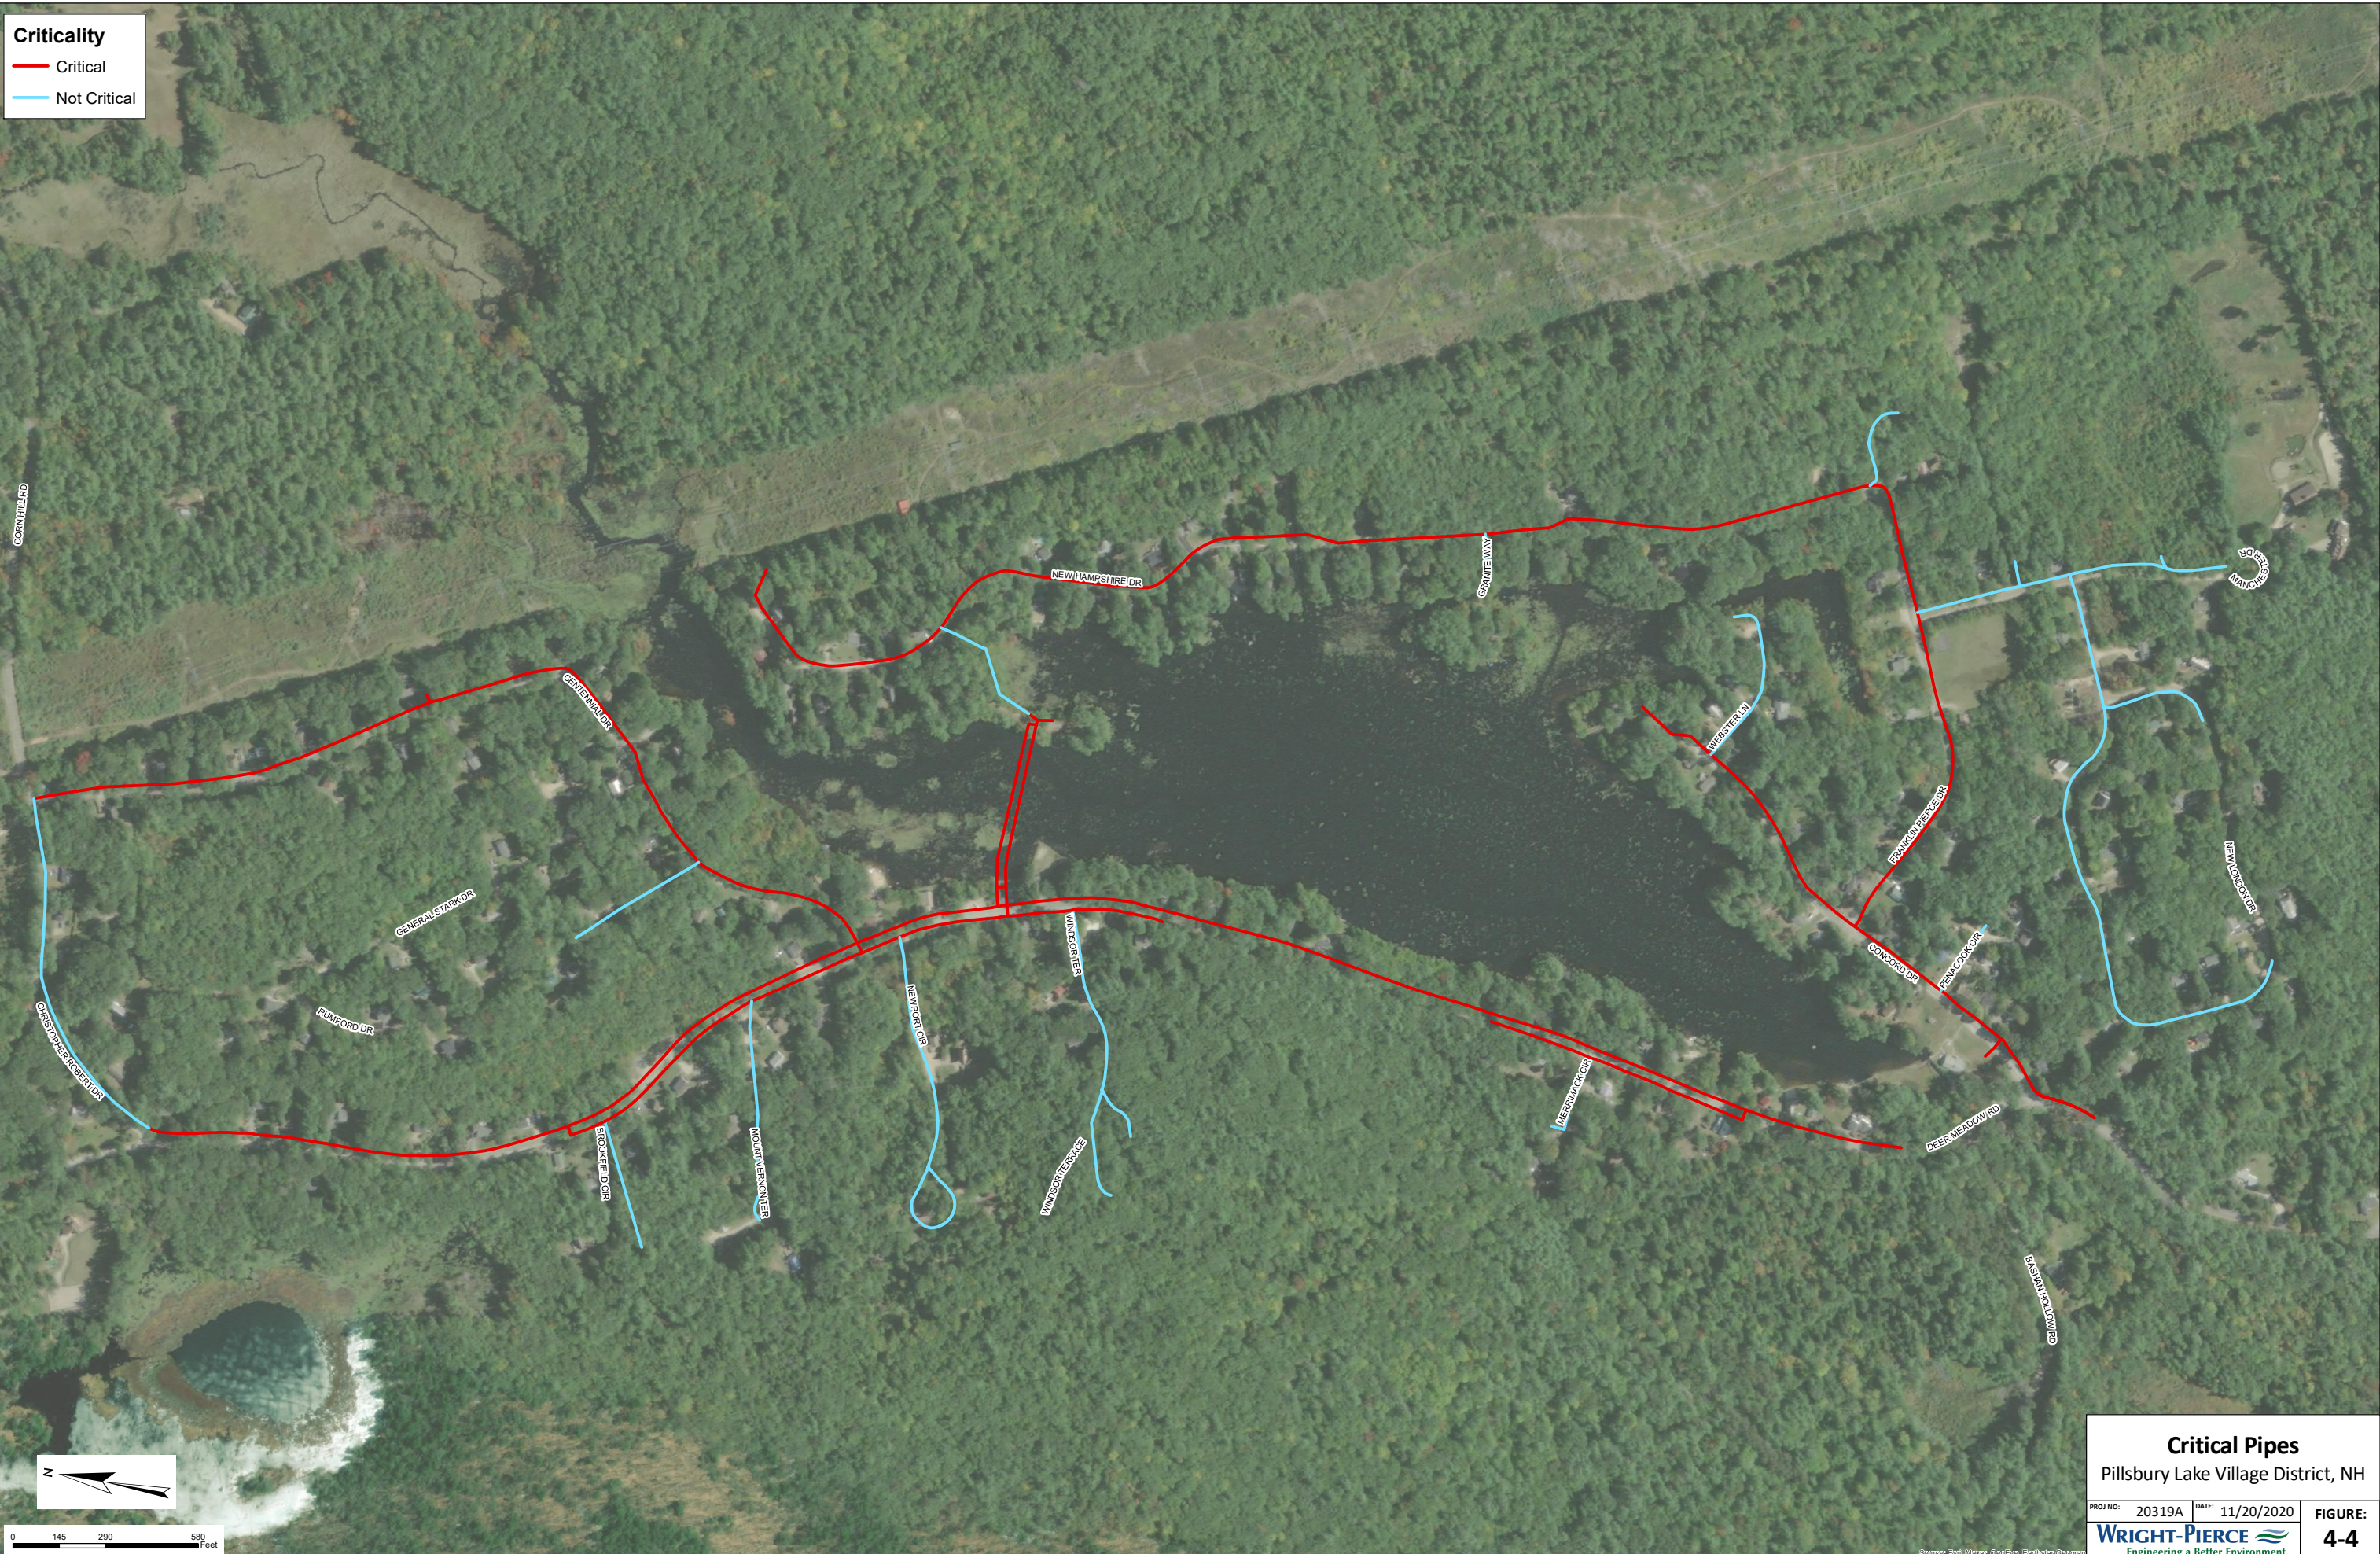
Criticality

- Critical
- Not Critical

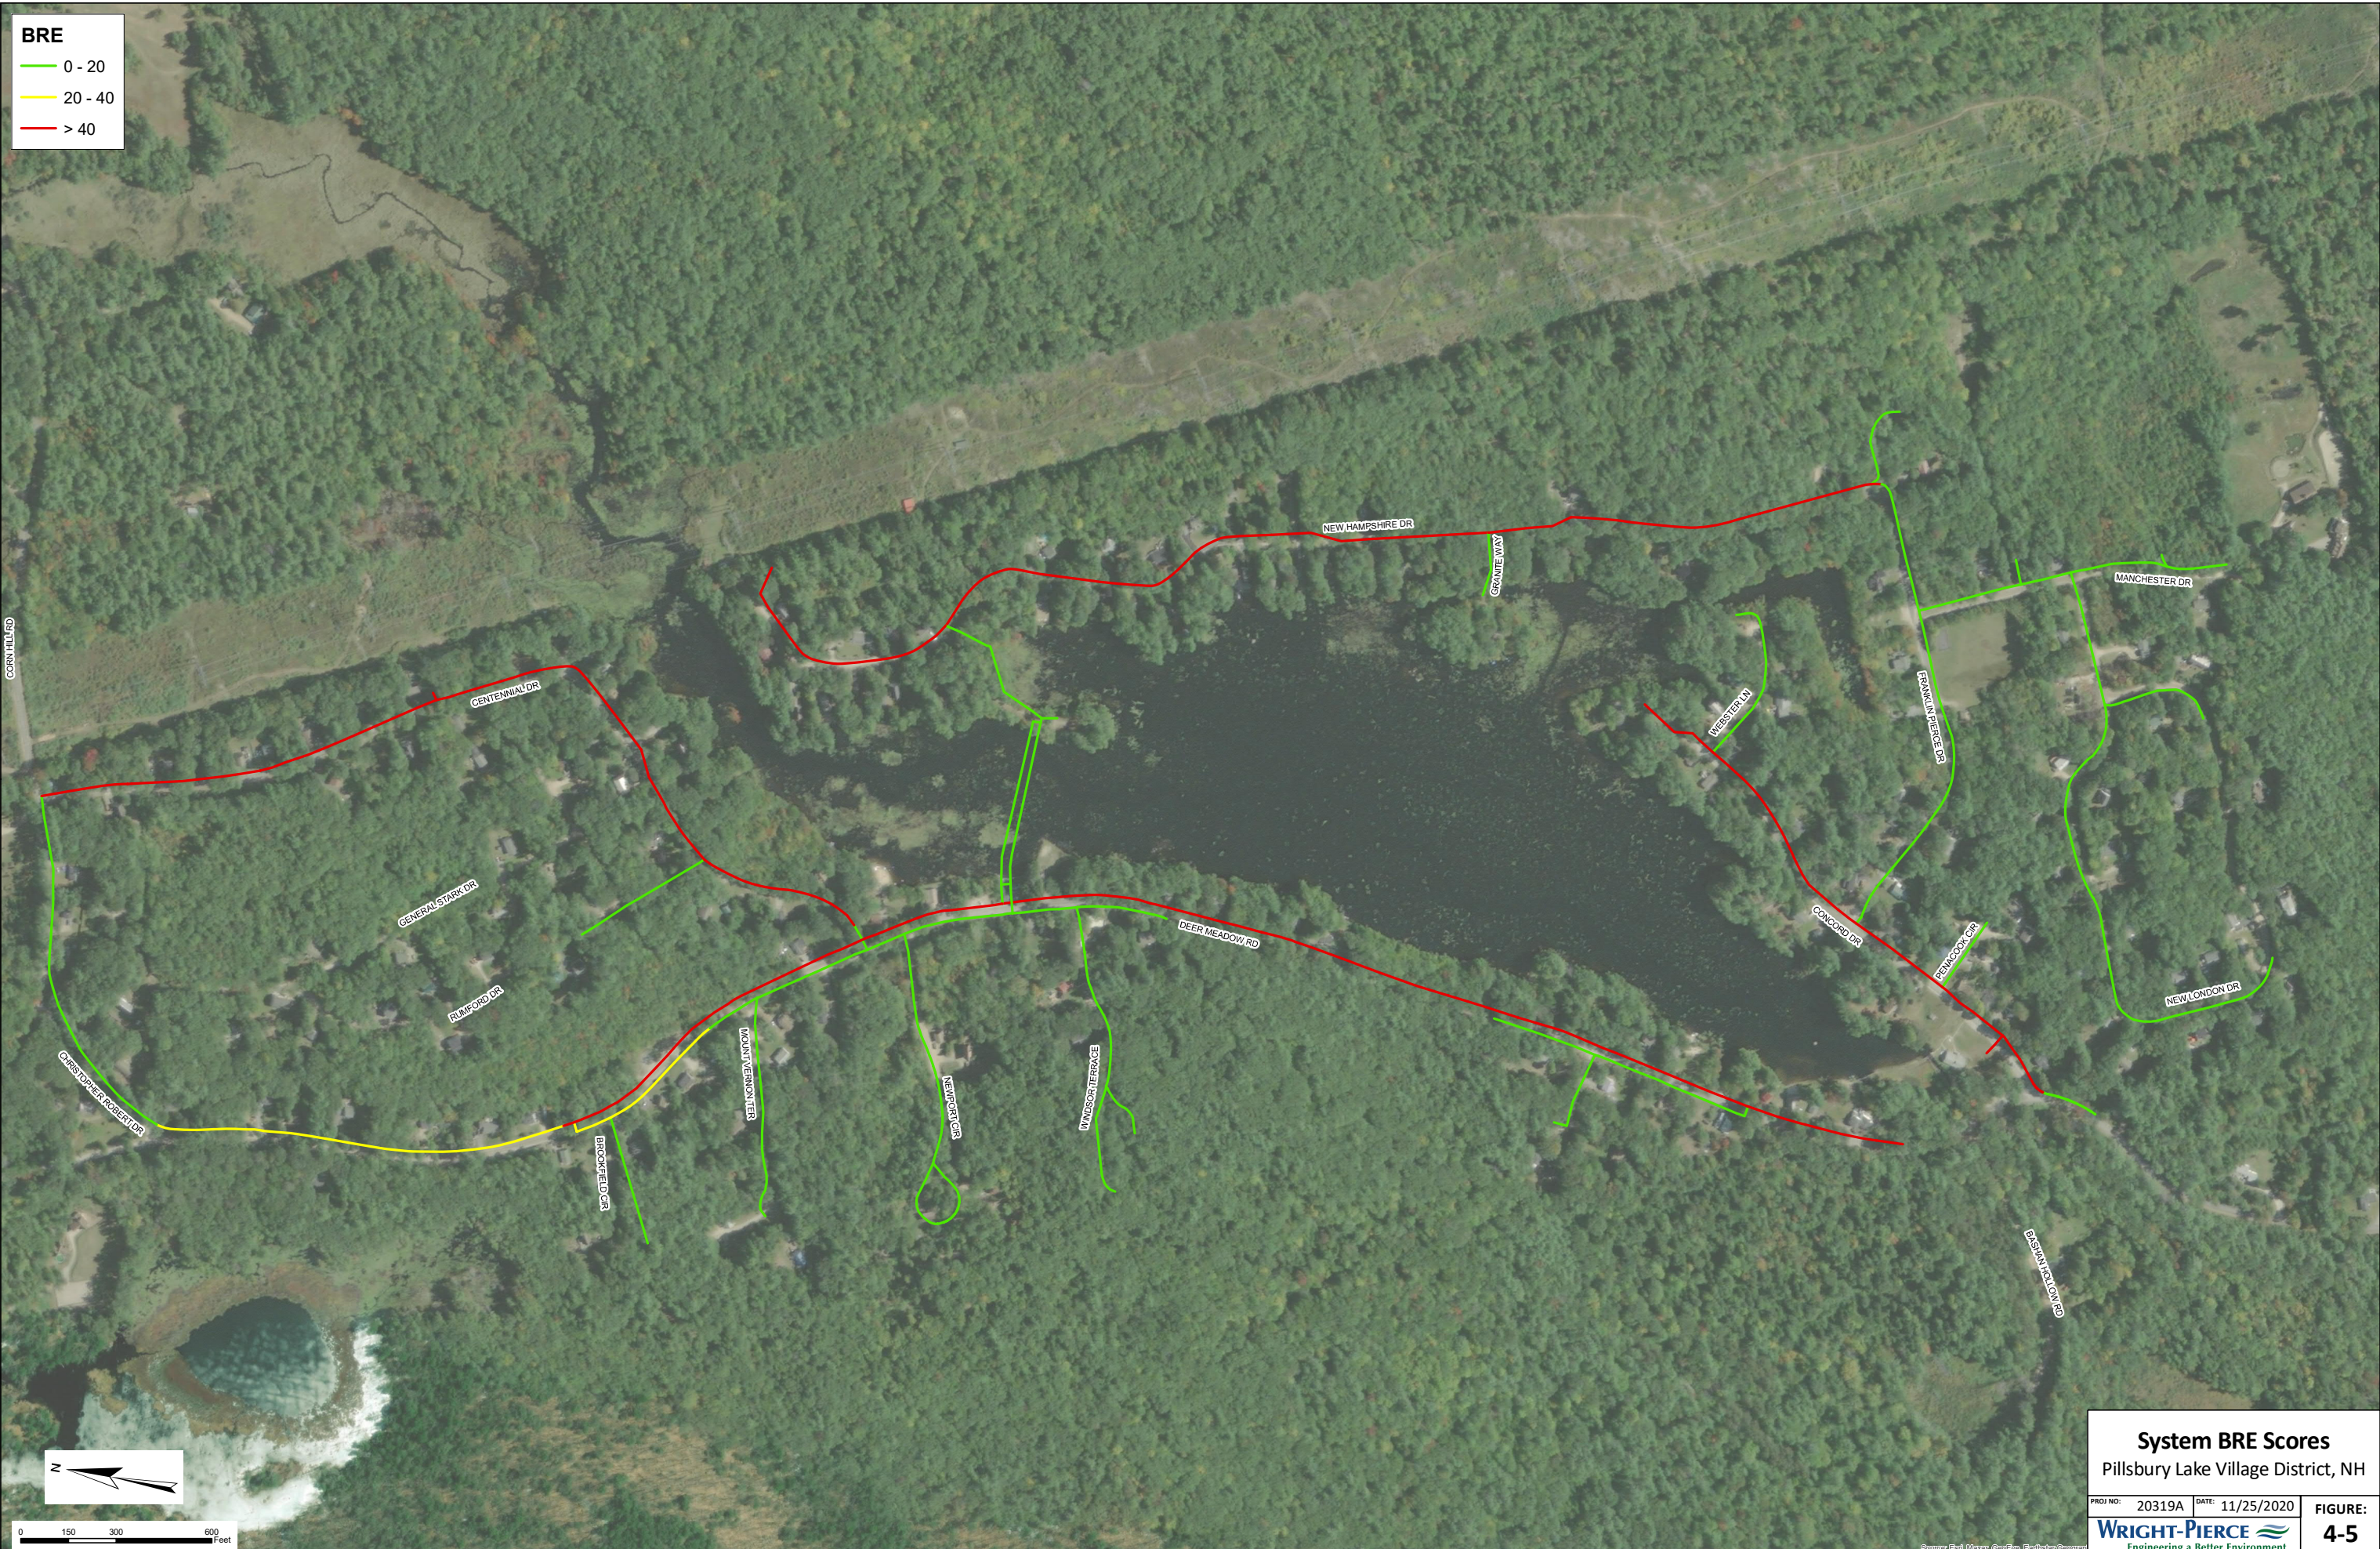
BRE

- 0 - 20
- 20 - 40
- > 40

Plotting the PoF scores against the CoF scores for all pipes in the system on a graph provides another visual means of reviewing this information (**Figure 4-6**). There are a few “critical” risk assets in the distribution system. These mains are considered critical because they serve a large number of customers, had a high number of breaks, connect distant portions of the system, or connect supply sources to the distribution system. These critical-risk water mains should be replaced prior to replacing mains elsewhere in the system. There are also a small number of “high” risk assets in the distribution system. These assets should be systematically targeted for replacement. Close monitoring of these high-risk assets is recommended. If the maintenance frequency of these assets starts to increase, replacement or relocation is recommended. In most cases, as older water main is replaced, there is significant reduction in the PoF score and therefore the BRE score. A copy of the BRE water main spreadsheet is included in **Appendix D**.
