**Le Ciel Venetian Tower Condominium Association  
Wind Mitigation Inspection**

**3971 Gulf Shore Blvd. N.  
Naples, FL 34103  
Collier County  
December 19, 2025**

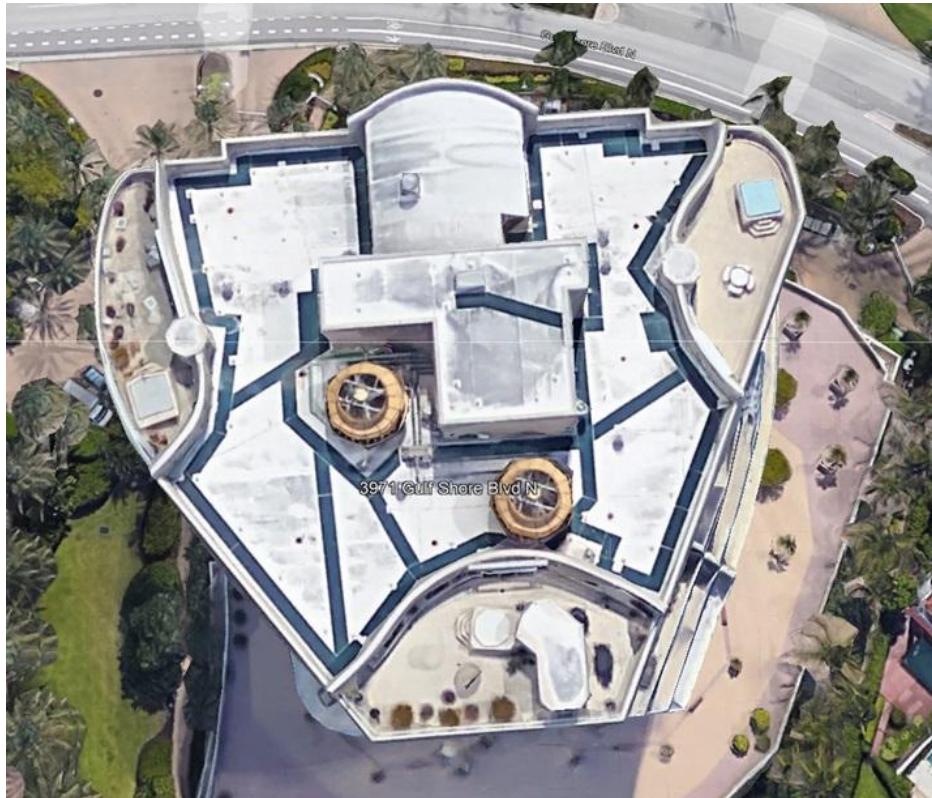
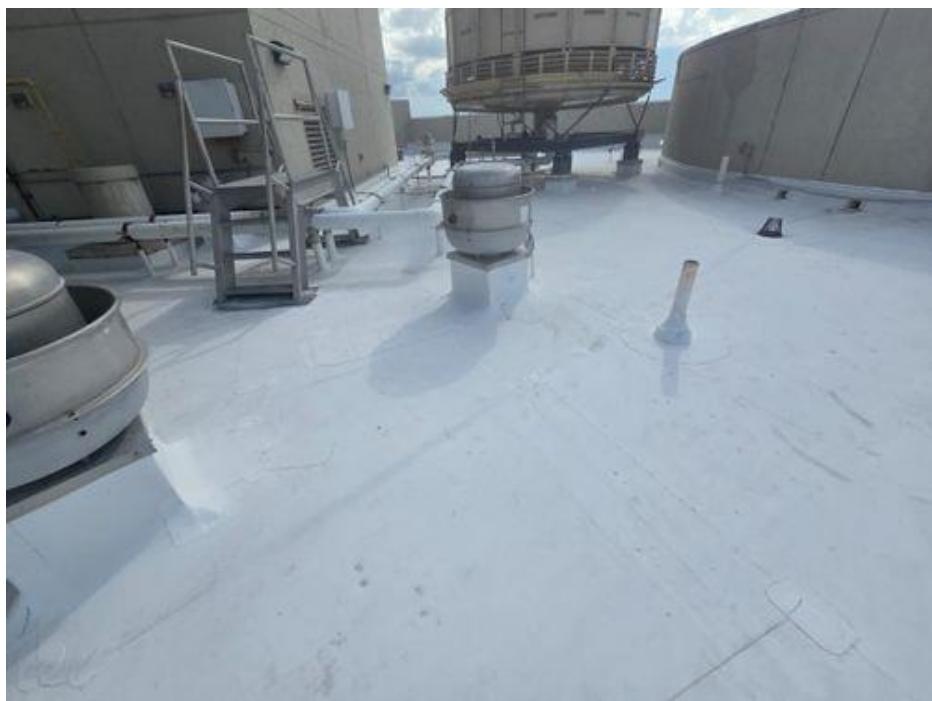
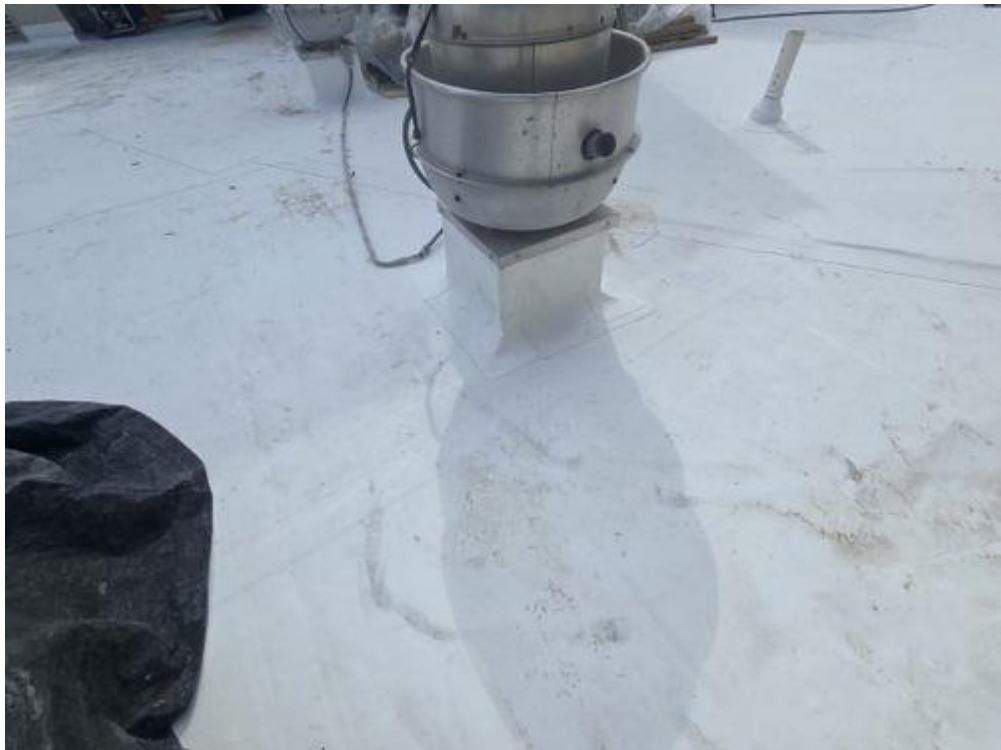
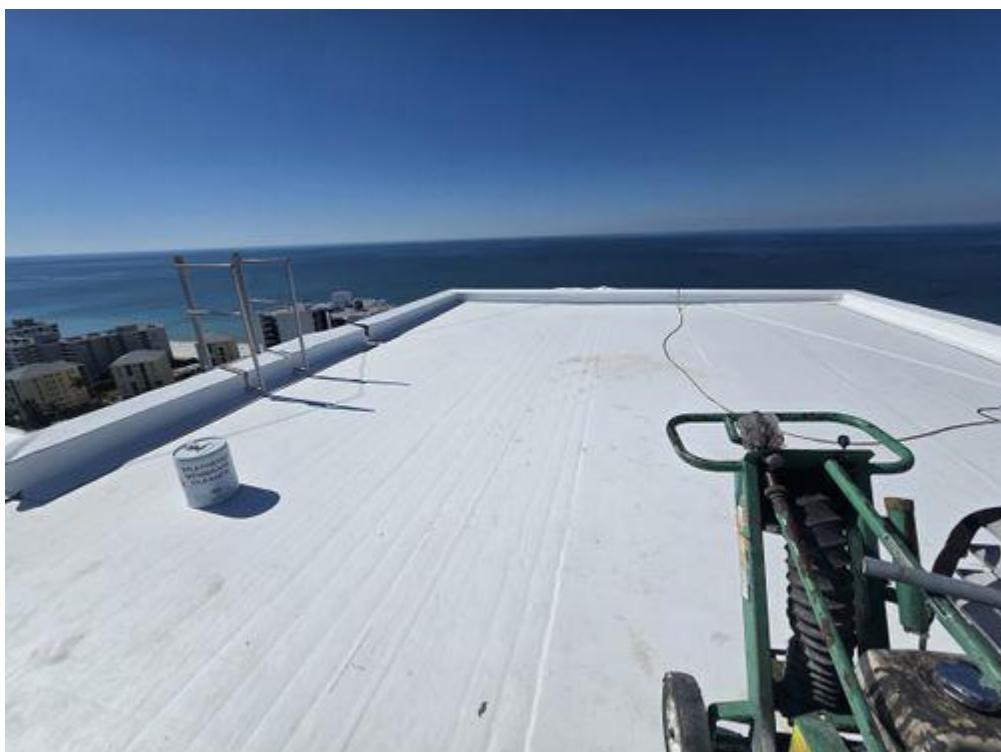
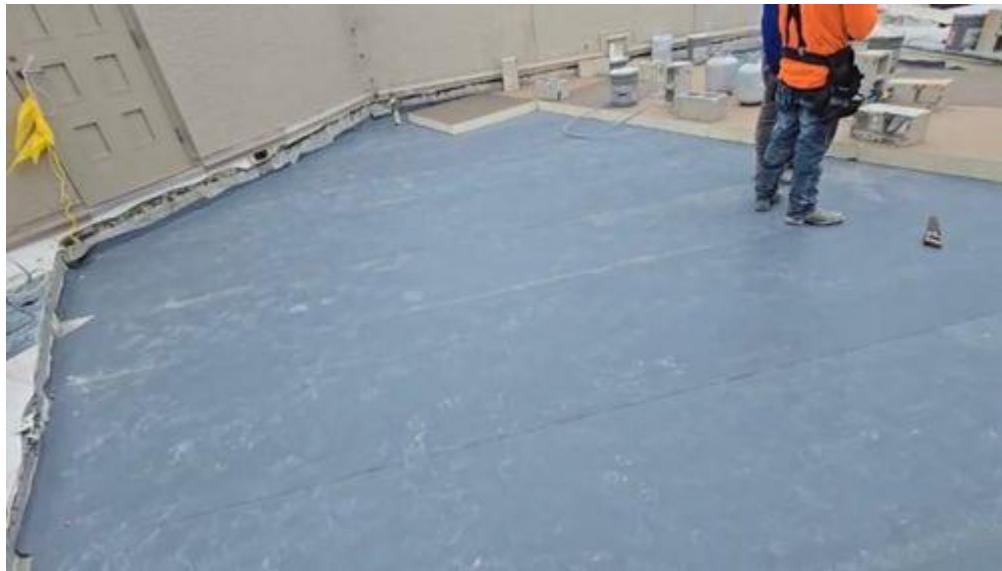
**Roof System:** The roof system is a single ply membrane system that has just been installed in 2025 Under Permit #PRRF2504696-RFI.

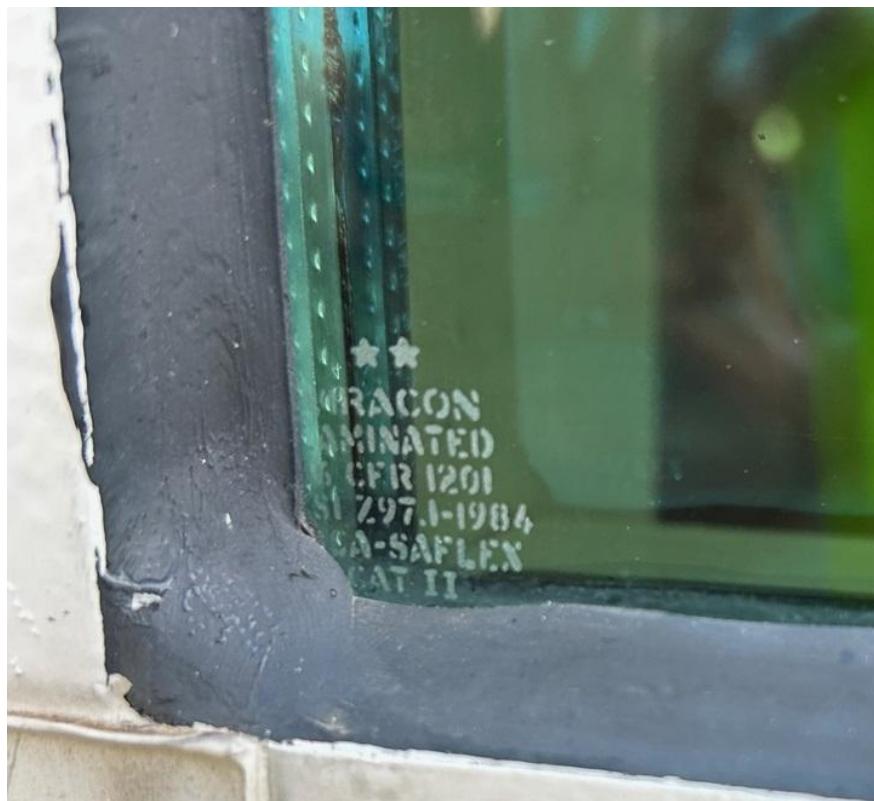
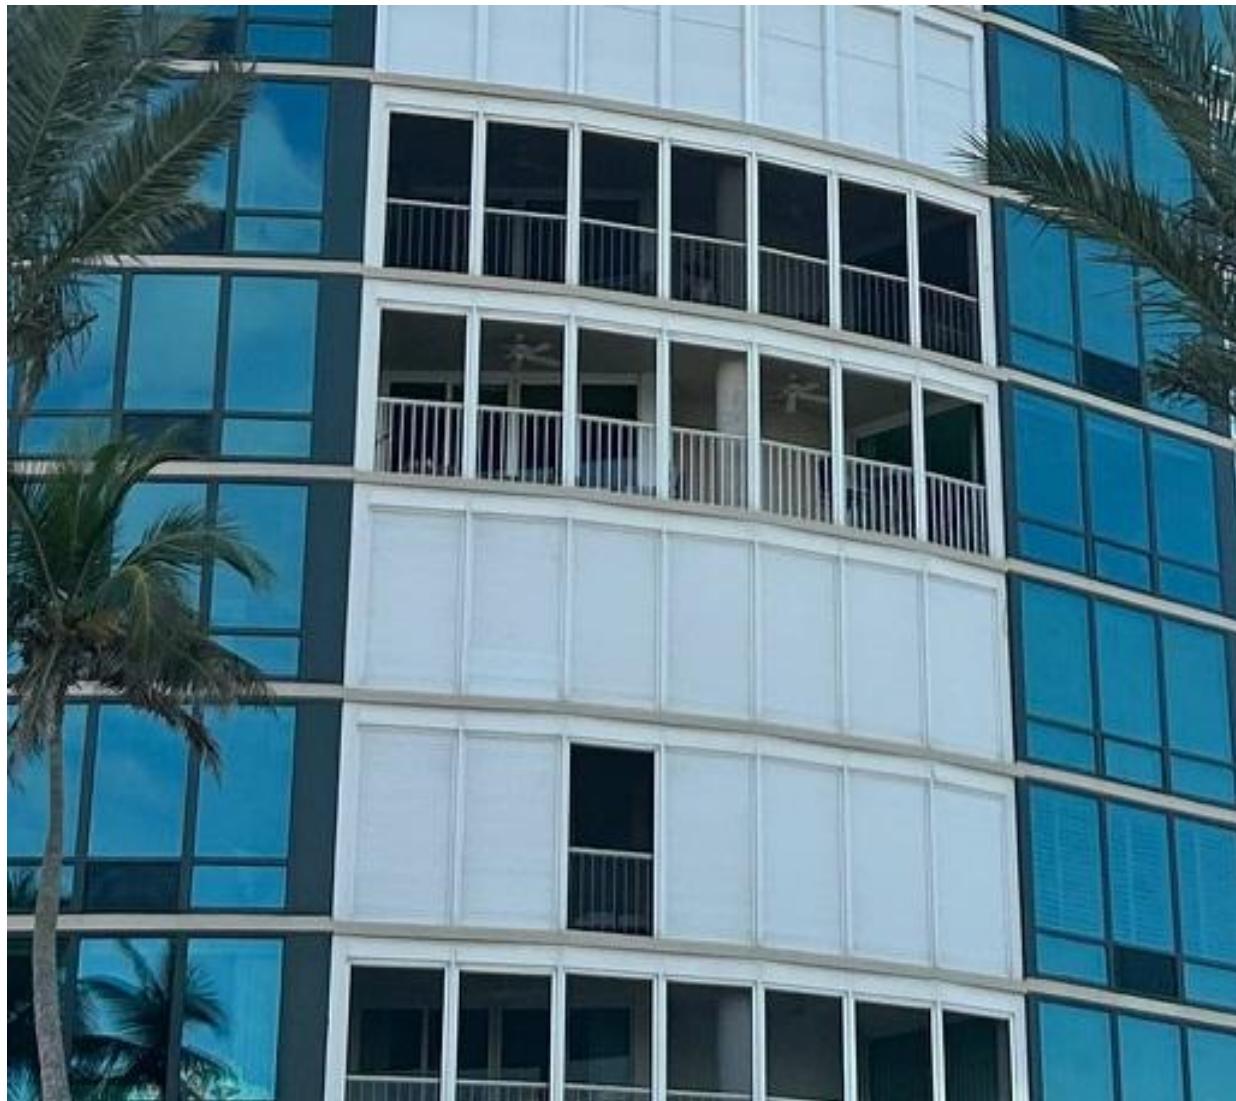
**Opening Protection:** All openings are protected by either impact windows or in the case of lanais, storm screens. The opening protection products appear to meet the the large missle and cyclic pressure as indicated by the laminated glazing meeting CFR 1201 Catt II.
