# Digs Report

# Home Inspection Summary

# Home Inspection Details

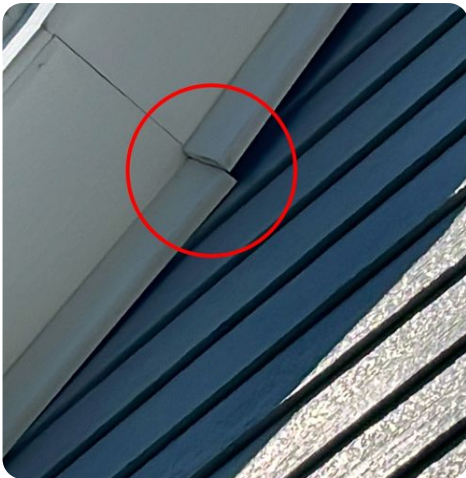
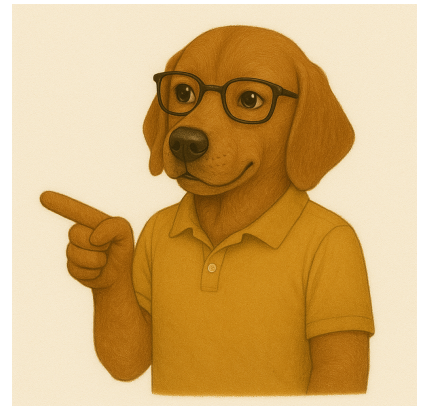
### 1 Overlapped Trim

There is a section of overlapped trim, which is caused by the PVC trim expanding during warmer weather. Minor adjustments can be made to secure the section.

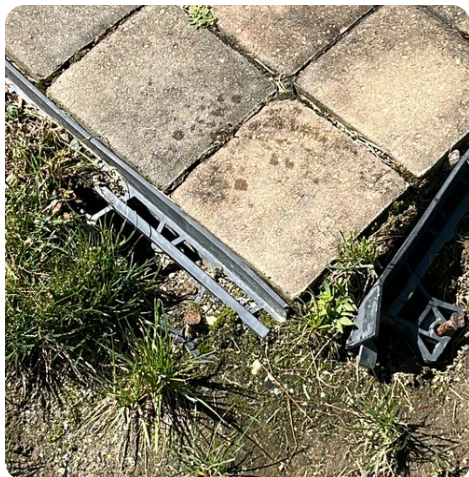
### 3 Minor Patio Settling

The inspector notes that a section of the rear patio has some erosion causing voids under the pavers. The inspector recommends having a qualified hardscape professional provide improvements to prevent further erosion and settling.

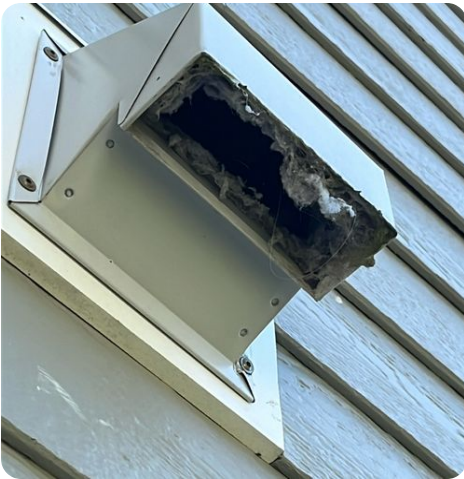
The dryer vent is in need of cleaning. A clogged dryer vent can pose a fire hazard and reduce the efficiency of your dryer. It is recommended to have a qualified HVAC technician or dryer vent cleaning service evaluate and clean the vent system to ensure proper functioning and safety. Regularly cleaning the dryer vent can also help improve the performance and lifespan of the dryer.

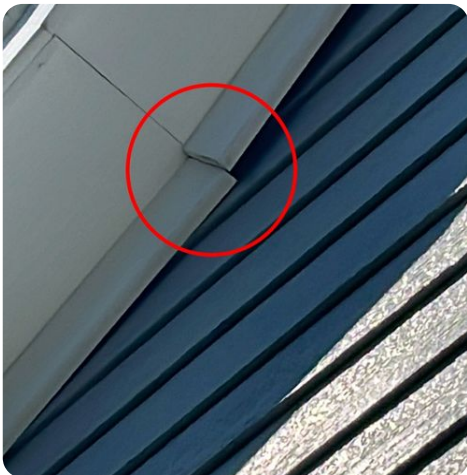
There is a section of overlapped trim, which is caused by the PVC trim expanding during warmer weather. Minor adjustments can be made to secure the section.
