Digs Report

Date of Certification: Date Report Delivered Property Address: Anytown, USA

Home Inspection Summary

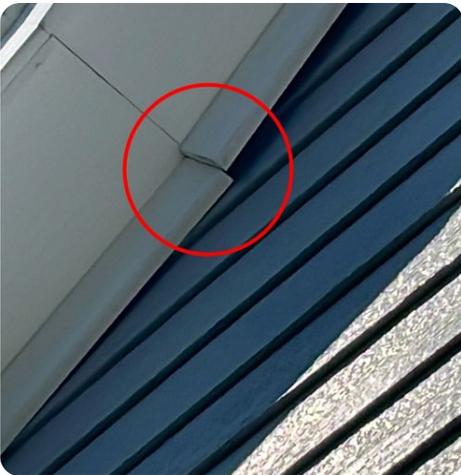
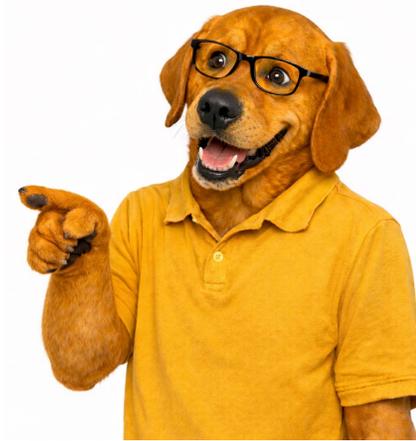
1 Overlapped Trim

Location: Exterior

There is a section of overlapped trim, which is caused by the PVC trim expanding during warmer weather. Minor adjustments can be made to secure the section.

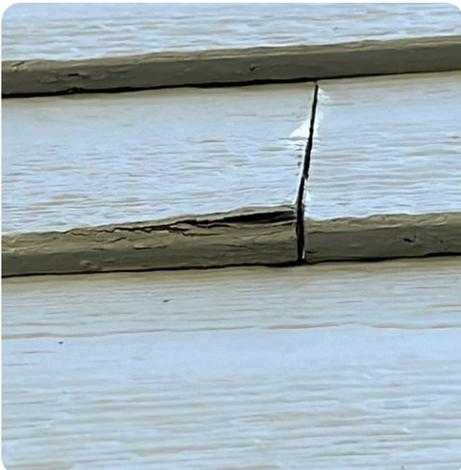
2 Deteriorated Fiber Cement Board Repairs Recommended

Location: Left Side of Home

One fiber cement board is showing early signs of deterioration. Repairing and sealing the area is recommended to prevent potential moisture intrusion. Contact a qualified contractor for maintenance.

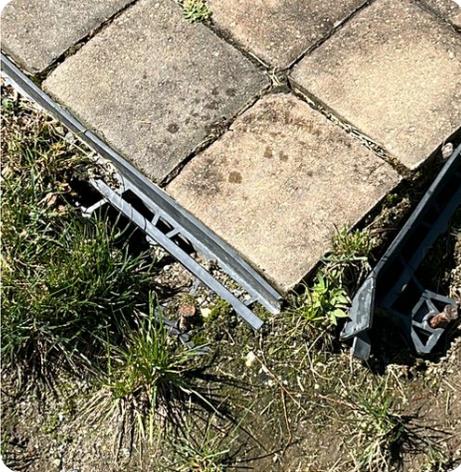
3 Minor Patio Settling

Location: Rear of Home

The inspector notes that a section of the rear patio has some erosion causing voids under the pavers. The inspector recommends having a qualified hardscape professional provide improvements to prevent further erosion and settling.

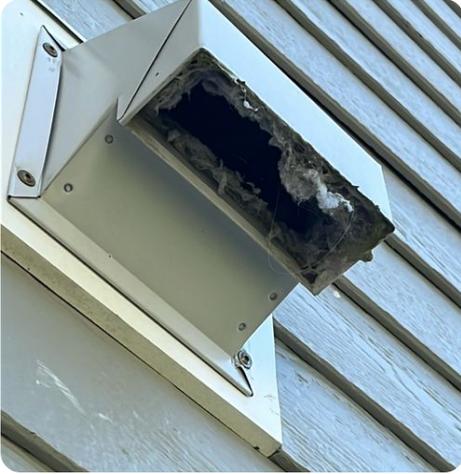
The dryer vent is in need of cleaning. A clogged dryer vent can pose a fire hazard and reduce the efficiency of your dryer. It is recommended to have a qualified HVAC technician or dryer vent cleaning service evaluate and clean the vent system to ensure proper functioning and safety. Regularly cleaning the dryer vent can also help improve the performance and lifespan of the dryer.

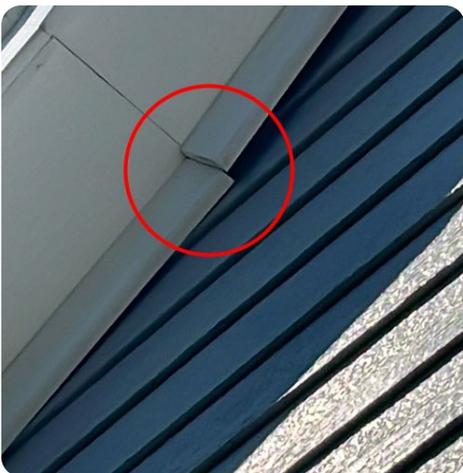
Location: Exterior

There is a section of overlapped trim, which is caused by the PVC trim expanding during warmer weather. Minor adjustments can be made to secure the section.

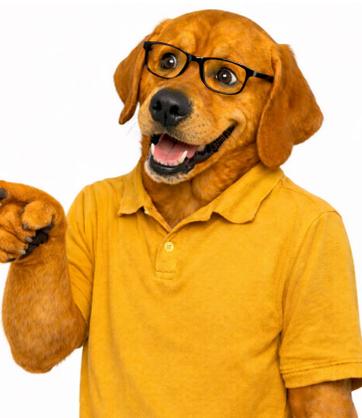
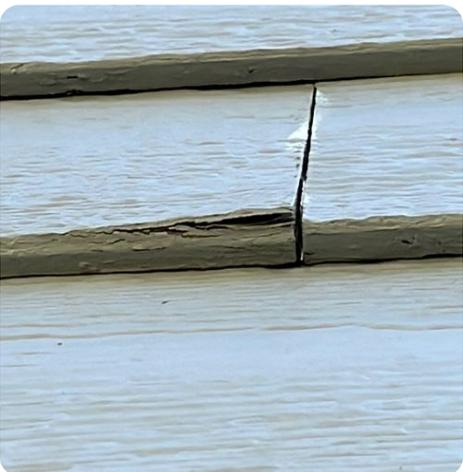
Deteriorated Fiber Cement Board

Location: Left Side of Home

One fiber cement board is showing early signs of deterioration. Repairing and sealing the area is recommended to prevent potential moisture intrusion. Contact a qualified contractor for maintenance.

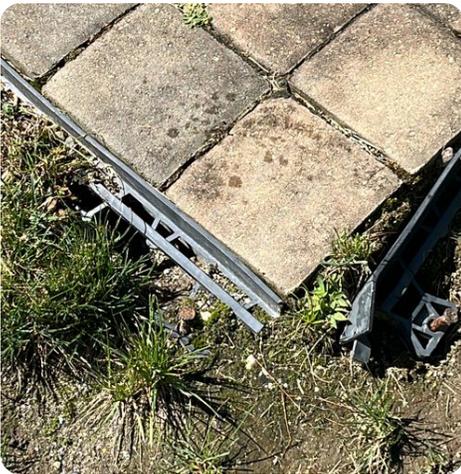
Location: Rear of Home

The inspector notes that a section of the rear patio has some erosion causing voids under the pavers. The inspector recommends having a qualified hardscape professional provide improvements to prevent further erosion and settling.

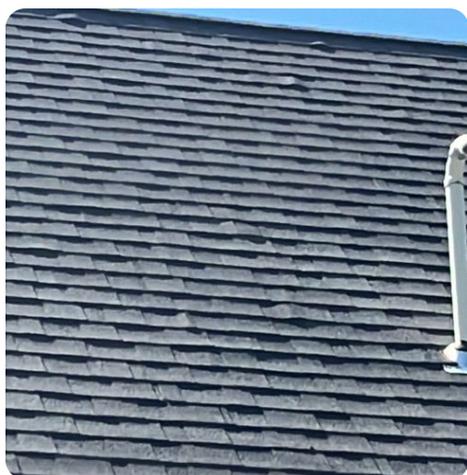
The presence of lifting shingles was noted on the rear of the structure. No signs of damaged or loose shingles were found. It is recommended to monitor this issue for any changes. Consider having a qualified roofer evaluate and repair as needed.

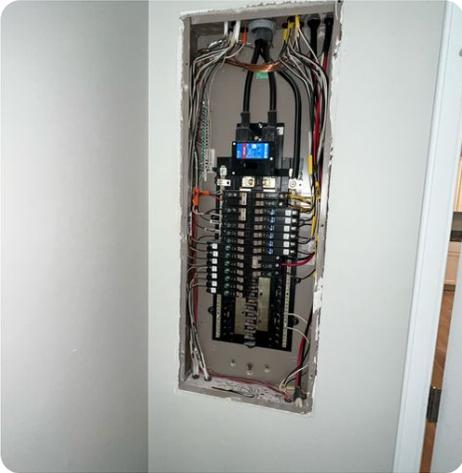
The interior components of the service panel were evaluated and found to be in satisfactory condition.

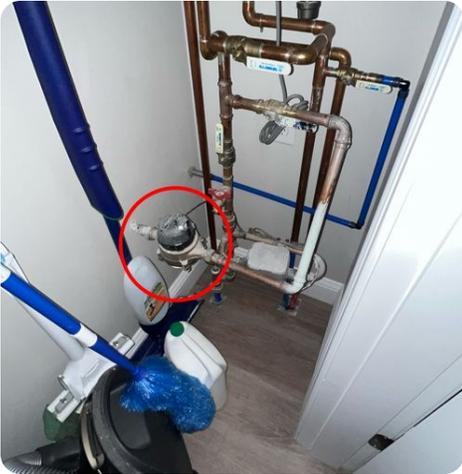
This property is equipped with a submeter which subtracts the exterior water usage from the sewage bill. These are typically installed for landscaping purposes.

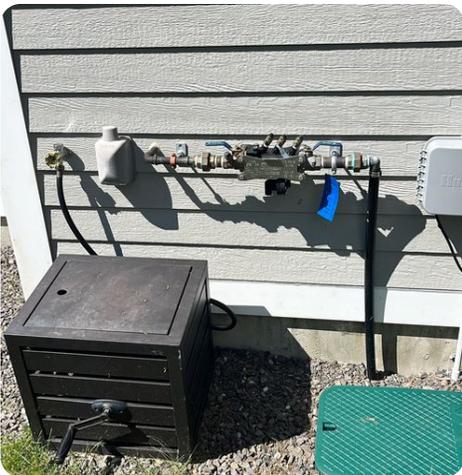
Irrigation System

The property is equipped with an irrigation system. Testing these systems is not within the scope of practice for a standard home inspection. An unknown condition may exist. For further information, recommend contacting the owner or for further evaluation contact a qualified irrigation specialist.

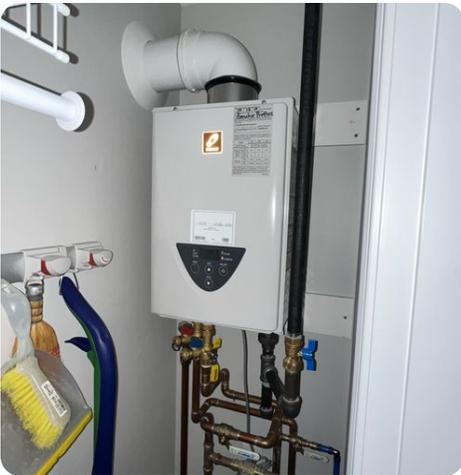
The gas on demand water heater was evaluated during the inspection and found to be in functional working condition.

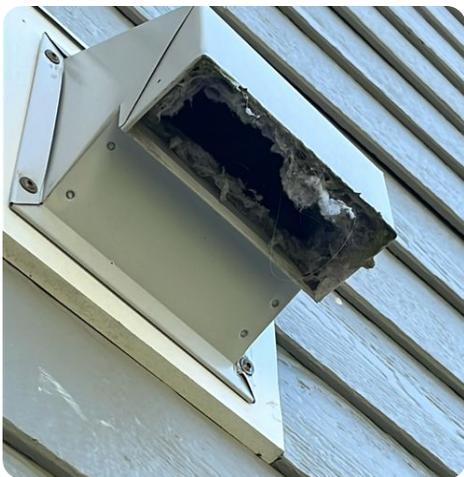
The dryer vent is in need of cleaning. A clogged dryer vent can pose a fire hazard and reduce the efficiency of your dryer. It is recommended to have a qualified HVAC technician or dryer vent cleaning service evaluate and clean the vent system to ensure proper functioning and safety. Regularly cleaning the dryer vent can also help improve the performance and lifespan of the dryer.
