Insured: YMCA- Franz Ross Park

Property: 1933 Quesada Ave

Type of Loss: Mold/Water

Estimate: YMCA-FRANZ_ROSS_

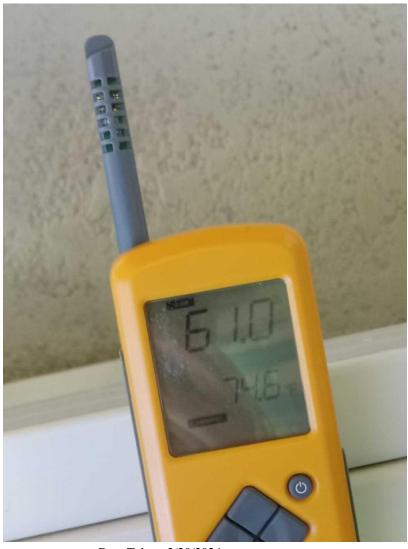
2 2-Humidity Date Taken: 2/20/2024 High Humidity Levels Perfect for Bacteria or Mold, amplification

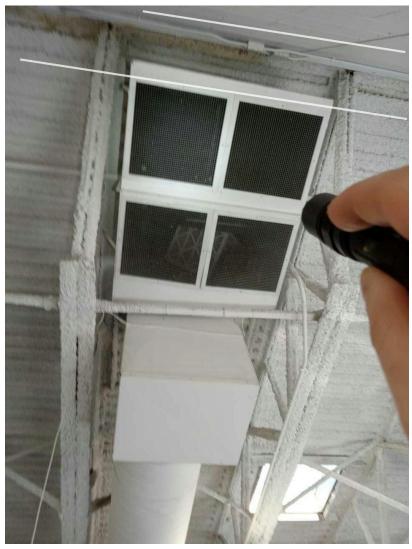
6 6-HVAC Filters 2 Date Taken: 2/20/2024 Discoloration near return Filter appears displaced

Upon our limited inspection from the ground level visible soil was present upon HVAC intake and there did not appear to be any filters in place. Or the visibility was such that our view of the HVAC system was poor. I have included two pictures showing the return. Each system has its own method where filters can best be deployed in order to filter out particulate from the air. Particulate includes many different organisms from human pathogens, viruses, skin cells, molds, bacteria, allergens etc. It is not uncommon for condensation and moisture to be present in or near HVAC systems and for microbial and other organic particulate to be found within. We recomend a thorough cleaning and sanitization and the filtration system re-established.

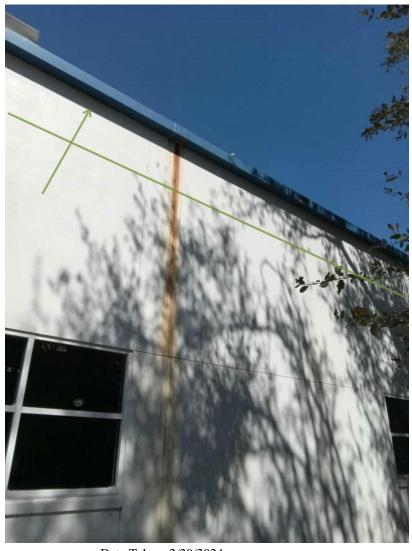
Issue #3- Discoloration on building materials, primarily ceiling and outside walls probably attributed to previous Roof and issues that have been reportedly resolved. We recommend this area be cleaned and then sealed over with with a stain and odor blocker. Due to the height this process will need to be executed using a lift system. (That will also be needed in order to have access to the HVAC).

9 9-Wall Exterior Date Taken: 2/20/2024
Interior of roof line is where discoloration exists on walls, ceiling and some pipes/rafters

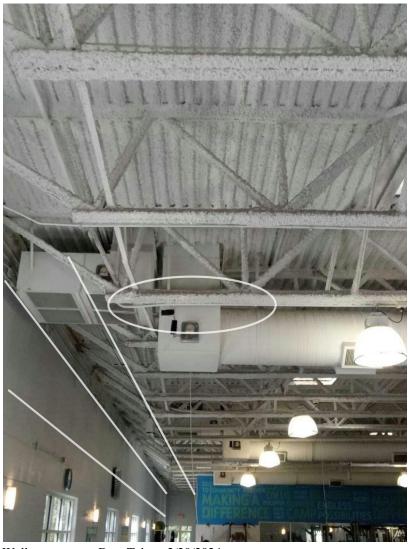
13 13-Dirty Ceiling & Walls Date Taken: 2/20/2024

Discoloration Likely from previous roof problems. Would benefit from Cleaning, Sealing and Encapsulation.
