# Monthly Environmental ECO Monitoring Report

Wolf Wind Energy Facility

Western Cape

February 2023

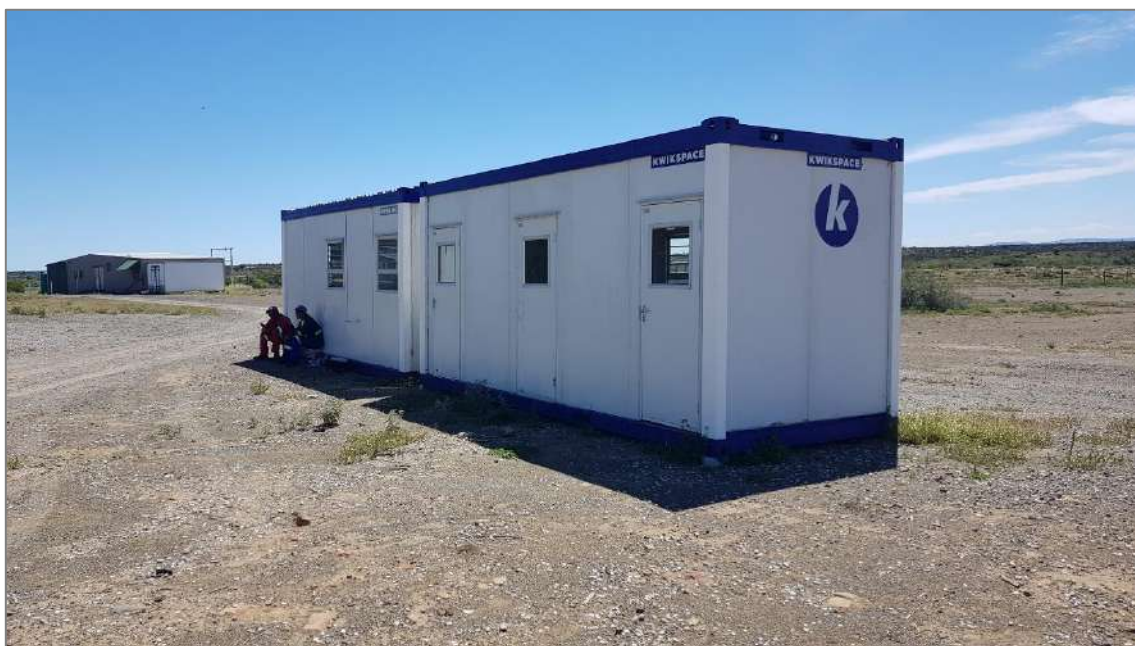
A small number of container offices were delivered to site and stored at the intended construction site camp. The construction site camp

**Figure 1:** Container offices being stored at the intended site offices.

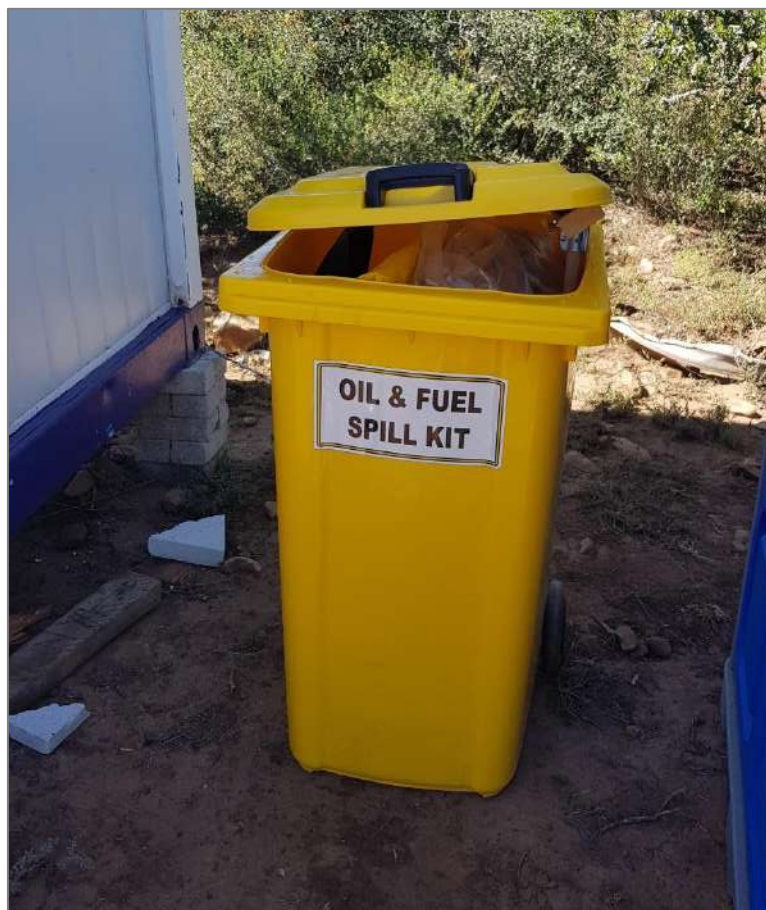
**Figure 2:** Spill kit located at the site laydown area.

Spill kits are to be made available to mitigate and clean any chemical spills when construction commences.

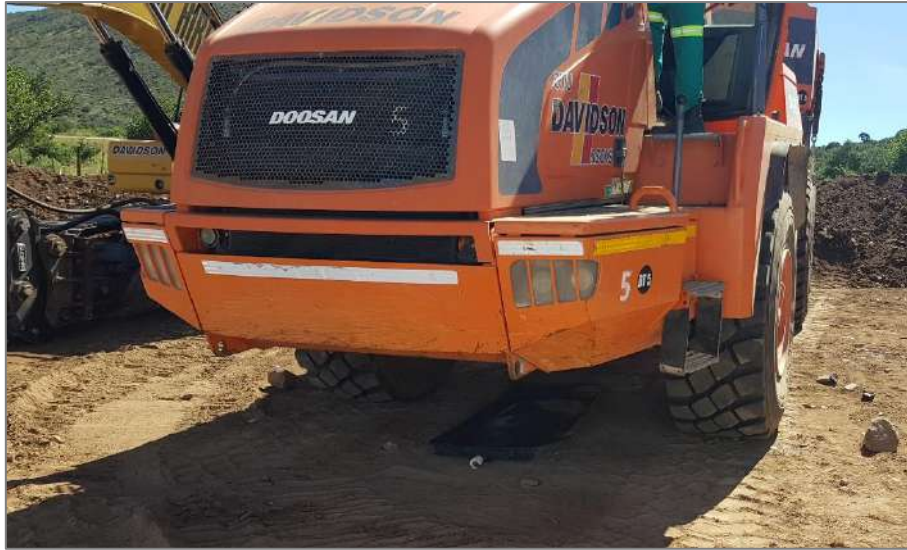
**Figure 3:** Drip tray being placed under vehicles when stationary.

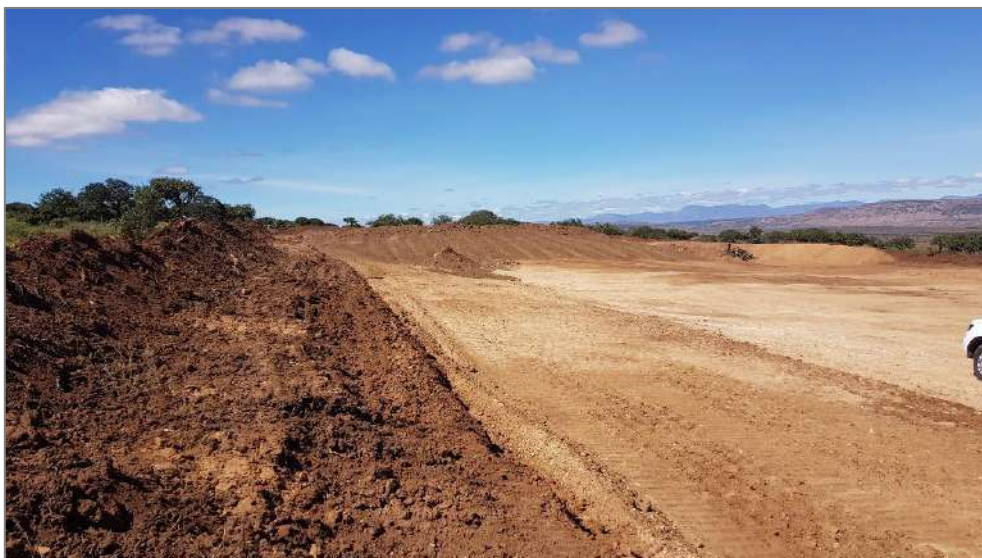
**Figure 4:** Topsoil being stored along the perimeter of the site laydown area.

Erosion and stormwater measures must be put in place to reduce loss of topsoil.

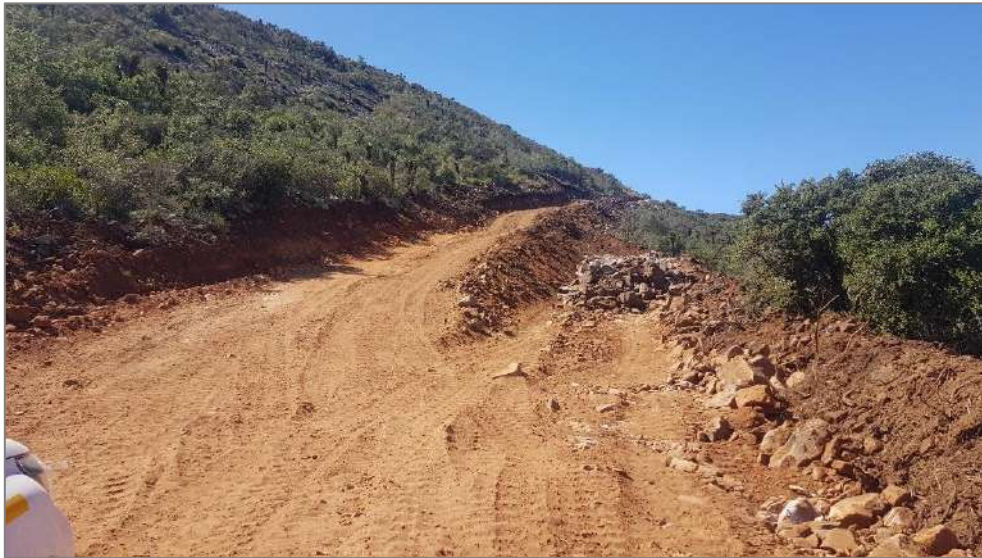
Works on two access roads has commenced with clearing and maintenance works.

**Figure 5:** Start of main access route to turbine positions.

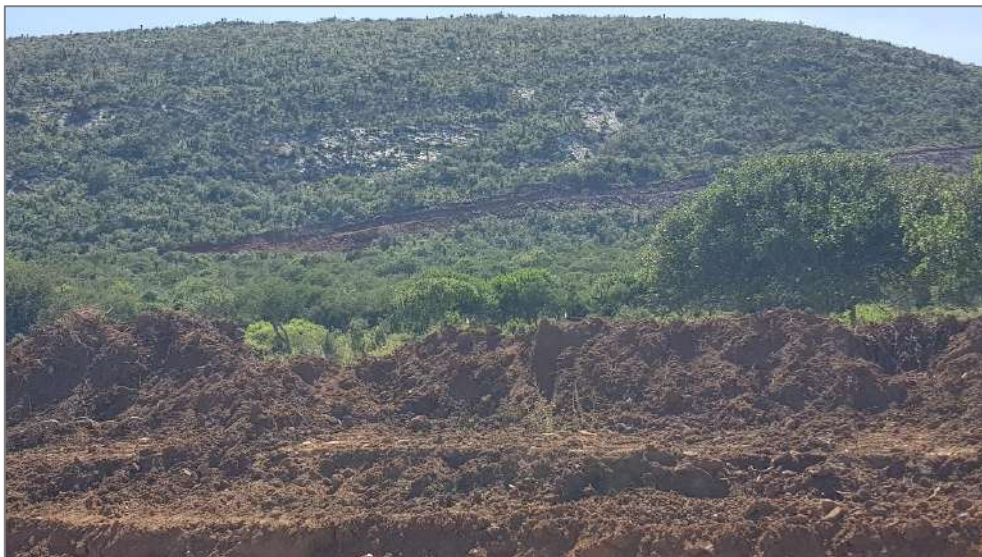
**Figure 6:** View of main access route to the north of site laydown area.

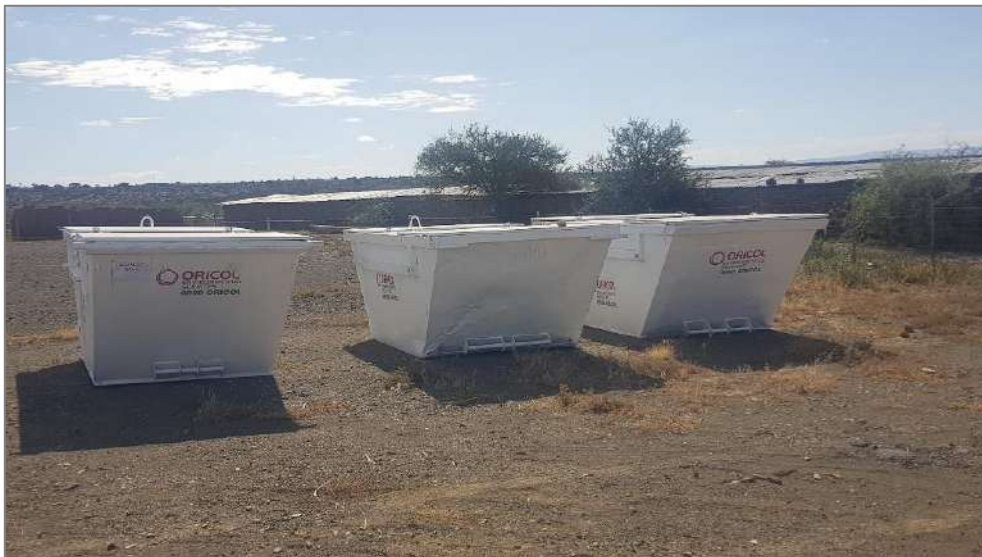
A designated waste area is present at the contractor site offices which will store waste temporarily prior to being transferred to the relevant waste facility.

**Figure 1:** Waste collection receipts received form service provider.

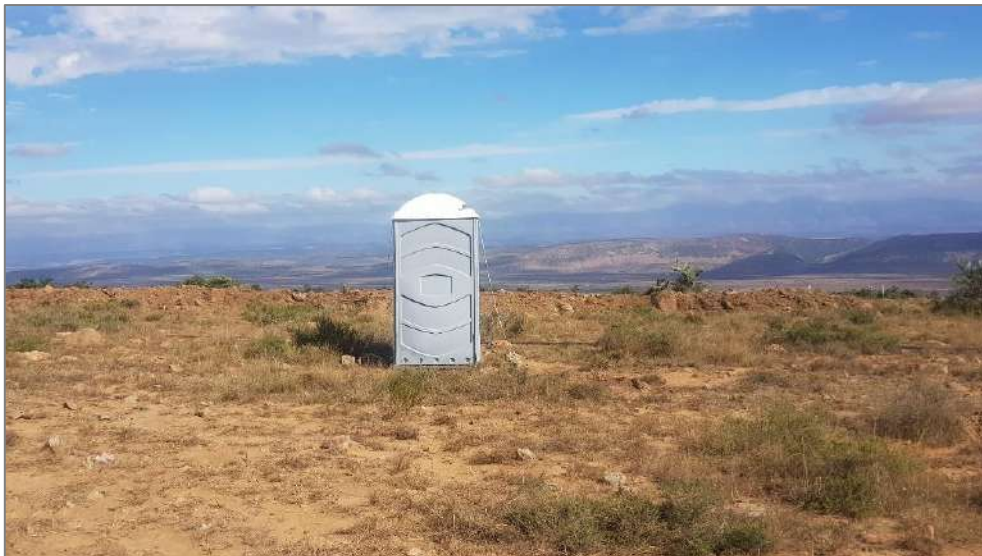
An estimated **2400L** of wastewater from portable toilets was removed off site during the reporting period.

**Figure 2:** Portable toilet, tied down and available to staff on site.

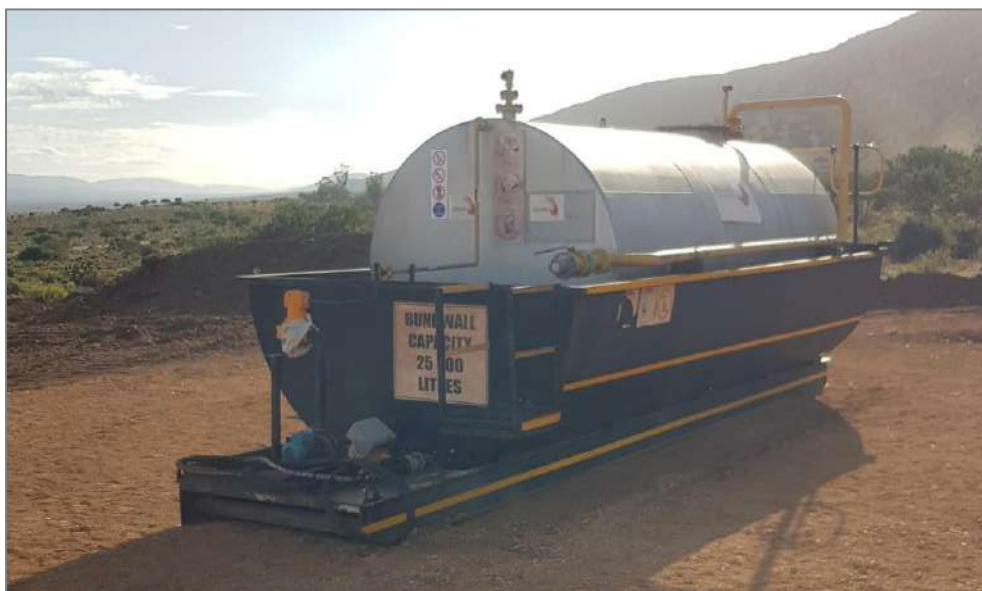
**Figure 3:** Bulk fuel storage container which arrived on site. Was not in use at the time of site visit.

Spill kits are to be made available to mitigate and clean any chemical spills when construction commences.

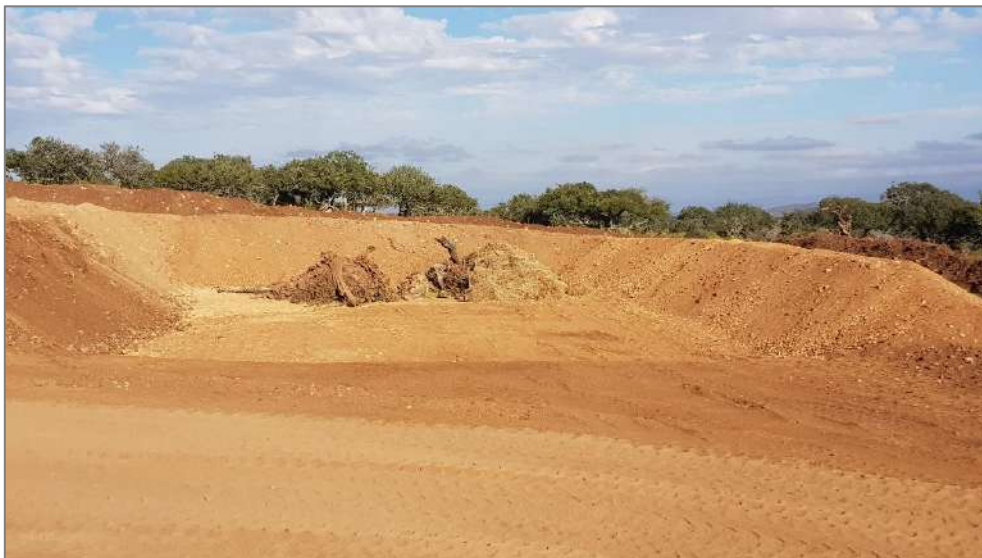
The contractor intends to propose the burning of cuttings on site in order to reduce the risk of spreading seed during transit. Any burning would be conducted under strict conditions and procedures as approved by the ESCO and review by the ECO. No procedures have been provided to the ECO for review.

**Figure 4:** Temporary storage area for alien invasives.

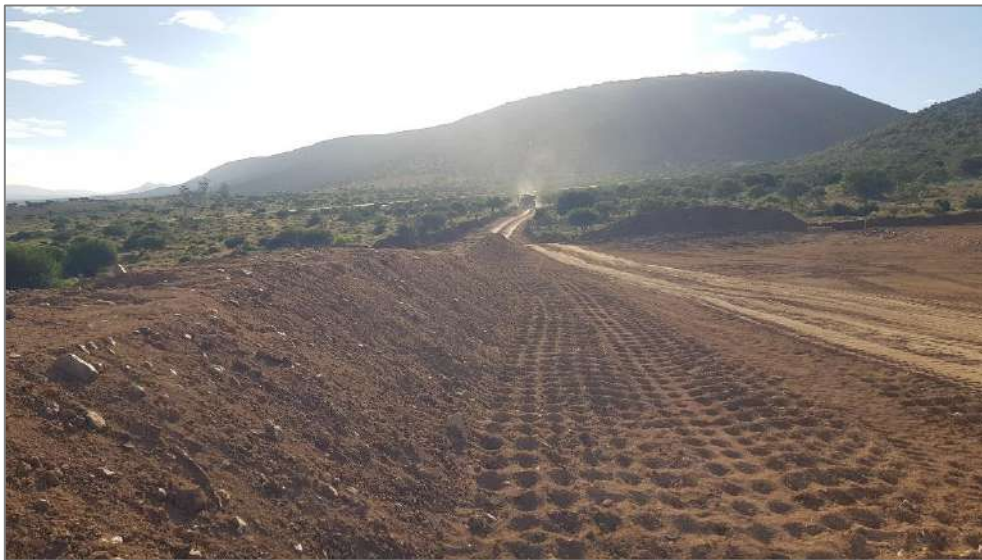
**Figure 5:** Topsoil be neatly stored at the laydown area.

Any topsoil stripped is to be stored separately for use at a later stage during rehabilitation.

Erosion and stormwater measures must be put in place and maintained to reduce loss of topsoil and prevent erosion.

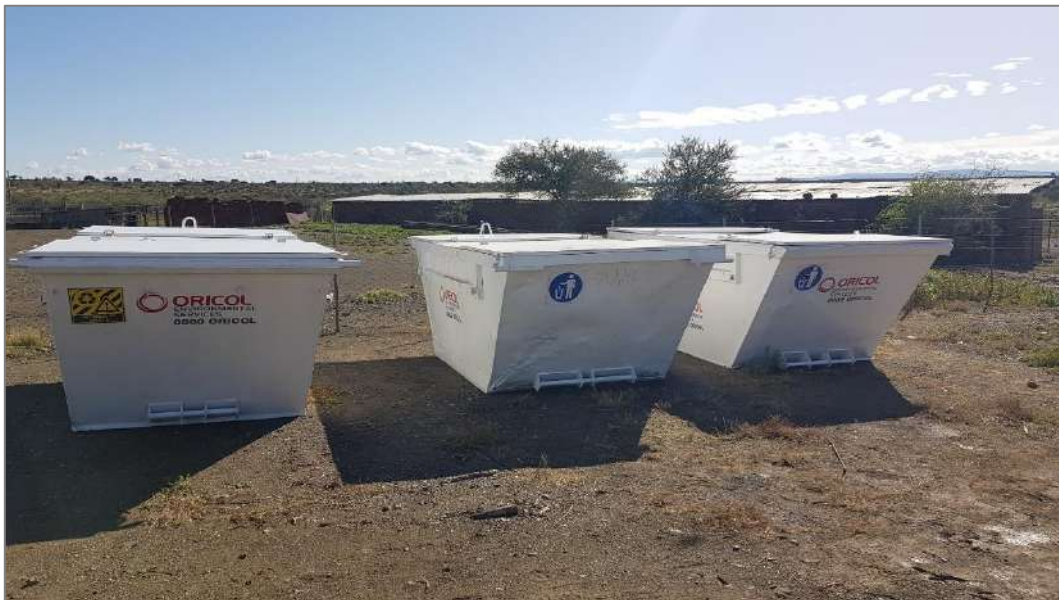
A designated waste area is present at the contractor site offices which will store waste temporarily prior to being transferred to the relevant waste facility.

**Figure 1:** Waste collection skips with signage to indicate permitted waste types.

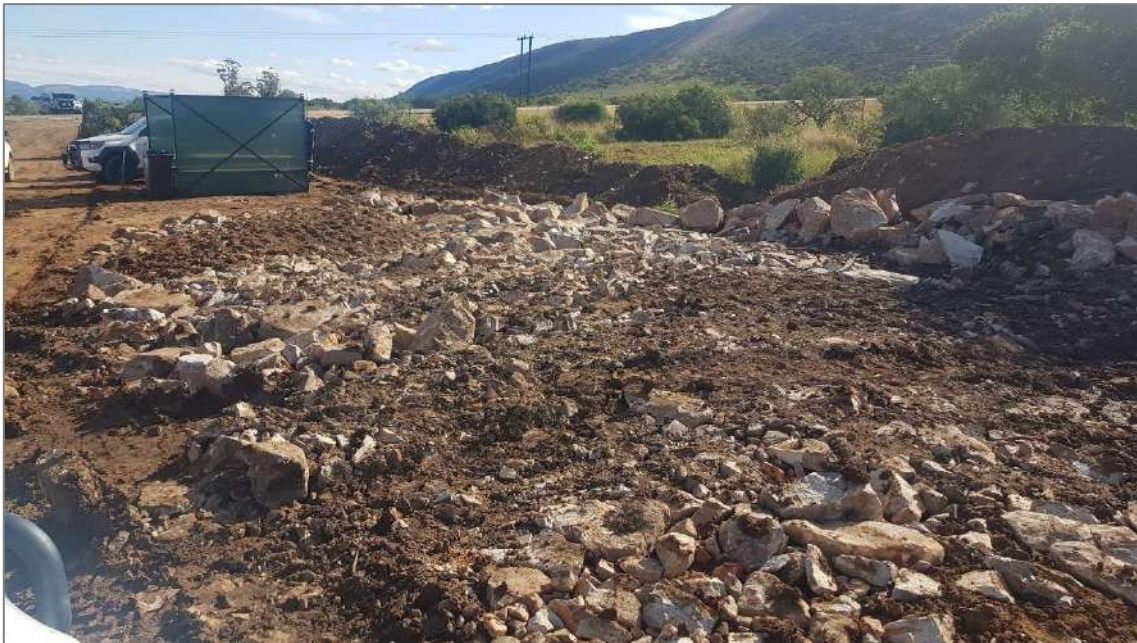
Measures are being implemented to alleviate excess stormwater on site including installing large rock material to aid with water filtration.

**Figure 2:** Measure being implemented to assist in drainage at the laydown area.

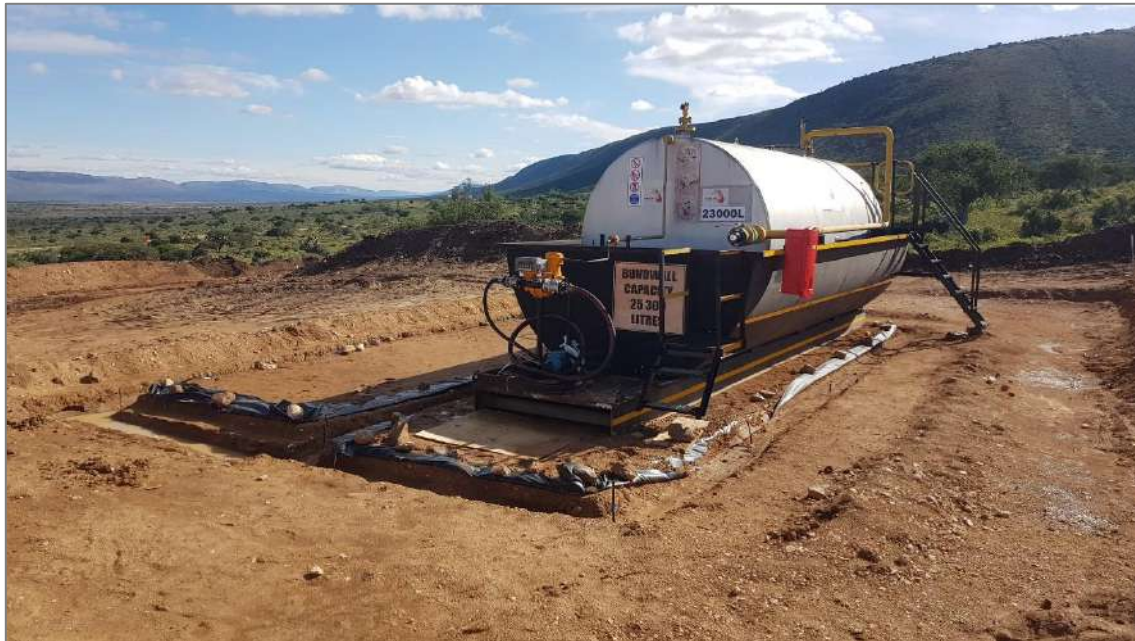
**Figure 3:** Works commencing on bunding for bulkf fuel storage container.

Spill kits are to be made available to mitigate and clean any chemical spills when required.

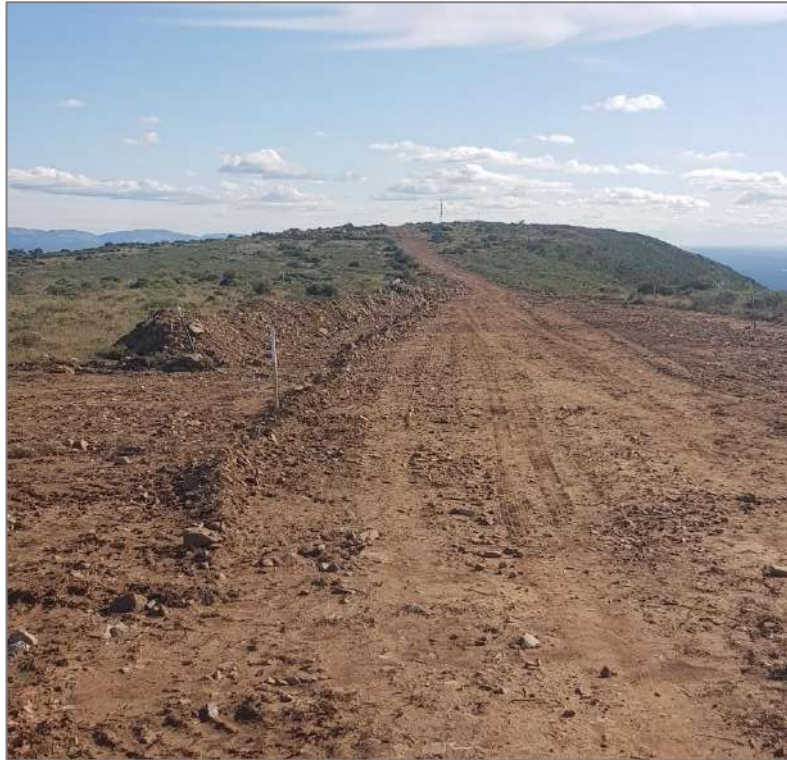
**Figure 4:** View of internal access road as seen from turbine position.

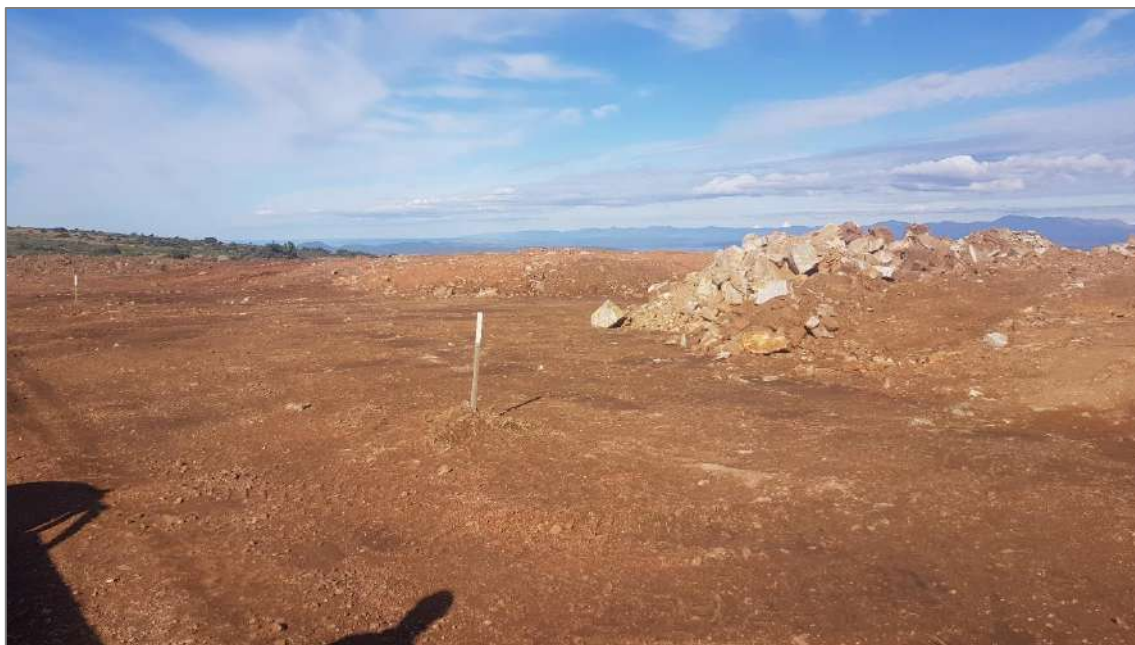
Stockpiles of soil material were observed as being kept separate.

**Figure 5:** Stockpile of material for access route. Stockpile is well maintained.

Erosion and stormwater measures must be put in place and maintained to reduce loss of topsoil and prevent erosion.

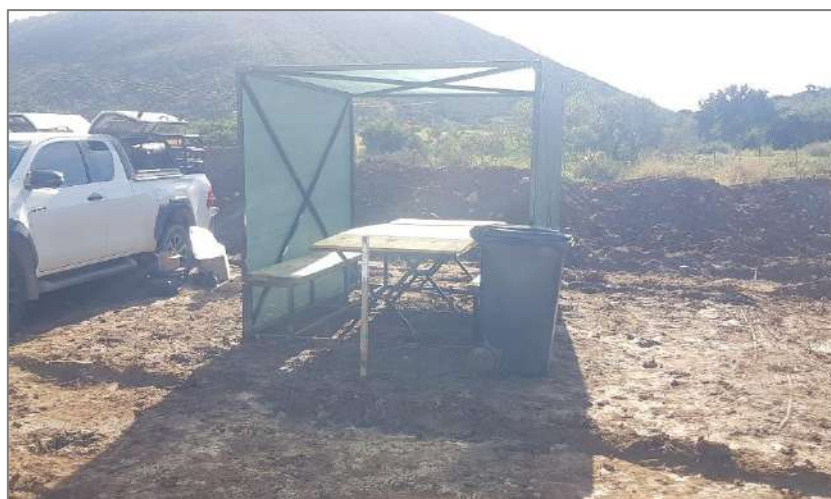
**Figure 6:** A eating area has been established at the laydown area at the base of the access road.

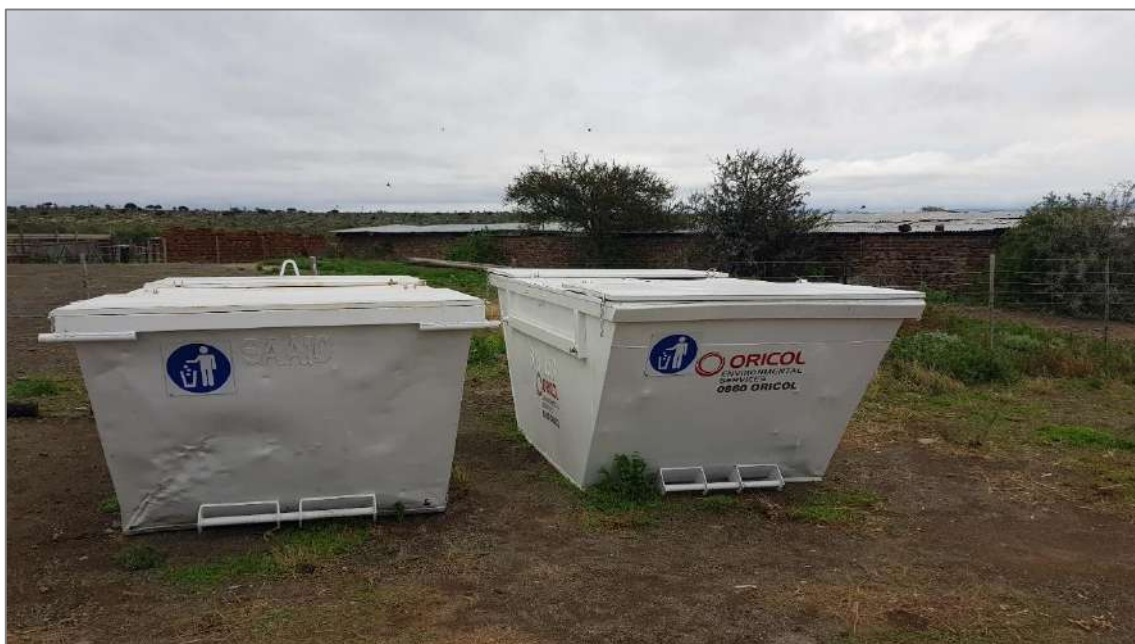
The designated waste area located at the site offices with skips being labelled for the relevant waste types and was in good working order, neat and clean.

**Figure 1:** Waste collection skips with signage to indicate permitted waste types.

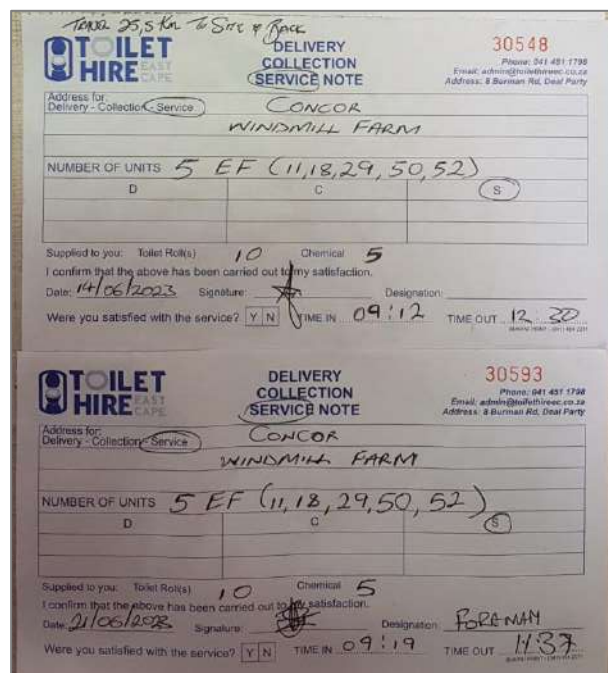
An estimated **11 800L** of wastewater was removed off site during the reporting period.

*Take 25,5 km to Site & Back*

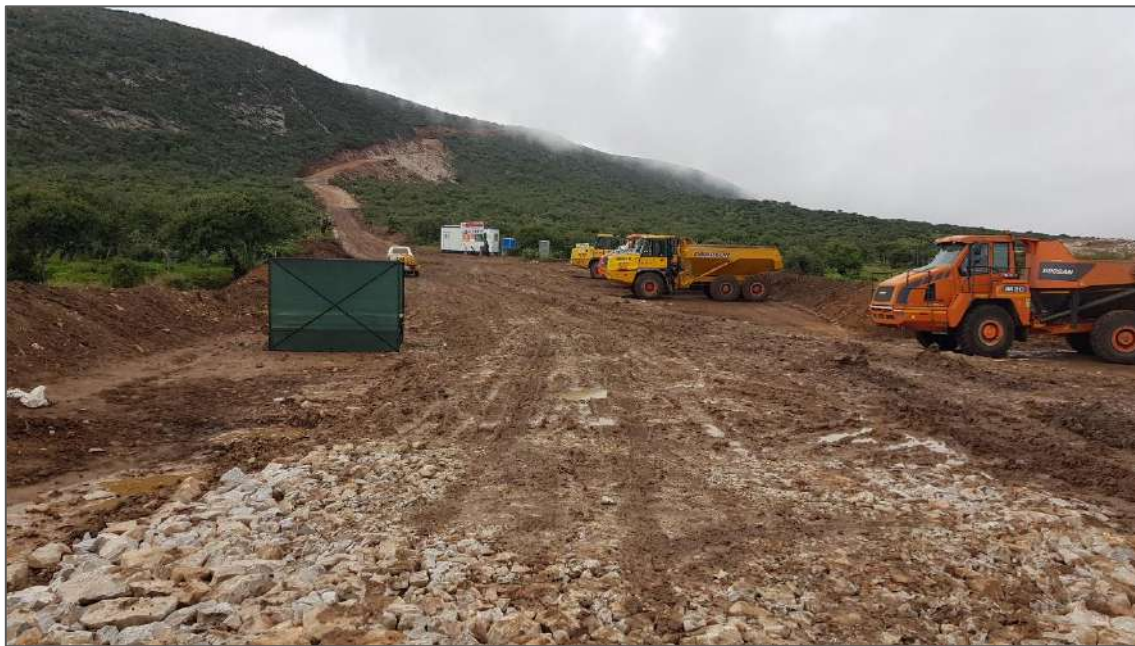
Measures are being implemented to alleviate excess stormwater on site including installing large rock material to aid with water filtration.

**Figure 4:** Measure being implemented to assist in drainage at the laydown area.

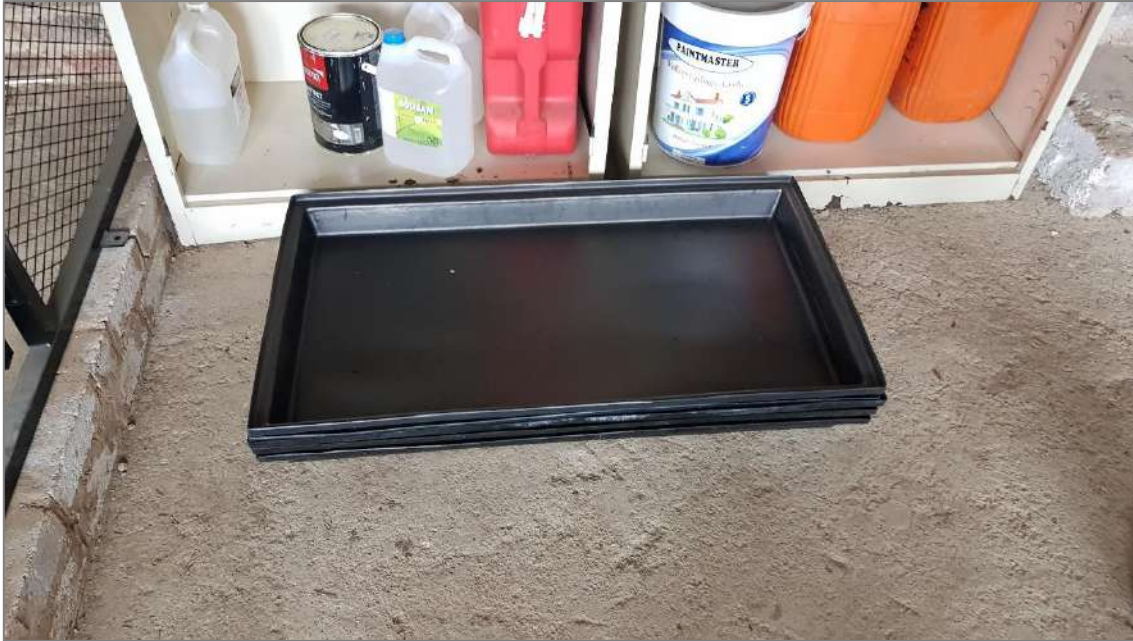
Drip trays have been distributed to each vehicle operator to be kept with dedicated vehicles for use.

**Figure 6:** Extra drip trays for use on site.

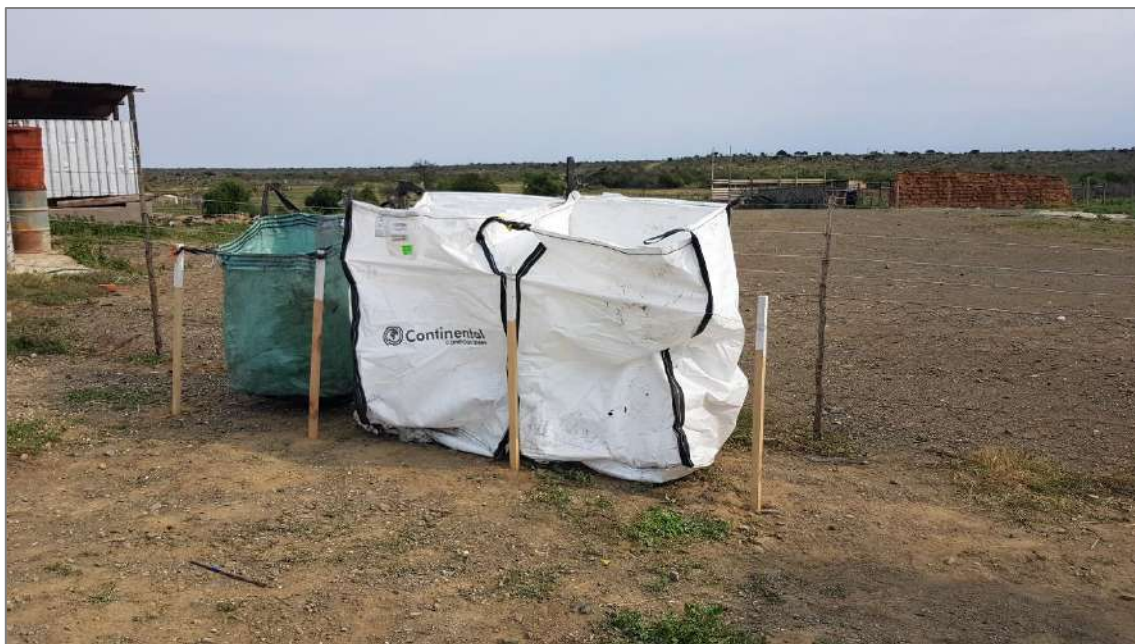
**Figure 1:** Waste collection sacks have been placed on site for all recyclable waste types.

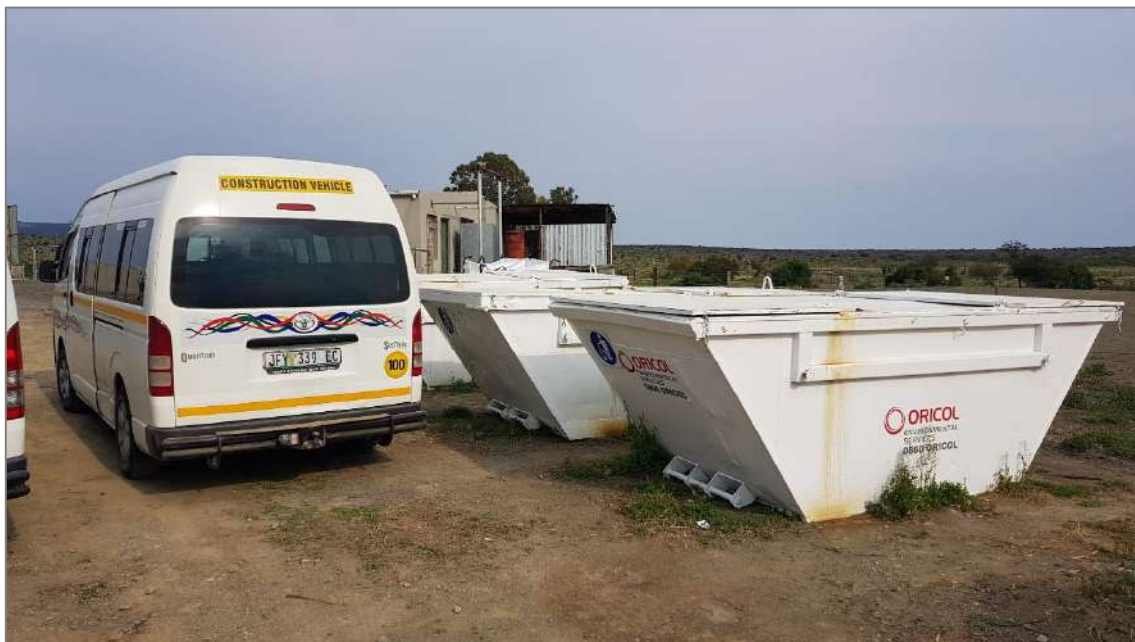
**Figure 2:** Access to waste skip impeded.

The contractor must always ensure that access to the waste skips area unimpeded with the exception of any trucks having to remove waste off site.

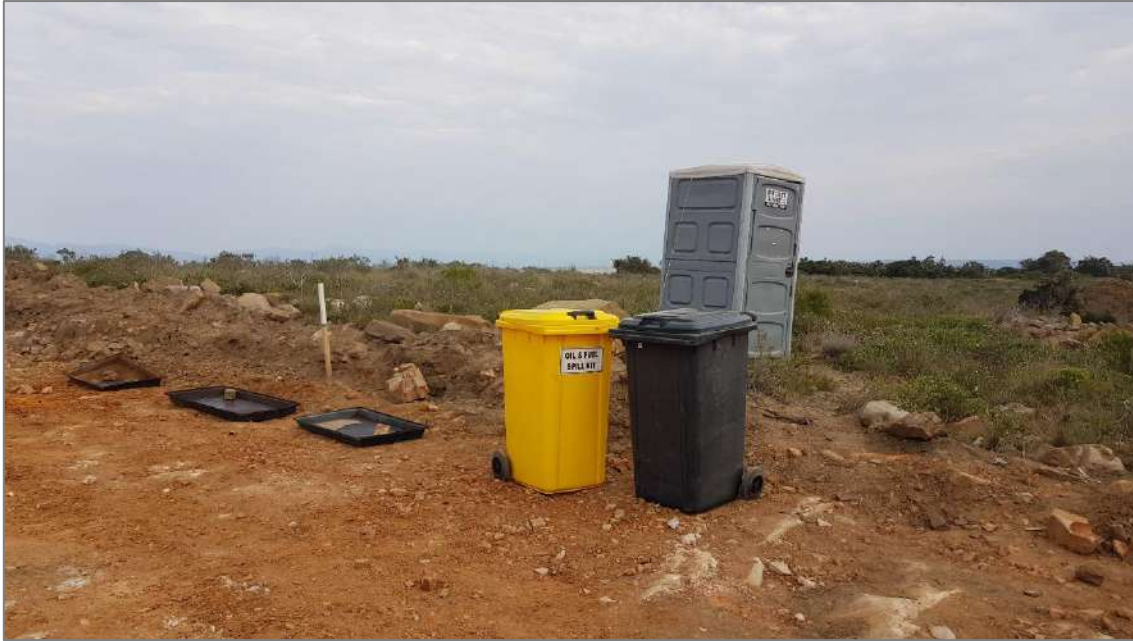
Drip trays continue to be distributed to each vehicle operator to be kept with dedicated vehicles for use.

**Figure 3:** Spill kit and drip trays on site.

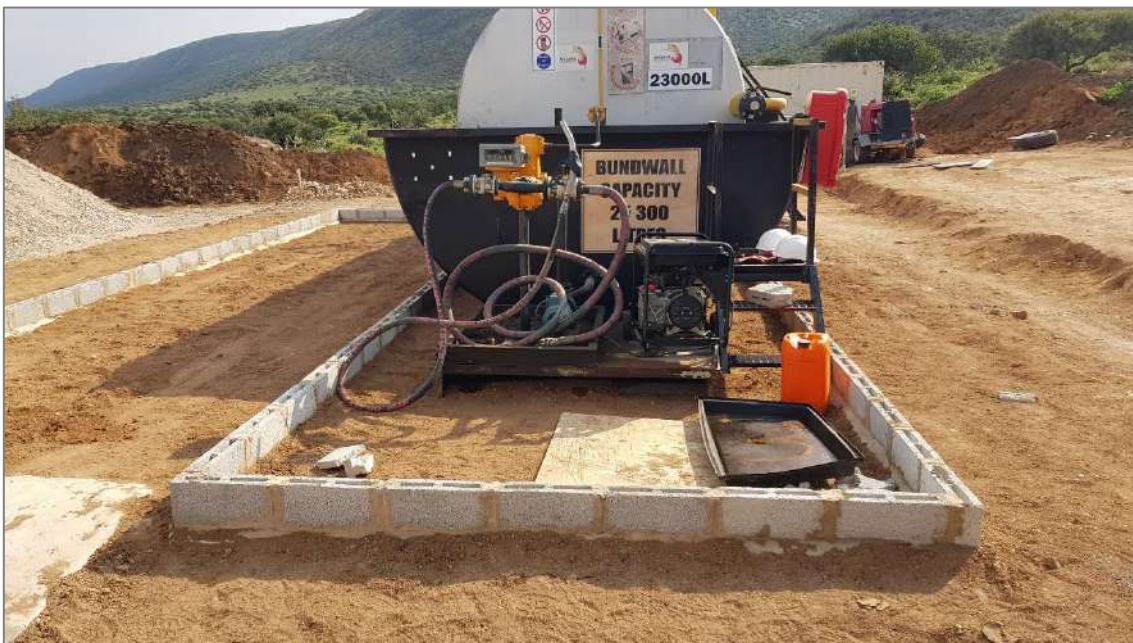
**Figure 4:** Self banded fuel storage with additional measure.

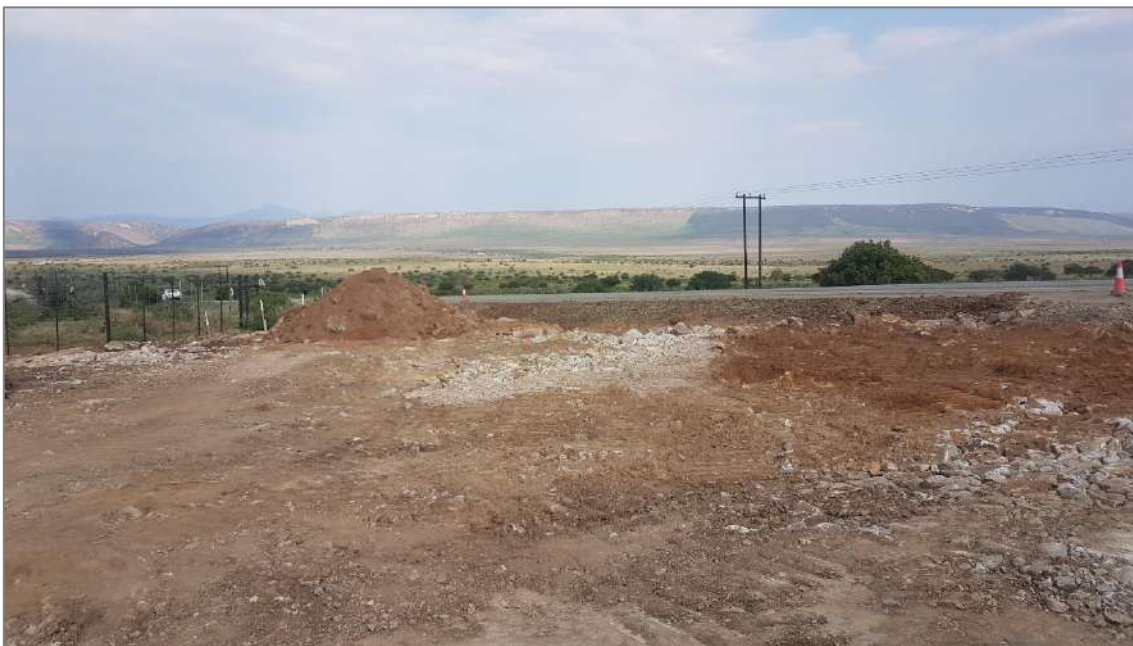
Work commenced on the main access point from the R75.

**Figure 5:** Widening of main access point for WEF at R75.

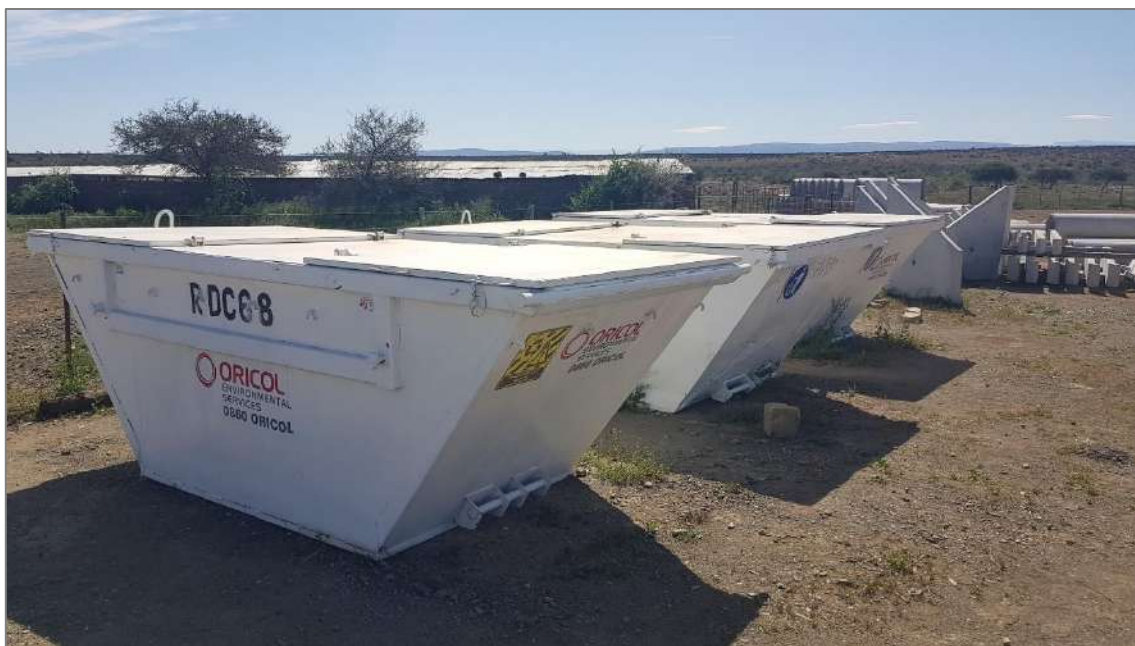
A designated waste area is located at the site offices which consists of two (2) skips labelled for the general waste. The waste area was observed in good working order, neat and clean.

**Figure 1:** Waste management area neat and clean.

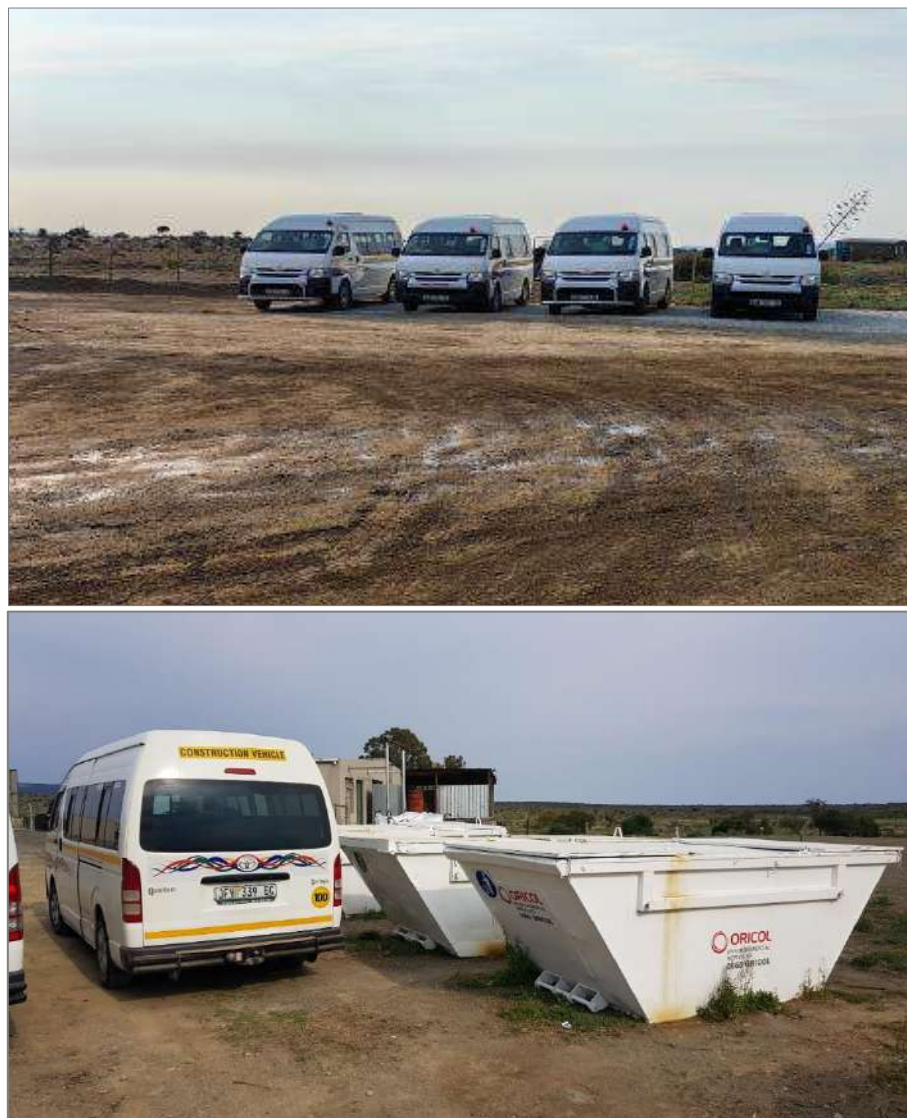
During the July site visit people transporters were observed to be obstructing access to the waste management area. The Contractor set aside and established a dedicated parking area for vehicles to ensure vehicles do not obstruct access to the waste management area.

**Figure 2:** Vehicles obstructing access to skips (Bottom); Dedicated parking area (Top).

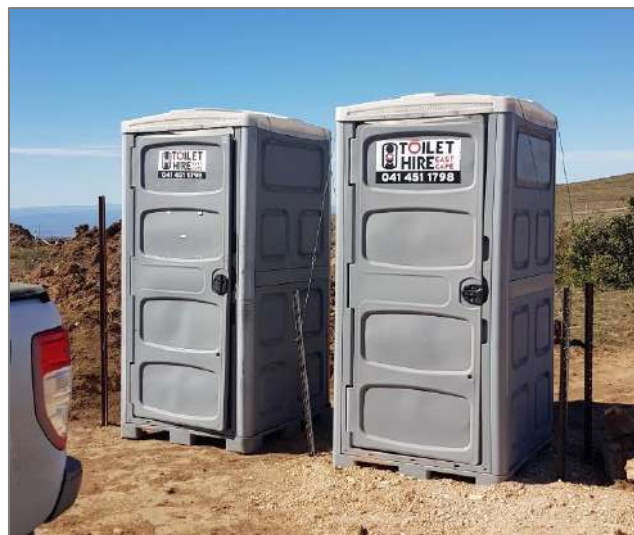
Mobile portable toilets are made available on site and are serviced weekly. Disposal and transport permits are available on site. Wastewater is disposed of at Fishwater flats disposal facility. The ESCO has requested that additional mobile toilets be provided for the working area. Mobile toilets are serviced once a week, or as and when required.

**Figure 3:** Mobile toilets tied down.

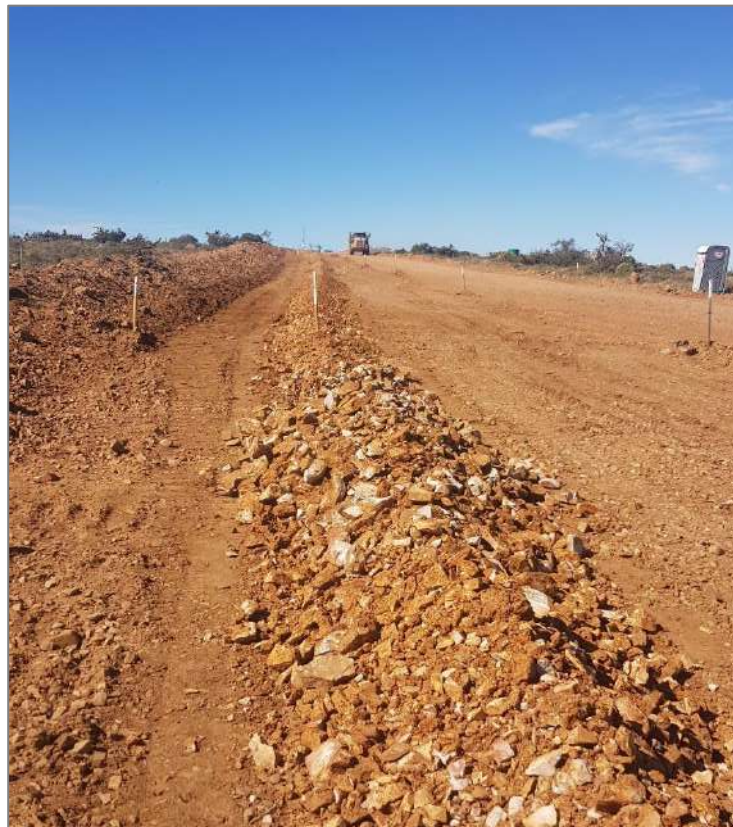
V drains have been installed adjacent to internal access roads.

**Figure 4:** V Drain installed for water run off management.

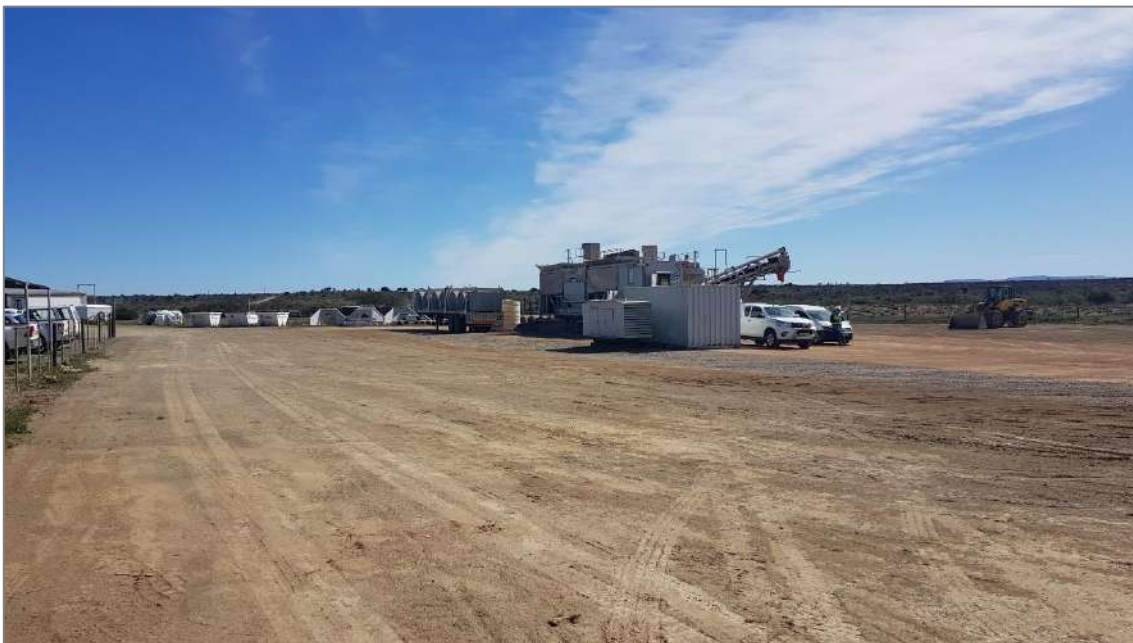
A mobile batch plant is being established adjacent to the site offices.

**Figure 5:** Mobile batch plant

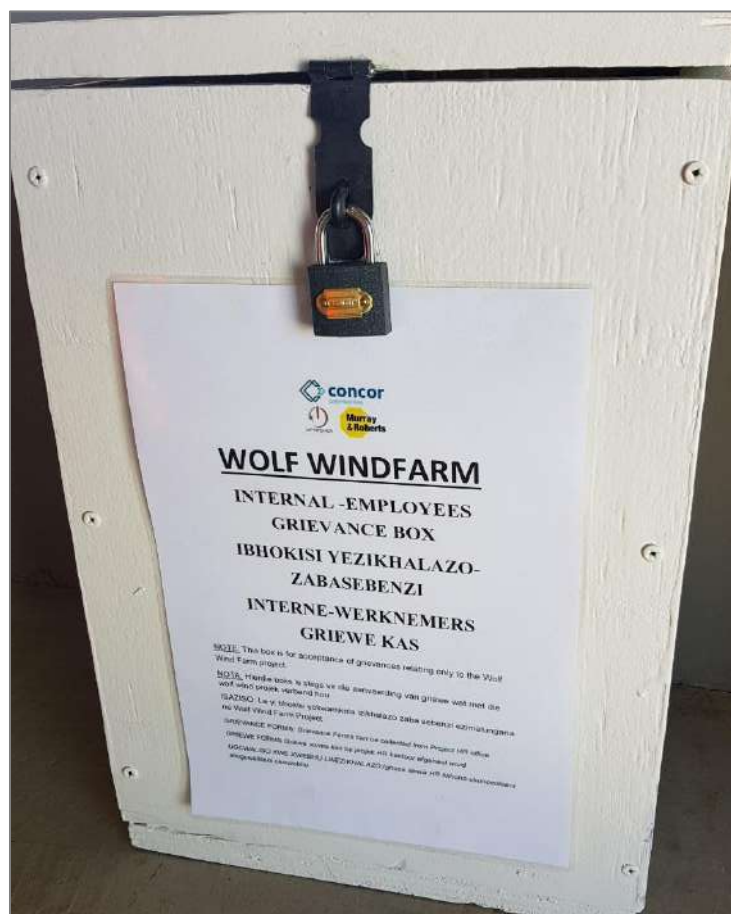
A box for receiving internal grievances was observed on site. This allows project staff to bring to the attention of the project manager any particular comments and or concerns.

**Figure 6:** Internal grievance box

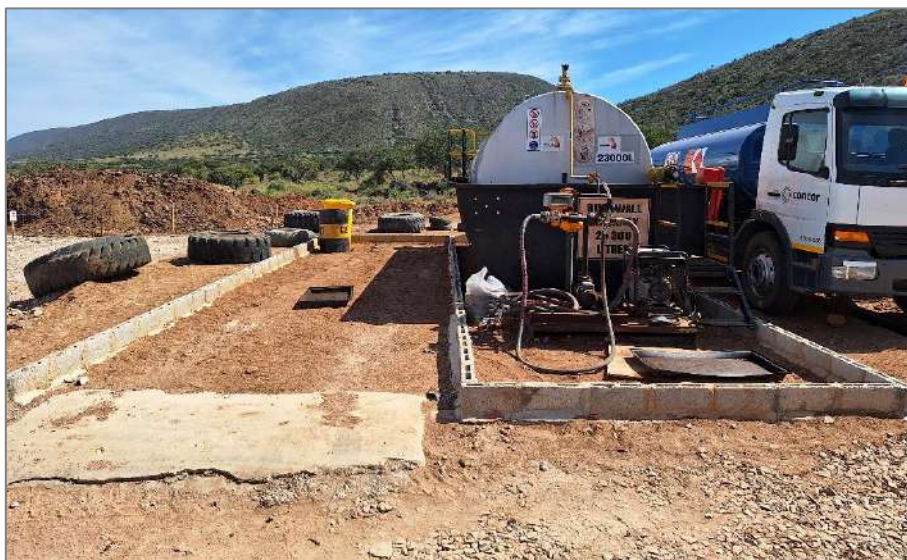
**Figure 1:** Self bunded bulk fuel with additional bunding measures in place.
