# Monthly Environmental ECO Monitoring Report

Wolf Wind Energy Facility

Western Cape

February 2023

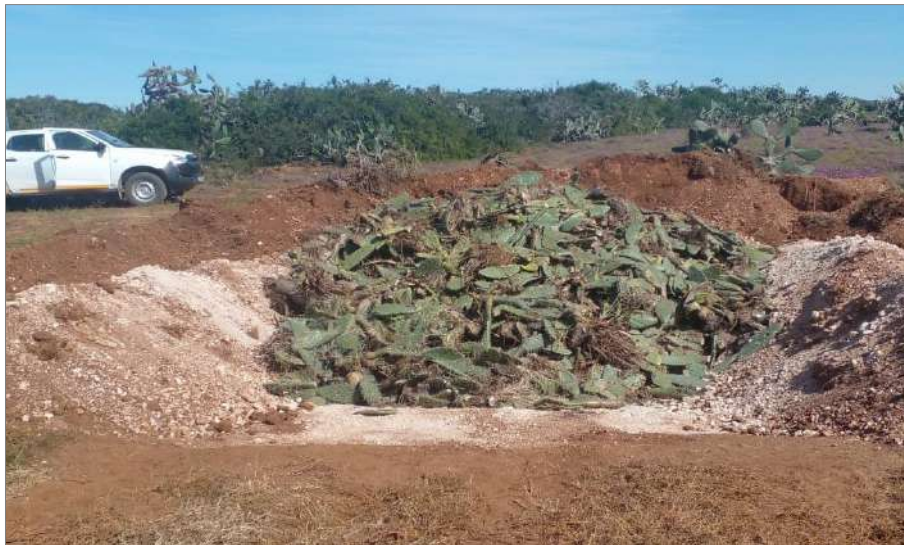
Any alien invasive species removed from the working area are stored in a dedicated area on site to dry and die out. The contractor intends to propose the burning of alien invasive cuttings on site to reduce the risk of spreading seed during transit. Any burning would be conducted under strict conditions and procedures as approved by the ESCO and reviewed by the ECO.

**Figure 2:** Stockpiling of removed prickly pear for eradication. (Billing, 2023)

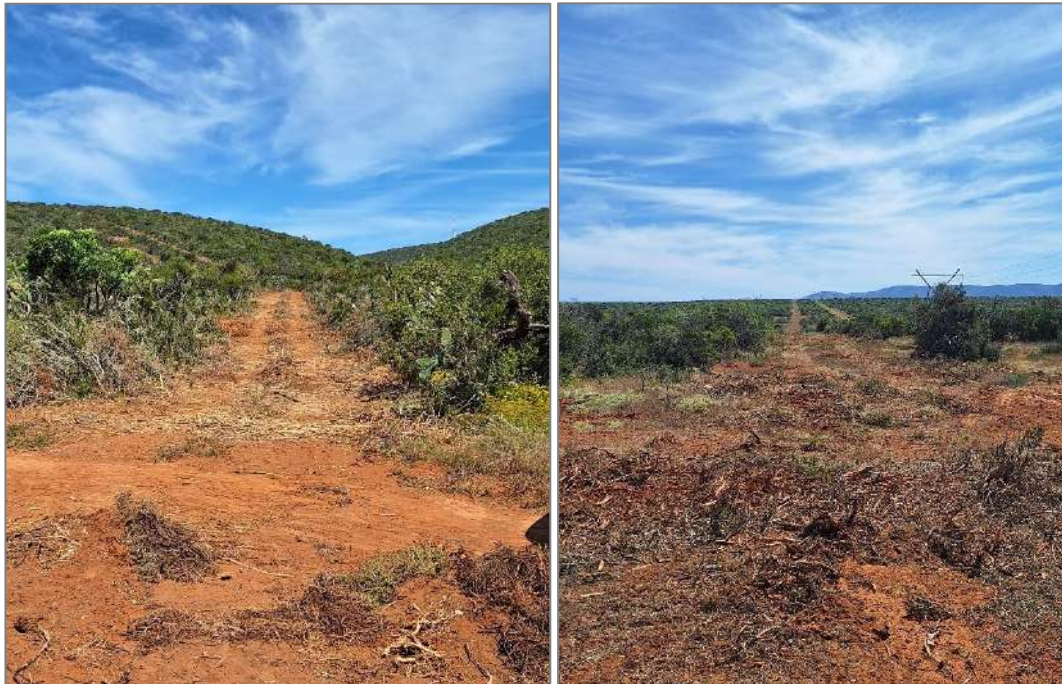
Access routes for the OHPL continues during this period.

**Figure 3:** New two track servitude road for OHPL.

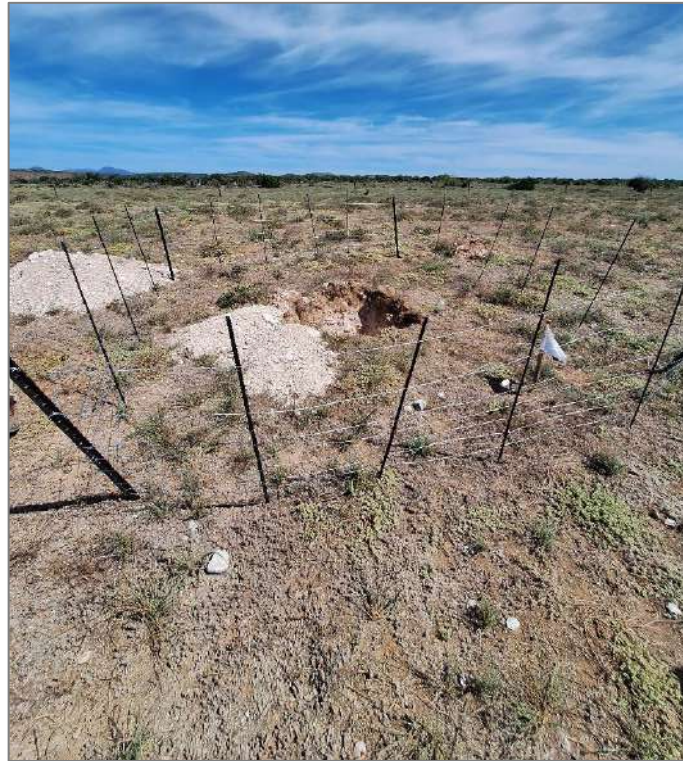
Barricading is erected around open excavations on site. Daily inspections have been requested by the ESCO on site.

**Figure 4:** Barricading located round OHPL excavations.

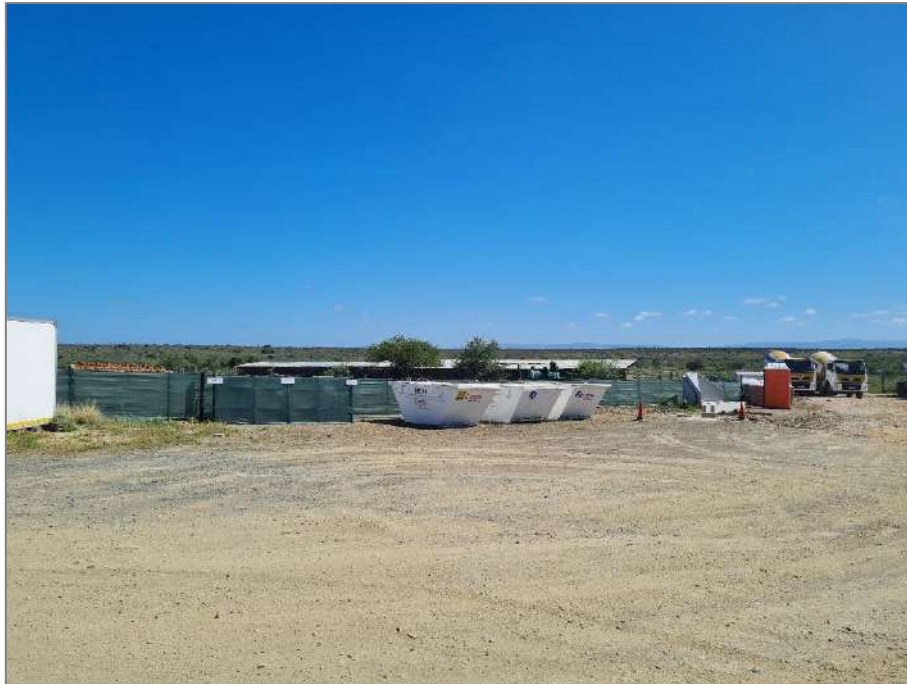
The Contractor has set aside and established a dedicated parking area for vehicles to ensure vehicles do not obstruct access to the waste management area.

**Figure 1:** Separated waste management area

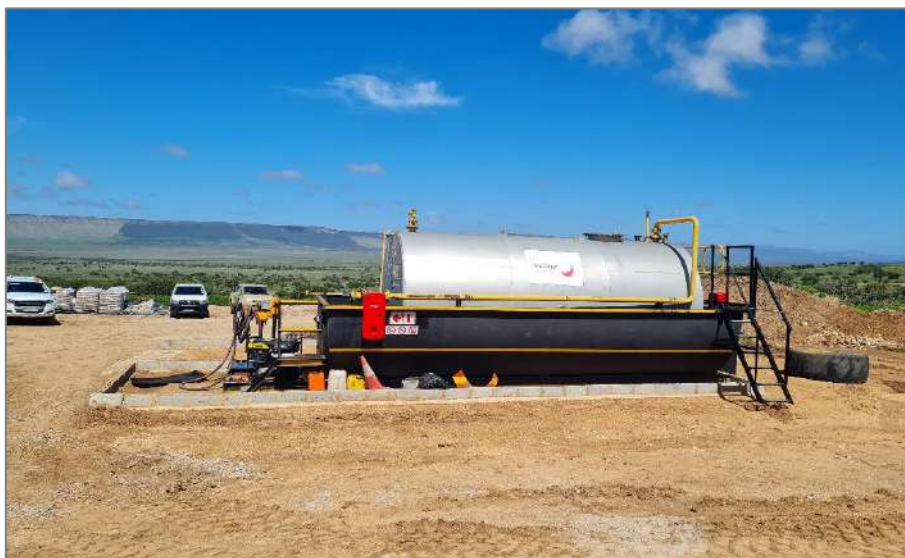
**Figure 2:** Bunded Bulk fuel storage area

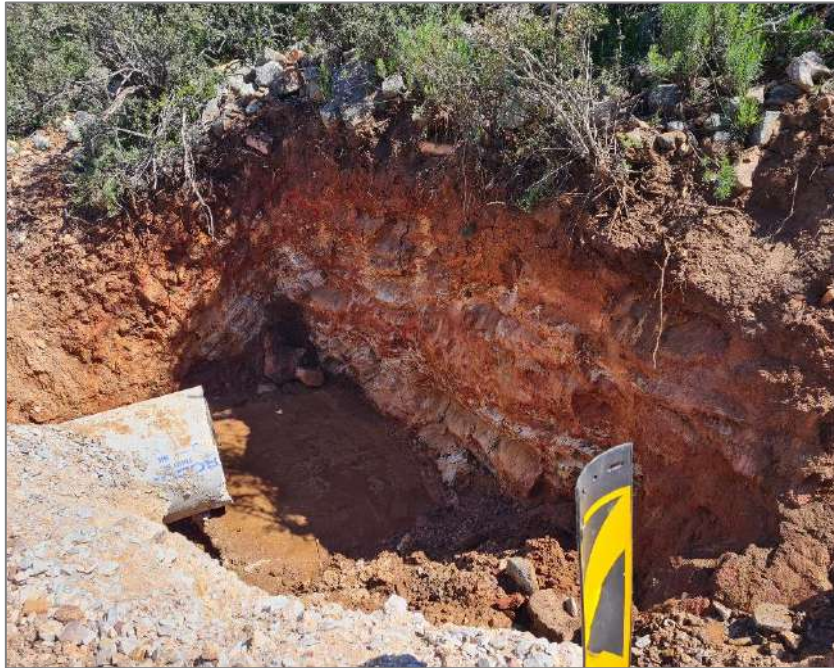
**Figure 3:** Culvert installation on the main access route.

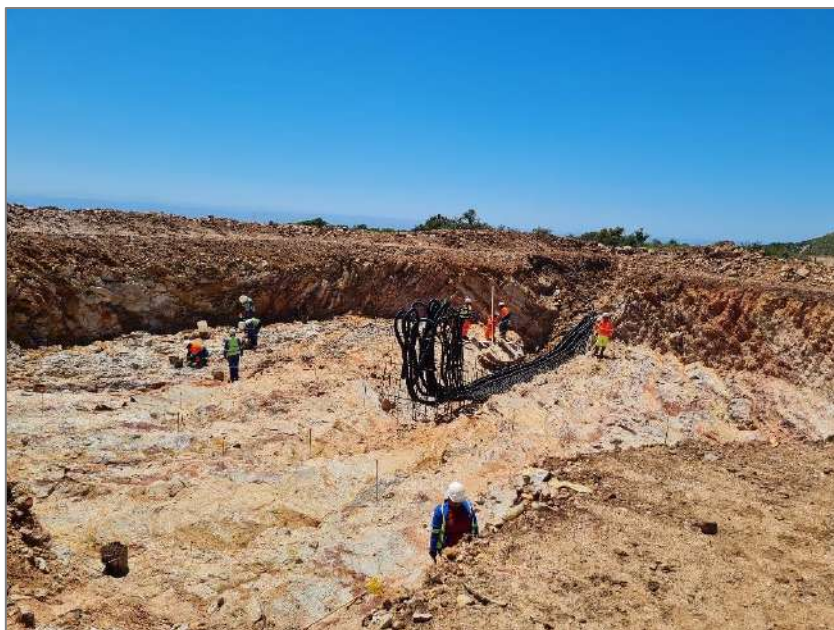
**Figure 4:** Cleaning of base excavations

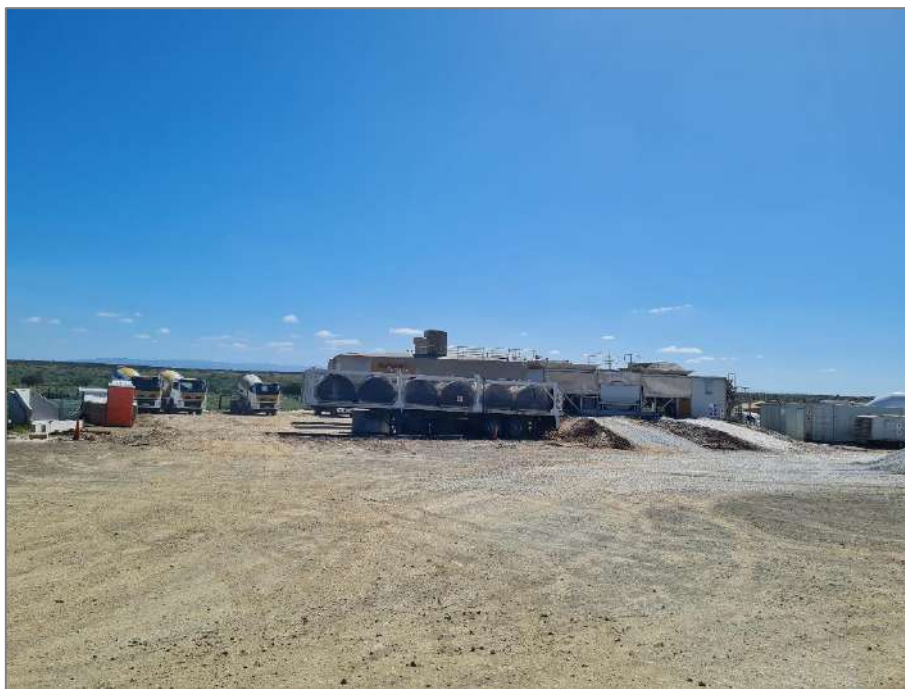
A mobile batch plant has been established adjacent to the site offices and is currently operational.

**Figure 5:** Operational mobile batch plant

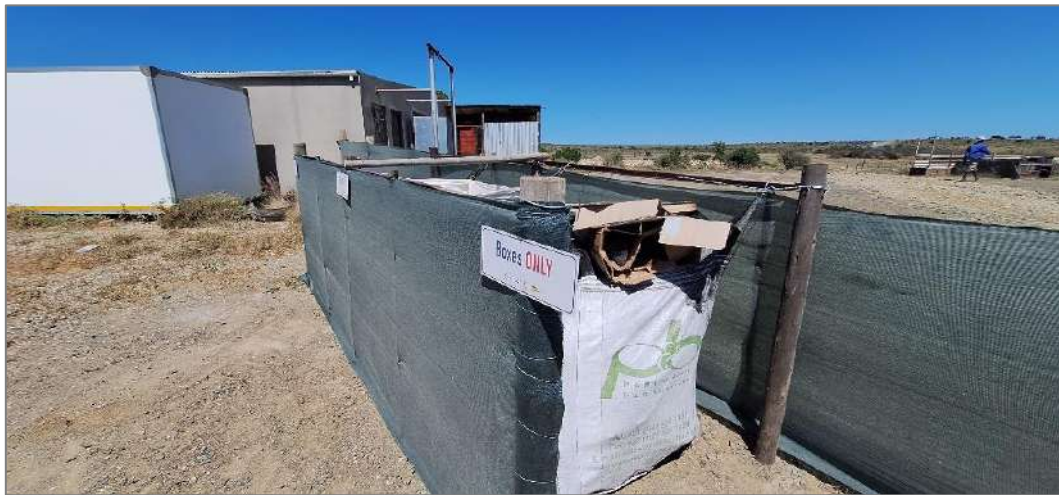
**Figure 1:** Separated waste management area

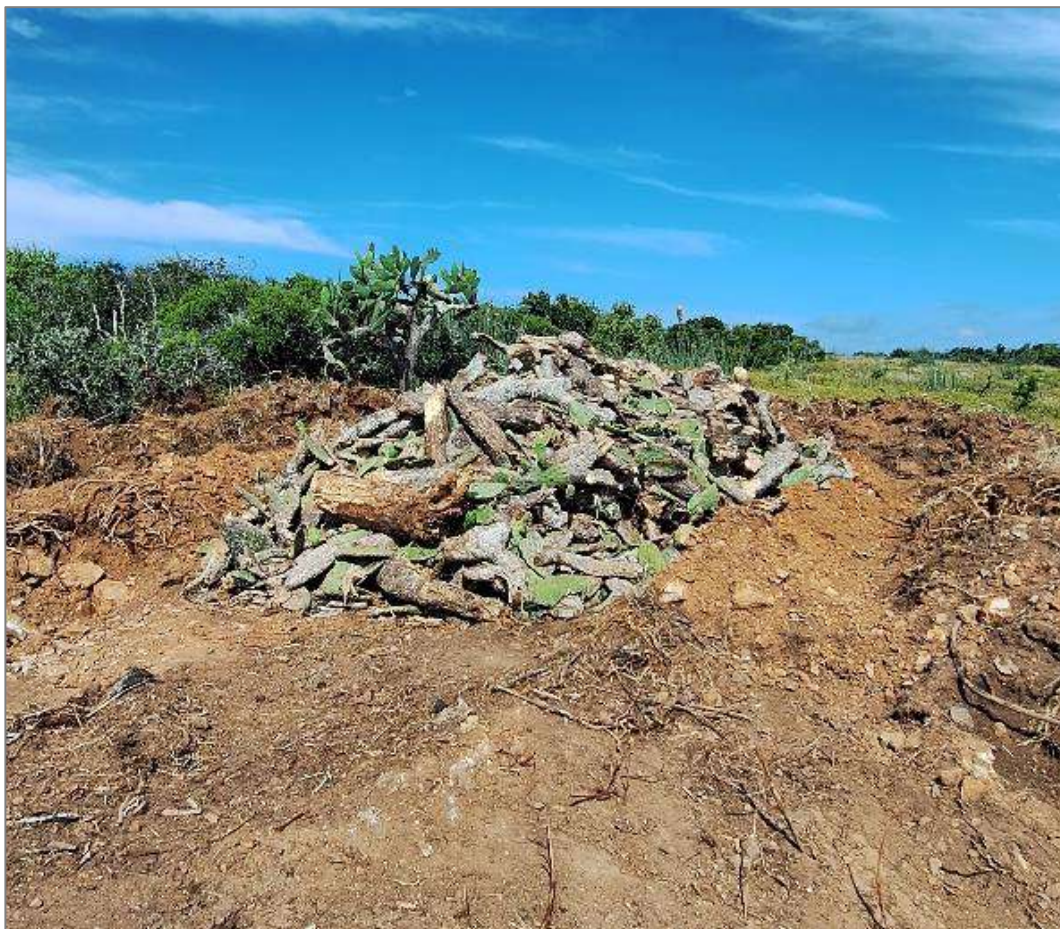
Any alien invasive species removed from the working area are stored in a dedicated area on site to dry and die out. The contractor intends to propose the burning of alien invasive cuttings on site to reduce the risk of spreading seed during transit. Any burning would be conducted under strict conditions and procedures as approved by the ESCO and reviewed by the ECO. The method statement has been submitted for approval.

**Figure 2:** Prickly Pear Stacked

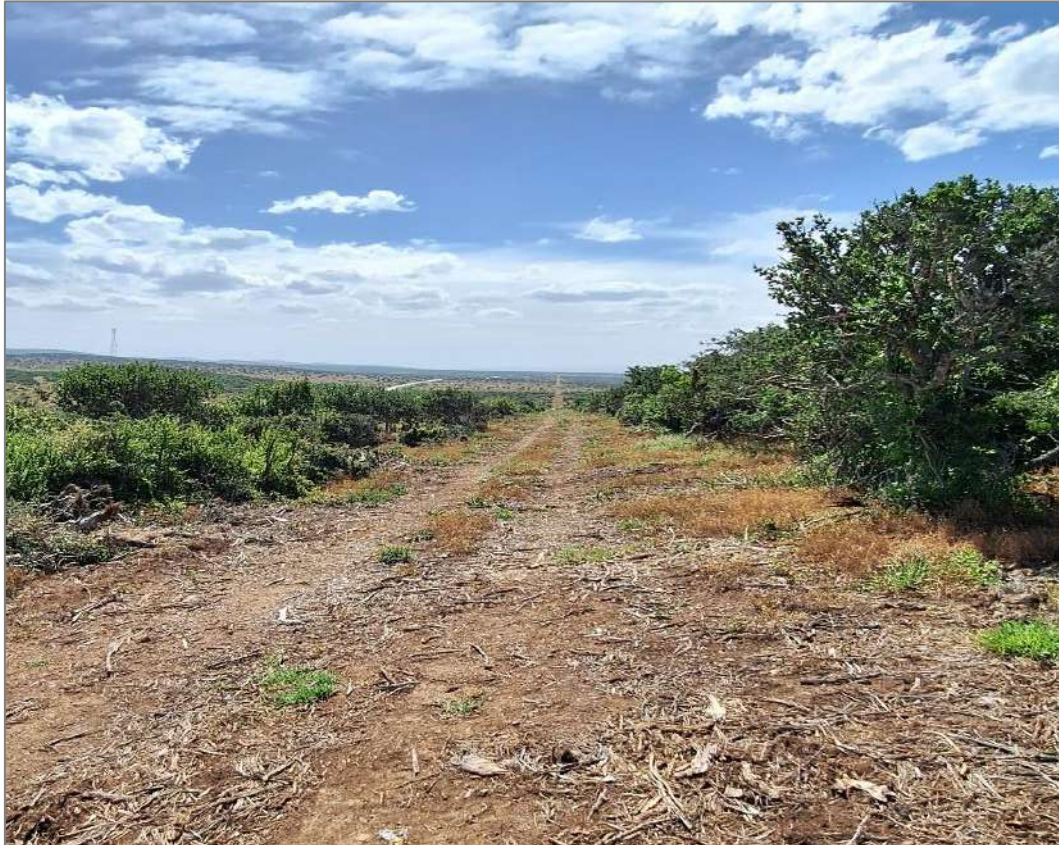
Bulk earthworks continue on roads and platforms, this includes cut to fill activities. Cleaning of base excavations continue, with concrete blinding having started. Trenching for MV cables and culvert installations on the main access road continue. Vegetation clearing for the OHPL servitude and tower positions also continues.

**Figure 3:** Access Road established for OHPL

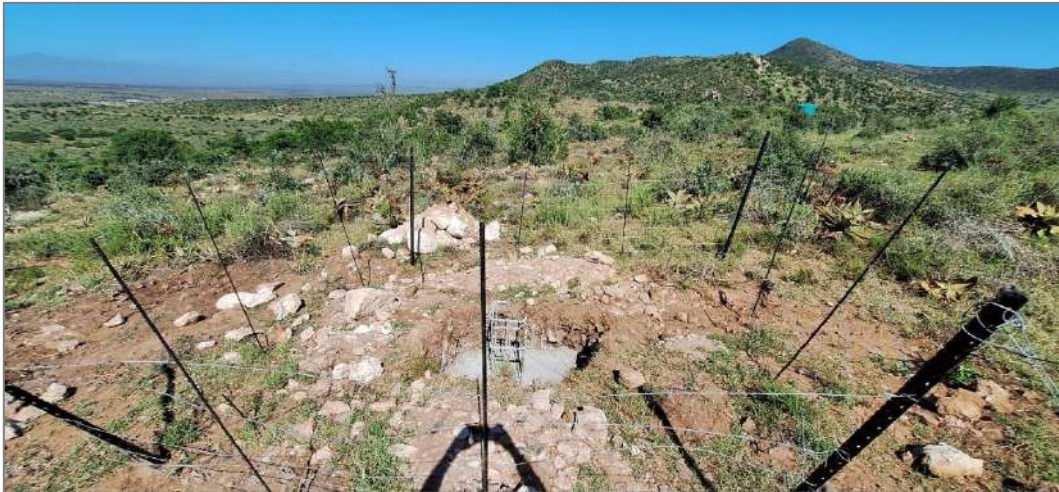
**Figure 4:** Open excavations barricaded.

Daily inspections have been requested by the ESCO on site.

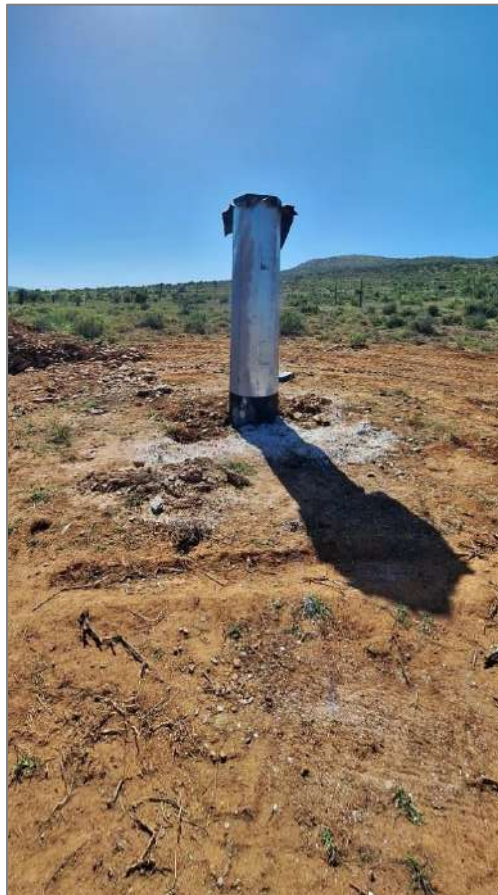
Installation of monopole bases and earth mat at the IPP Station has begun.

**Figure 5:** Monopole installation.

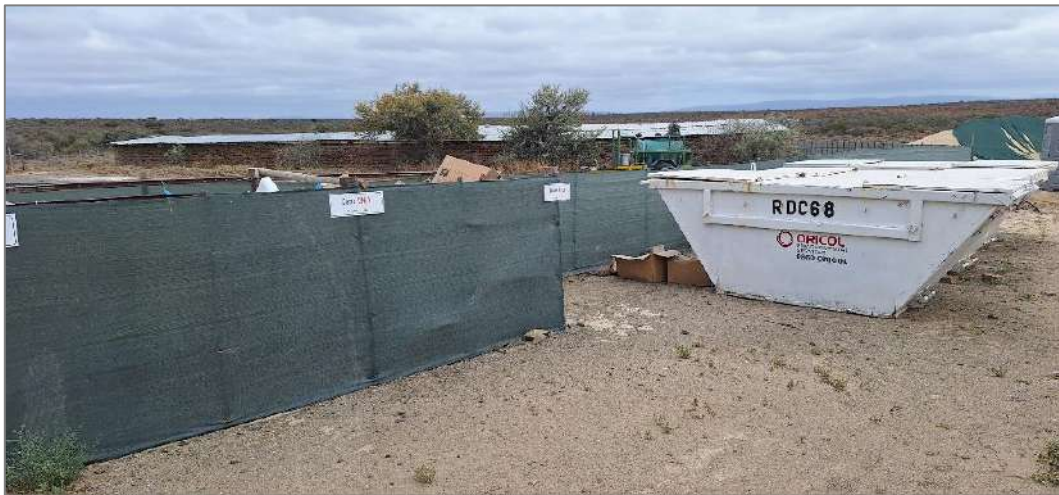
**Figure 1:** Separated waste management area

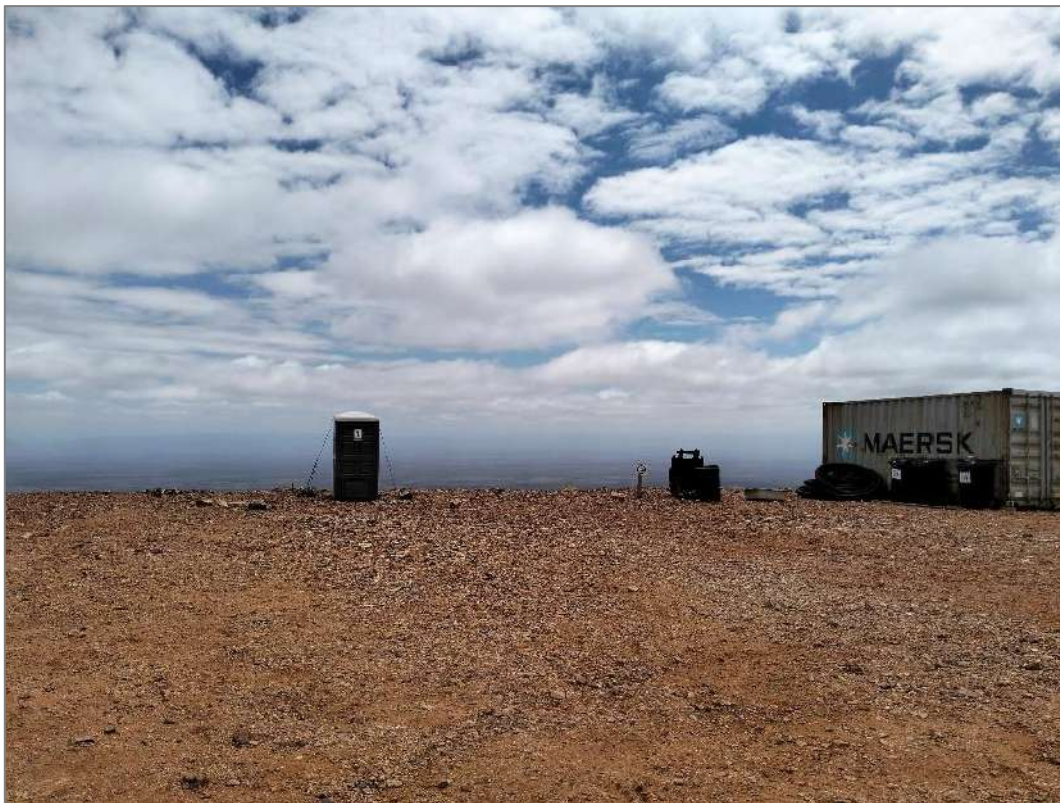
Smoking areas are available at workstations.

**Figure 2:** Smoking area and waste bins (WEA 07)

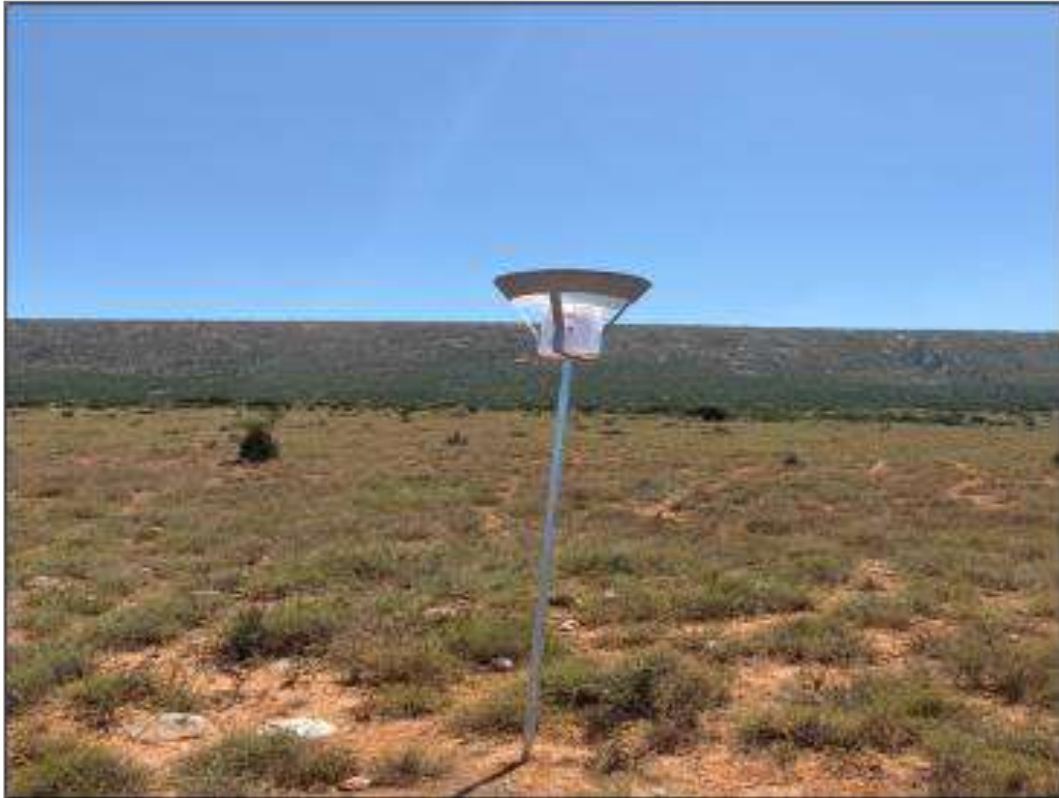
Dust buckets for monitoring were installed during this reporting period.

**Figure 3:** Dust bucket installed for dust monitoring. (C. Billing, 2023)

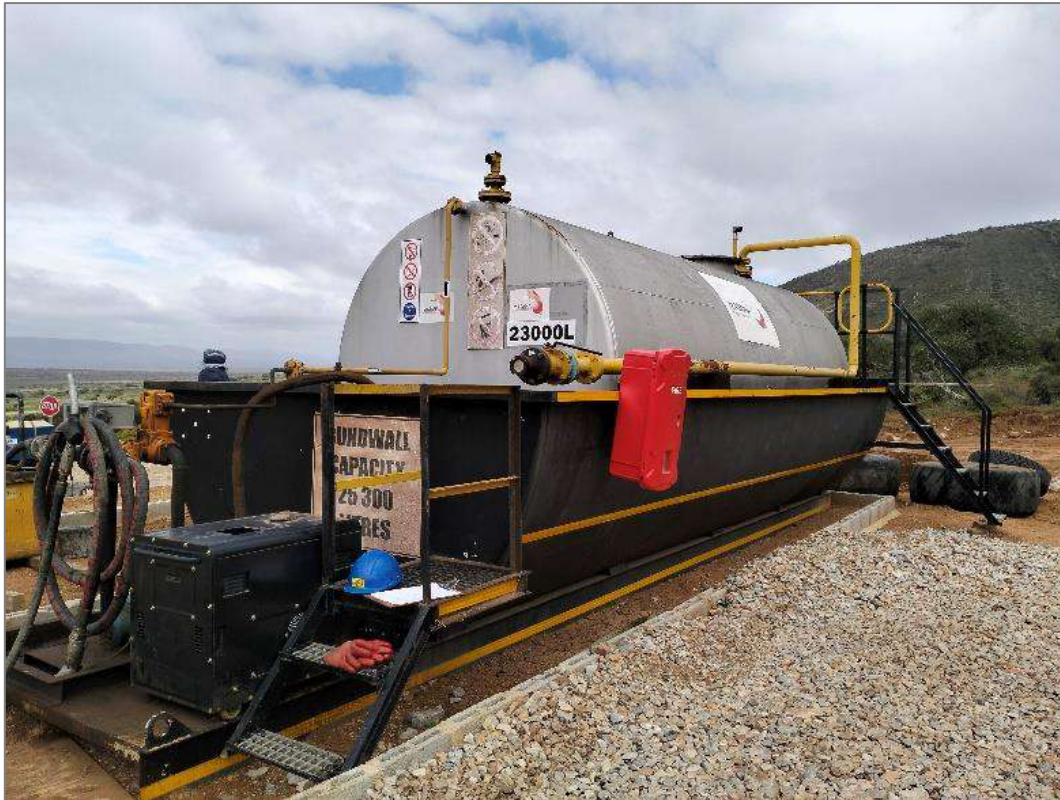
The storage area located at the site offices appears neat and clean.

**Figure 4:** Bulk fuel storage with additional bunding.

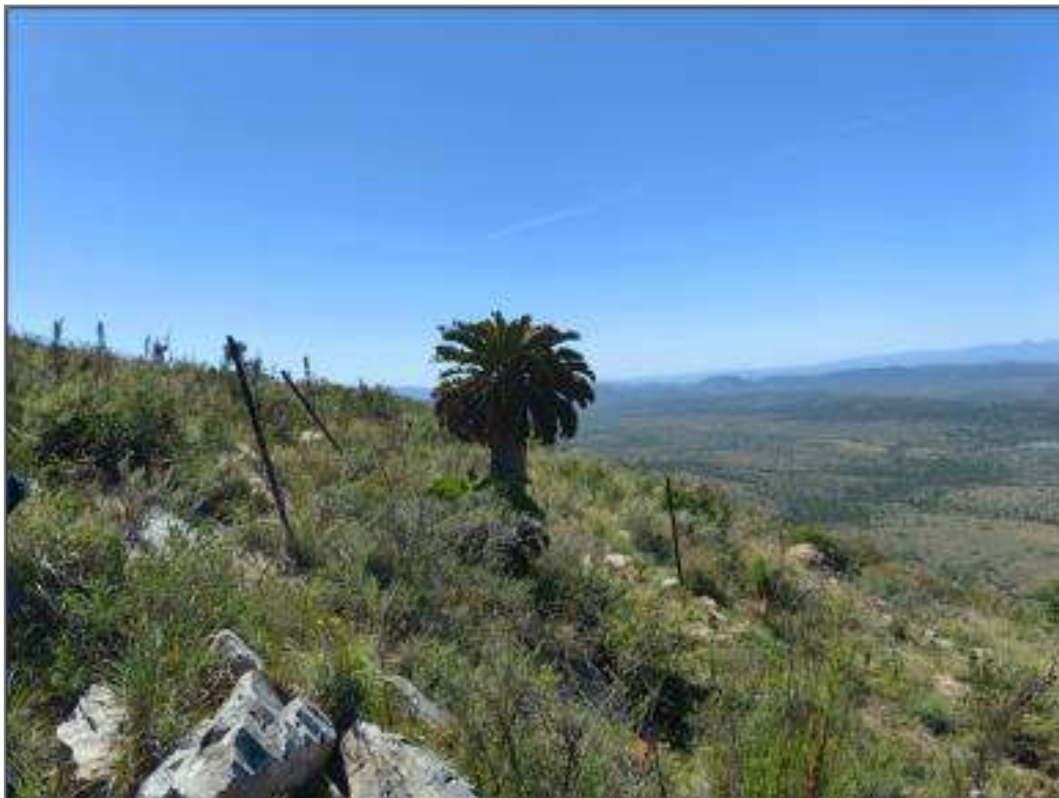
**Figure 5:** Cycads barricaded at WK61 (C. Billing, 2024)

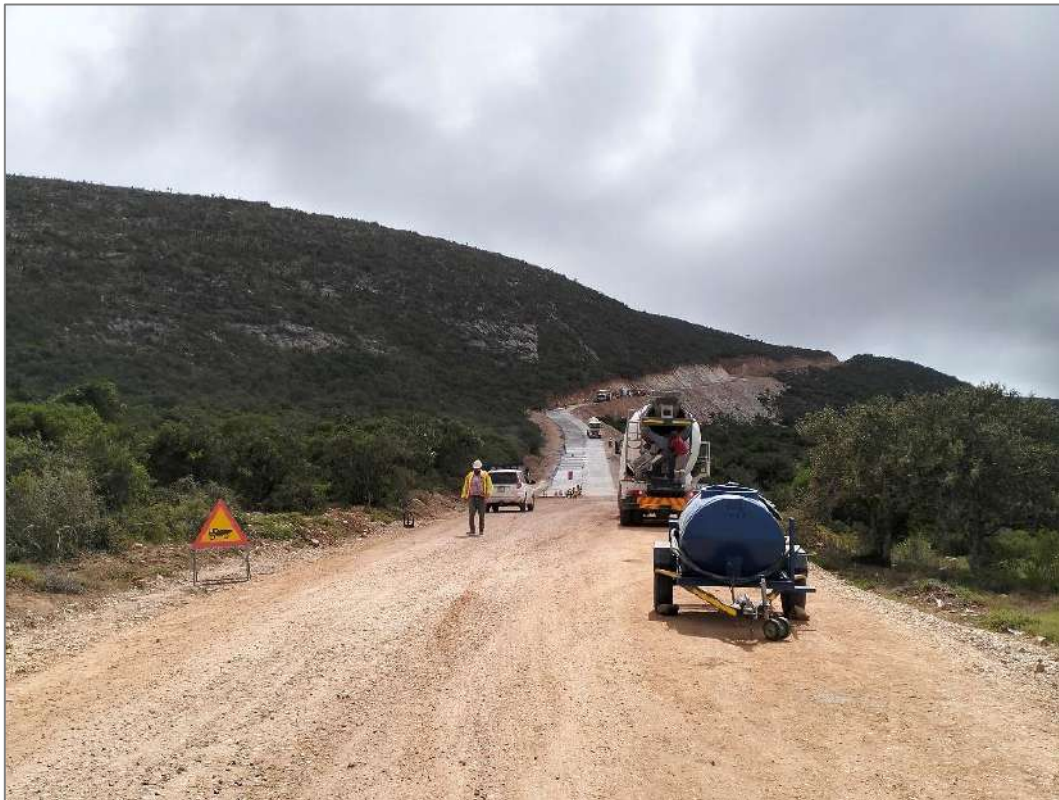
**Figure 6:** Concrete on the Main access road.

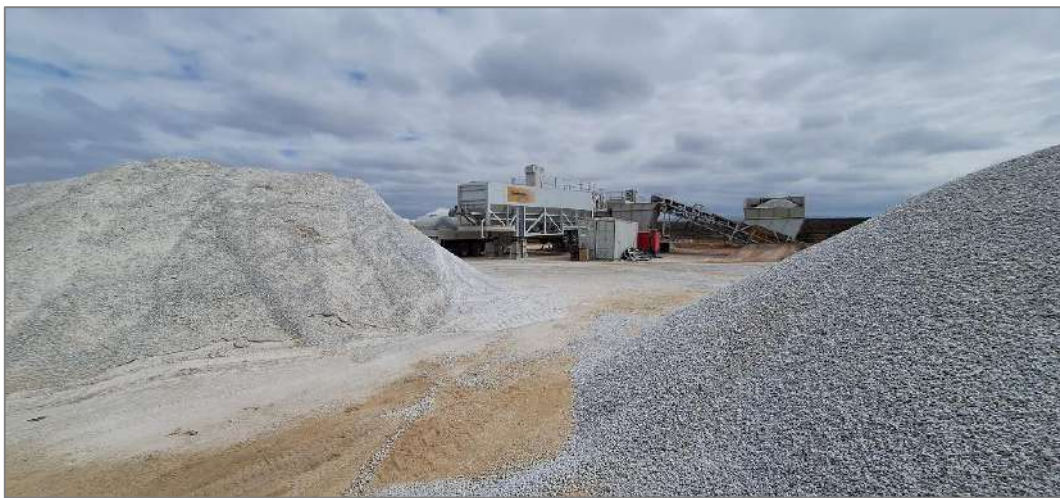
**Figure 7:** Operational batch plant.

It is advised that if repairs are going to be carried out on hired plant at the campsite platform, a concrete workshop surface with sump/oil separator will be required to prevent pollution.

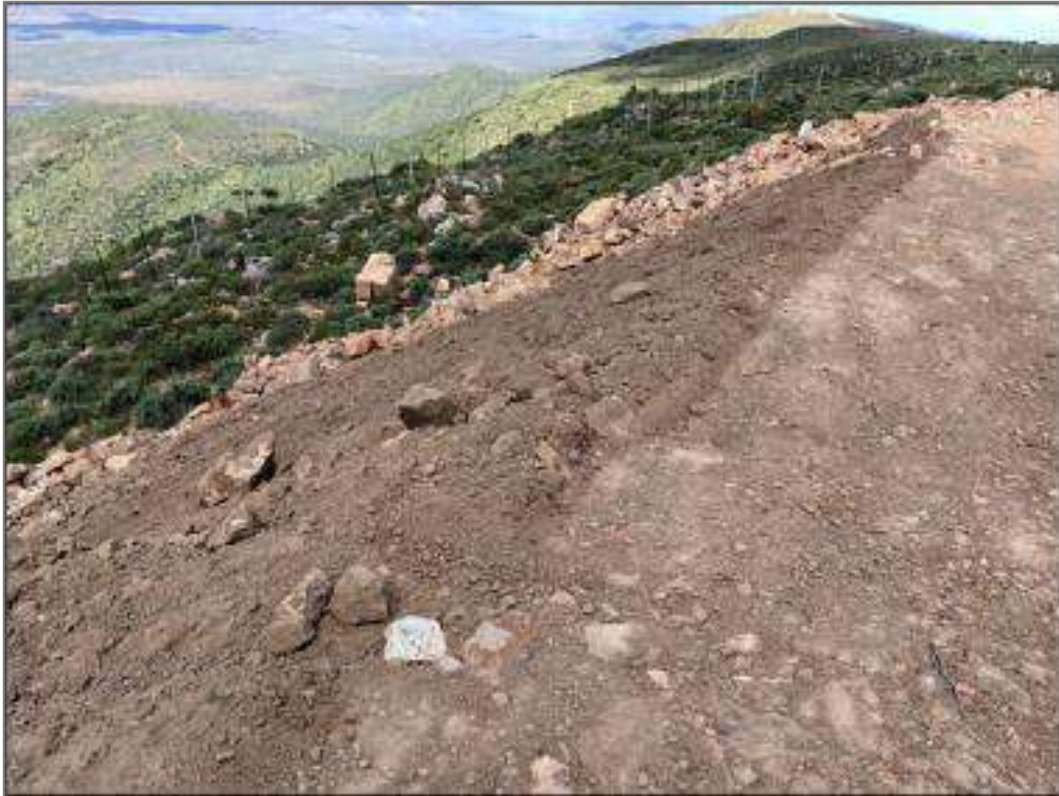
Rehabilitation has been started at WEA 09, with topsoil being placed on the slopes surrounding the hardstands.

**Figure 8:** Topsoil being placed on slopes for rehabilitation.
