ALGAE and CYANOBACTERIA in GREENE ACRES LAKE (2023)

M. Casteel

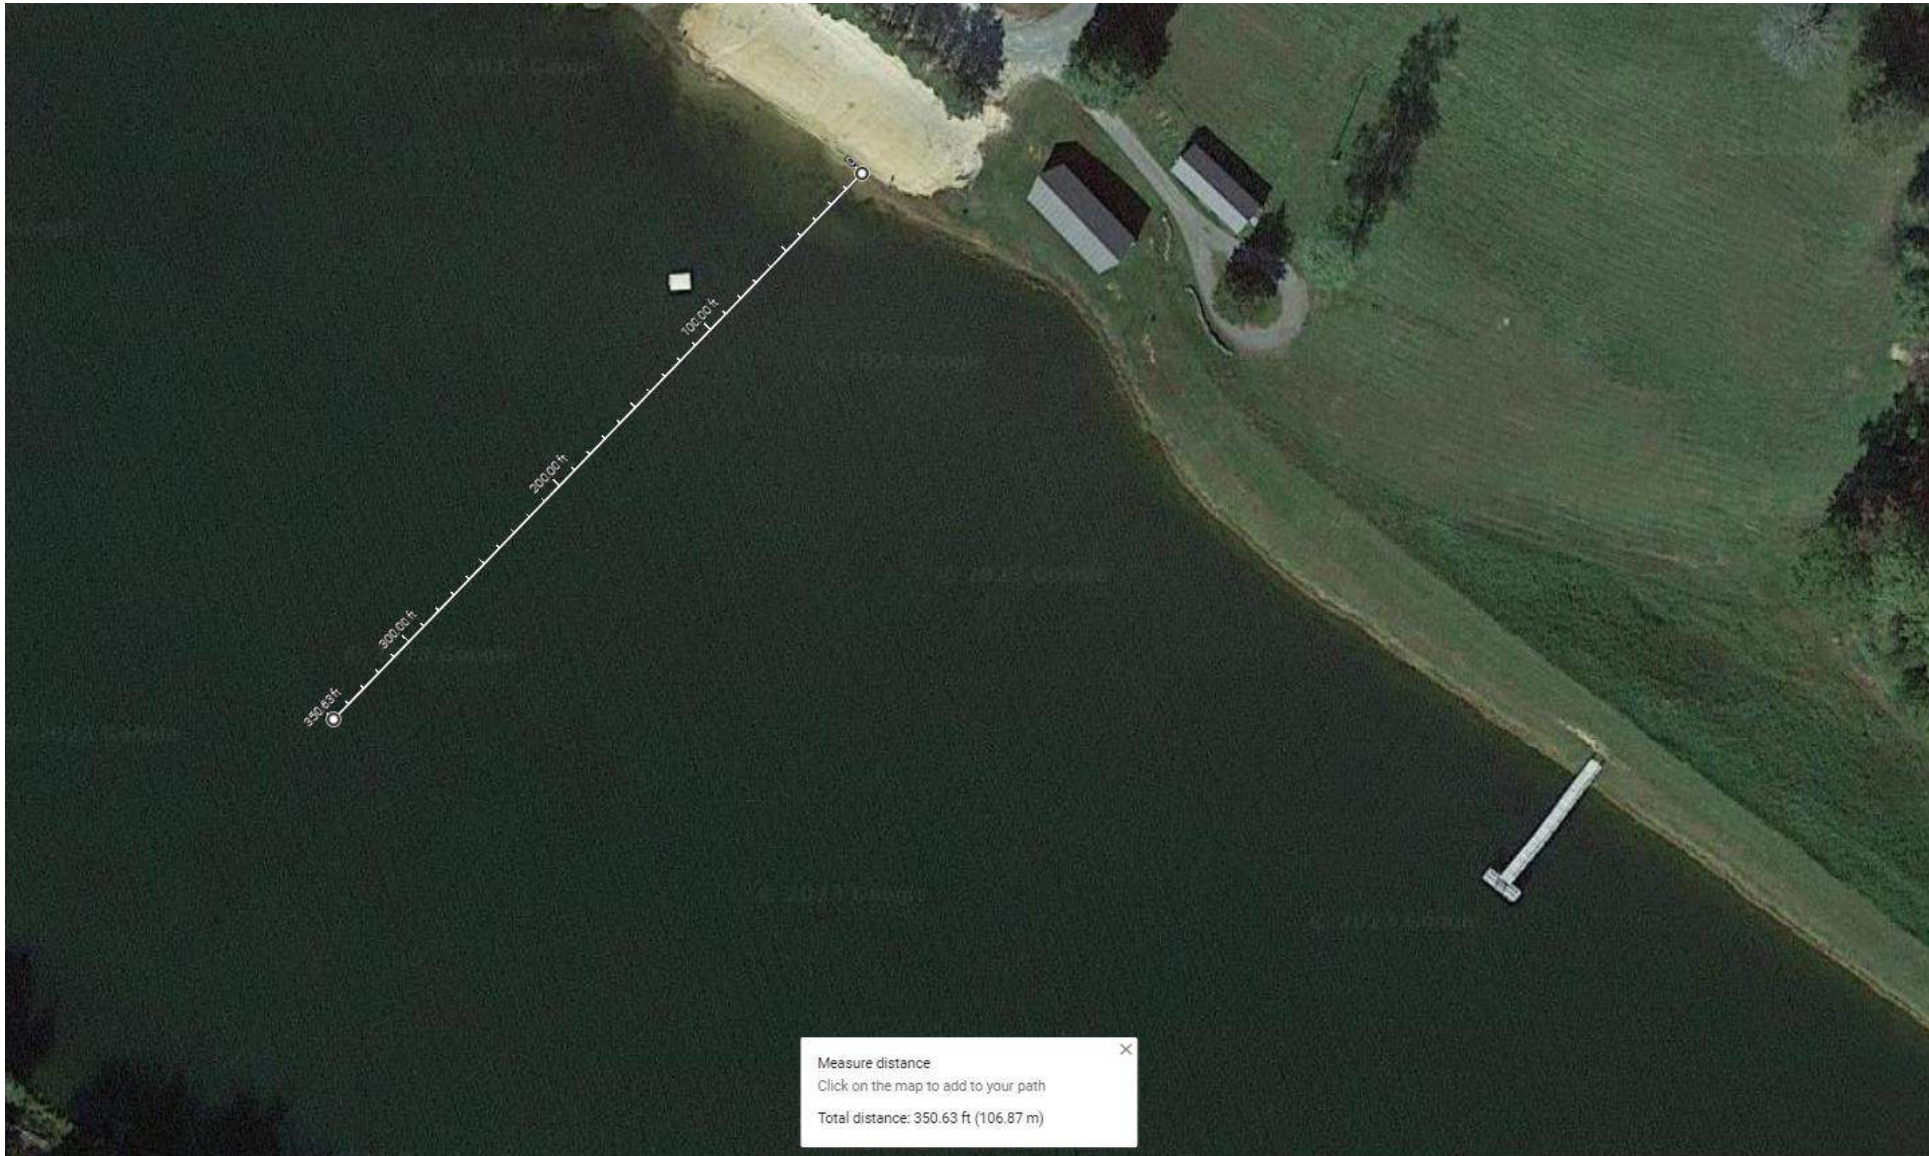
SITES 1-15

Each site is labeled A through F. "A" indicates shoreline (0') to 5', B = 15'; C=30'; D=45'; E=100' (swim platform); F=250'; G=350'. These are APPROXIMATE distances and can vary by Site.

This graphic shows the linear distance from the shoreline to the approximate midline transect of the lake

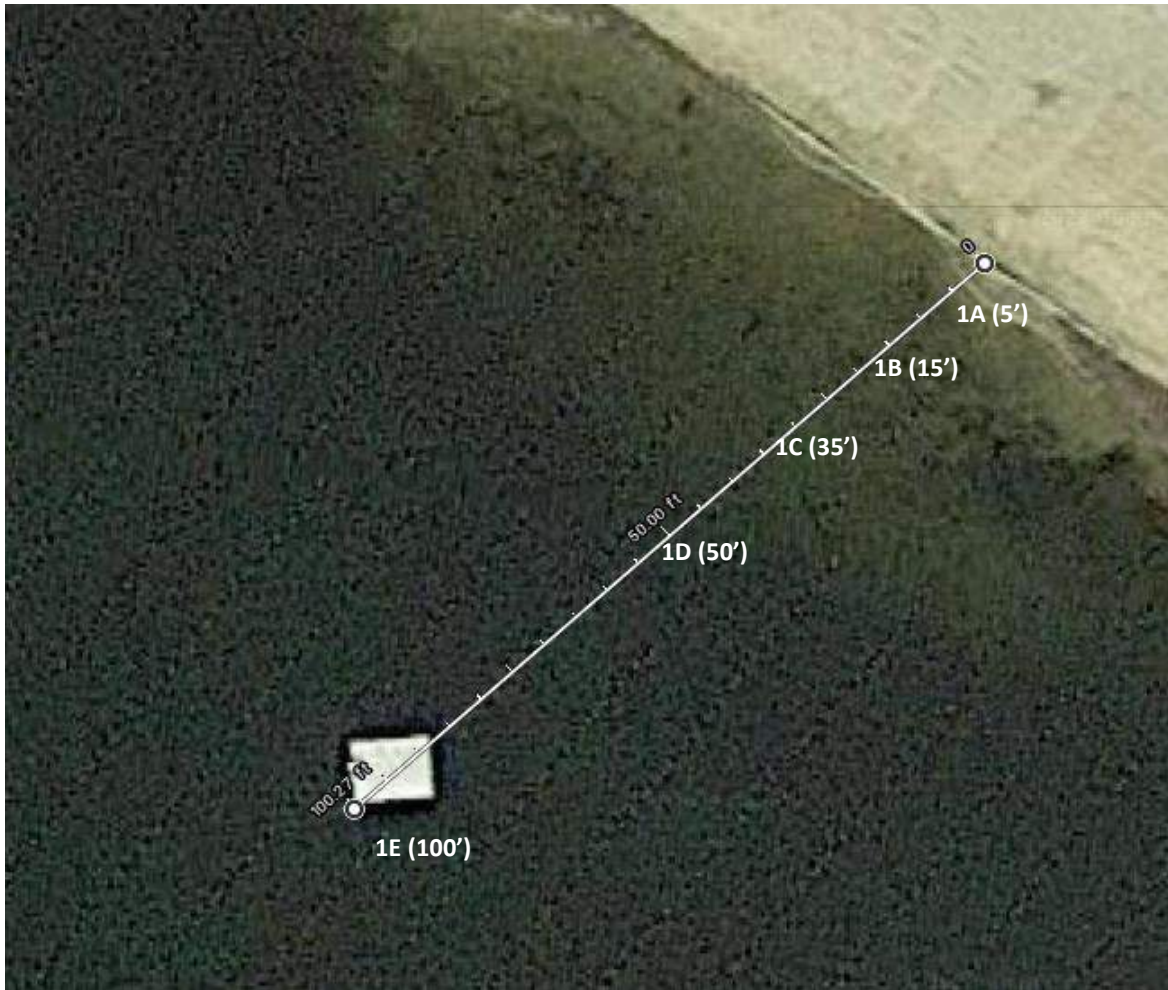
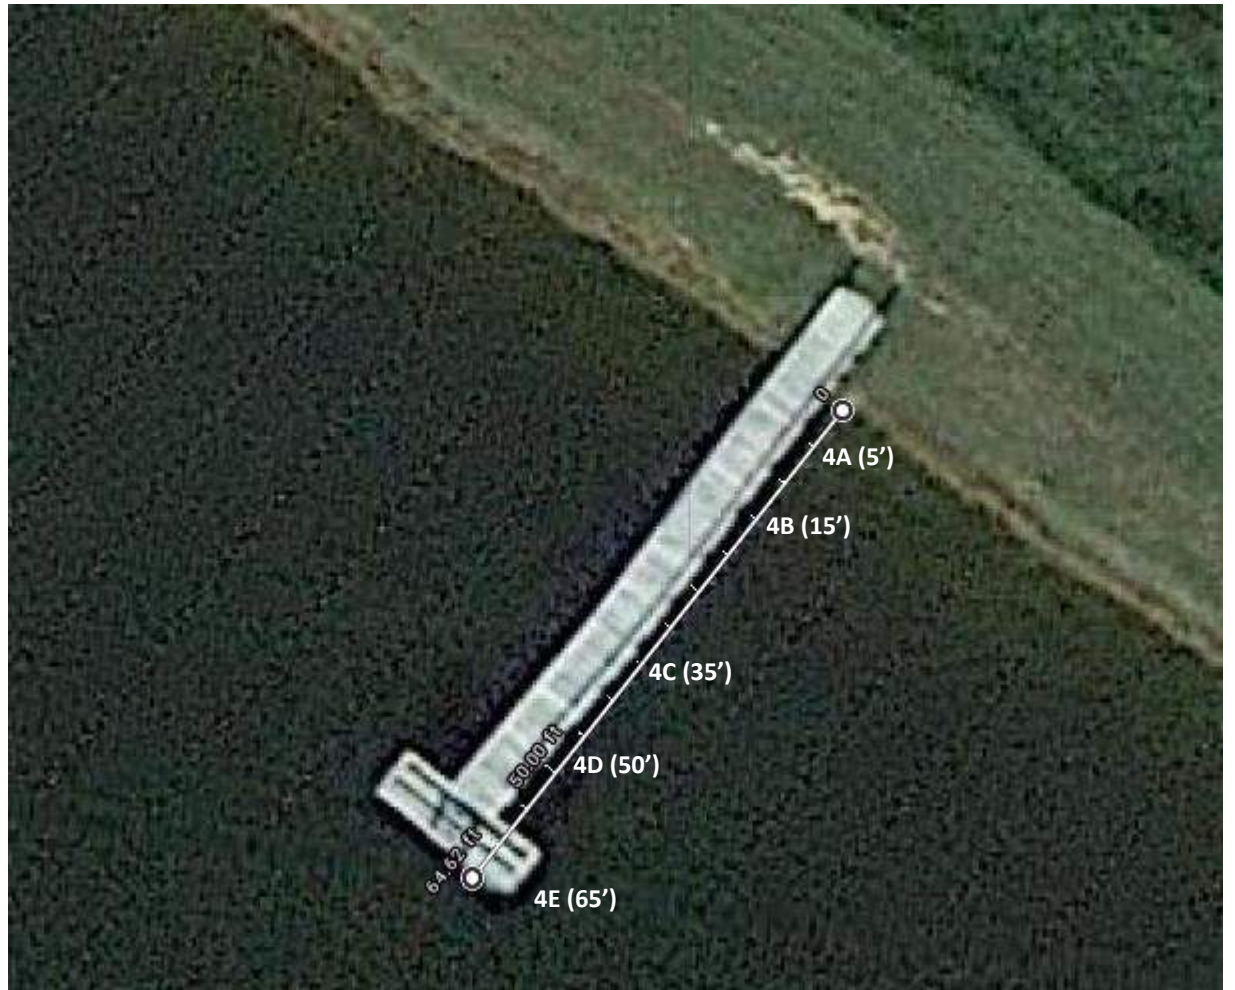
These graphics are examples of Sites 1A-1E and 4A-4E. If a sample is taken near the swimming platform, for example, the designation is "Site 1E."

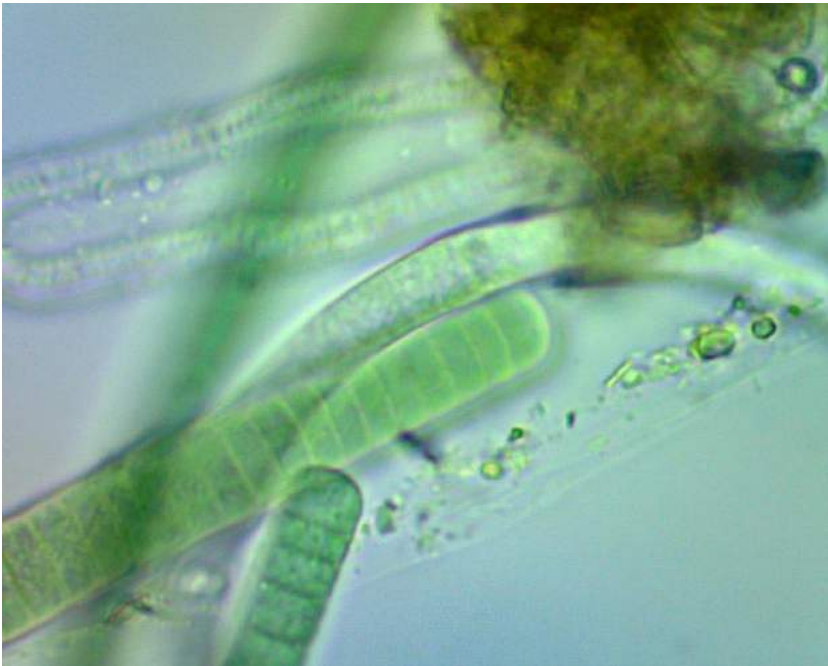
Location = Site 9.3A (Section 4)

Date = 4-21-23

≤2" diameter, gray/black/brown accumulations, assumed to be detached benthic mats loosened by increased Spring activity were observed and counted (#DBMs = 8) whereas no DBMs observed in other Sections on this date. The microscope images show filaments that are consistent in appearance with cyanobacteria; definitely *Oscillatoria* (see [here](#) and [here](#)); [sheath present \(indicating Microseira \(aka Lyngbya\)\)](#)(?) and similar to isolates from 2022.

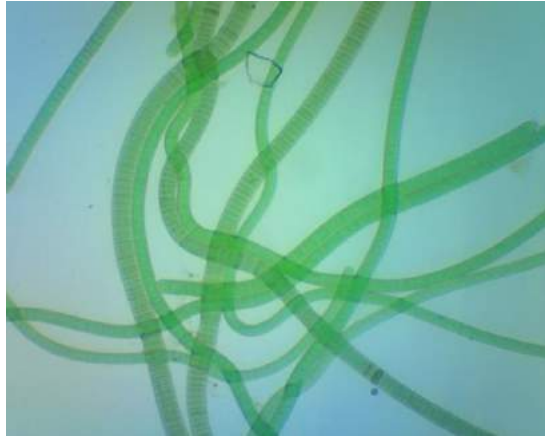
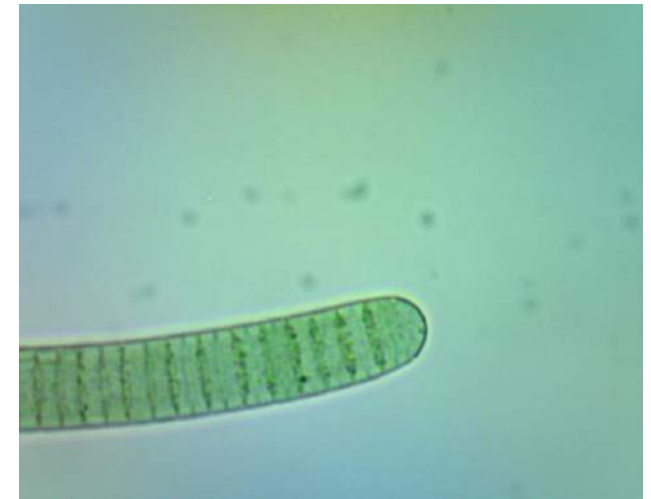
Location = Site 9B (Section 5)

Date = 5-25-23

≤2" diameter, gray/black/brown accumulations, assumed detached benthic mats (DBMs) loosened by increased Spring activity (#DBMs = 3 in Section 5; there were 36 DBMs in Section 4). These filaments are consistent in appearance with cyanobacteria; definitely *Oscillatoria* (see [here](#) and [here](#)); [sheath present \(indicating Microseira \(aka Lyngbya\)?](#)

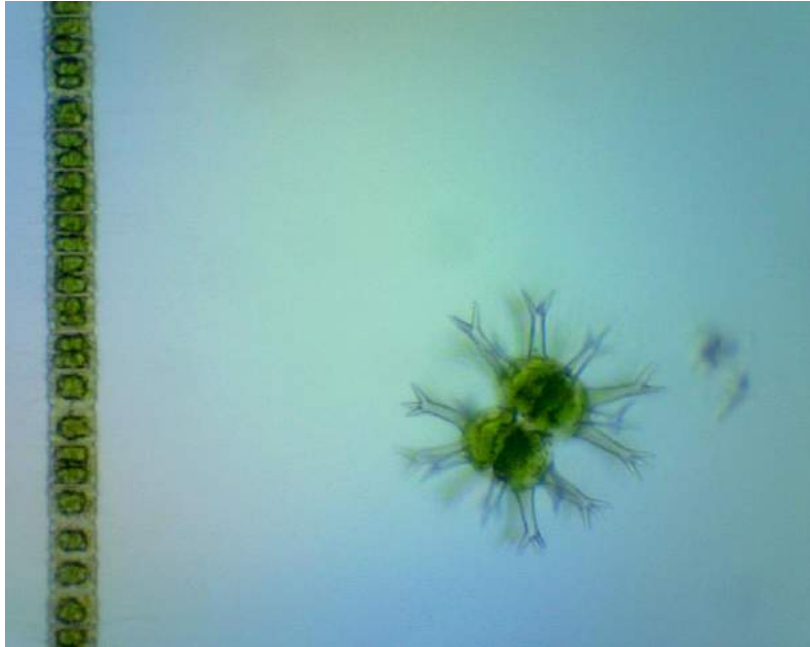
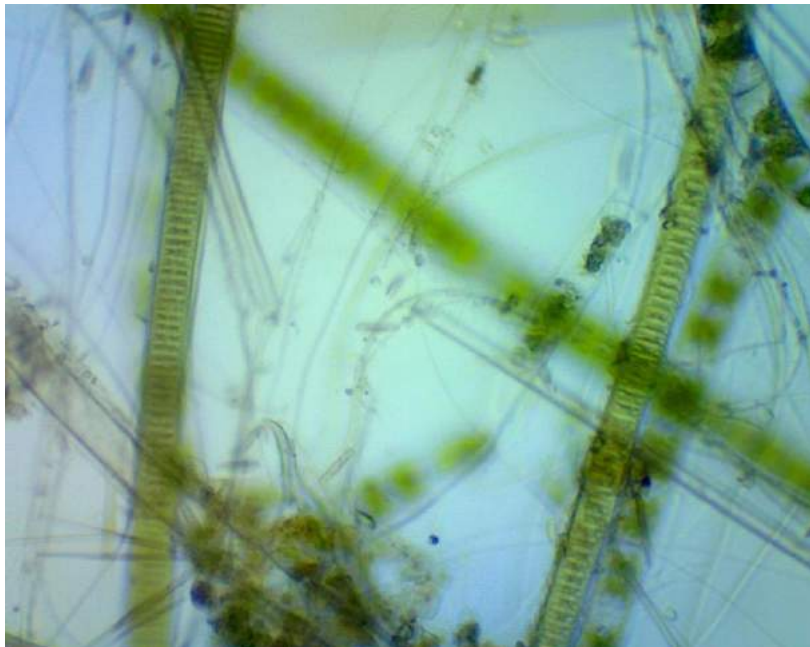
Location = Site 6A (Section 10)

Date = 6-1-23

This sample was taken near the drain, along the shoreline, from surface material that resembles green filamentous algae (GFA).

The upper image shows two species; the cell on the right is a species of GFA called *Staurastrum* (and has been seen in 2022); the filament on the left is a species TBD but is thought to be a GFA.

The bottom image shows two strands / filaments consistent in appearance with cyanobacteria; definitely *Oscillatoria*, but as before more work needs to determine if there is a sheath present, which indicates *Microseira*. These filaments were the only ones observed in the entire slide preparation but shows the presence of cyanobacteria.
