Rotorheads,

Sad to say that the Covid pandemic is still with us but, we're especially dedicated, so restoration goes on. The weather has cooled and been very nice, improving working conditions. During this period work was done on the R44, HH-1N, HH-46, HRP and Helipod.

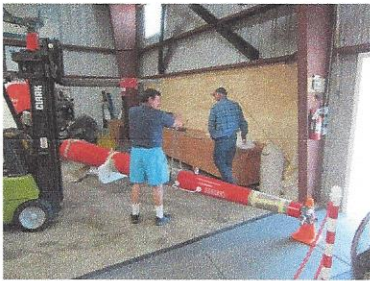
Lifting the R44 tailboom

The R44 Clipper II had the tailboom installed. This installation required lifting with the forklift and careful alignment for the tail rotor drive shaft and gearbox. More careful alignment and attachment parts coordination was required for installation of the exhaust manifold. With the tailboom aligned and attached, the tail rotor assembly and blades could be mounted. With the exhaust manifold securely in place, the engine cowling could be attached. All that is left to be done to make a complete ship is mounting the rotor blades, which we will wait on for now pending display relocation. The HH-1N Huey November saw work on the main rotor scissors and sleeve assembly. That assembly was then attached along with the swashplate to the rotor mast.

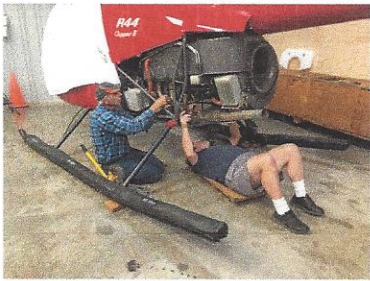
Checking exhaust alignment

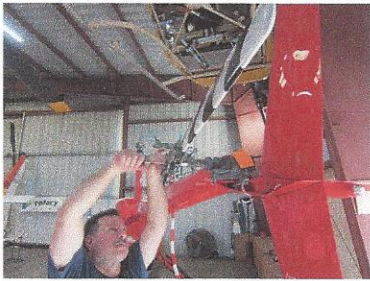
Installing the R44 tail rotor

mast assemblage was hoisted to the top of the fuselage, aligned and lowered into the transmission. The tail rotor drive shaft hangar bearings and shaft sections were installed connecting the main transmission to the tail rotor gearbox. Finally the tail rotor and right horizontal stabilizer were attached.

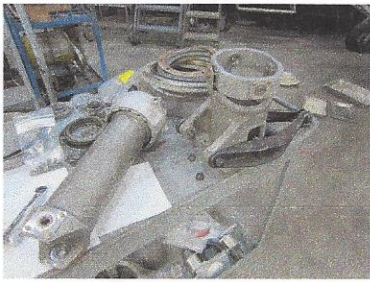
Huey sleeve components

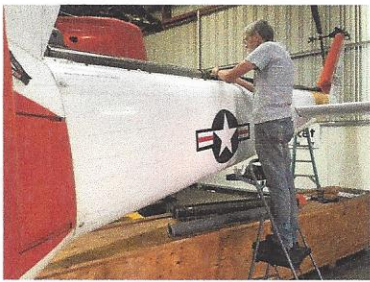
The HH-1N tail rotor drive shaft

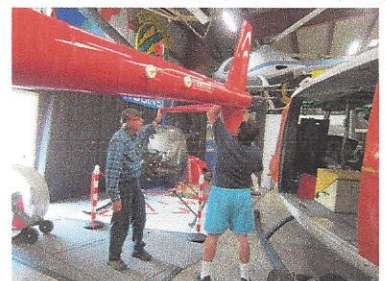
Checking the R44 tail alignment

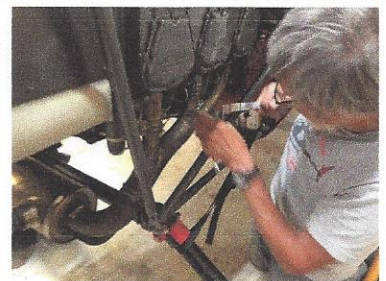
Securing the exhaust manifold

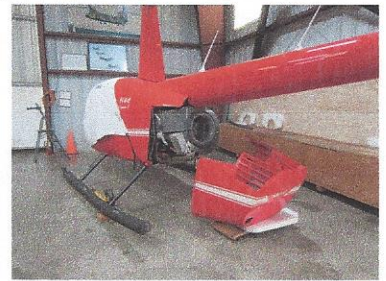
Installing the engine cowling

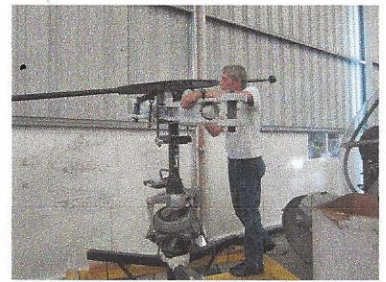
Installing the Huey stab bar

The rotorhead with the stabilizer bar on top of it was then attached to the top of the rotor mast along with the rotor control rods. The fuselage upper cowling was opened to accommodate the mast. The whole rotor

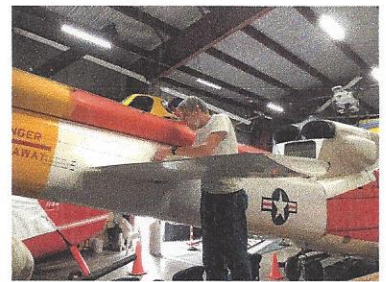
The Huey horizontal stabilizer

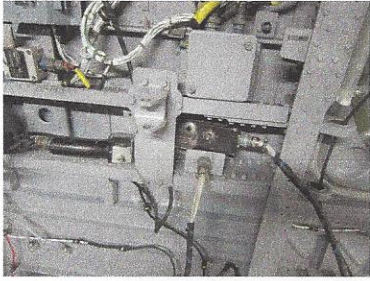
H-46 searchlight control box

The HH-46E Sea Knight had the aircrew searchlight control box installed. The radio

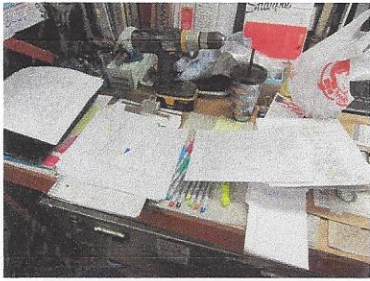
H-46 radio wiring diagrams

wiring diagrams were organized and studied in preparation for radio installation and checking the ICS.

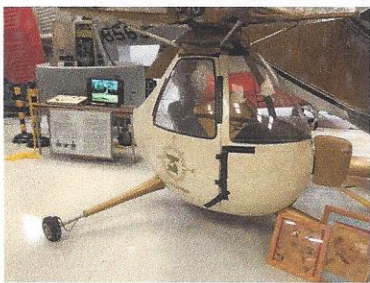
Helipod cockpit door attached

HRP Rescuer control cables had the tension adjusted. Work continued to break the de-phaser free. The de-phaser allows the synchronizing shaft connecting the forward and aft transmissions to be uncoupled so the blades can be folded. However, some 60 plus years of outdoor storage has locked the shaft sections together. Our last bird worked on during this period was the **Helipod** which had the cockpit door installed. The little Helipod is looking more like a complete aircraft.

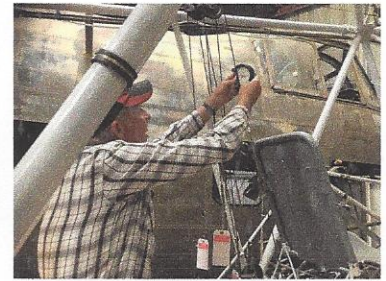
HRP control cable tensioning

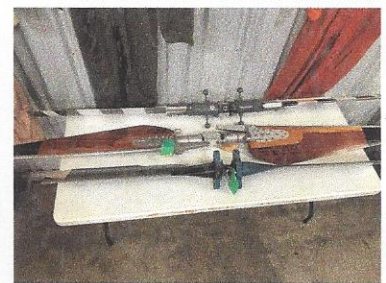
Complete tail rotor assemblies

Some other projects included the tail rotor display and the model room along with a few other things. The **Tail Rotor Display** had some assemblies put together. In addition, separate blades were reorganized and positioned for display

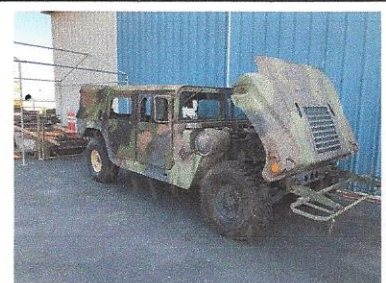
HMMWV opened for work

mounting. In the **Model Room**, new water was added to the H-34 Mercury astronaut recovery diorama. An **HMMWV Humvee** was acquired. It was made operational and parked in the vehicle garage. HMMWV stands for High Mobility Multipurpose Wheeled Vehicle or Humvee for short. I think the DOD pays some contractor by the letter to think up these acronyms, the military is chock-full of them. The museum also received another **Box of Gauges**, panels and electrical boxes. These were sorted and stored. They always come in handy for filling out instrument panels and covering holes. We have acquired quite a store of gauges and panels.
