INSPECTION REPORT
1 N
Greensburg IN 47240

INSPECTED BY
Jordan Wallpe
Wholesome Homes
Co. LLC
HIO2200120

INSPECTION DATE
📅 11/14/2023
🕒 03:30 PM

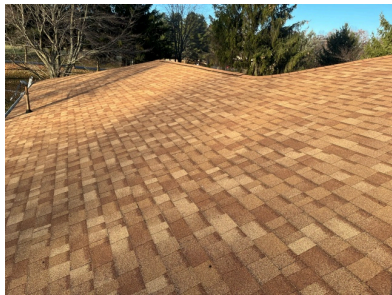
1.0 Item 1 (Picture)

The roof looked to be newer and the seller mentioned the roof was replaced 5 years ago. I did not notice significant or notable defects with the roof.

Continue to monitor for missing shingles or debris on roof that could cause damage.

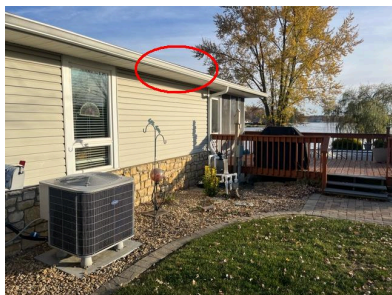
1.1 Item 1 (Picture)

The roof drip edge on the west side of the home was misplaced slightly near the pool pump. This could allow water moisture into the exterior wall if not repaired to allow water to drain properly into the gutter. Recommend gutter specialist repair/reset drip edge.

West side of home. Drip edge above gutter.

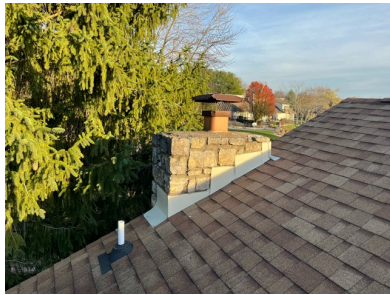
1.2 Item 1 (Picture)
Chimney

The stone chimney and rain cap is deteriorating and cracking. This is a significant safety concern as a large stone was loose and could have fallen down on the sidewalk at any time.

I recommend a chimney masonry expert repair/repoint damaged chimney. Consider updating chimney clearances to meet today's standards as well.

The chase was capped off and is not currently usable. Contact a chimney sweep to bring chimney up to code if use is ever desired.

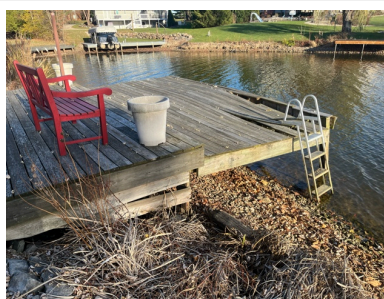
2.3 Item 2 (Picture)
lake dock

Safety Concern. The lake dock was in bad condition and should not be walked on until completely repaired by a professional. There is a risk that the dock could fail even further. The west side deck railing was deteriorating and some balusters were loose. This could not support normal forces and could fail and cause injury.

Recommend checking with local HOA on requirements. Recommend hiring an experienced professional to repair or replace the dock and repair the deck.

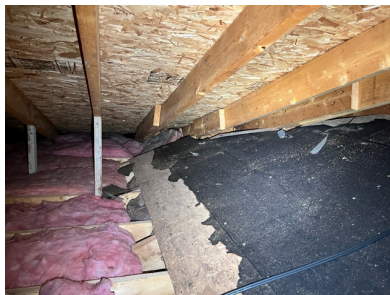
3.5 Item 1 (Picture)

The roof structure was re-framed during an add-on from the past. This framing is what is causing the sways in the roof line on the east side of the house. I did not notice any major concerns while walking the roof and also while inspecting via the attic.

Continue to monitor for changes in the roofline and consult with contractor if concerns arise.

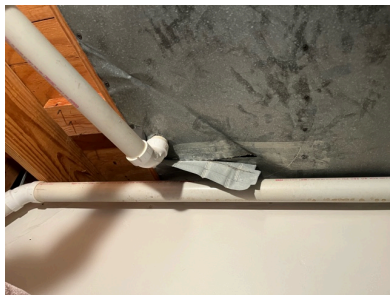
4.3 Item 1 (Picture)

A plumbing waste line was ran through a return duct in the basement mechanical room. This has two moderate possible issues. The first being that the gap around the plumbing line is not sealed and will pull air from the mechanical room instead of where the vent is intended to pull air from. Secondly, if the plumbing line has a leak inside or outside then the waste will enter into the return duct causing possible health concern.

Recommend having a plumber re-route waste line if this is an area of concern.

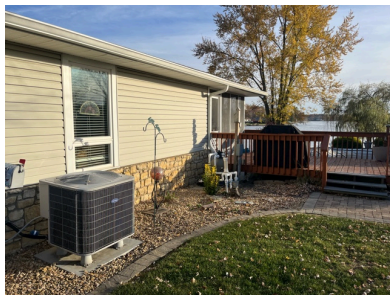
The outdoor unit was clean and level. Homeowner/seller stated the unit was replaced about 8 years ago. I did not run the AC during inspection due to the temperature being below 60F. I recommend annual servicing of HVAC systems by a trusted professional.

4.8 Item 1 (Picture)
Outdoor condenser unit

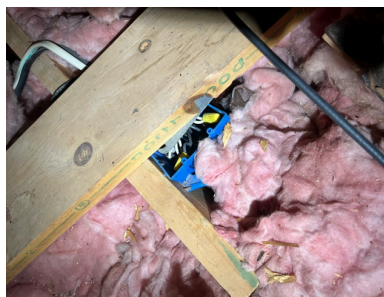
Safety Concern. A few boxes were missing covers or had inadequate covers. The back balcony storage room had a light that is incorrectly wired and needs repaired. This is a shock and fire hazard currently. The bare copper wire is energized and inside open conduit.

6.3 Item 2 (Picture)
In attic near house fan

Recommend hiring an electrician to repair or replace.

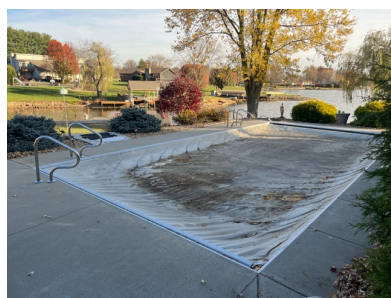
The pool was not tested during inspection.

12.0 Item 1 (Picture)
pool
