THE OFFICIAL PUBLICATION OF THE INTERNATIONAL EROSION CONTROL ASSOCIATION

JULY / AUGUST 2019 VOLUME 14, ISSUE 3 IECA.ORG

22 SEDIMENT BASINS

Unexpected Outcomes: Making Best Practices Better

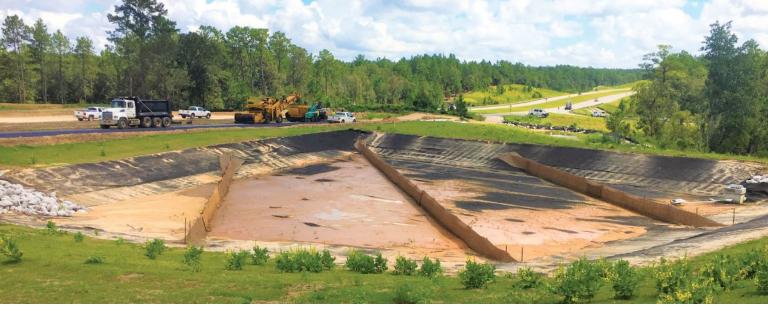
A sediment basin in sandy soils with a diagonal flow path

The two-year, 24-hour storm event for the coastal project area is 5.7 inches—likely too great for a practically designed and implemented sediment basin volume. To account for the lack of designed capacity, the project inspection staff and environmental quality assurance team from Volkert Inc. made sure that sediment basins were excavated to fill all available space to increase treatment capacity.

The unexpected outcome was realized and reinforced with ever-increasing rain events, including those associated with tropical storms in the coastal city and hurricanes in the region. The project continues to receive rains reaching up to 4.5 inches in less than 24 hours, sometimes after days of consecutive storms. To date, after nine months of construction, and in spite of the heavy precipitation, some skimmer outlets have never floated. Due to the sandy nature of the soils on site and in the watershed, the majority of potential runoff simply does not make it to the basins before infiltrating.
