To: First Colony (FC) HOA Board (R. Dunham, J. Snyder, D. Lawson, J. Riddler, L.Lonsbury-Fleenor)
From: FC Grounds Committee (R. Williford, L.Lonsbury-Fleenor, M. Wolfe)
CC: M. Morenings (universallawntn@gmail.com)
Subject: FC Grounds Committee Report #2
Date: 1/26/26

The Grounds Committee is pleased to provide this follow-up report to the one we previously released 8/30/25 (copy on <http://www.firstcolonyhoa.org>). We encourage the Board to address the following opportunities for improvement to enhance the appearance of our community. We plan to release a 3rd report in late May 2026. We trust many of these recommendations will be addressed by then.

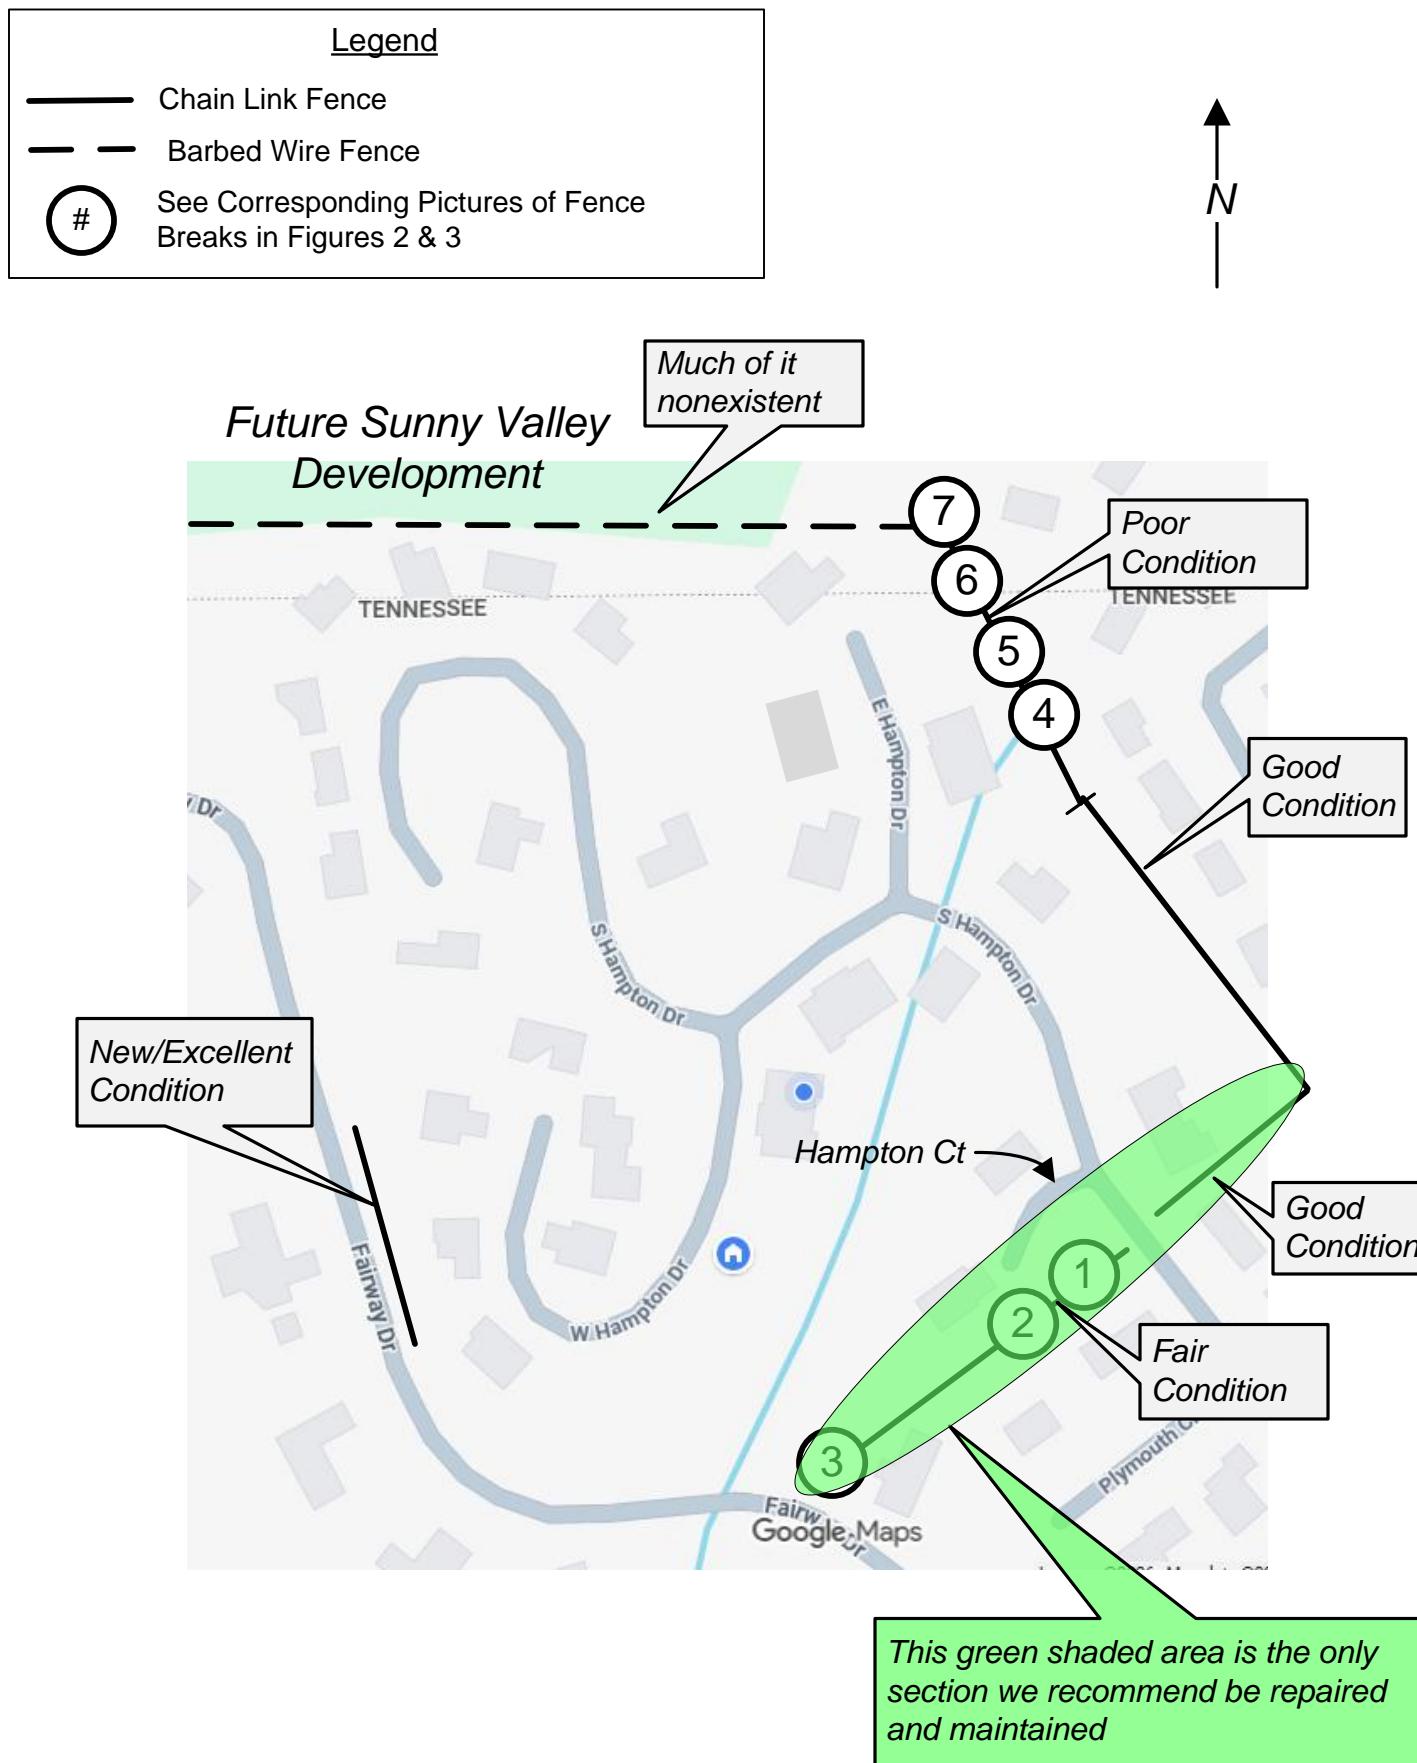
See Figure 1. Much of the property line is heavily wooded. It is unclear the exact location of the property lines. There is no fencing to the north and much of the west of FC. We suggest that the HOA assume responsibility for repairing and maintaining only the chain link fencing along the southeast boundary that is shaded in green since it's easily visible to Hampton Ct. and 202 S. Hampton Dr. owners. Figure 2 shows breaks in this fencing requiring repair.

Figure 1. Type & Condition of Fencing Around FC
Repair and Maintain Only the Section Shaded in Green

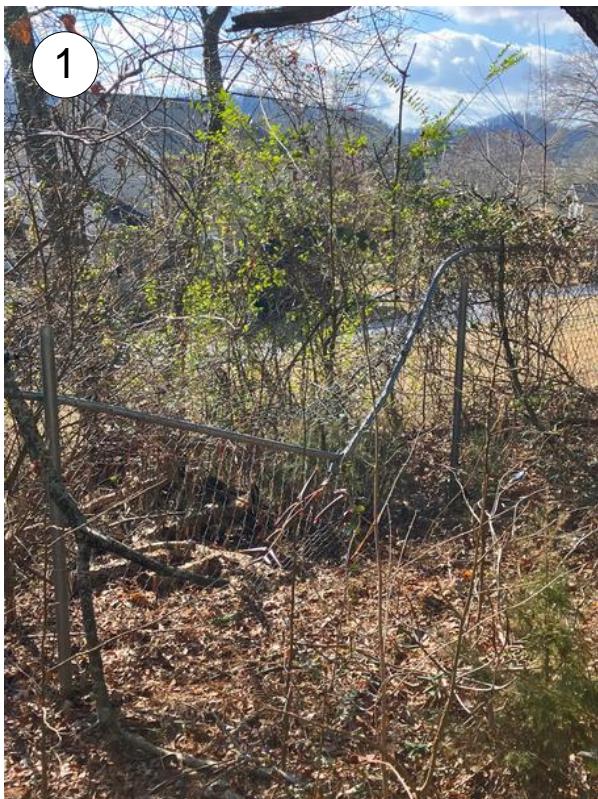
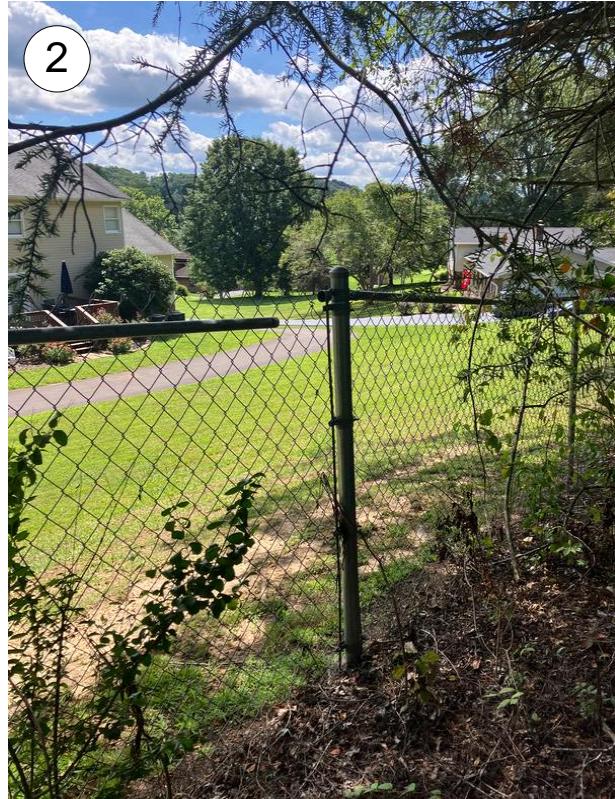
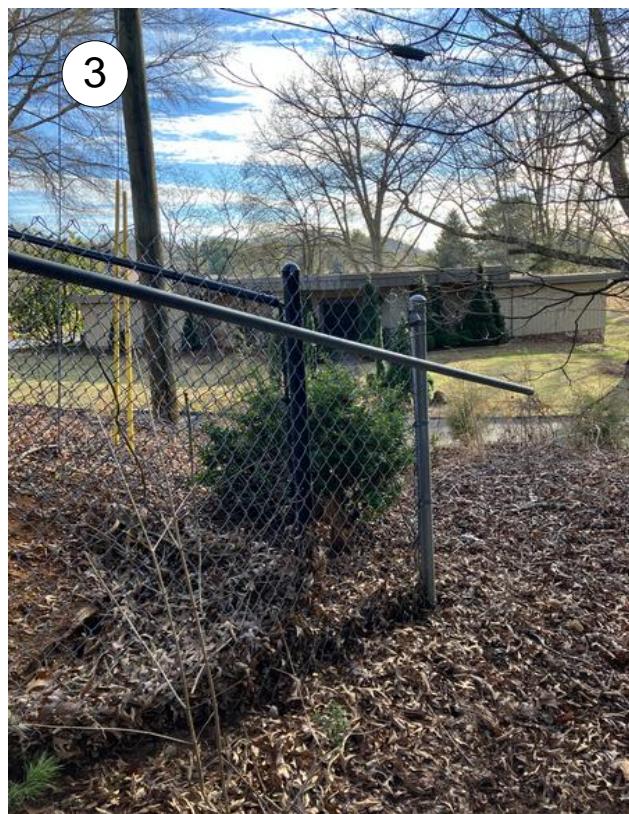
Requests to fix the broken fencing adjacent to Hampton Ct. were made at both the 2024 and 2025 annual meetings. It encouraged us to broaden our examination of the type/condition of the fencing around the entire FC property line and make the following recommendations.

Figure 2. Chain Link Fence Adjacent to Hampton Ct. Needs Repair

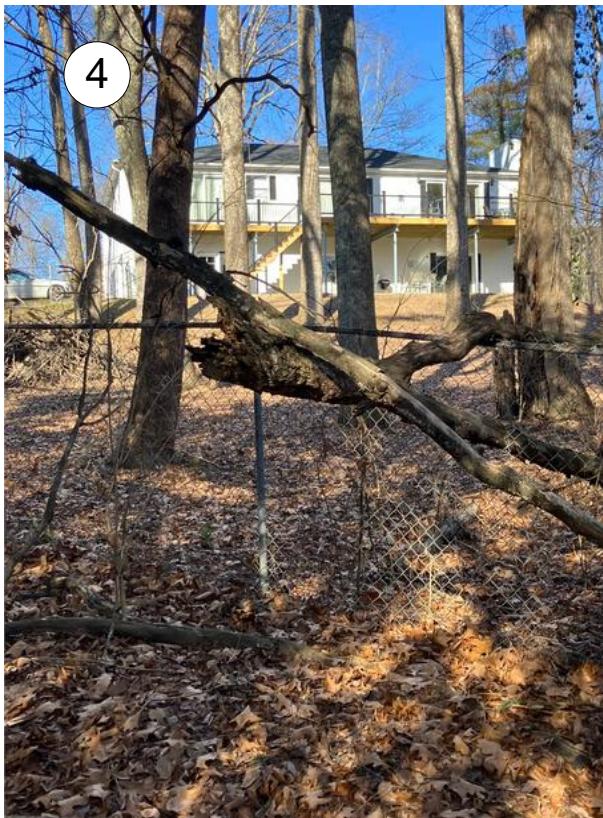
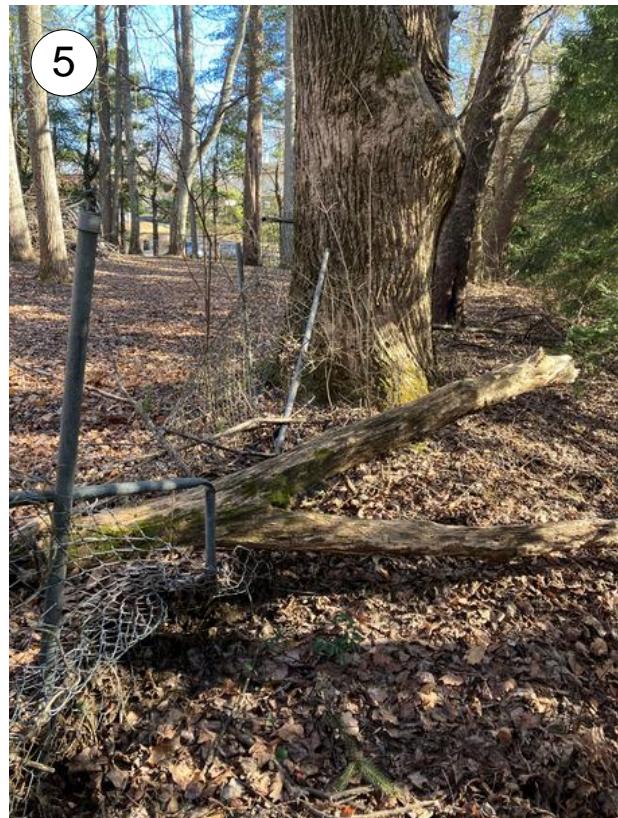
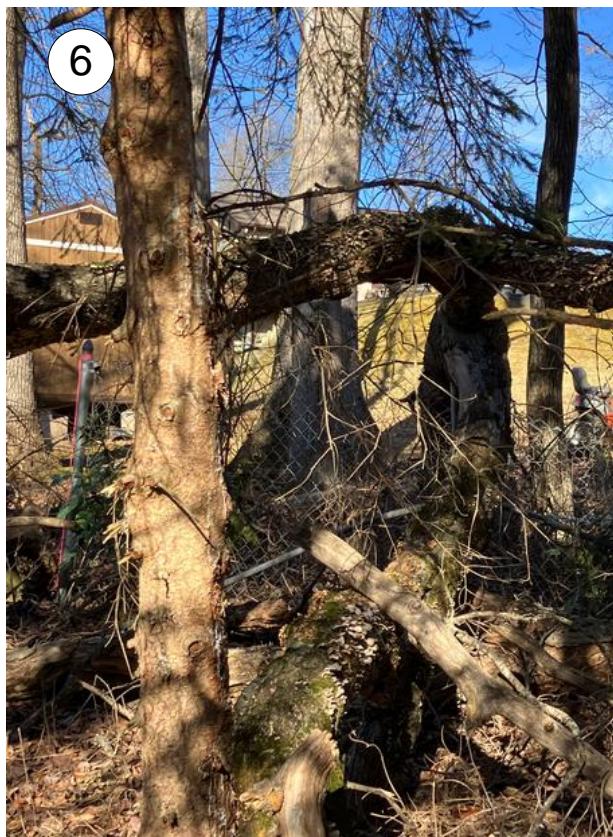
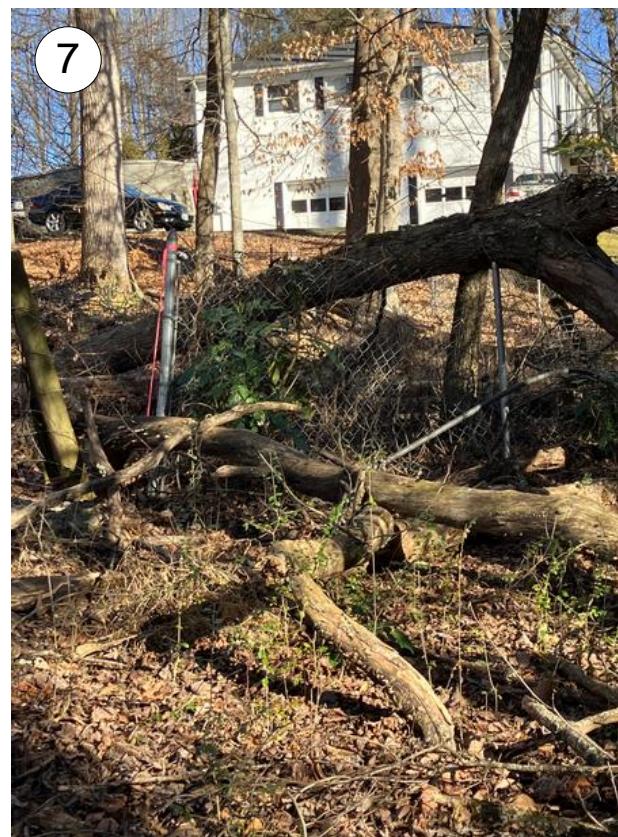
The chain link fencing down the east of S. Hampton Dr. and E. Hampton Dr. is ~12 ft. on the other side of the thick trees (why it can't be seen from FC). These trees remain a significant obstacle to even getting close to the fencing from the FC side. These trees are behind the fencing as seen from the single-family homes outside of FC. This fencing also has different types/heights. Both characteristics strongly suggest this fencing was installed by the adjacent homeowners outside of FC and is their responsibility to maintain. Figure 3 shows how bad some of this fencing is along E. Hampton Dr.

Figure 3. Broken Fencing 12 ft. Behind Trees Alongside E. Hampton Dr.
Responsibility of Homeowners Outside of FC – Do Nothing

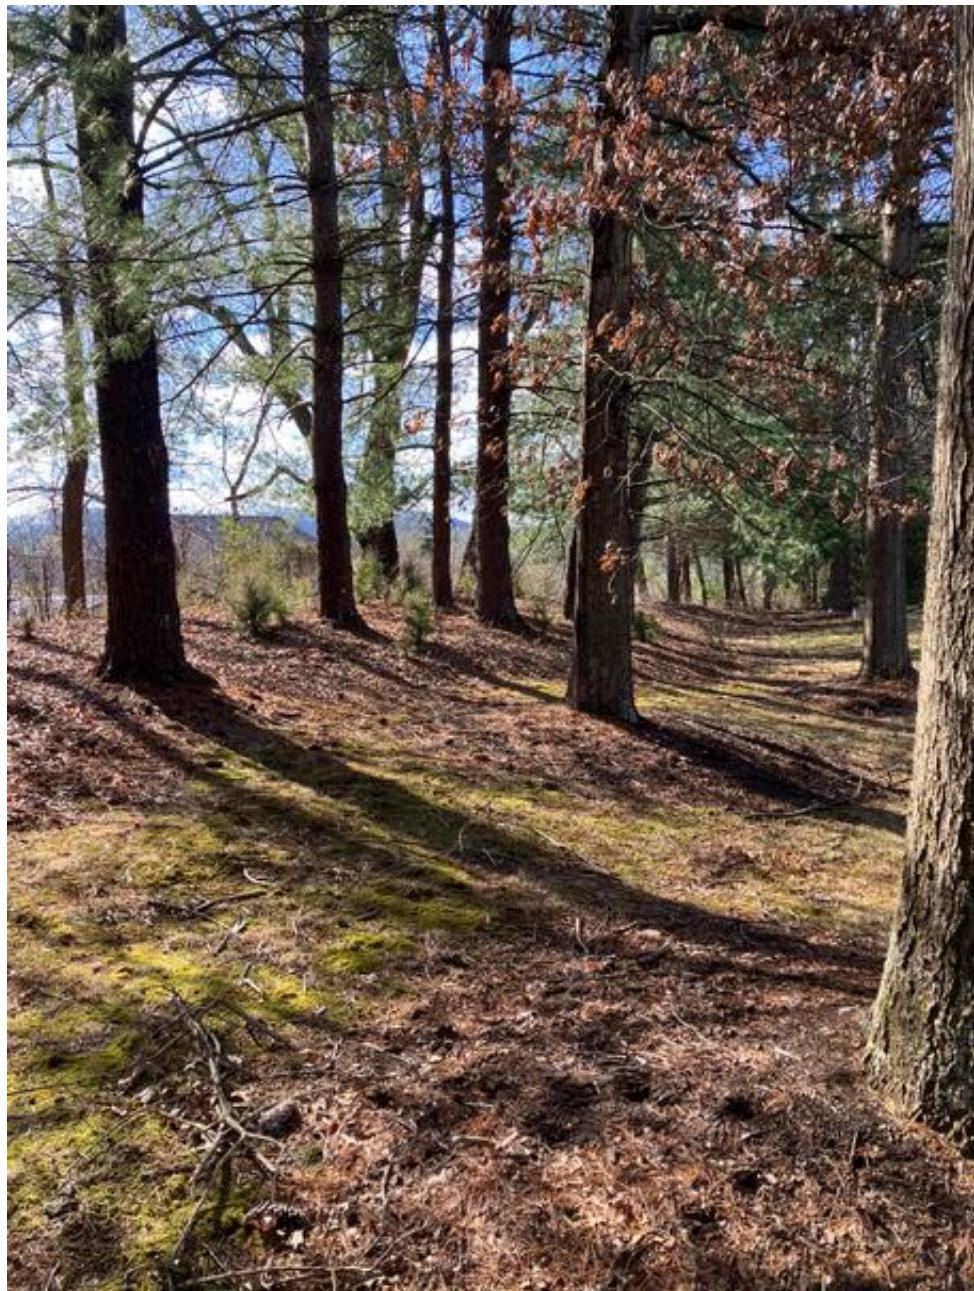
Figure 4. Area Between Hampton Ct. and Fence Line
Lay Mulch or Pine Straw

See Figure 4. The area between Hampton Ct. and the fence has invasive plants and is easily visible to Hampton Ct. owners on a daily basis. We believe this area should be cleared of invasive plants and then mulch or pine straw (perhaps cheaper) laid.

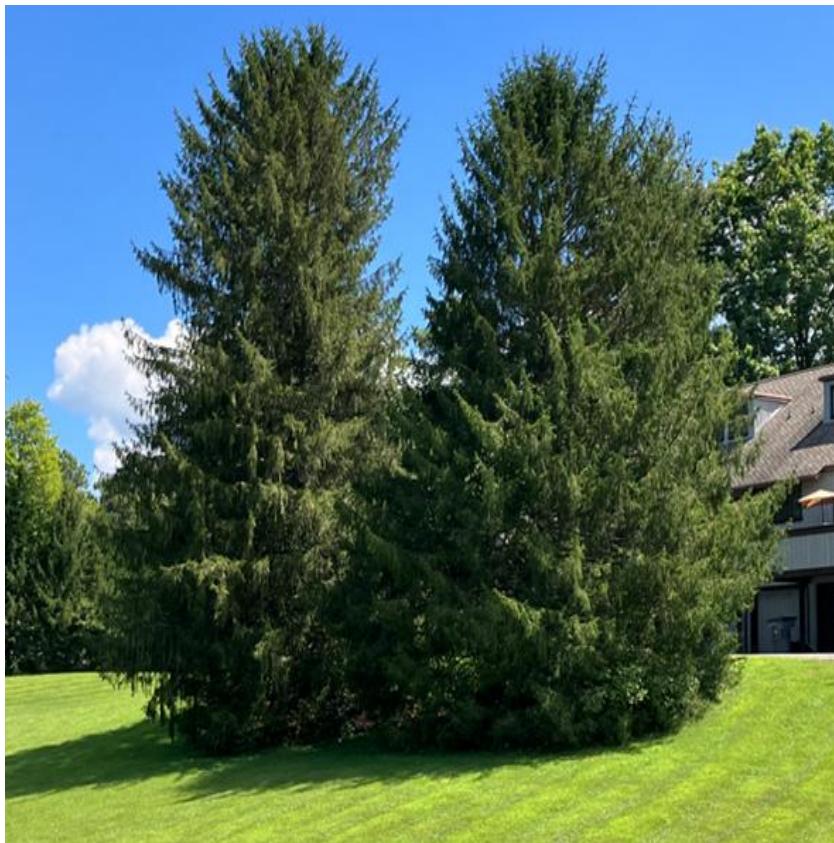
Before

Figure 5. Removal of Low Branches from Trees
Case Study – Large Fir Trees in Field Down from Hampton Ct.

- *Invasive plants around/within perimeter of trees*
- *Several 2" diameter ivy stalks growing up from ground high into trees impacting their long term health*
- *Challenge for lawncare staff to mow around*

There are several trees in the common area whose low branches need to be removed to improve their appearance and enable access to landscapers for mowing. The Grounds Committee did this to the large fir trees in the field behind Hampton Ct. this summer with prior approval from the Board. See Figure 5. Figure 6 shows other trees needing low branches removed elsewhere in FC.

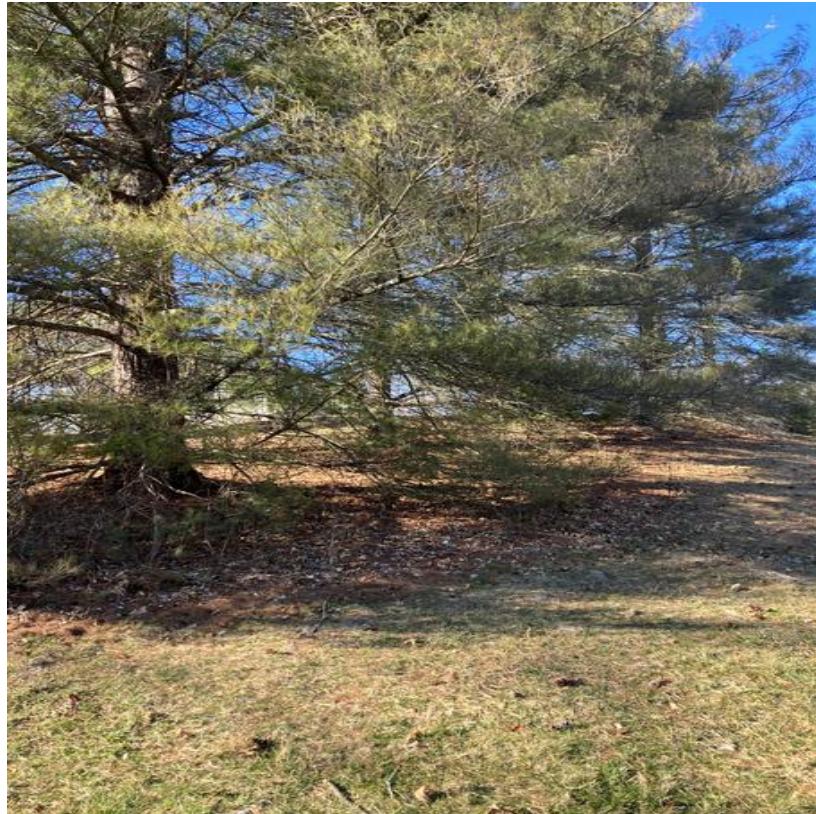
7 Trees Behind 101 and 111 E. Hampton Dr.

Figure 6. Trees Needing Low Branches Removed

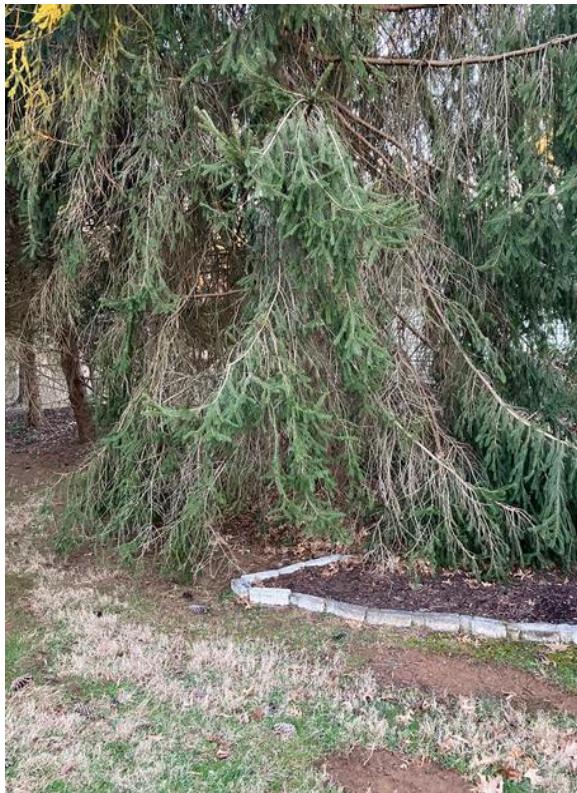
Right Side of 202 S. Hampton Dr.

Figure 6. Trees Needing Low Branches Removed (cont'd)

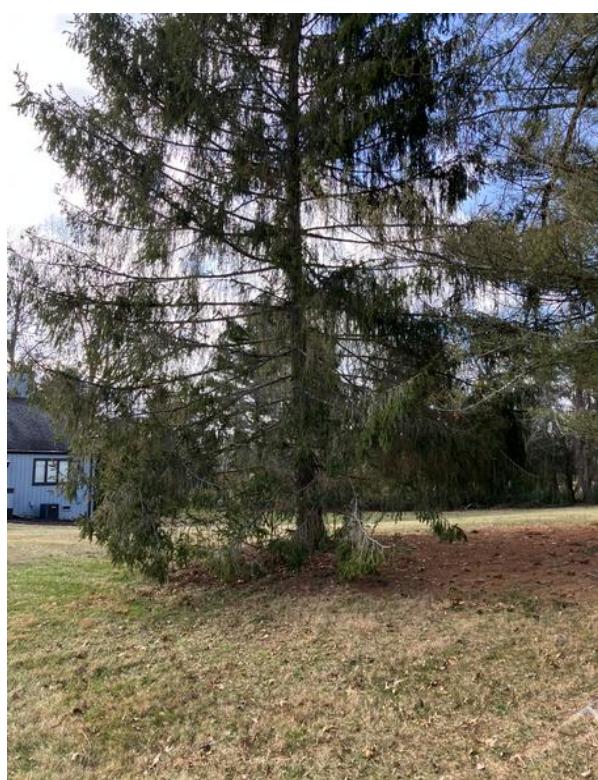
Back of 286 S. Hampton

Figure 7 shows two Holly trees for which trimming the top was missed by Universal Lawn.

Figure 7. Trimming Top of Holly Trees
These Two Evidently Missed

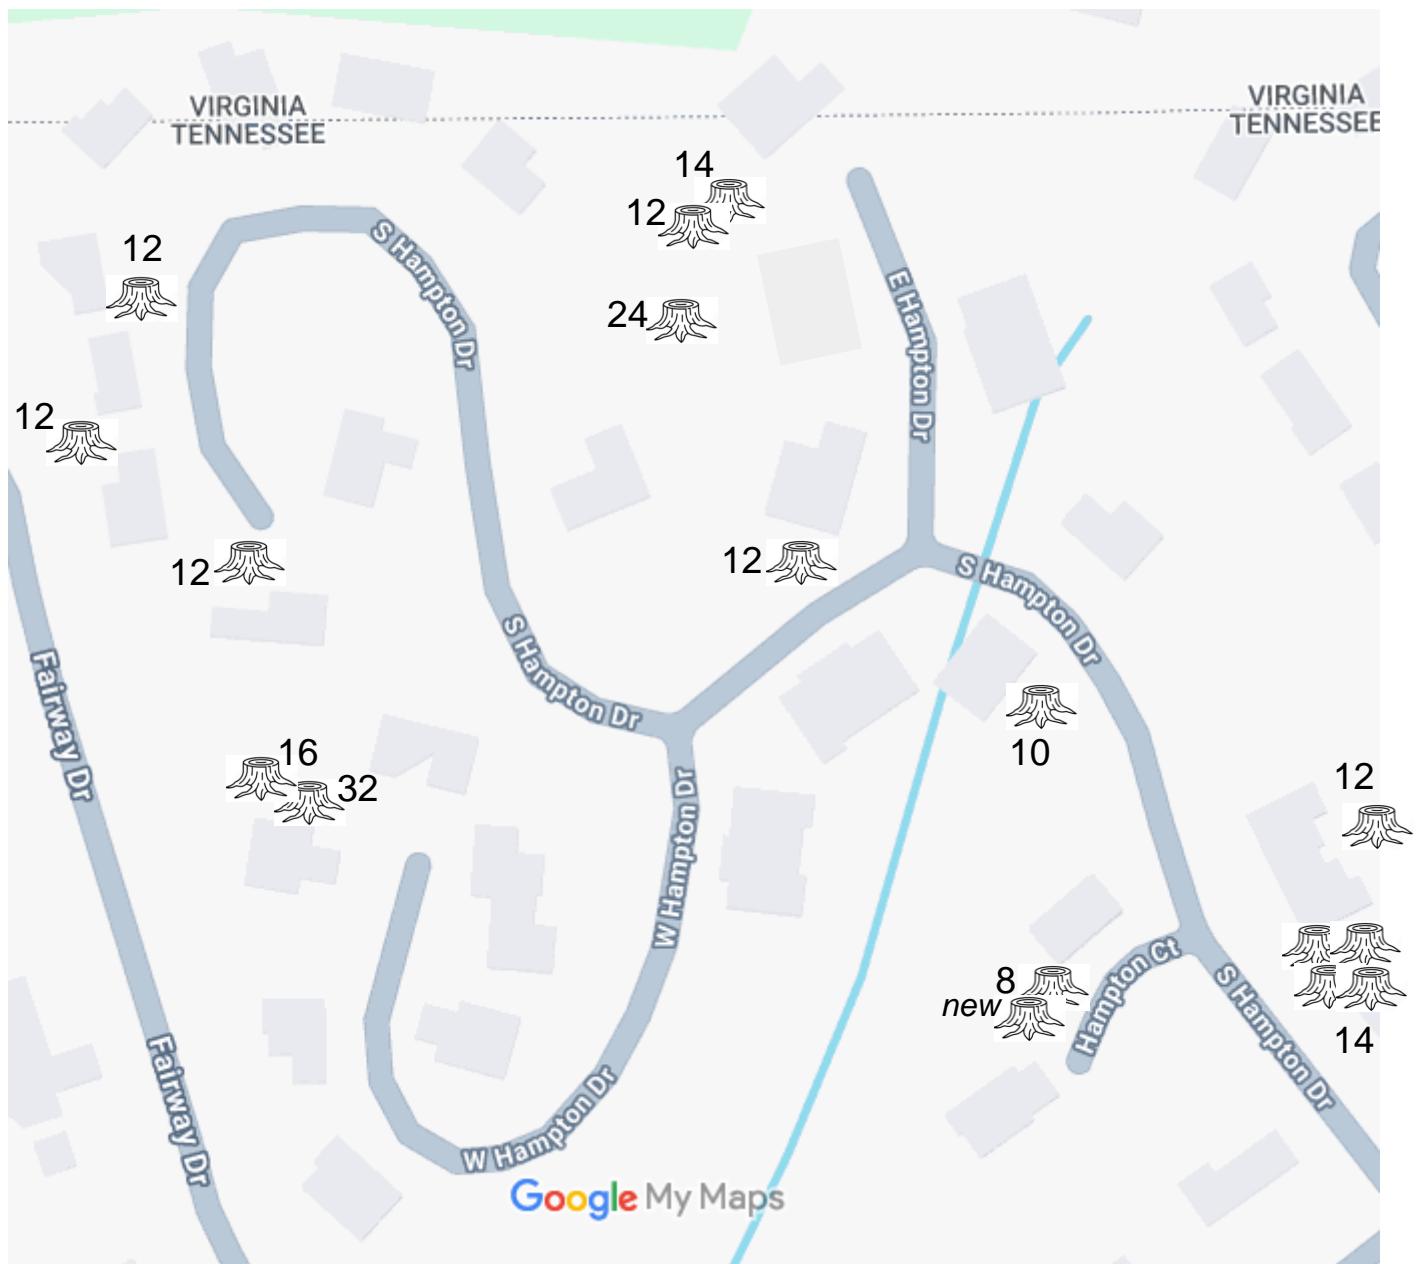
Figure 8. Location of Stumps Needing Grinding

*This symbol notes approximate location of stumps
Corresponding numbers indicate respective diameter in inches.*

Figure 8 shows the location of 17 stumps that need to be grinded. Matt (Universal Lawn) explains that he previously proposed renting a stump grinder to remove these stumps for an additional fee.

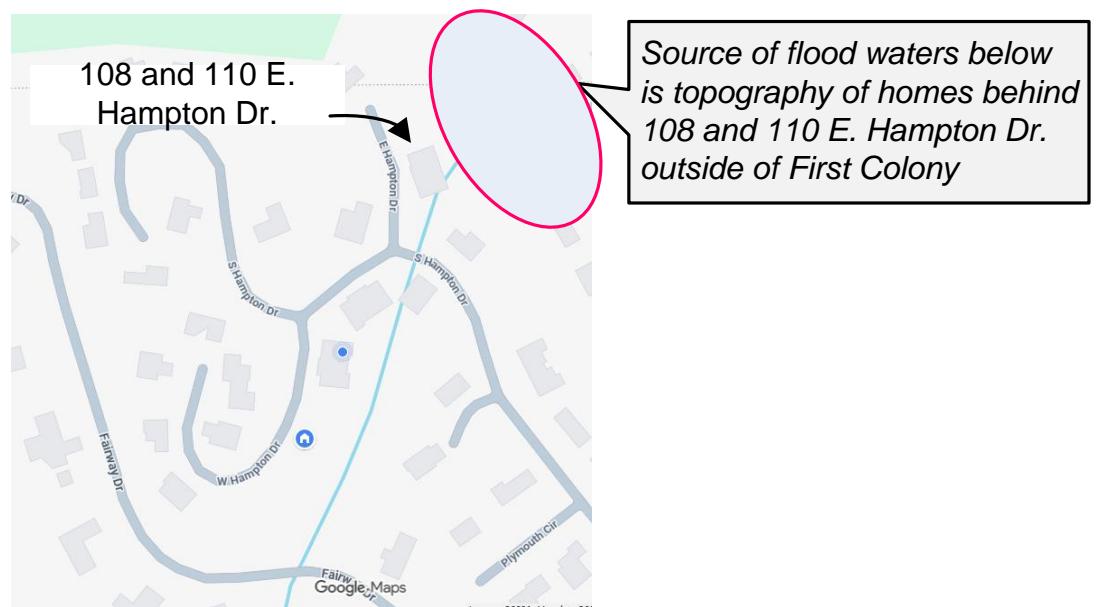
July 30, 2025 Storm

We are aware of several areas within FC that have occasional flooding after very heavy rains. This occurred once in 2025. The source for the flood waters shown in Figure 9 is the topography of the properties behind 108/110 E. Hampton Dr. outside FC. An improved drainage plan should have been addressed by FC developers in the 1980s. We believe erosion/coir logs would help to mitigate the problem. See Figure 10.

Figure 9. Major Source of Occasional Flooding

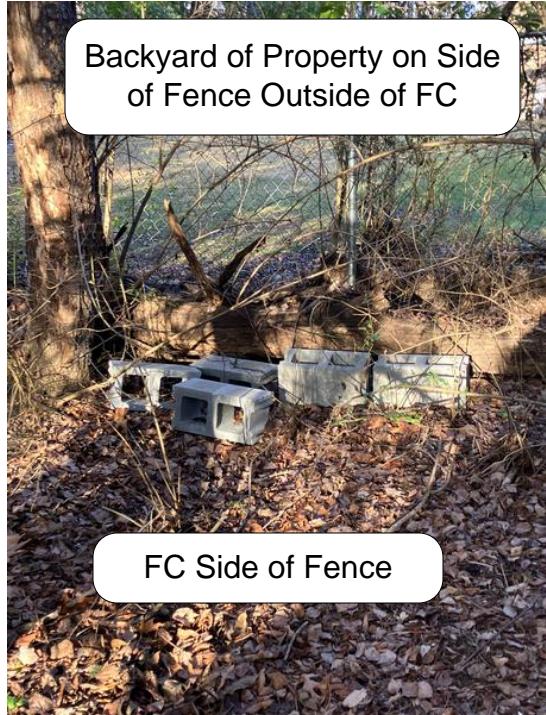
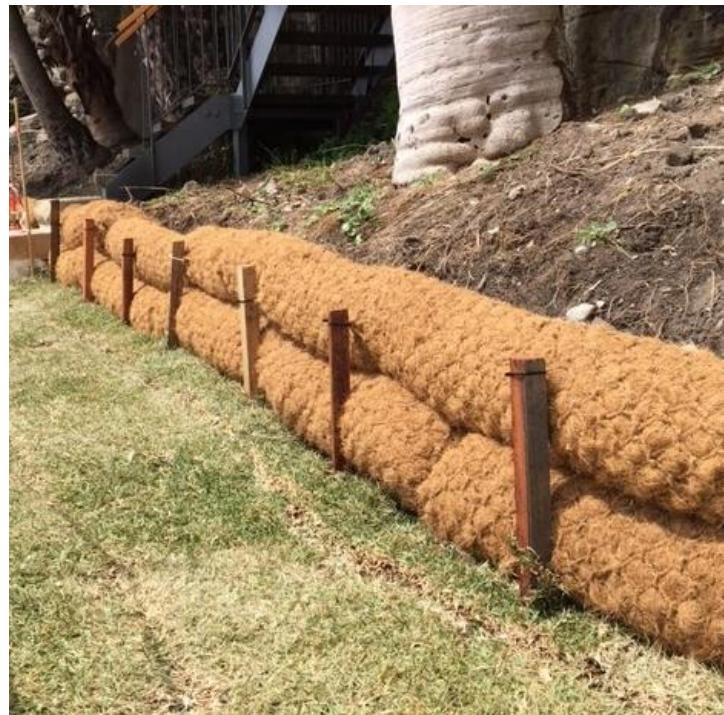
Behind 110 E. Hampton Dr.
What's There Now

Figure 10. Improve the Barrier to Impede Flow and Reduce Erosion Shown in Figure 9
