What it means if your Reduced Pressure Principle (RP) backflow device is leaking

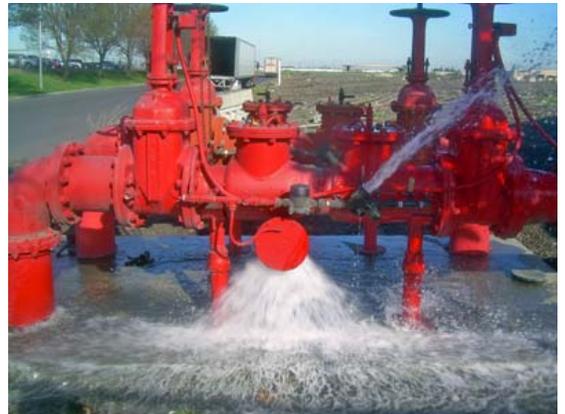
If you see a continual drip or stream of water, or a full-blown discharge as you can see in the picture on the right, then you most likely have a failure of one of the components of the device. You will need to have the device tested and repaired to fix the leak.

Do not attempt to "fix" the relief valve. The problem is most often internal and using any method to "fix" the relief valve may in fact damage it. Most leaking is caused by a failed internal component, in which case, the relief valve is operating correctly by opening and discharging water.

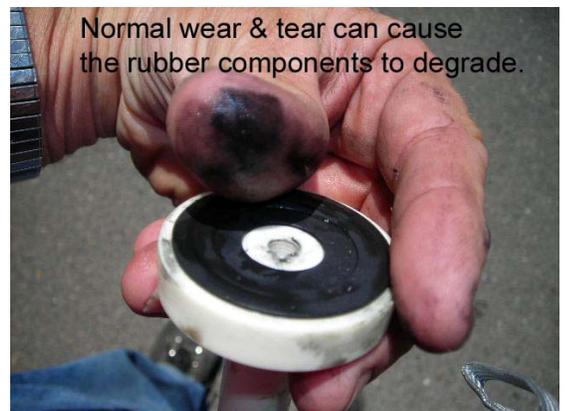
Normal wear & tear can cause the rubber components to degrade.

An RP is composed of two check valves and a relief valve, which incorporate a variety of rubber parts, plastic parts, springs, diaphragms, o-rings, and so forth. These parts can wear out from normal wear and tear, be degraded by the water and substances found in the water or be damaged by debris in the water, such as rust, rocks, nails, wood, solder, and whatever other substance has found its way into the water supply.

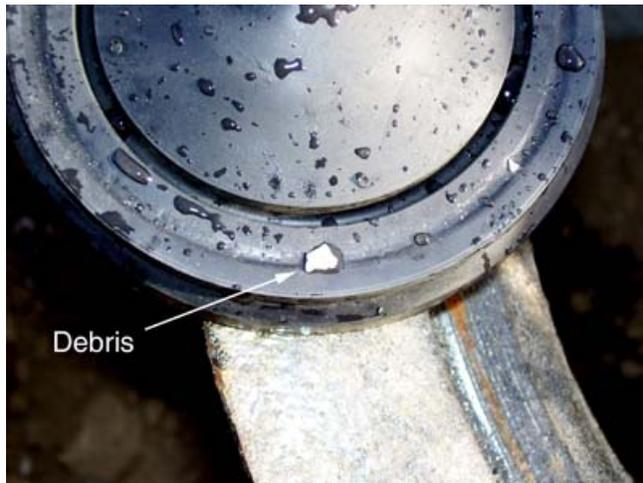
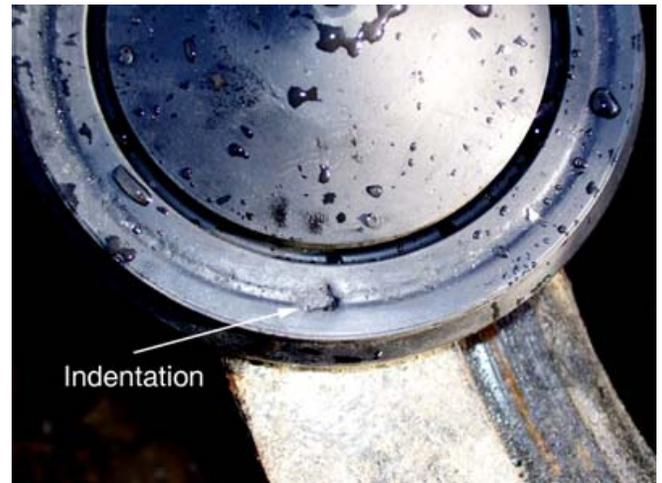
Debris that gets stuck and embedded in the check valve will cause a leak around the debris. Once the debris is removed, an indentation is left in its place, and water leaks through the indentation. Thus, it is most often necessary to rebuild or replace the check valve to stop the leaking. The pictures below show you how debris damages a check valve disc.

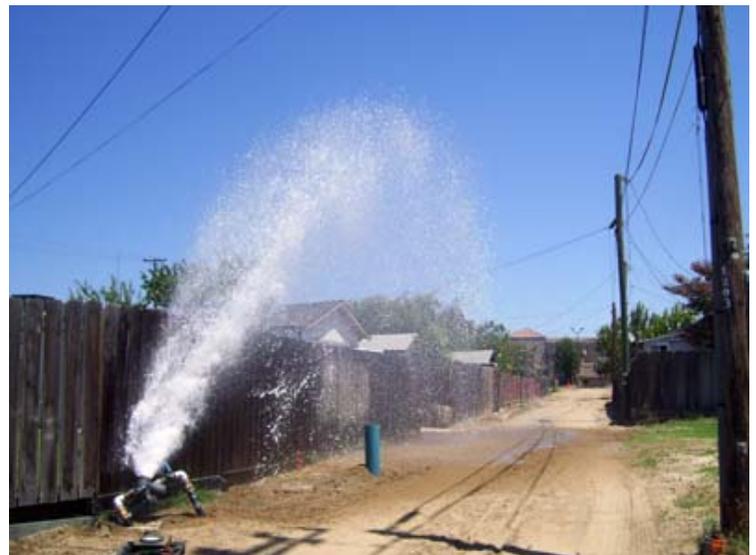
Whenever possible, the device should be flushed during the repair, which helps move a high volume of water at high velocity, which helps rid the water main of debris that can cause problems in the backflow device.
