CHASING PICOFARADS

Troubleshooting Capacitive Fuel Indication Systems

BY BRAD PRIMM

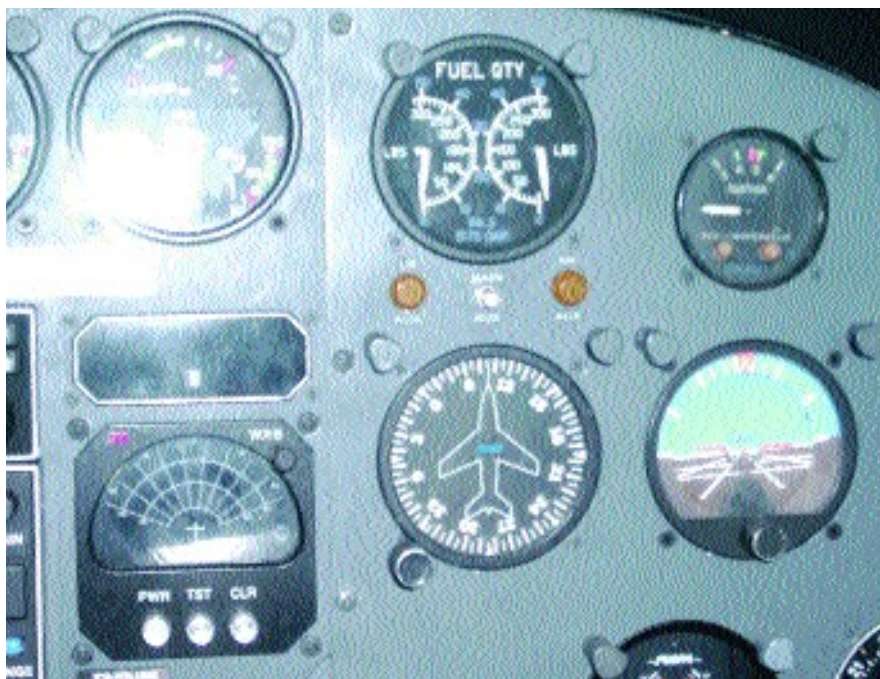
Cessna 340 fuel quantity indicator

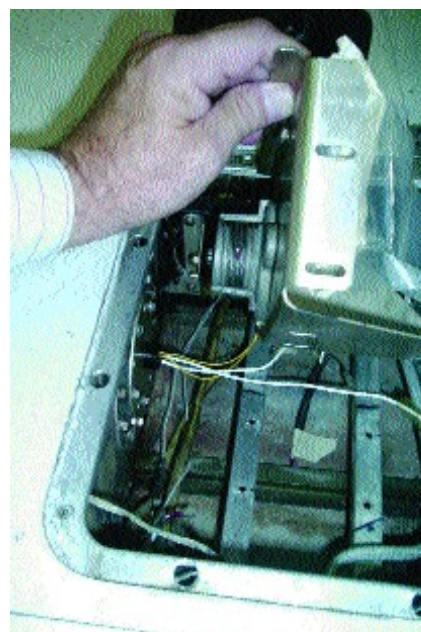
Autopilot servo is held out of the way to show fuel probe stand-off and wiring is in its native element.

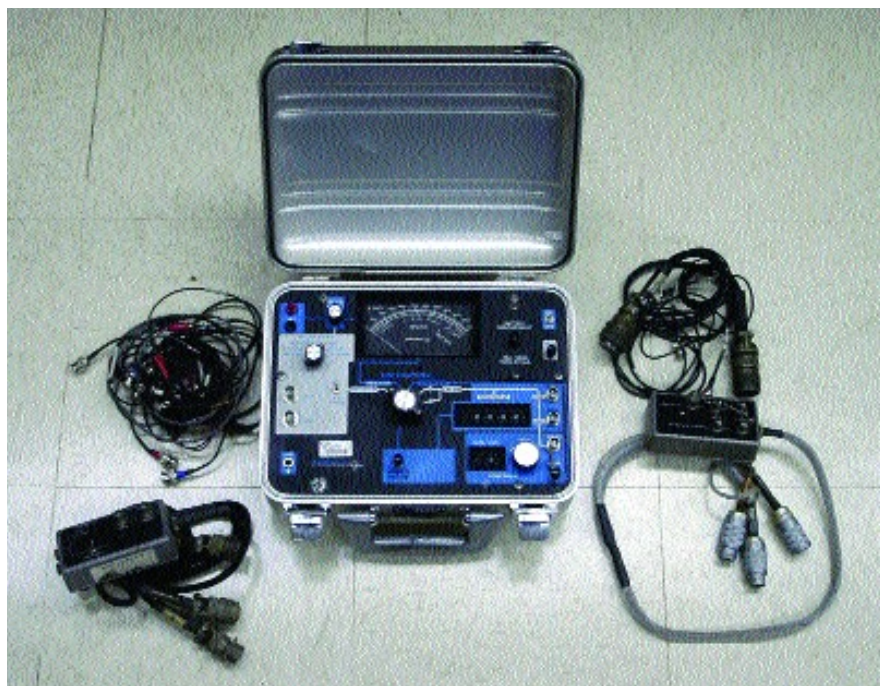
Barfield 2548 test unit with adapter harnesses and test lead package.

Both breakers were replaced. Also, the maintenance procedure for the fuel quantity system calls out for a special test set for troubleshooting and adjustment. Who needs a test set when you have mechanics? Our theoretical shop had a Barfield 2548G/GA test set but, it hadn't been calibrated since 1989 and the basic test lead package was missing. In addition to the test set and basic test lead package, you must also have a special adapter harness for each specific aircraft type (most adapter harnesses cover several models) so that the test set can be inserted in-line between the signal conditioner and the probe system to make measurements and adjustments.

quick call to the helpful folks at Barfield and he had the supplemental instructions in his email within minutes. Now armed with the aircraft maintenance manual instructions, the Barfield 2458 manual, and the 101-0411 adapter harness supplemental instructions, he proceeded with calibration and testing. The procedures are detailed and must be followed to the "T." Pay particular attention to the installation of shorting caps on the unused HI-Z and LO-Z lines, when to connect or not connect the grounding jack of the test set to airframe ground, and when to connect the adapter harness to the signal conditioner.

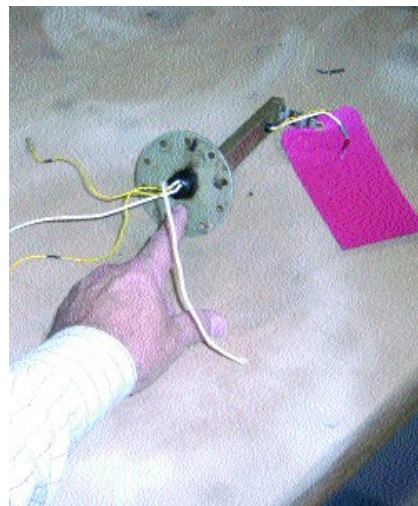
Defective potted feed-through on stand-off assembly.

The resistance checks revealed numerous problems on both sides. Troubleshooting the wiring, our persistent avionics technician found the harness section for the inner aux tank, on the right hand side, was reading less than 10 megohms. This was the probe that was just replaced! After the mechanics extracted the probe assembly again for further testing, he found the splice in the potted feed-through was bad and not field repairable. A new harness and standoff assembly

was ordered and installed. The probe was reused. Also, on the left side, the main tank pigtail harness was reading less than 900 megohms. Redoing a splice in one of the lines repaired this problem. On both sides, the harnesses were carefully inspected and all of the Cessna quick-disconnects for the probe harnesses were cleaned and retentioned.

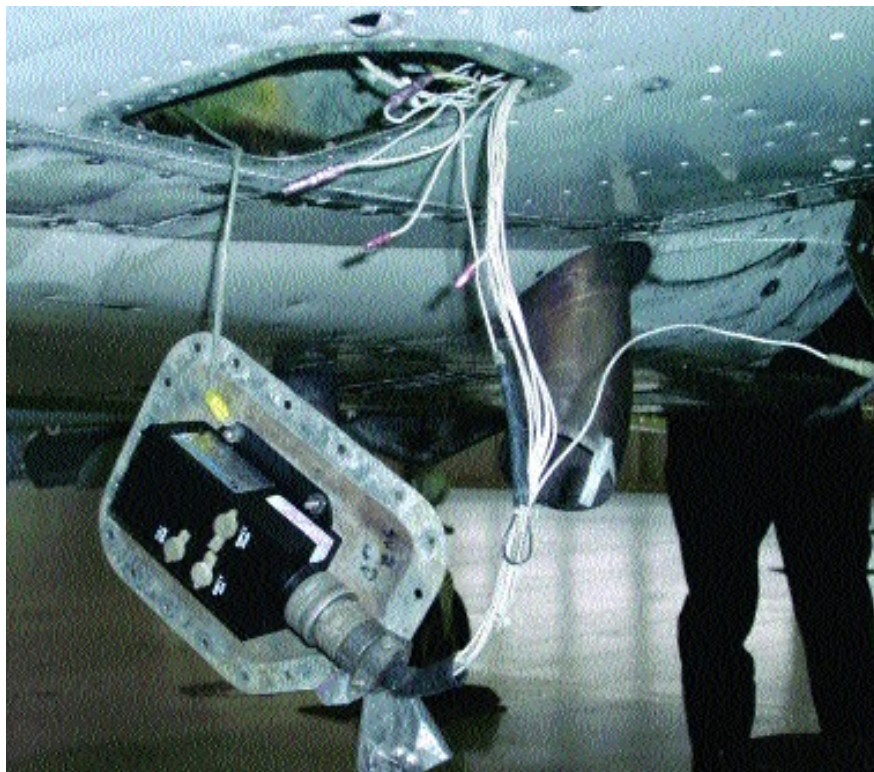
Signal Conditioner, note the adjustments marked on case.

System calibration. This procedure is used to adjust the empty and full settings on the signal conditioners. The signal conditioner is connected to the adapter harness for these adjustments. The procedure is done with empty tanks and this allows the technician to bounce between the empty and full adjustments of the signal conditioner until no further improvements to the calibration can be made. The test set is used to simulate the capacitance of the probe (or probes) with full tanks. The procedure is repeated for each main
