Lake and Watershed Management Plan Update for Silver Lake

February 2014

**Submitted to:
Silver Lake Watershed Commission
Perry, NY**

**Submitted by:
F. X. Browne, Inc.
Lansdale, PA**

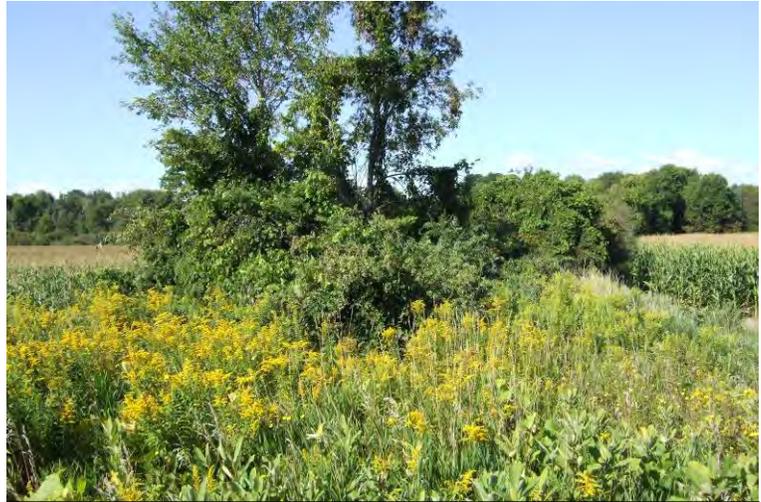
Agricultural land uses are predominantly hay and pasture or corn and soybean crops. Only one confined area feeding operation (CAFO) is located in the watershed. The Pingrey Farm CAFO appears to be well managed and there does not appear to be any issues with its discharges. Reconnaissance of the other agricultural areas indicates that the primary source of nutrients may be runoff from agricultural fields. Several agricultural fields within the watershed have very little separation between the edge of farm fields and stream banks, especially in fields where crops are grown.

Typical view of croplands adjacent to stream channel with deficient riparian buffer.

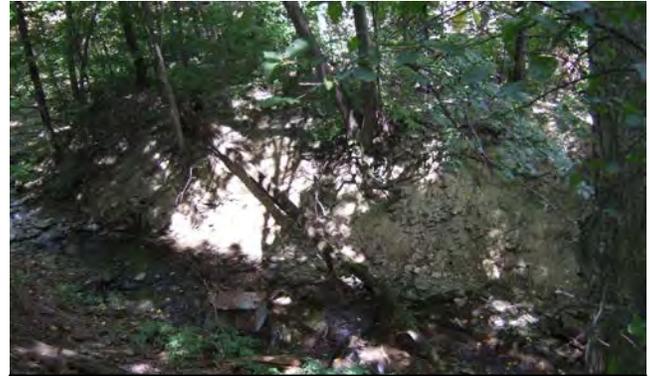
Streambank Erosion in the Silver Lake Watershed

Streambank erosion is typically a major source of nonpoint source pollution in many watersheds. Eroded streambanks are highly susceptible to continued and significant erosion which deposits sediments and nutrients directly into the streams and ultimately into Silver Lake. During rain events, stream flows and velocities increase, and erosion begins. Several streams flowing into Silver Lake have eroded streambanks and lack adequate vegetation. It is likely that other areas of streambank erosion exist along the tributaries on private land that could not be inspected as part of this project. Any additional areas of streambank erosions that are identified by either the Conservation District or the Watershed Commission should be documented and added to the list of problem areas.

Restoration of eroded streambanks is a cost-effective way to significantly reduce sediment and nutrient loadings to Silver Lake. By using bioengineering (vegetative) or a combination of bioengineering and structural engineering streambank stabilization techniques, the erosion problems can be corrected while the stabilized streambank can serve as a vegetative buffer and, in many cases, a restored riparian corridor. Riparian buffers along the streams will reduce the quantities of sediments and nutrients that enter the streams via stormwater runoff.

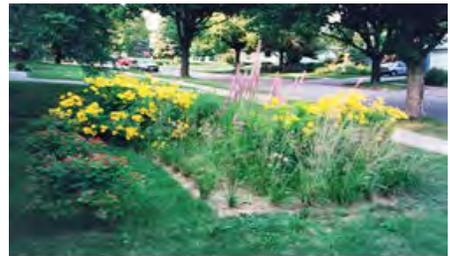
A flourishing rain garden.

A rain garden (bioretention basin) is a shallow surface depression planted with native vegetation to capture and treat stormwater runoff. The purpose of this BMP is to capture, treat and infiltrate stormwater. Rain gardens store and infiltrate stormwater runoff, which increases groundwater recharge and may decrease downstream erosion and flooding. Stormwater runoff water quality is improved by filtration through the soil media and biological and biochemical reactions within the soil and around the root zones of plants. Rain gardens improve water quality, reduce stormwater runoff and peak volumes, increase groundwater recharge, provide wildlife habitat and are aesthetically pleasing. Rain gardens can be installed by individual homeowners to treat stormwater runoff from their rooftop and driveways. Rain gardens can be an aesthetically pleasing way for homeowners to combine stormwater management and landscaping to their property. Stormwater is directed to the rain garden and provides water and nutrients for the plants. Excess stormwater is stored in this area and can continue to be used by the plants days after a rain event.

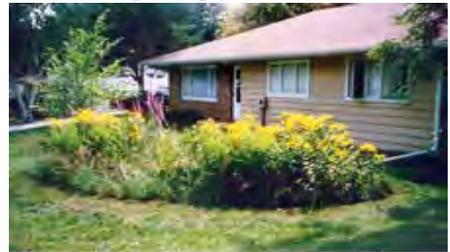
This rain garden is two years old. Weeds have a hard time growing. Birds and butterflies are regular visitors to the garden.

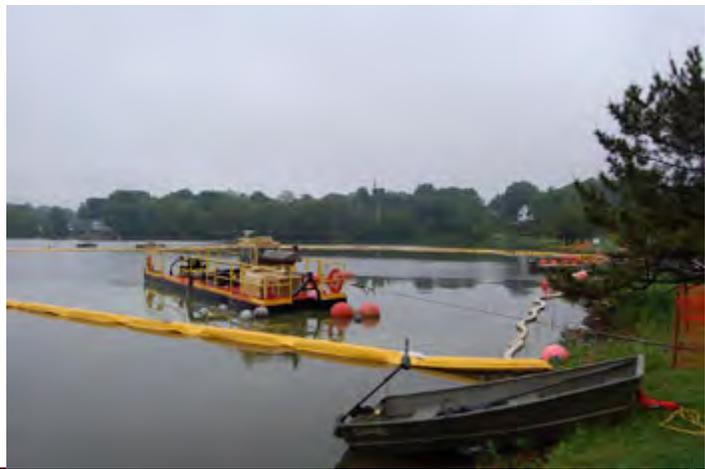
Hydraulic Dredging (source WMGLD.com)

Two commonly-used methods exist for dredging freshwater lakes. These include mechanical dredging, during which material is manually removed with heavy equipment such as bulldozers and clamshell diggers, and hydraulic dredging, during which dredged material is “sucked” out of the lake using a device called a cutterhead. Mechanical dredging could be accomplished during lake drawdown, if possible, or using a

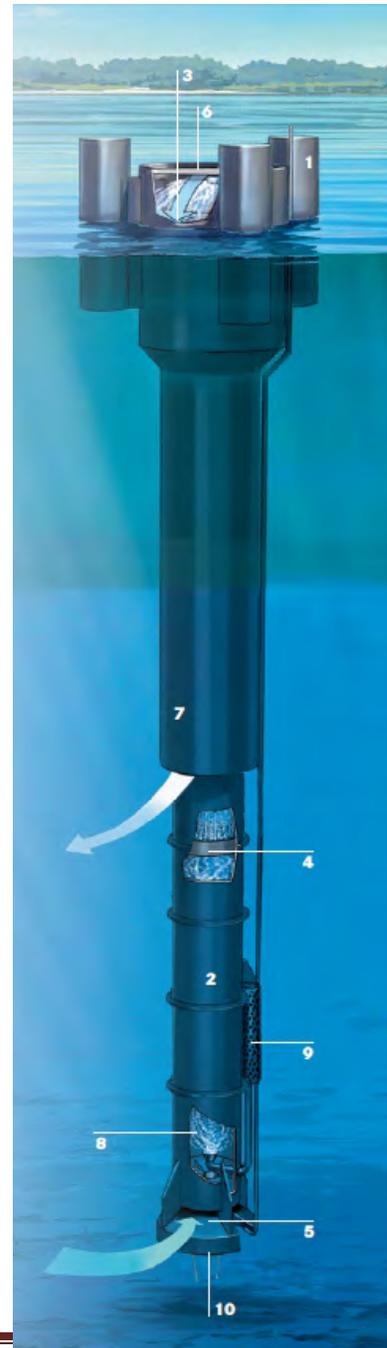
1. Floating tanks
2. Upstream pipe (Telescope)

3. Degassing chamber
4. Mixing device
5. Suction fence
6. Covering fence
7. Downstream pipe
8. Oxygen input
9. Submersible pump with ejector
10. Main ballast tanks

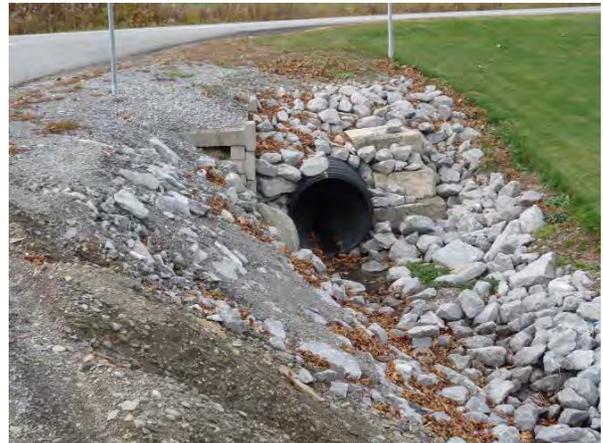
Culvert outlet with rock rip rap. Deep rills can be seen in the left corner.

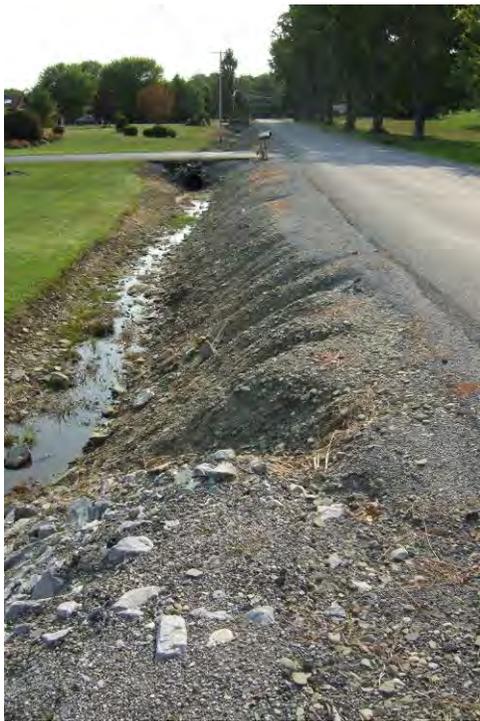
Looking downstream from the culvert outlet. Rock rip rap and deep rills can be seen in the roadside bank.

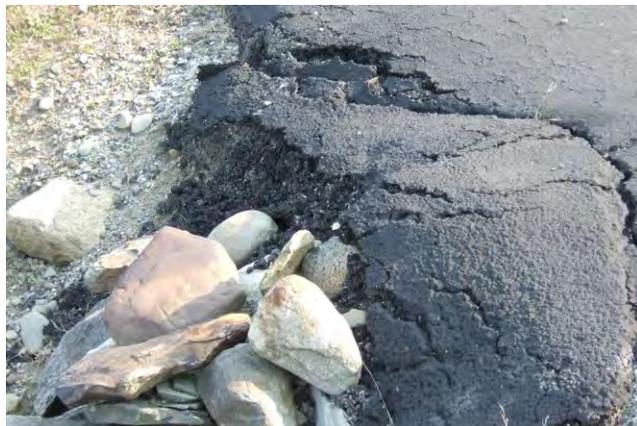
One the of the three driveway crossings (view from the inlet). Stabilization efforts can be seen, but have been ineffective.

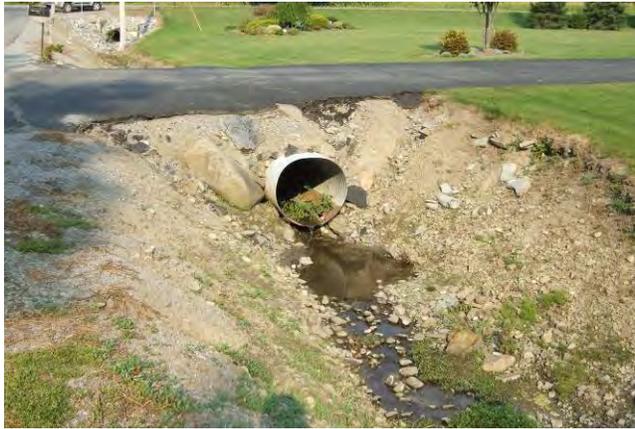
View of the first driveway crossing outlet. Similarly, stabilization has been attempted. Erosion can be seen on both banks from the road and the driveway.

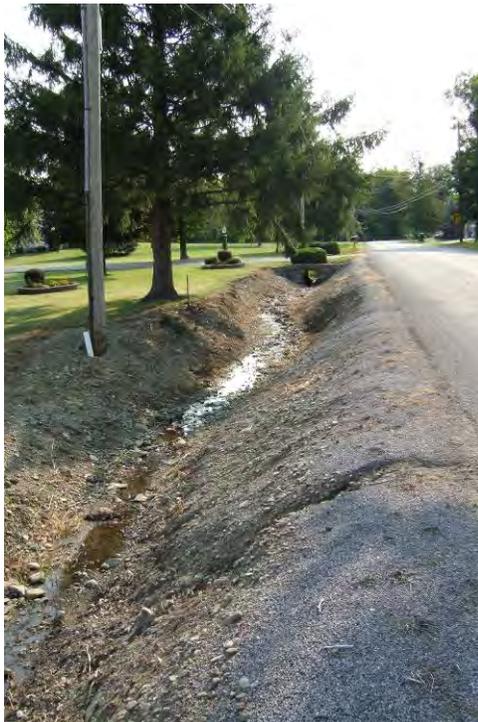
A view of the channel between the first and second properties. The second driveway crossing can be seen. Steep bank grade and rilling can be seen. The far bank, lacking vegetation, is also seen.

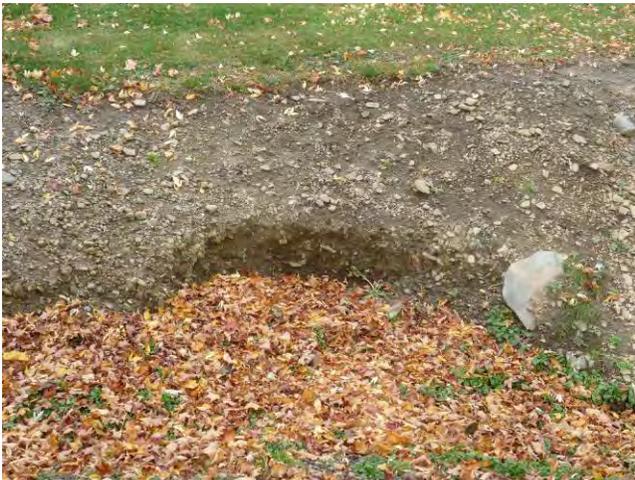
Part of the channel between the second and third properties. Water has cut into the far bank approximately 6 inches to 1 ft deep. The telephone pole is to the immediate right of the photo.

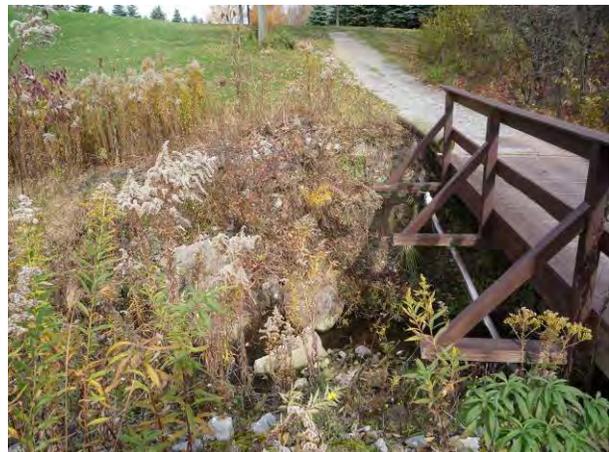
Golf Cart access bridge. Banks underneath appear to be eroding, which could create an unstable bridge.

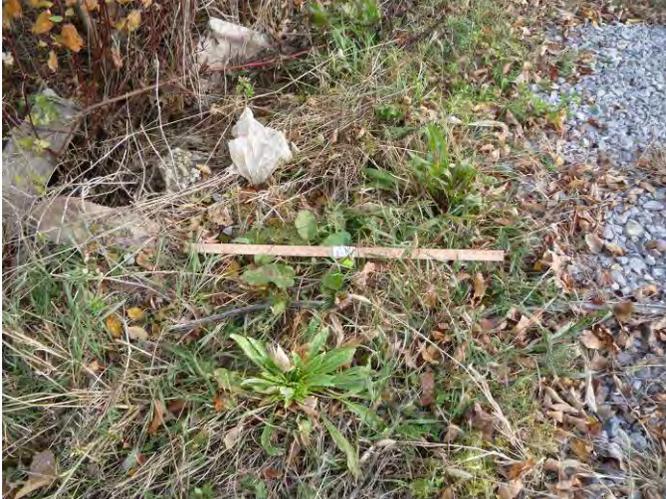
Portion of the channel where the bank comes approximately 3ft from the roadway. Some concrete slabs can be seen; used to attempt stabilization.

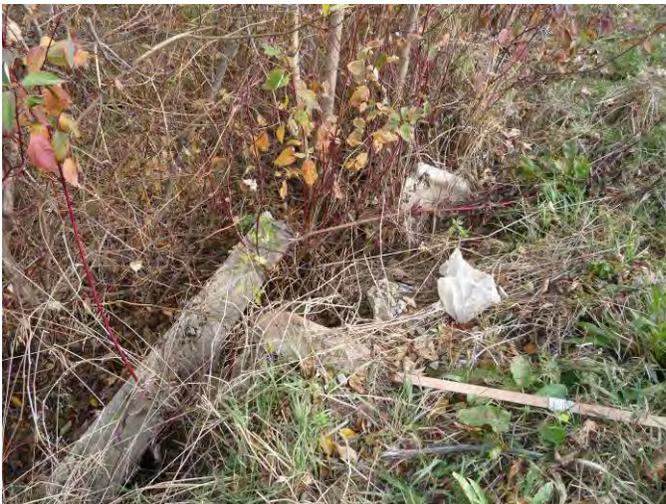
Concrete slabs used to stabilize the bank (continued from above).

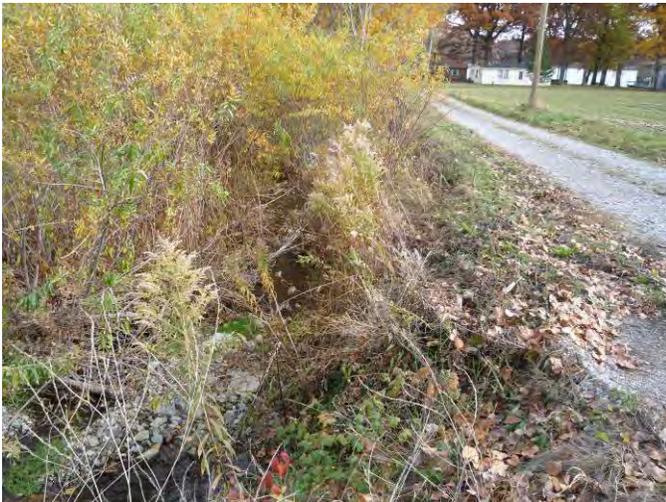
Bank erosion along the roadway.

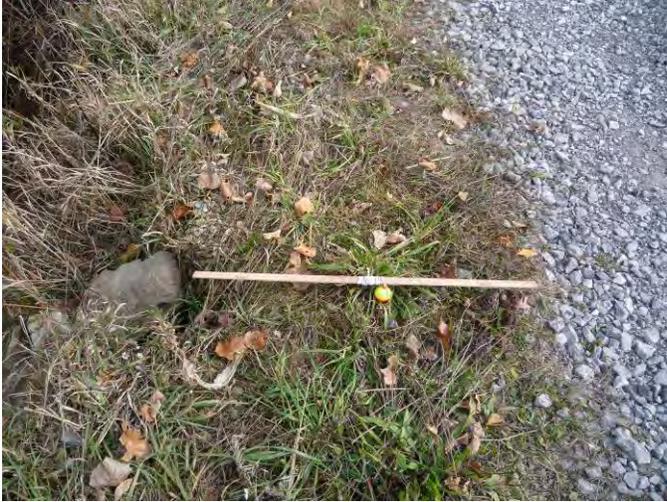
Portion of the channel where the bank is less than 3 ft from the roadway.

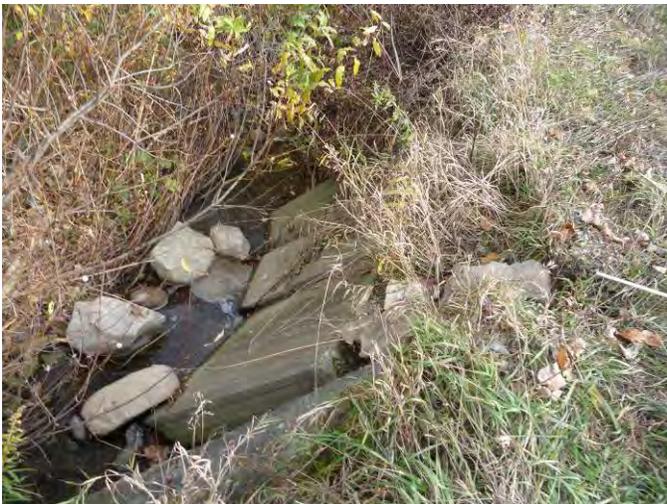
More stabilization efforts. Concrete slabs and other cobbles used.

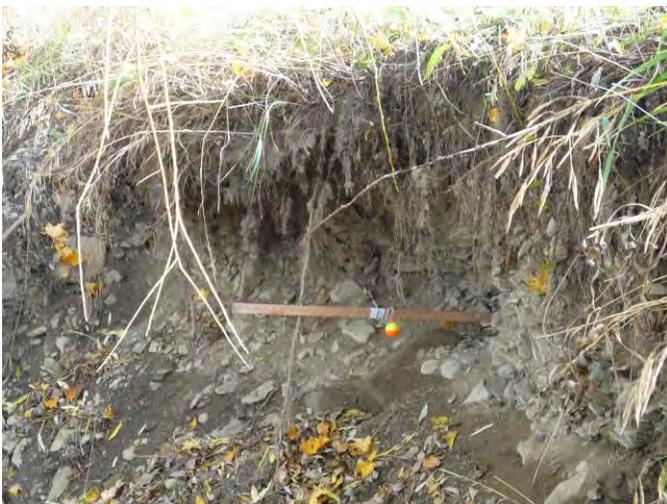
Bank cuts under the top approximately 26 inches.

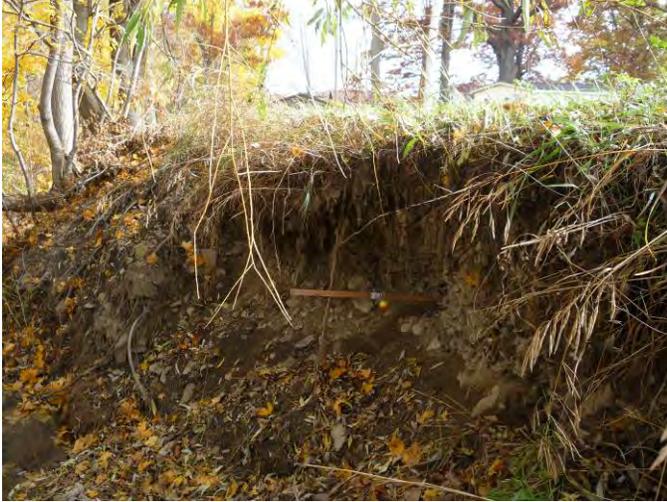
Tree and shrub roots have been exposed due to bank erosion.

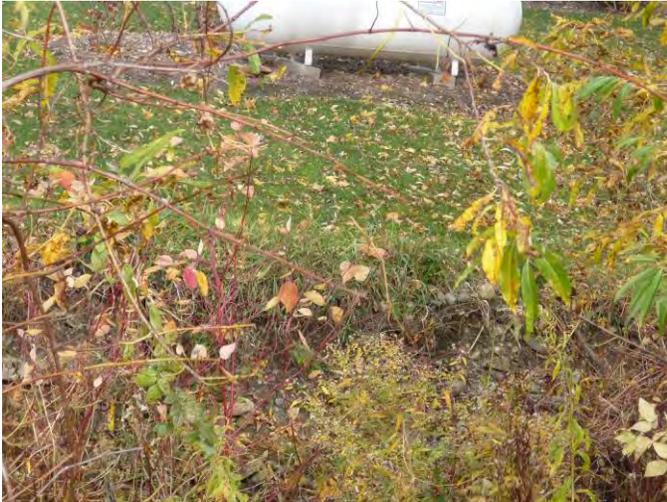
The channel is eroding the bank and lawn of property owner. Propane tank is approximately 20-30ft from bank.

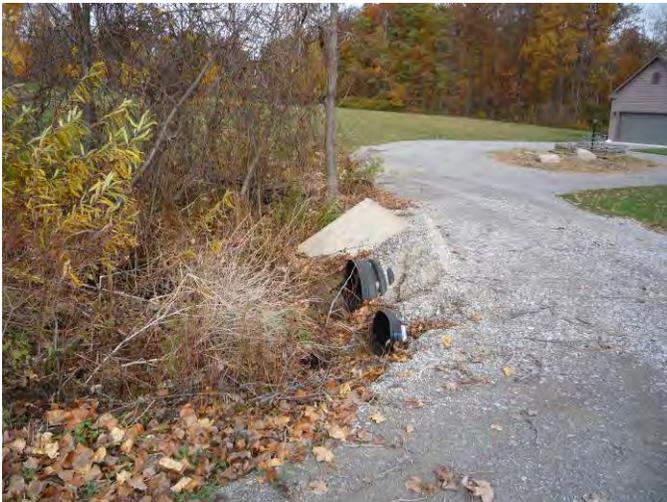
Driveway crossing suffering from erosion. Rill can be seen on the sides of the drainage pipes and a concrete slab was placed along the far bank to help stabilize the bank.

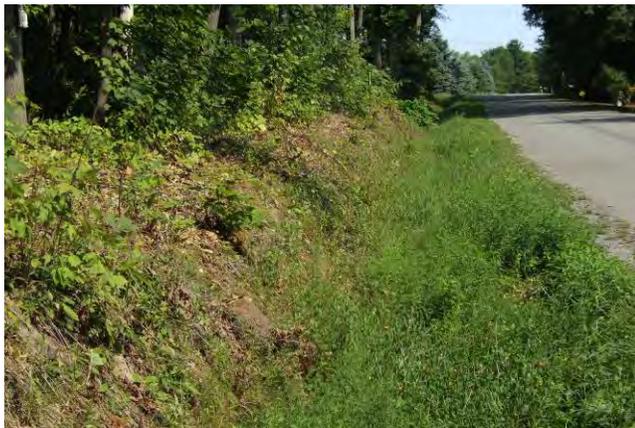
Successful remediation of the ditch along Luther Rd.

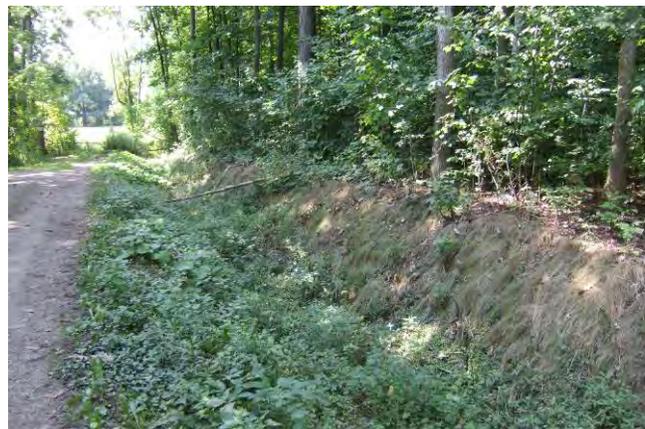
The corner of Silver Grove and Luther Rd. Erosion of the inner bank can be seen as well as rock rip rap used to stabilize the bank.

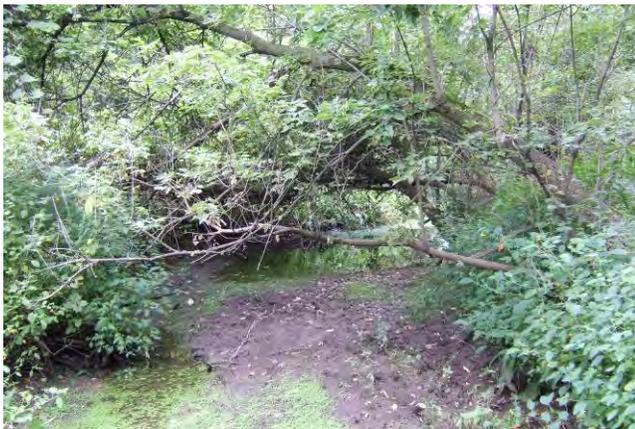
These pictures show evidence of disconnected flow areas and sediment deposition. The channels are undefined in parts and debris and log jams can be seen in the channel.

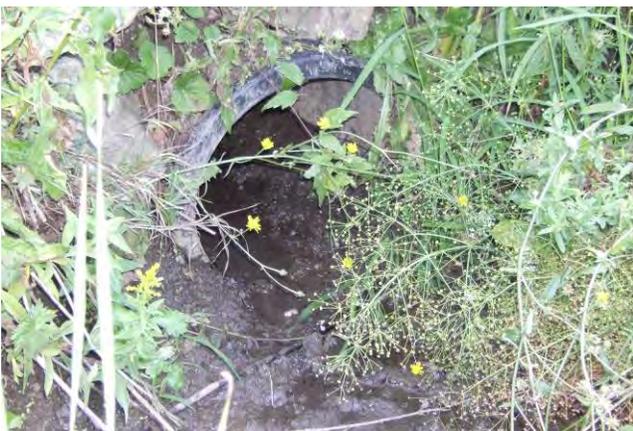
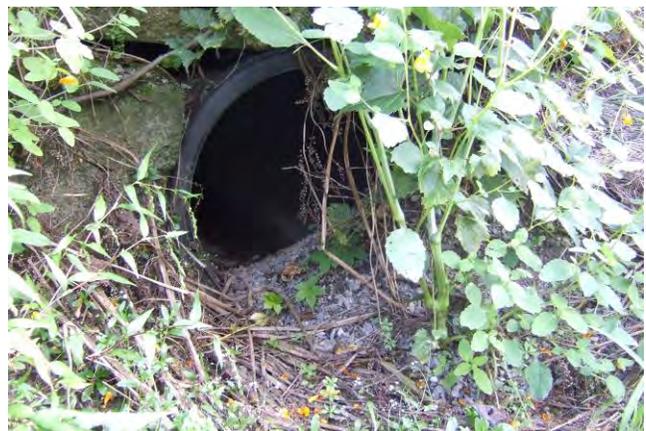
Silt and gravel deposition has partially filled culverts at the end of the stream channels.

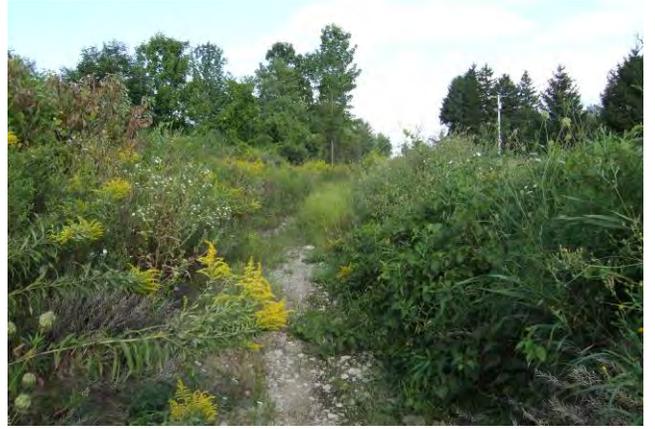
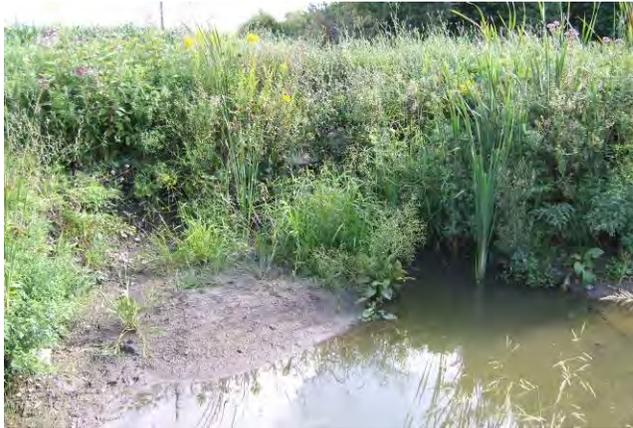
A gravel bar can be seen at the center of the channel that is running dry due to the drought like conditions.

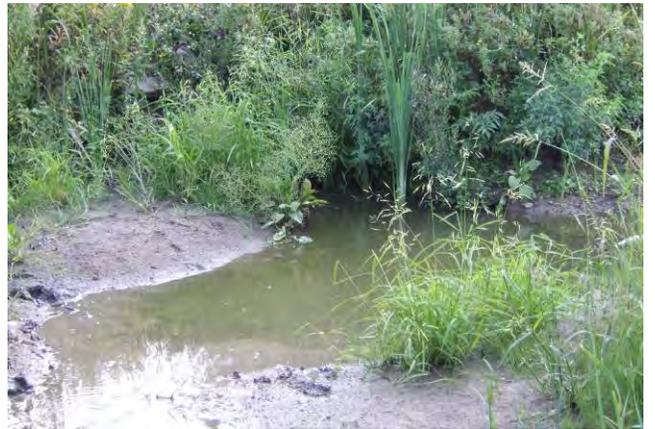
Deposition of silt just upstream of the roadway culvert is evident in these photos.

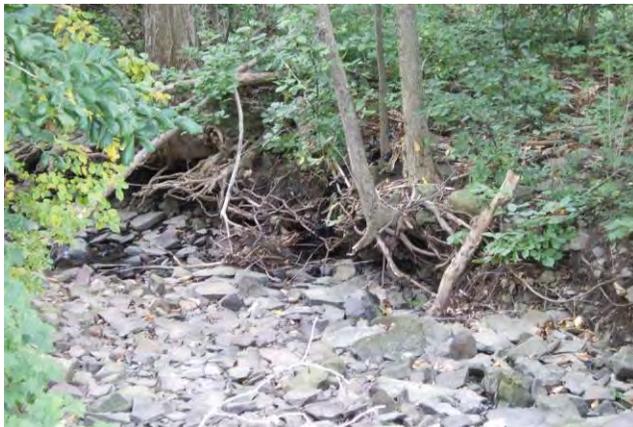
Undercut banks with exposed roots are visible on the outside bend of the stream.

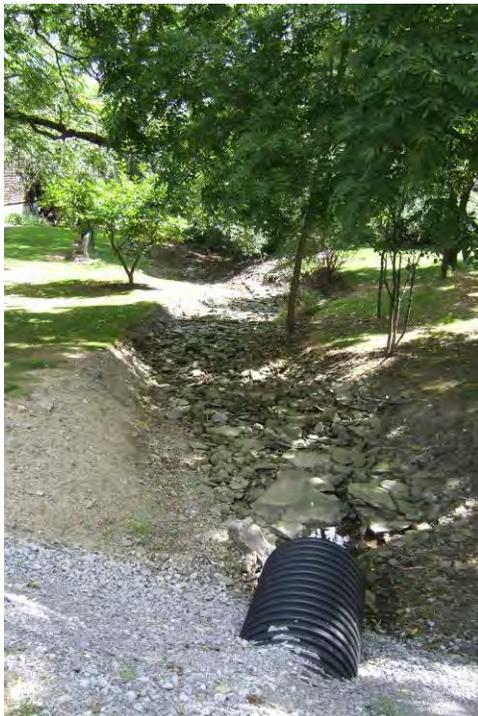
View of culvert and riprap stabilization looking downstream from Bacon Rd. Bare soils can be seen on the left bank and mowed grass is adjacent to top of banks on both sides.

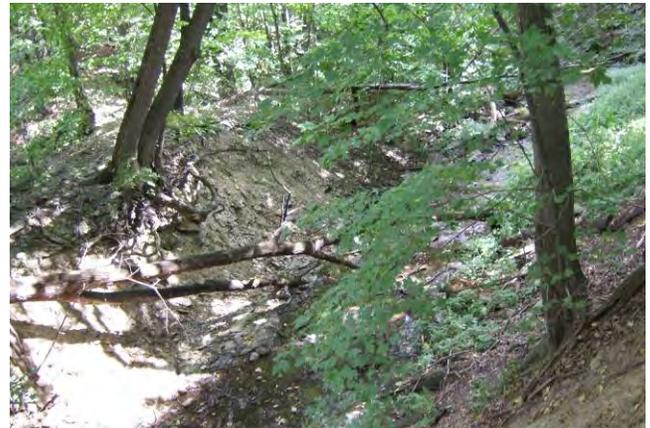
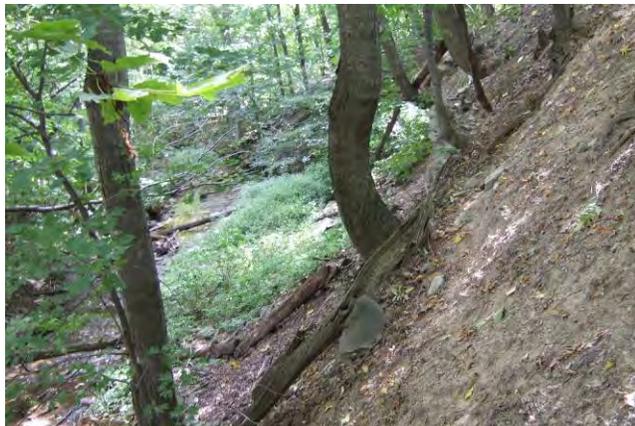
Undercut trees with exposed roots approximately 10 feet above stream channel and large fallen trees were observed here.

Steep side slopes with very little vegetation and exposed soils pose very high erosion potential.

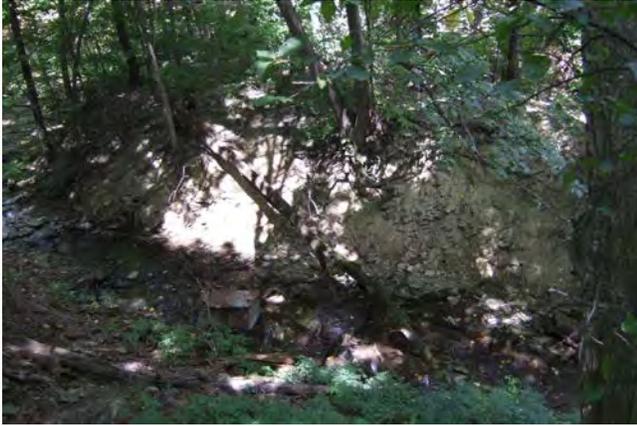
15 feet high banks with exposed soils and trees with undercut and exposed roots pose a very high risk for severe erosion and tree falls.

Very steep and high side slopes on the right bank appears to have been caused by high flows and severe erosion.

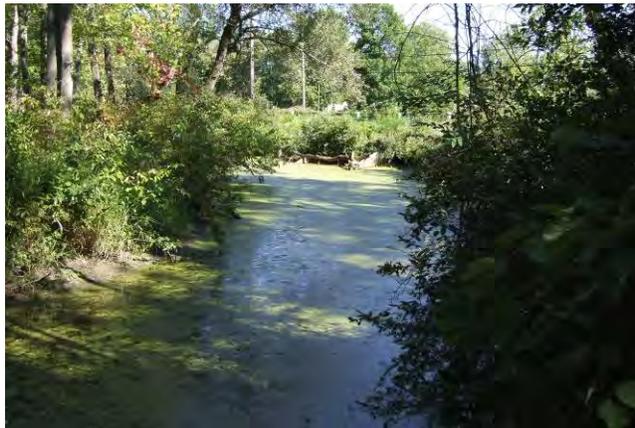
View of Silver Lake inlet (dual 72” corrugated metal pipe culverts). Algal bloom can be clearly seen along entire length to culverts.

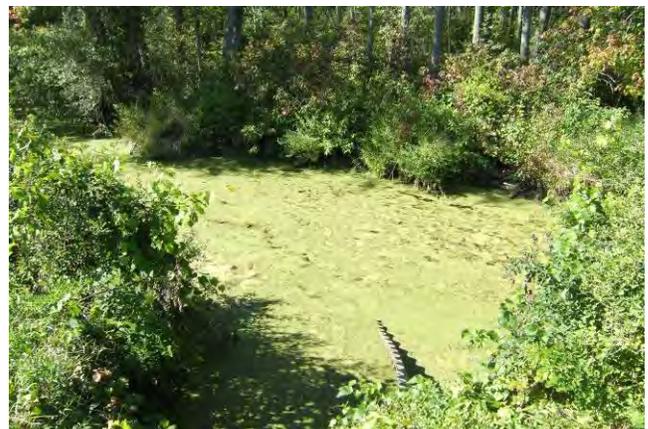
View from Oatka Rd. looking north. Culverts can be seen in the foreground and algal blooms have turned the stream channel completely green.

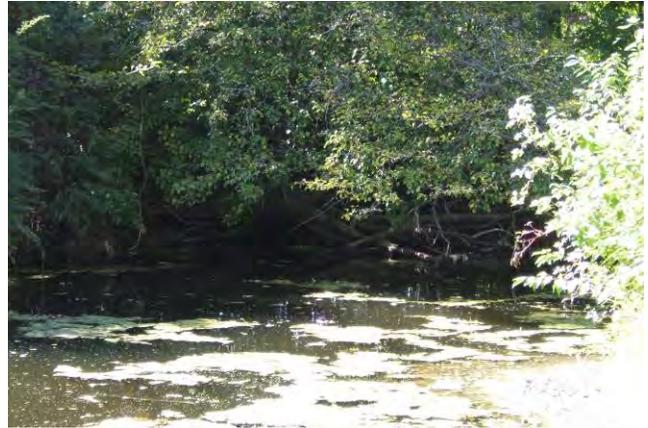
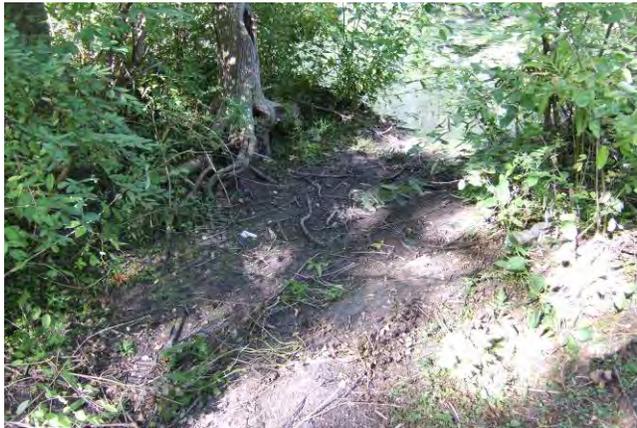
Undercut banks around bends

Bare soils at access point to stream where canoes and watercraft are regularly placed into stream.

Moderate erosion (2-4' cut banks) around some bends were observed but appear to be stabilizing.

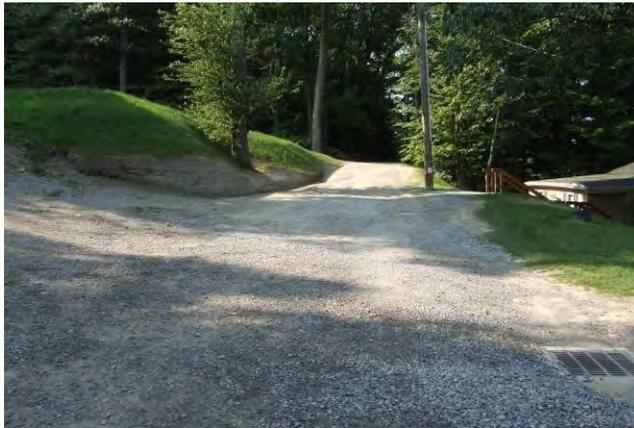
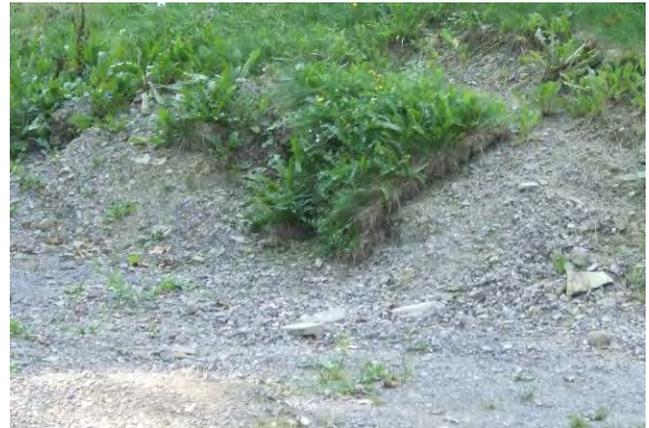
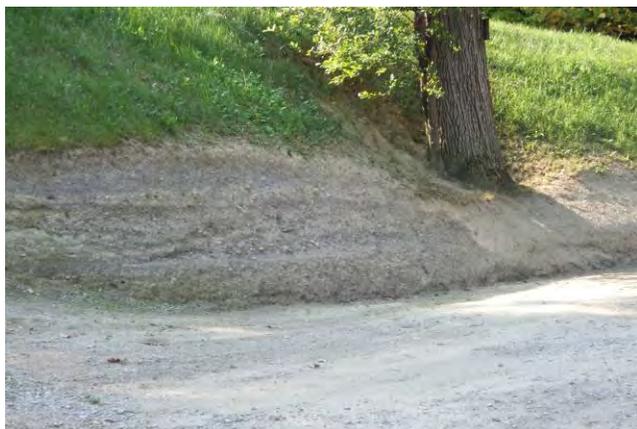
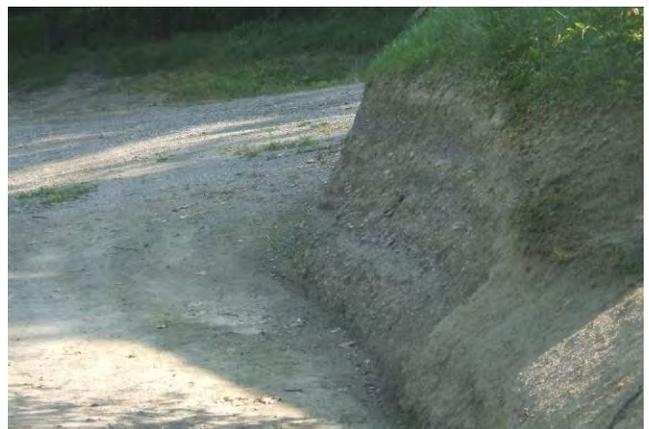
Bare and exposed soils at toe of slope and adjacent to a storm drain that discharges into the lake. Erosion was evident on the gravel road.

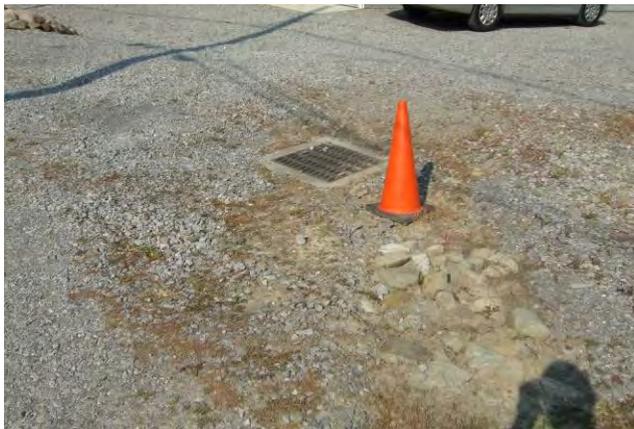
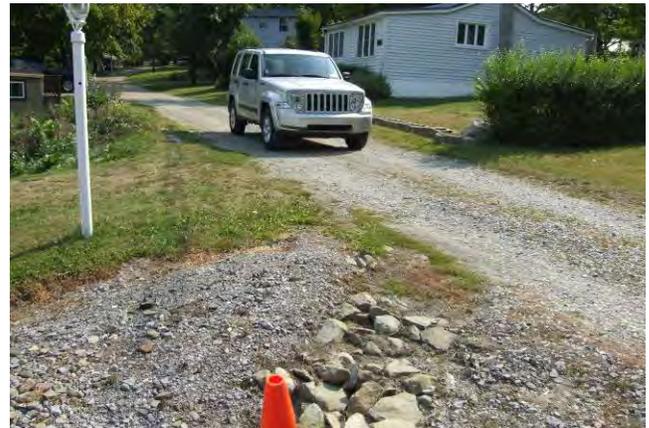
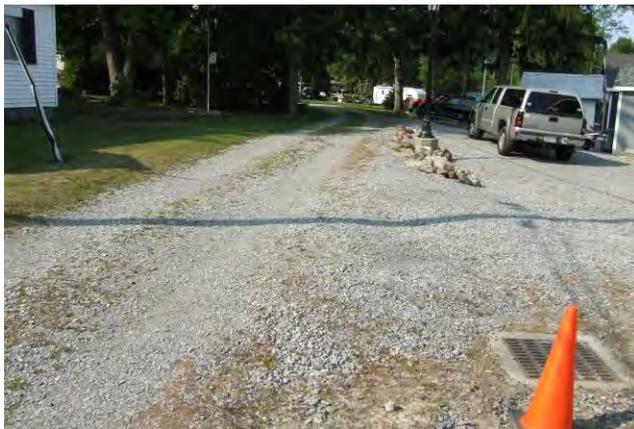
Minor to moderate erosion in and around stormwater inlet that discharges into Silver Lake. Efforts to stabilize with riprap do not appear to be working. Roadway regrading and stabilization may be necessary to alleviate this problem.

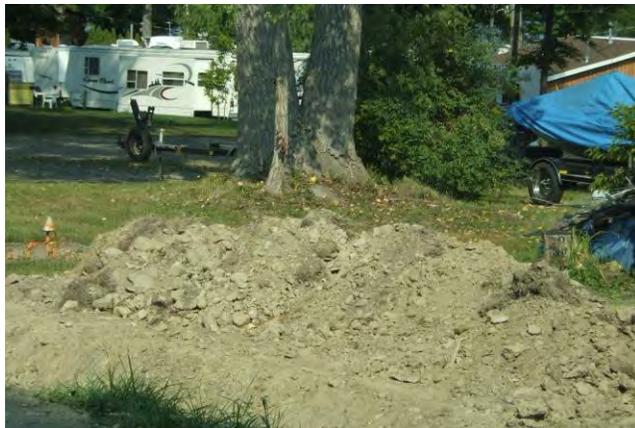
Soil stockpile showing recent construction activities with ditch repairs and installation of culverts

View of ditch along Lake Shore Dr with fallen sign that indicated ditch repair work

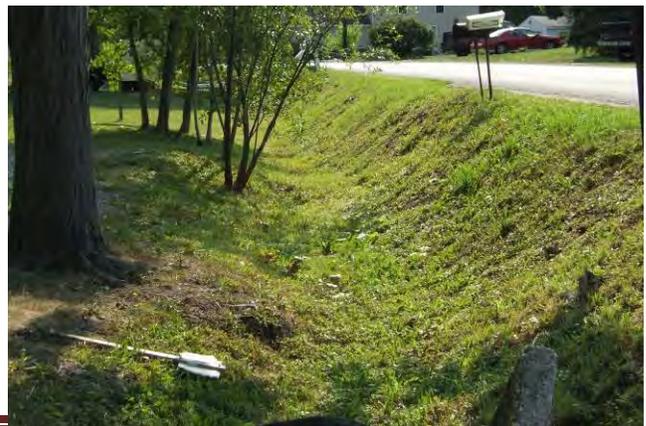
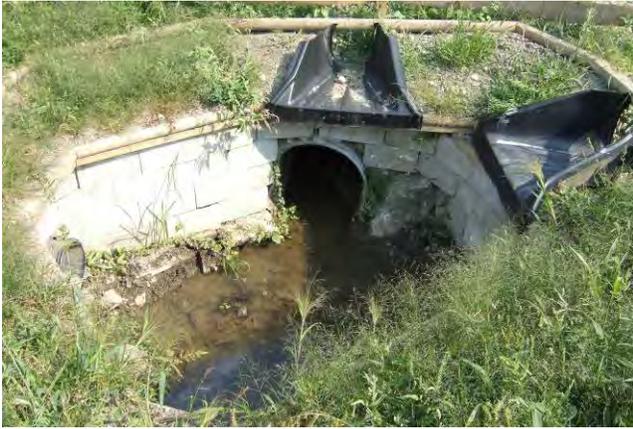
Culverts and end sections with minor erosion around buried culvert pipe

Bare soils showing recent construction activities likely associated with culvert and ditch repair work

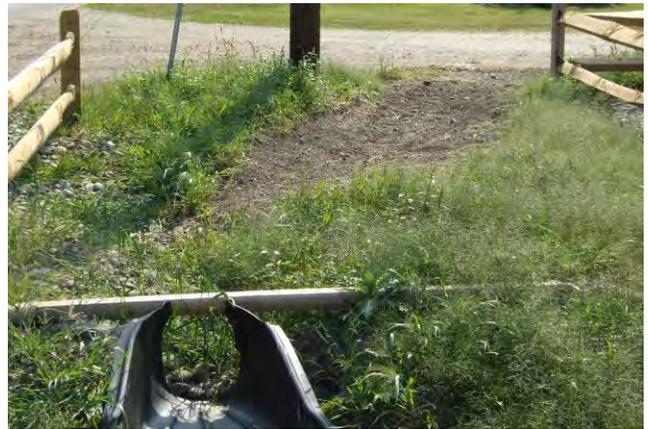
Gravel and sediment in end section of culvert indicating moderate erosion in upstream channel.

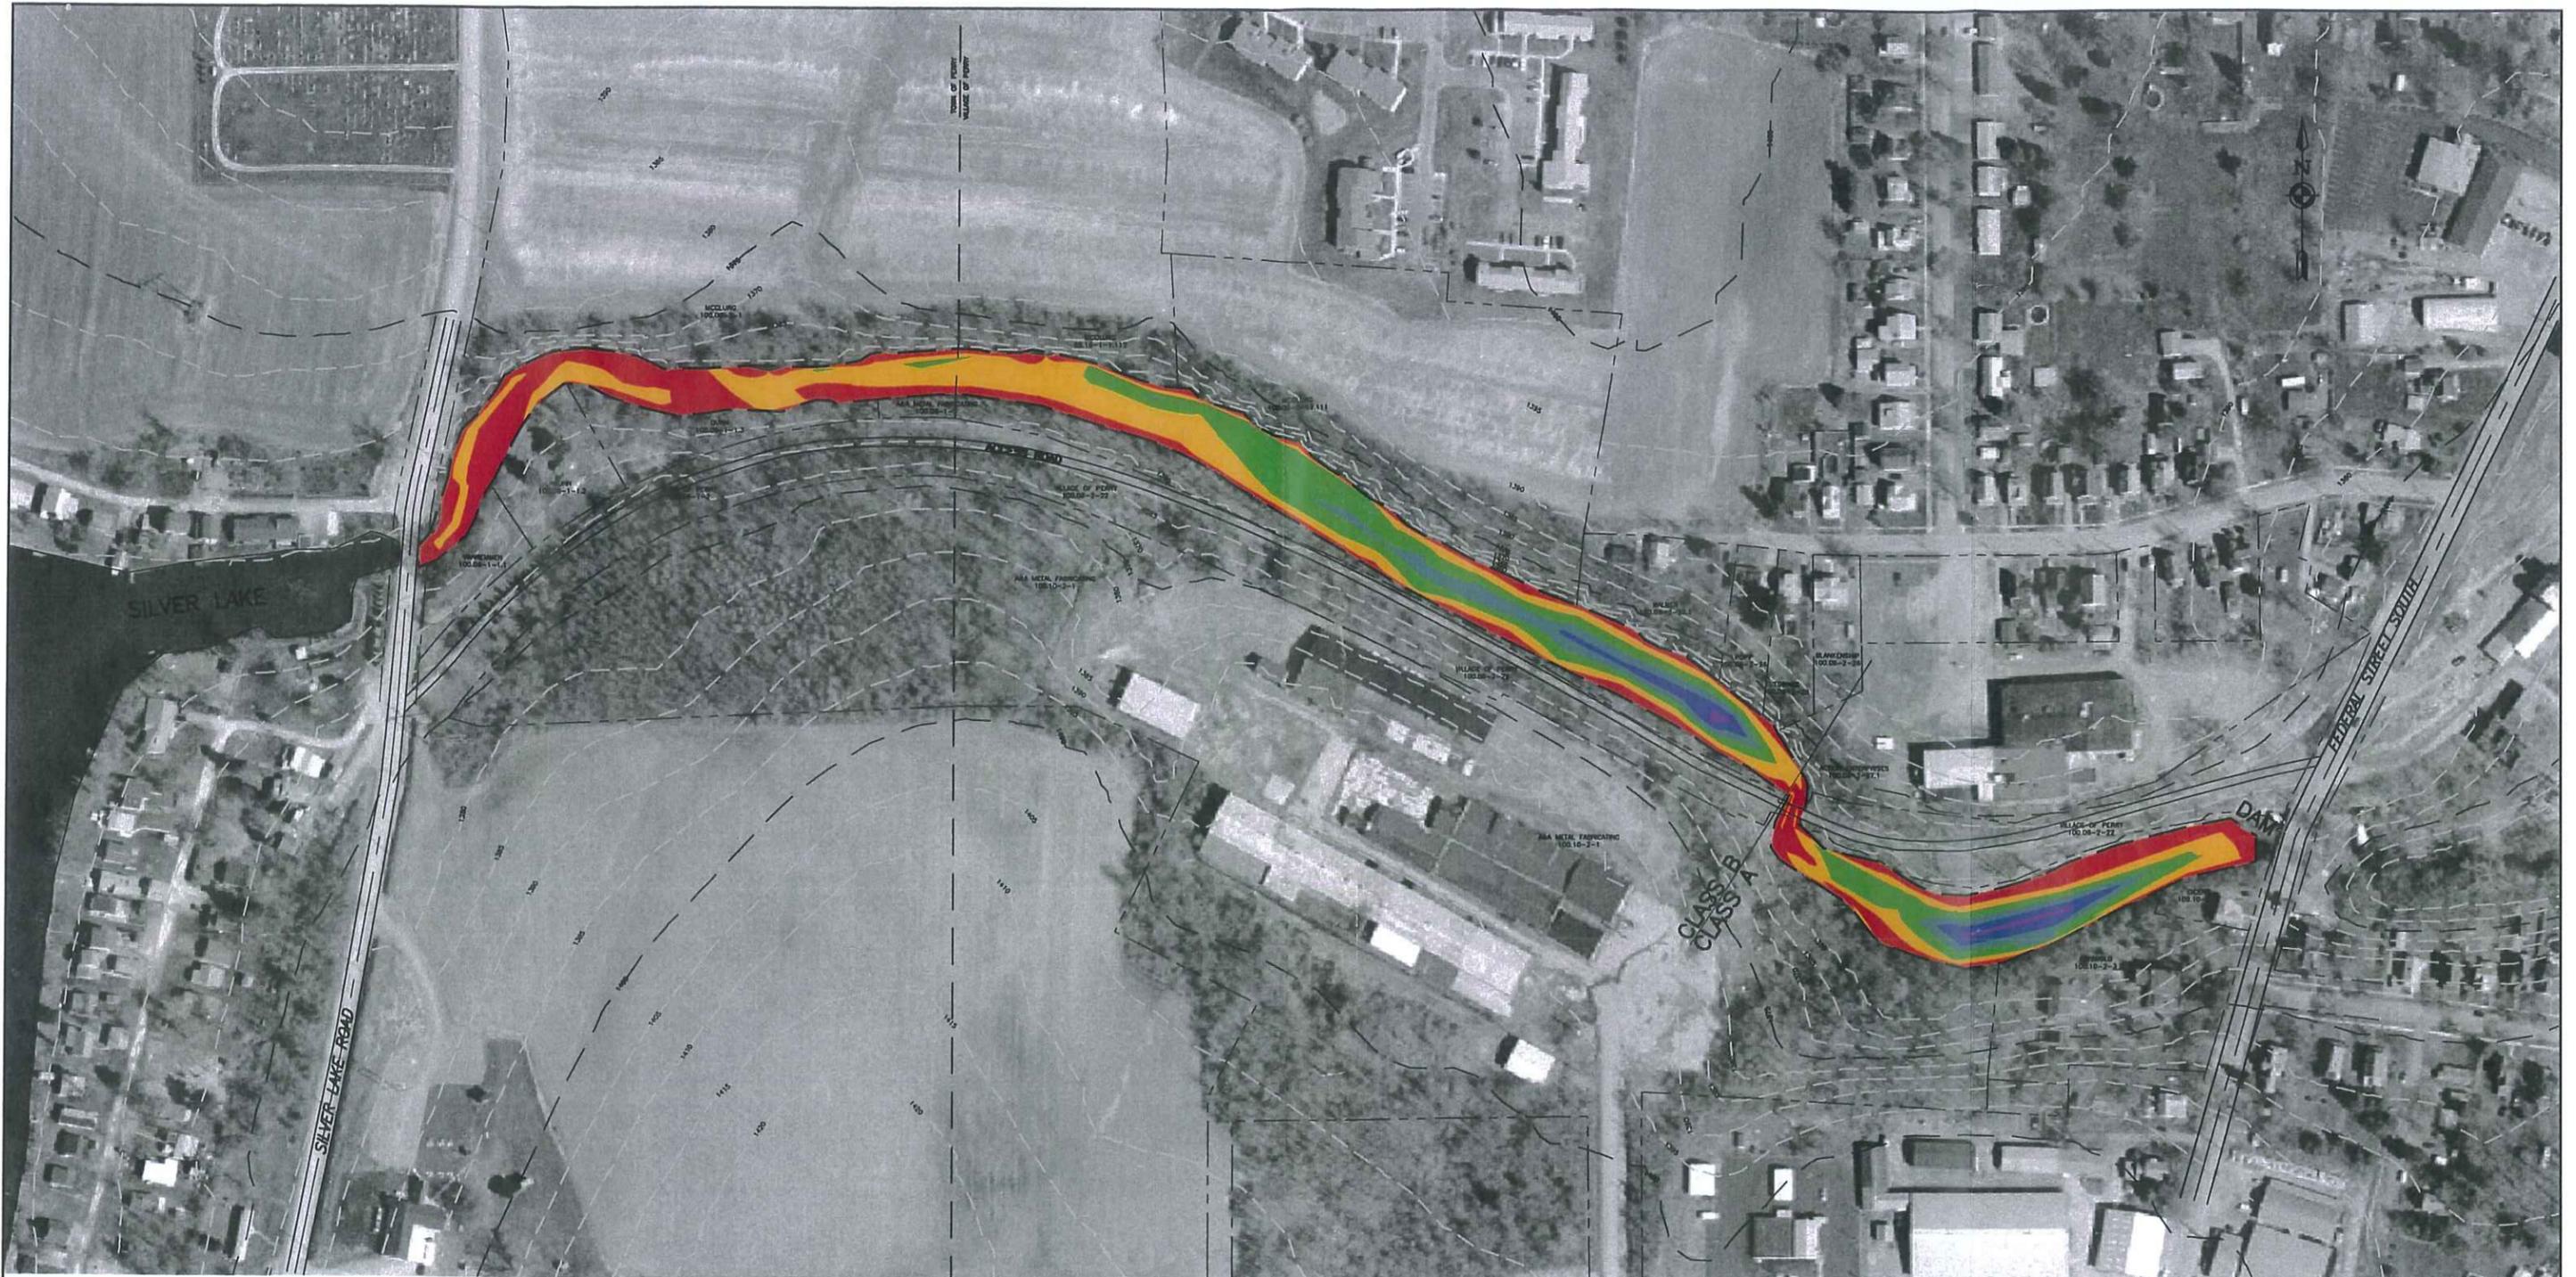
Outlet Sediment Thickness Map (Clark Patterson Lee 2010)

In 2009, the Village of Perry conducted a preliminary feasibility study for sediment removal in the Silver Lake outlet. The study determined that the outlet contained approximately 20,000 cubic yards of sediment clogging the channel, with a total capital cost for removal of \$339,000 (Clark Paterson Lee, 2010). During our macrophyte survey, the channel was found to be choked with macrophytes to the extent that it was impossible to traverse the channel. See Appendix F for a copy of the outlet sediment thickness map.
