Re: Wetland Site Assessment and Recommendations
(JFNew Project # 1005009.00)

Meadowbrook Condominium Association Wetland Complex Assessment Report

JFNew Project File No. 1005009.00

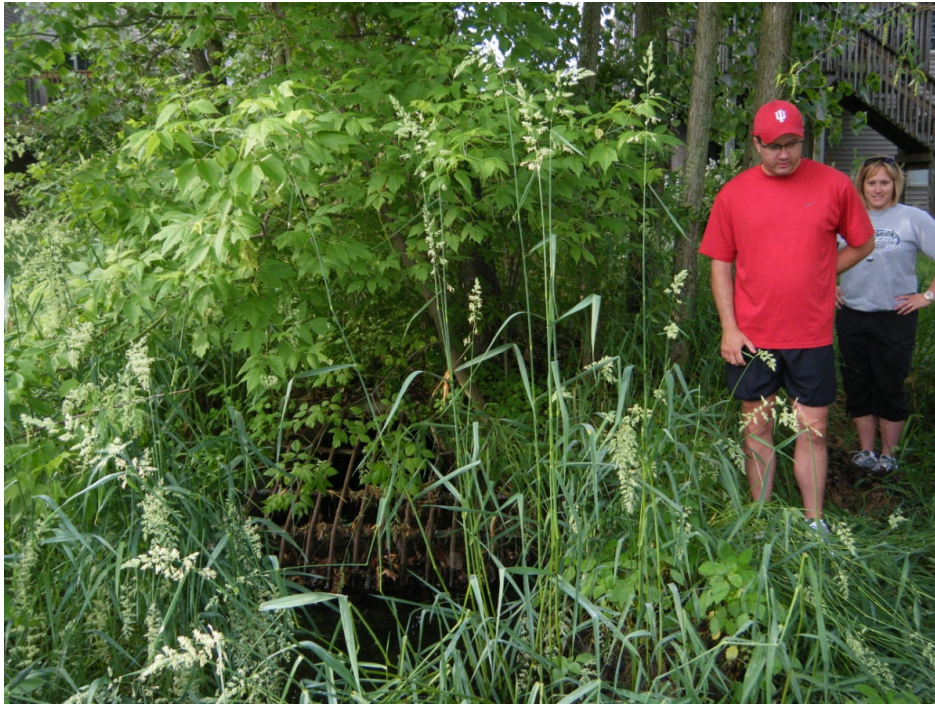
- Bur-reed (*Sparganium eurycarpum*)
 - New England aster (*Symphyotrichum novae-angliae*)
- There are two stormwater discharges into the southern portion of this wetland complex. The southernmost outfall (between Lots 16 & 17) shows signs of previous discharge of sediment (Photograph No. 1 of

Appendix A)¹. A small channel going north into the wetland complex divides the sediment load. Reed canary grass has colonized this sediment load.

Photograph No. 1 - View south at storm water outfall located between Lots 16 and 17

- ➔ Recommend removal of this sediment load through the use of either hand shovels or a back-hoe. This activity may be able to be conducted under the auspices of the Clinton County Drain Commissioner's office as part of their maintenance activities of this alleged designated drain/detention basin. If this activity is not able to be completed as part of County drain maintenance, a permit from the MDNRE LWMD will be required prior to initiating any ground disturbing activities.

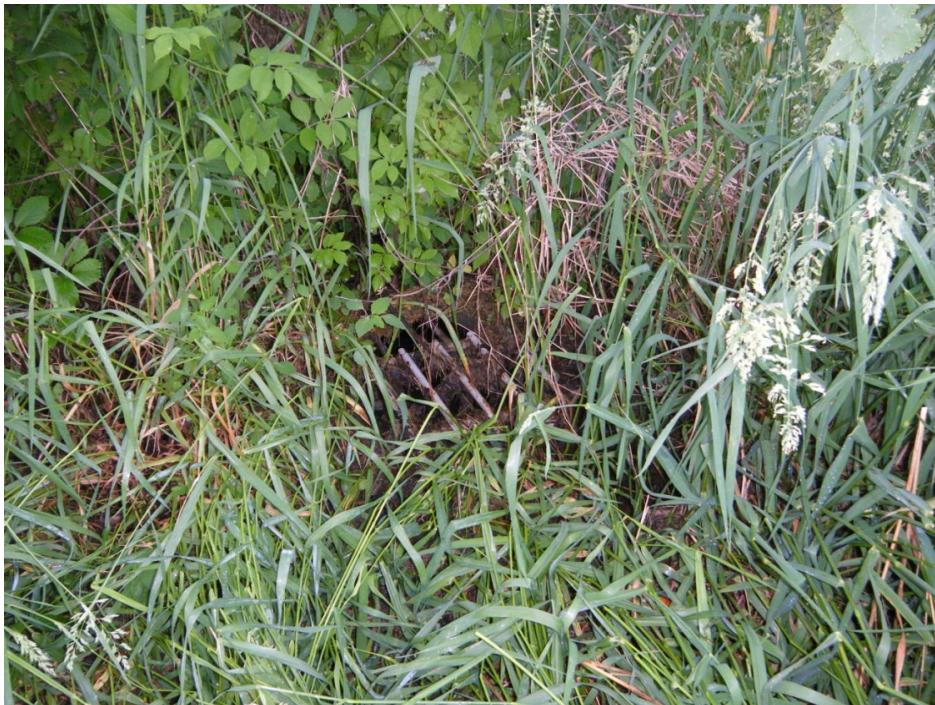
- The northernmost outfall (south of Lot 8) appears to be blocked with leaves and only a minimal amount of sediment or loading into the wetland complex was evident from this discharge/outfall (Photograph No. 2).

Photograph No. 2 - View east at stormwater outfall located south of Lot 8
(Note: blockage within outfall and heavy growth of vegetation at discharge point)

- ➔ Recommend removal of leaves and other debris apparently blocking this discharge/outfall to the wetland complex.
- The overflow outlet pipe for this wetland complex is located just north of Lot 14 (Photograph No. 3). The outlet was not obstructed and appeared to be passing a small amount of water.

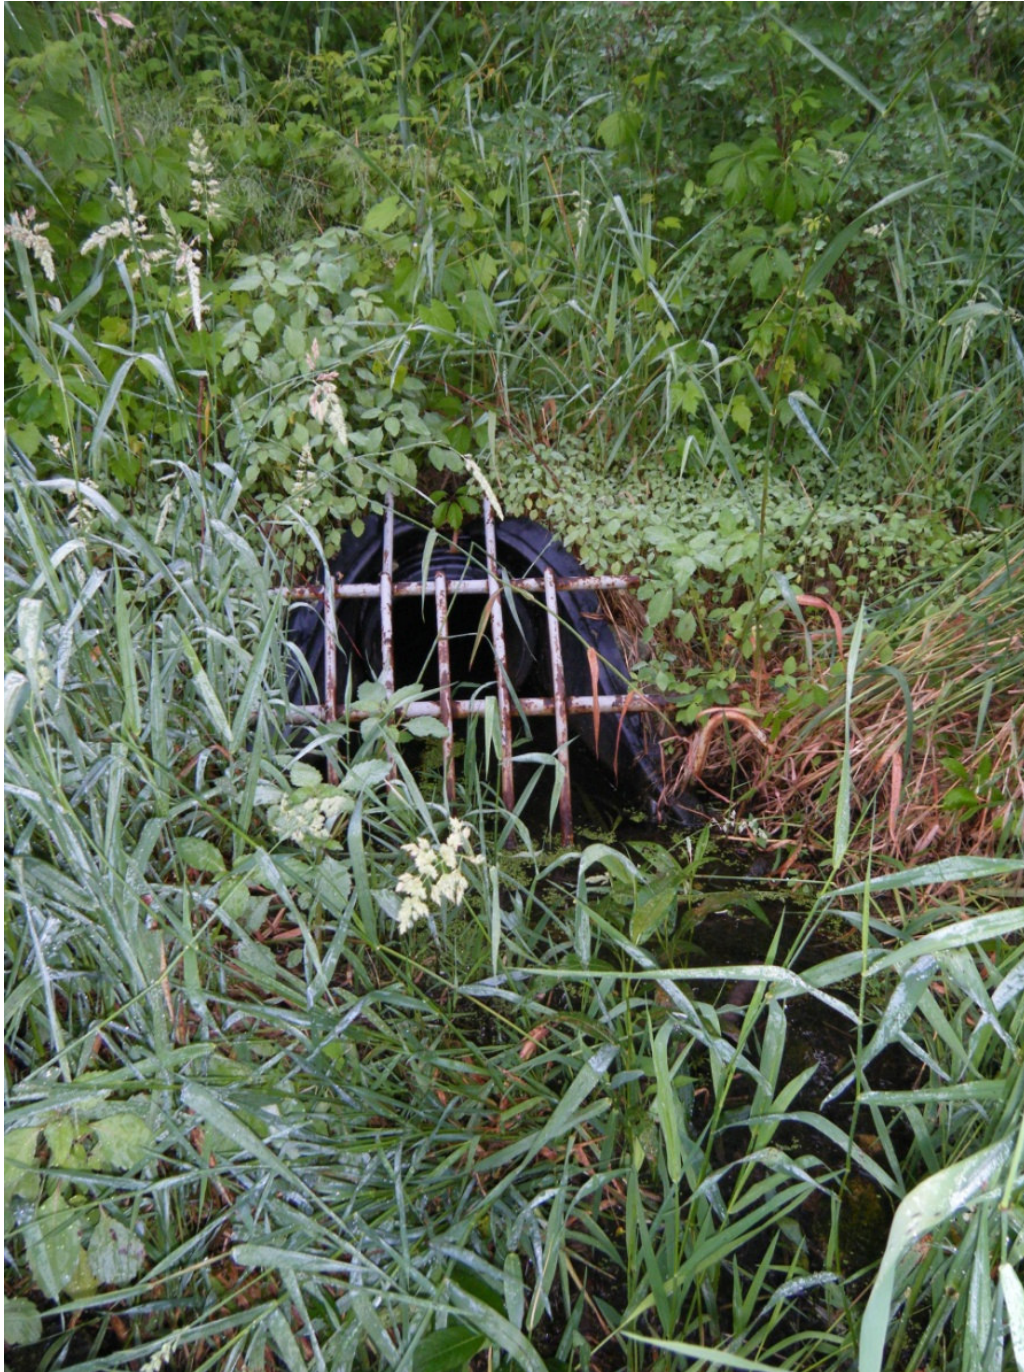
Photograph No. 3 - View east at outfall located north of Lot 14

- ➔ No recommendations for this outfall

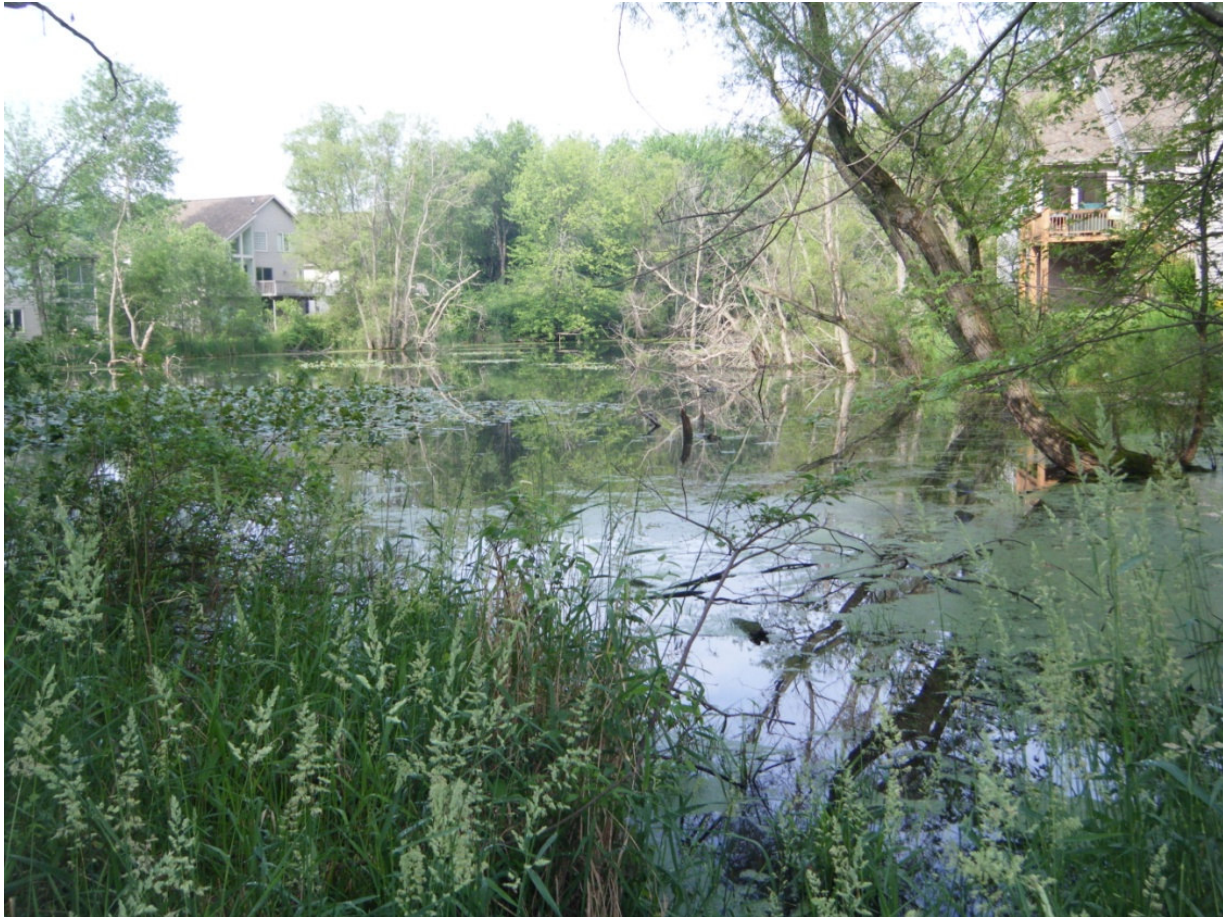
Northern and northwestern portion of wetland complex (Photograph No. 4)

- mostly open water, submergent, emergent, and forested wetland
- Apparent deeper portions of the wetland complex - approx. 6 feet deep
- Most properties maintaining a vegetative buffer between mowed lawns and wetland complex
- Vegetation within this portion of the wetland complex dominated by:
 - Duckweed
 - Yellow pond lily (*Nuphar variegata*)
 - Fragrant white water lily (*Nymphaea odorata*)
 - Water milfoil
 - Reed canary grass
 - Touch-me-not/Jewelweed
 - Silver maple (*Acer saccharinum*) in forested wetland areas
- There are three storm water discharges into the northern portion of the wetland complex. The first one is located in the northern to northeastern

Photograph No. 4 - View west at northwestern open water portion of wetland complex

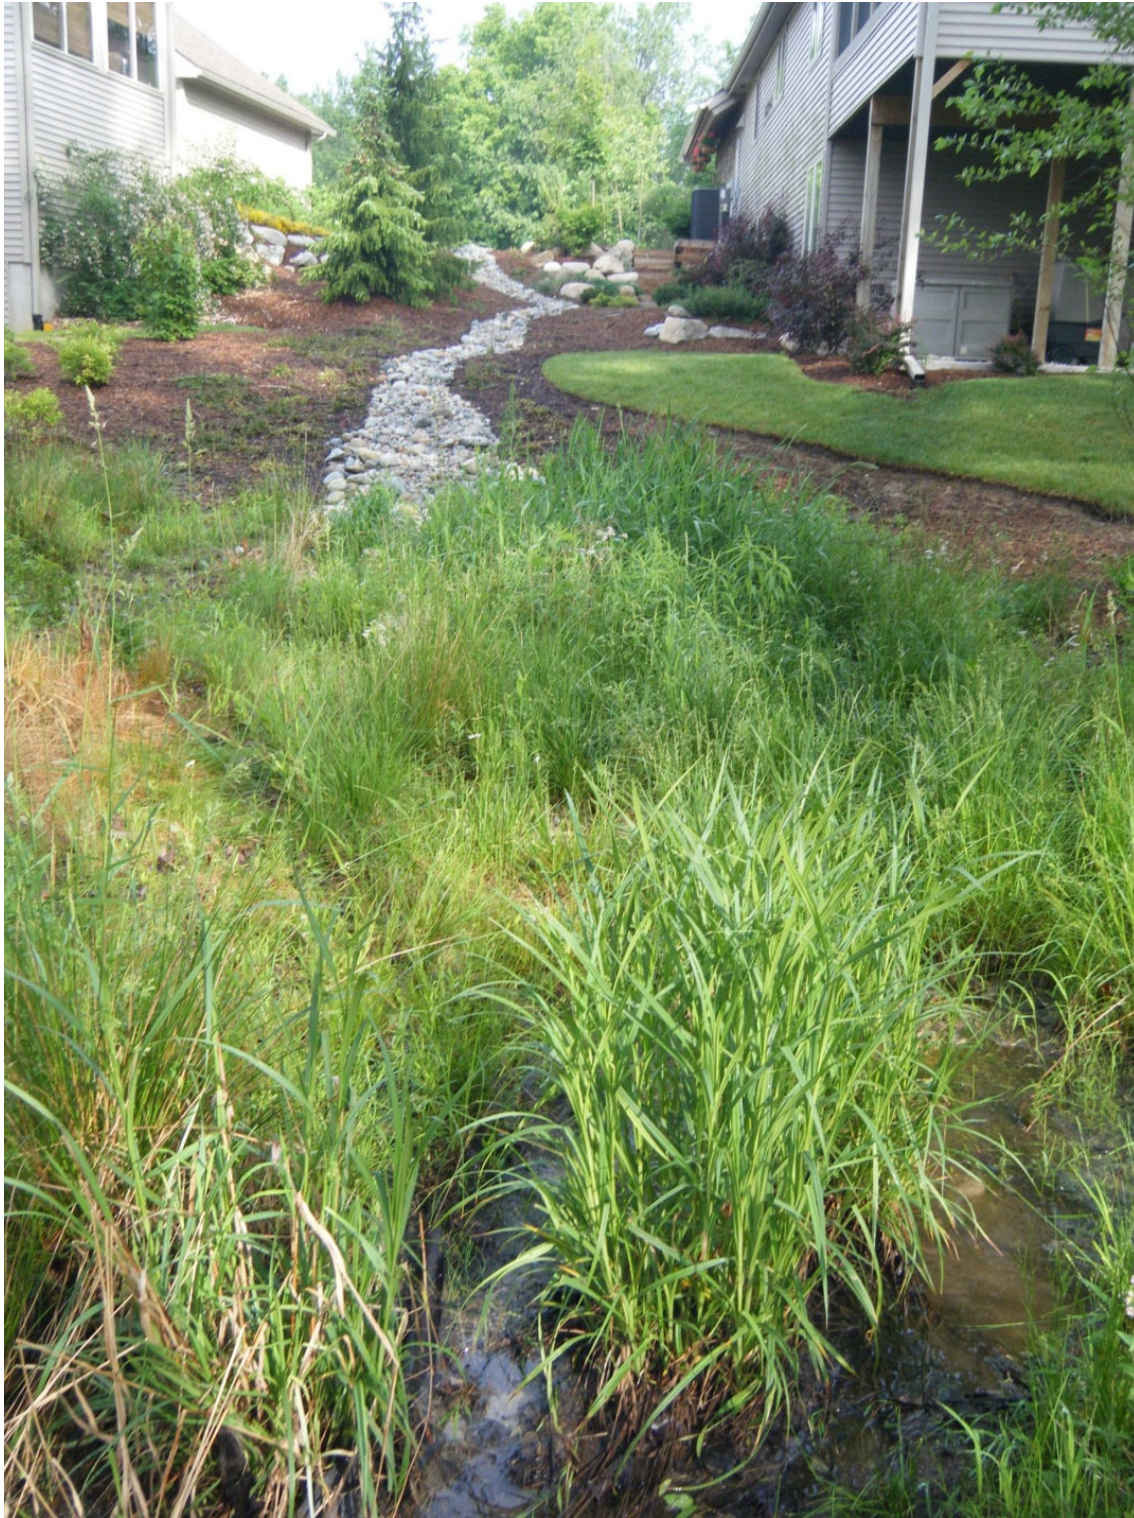
end between Lots 126 and 127 (Photograph No. 5). Efforts have apparently been made to control erosion and stabilize the outfall and discharge into the wetland complex.

Photograph No. 5 - View northwest at storm water outfall located between
Lots 126 and 127

- ➔ Recommend removing by hand and/or treating reed canary grass with an aquatic-approved herbicide to prevent its inevitable spread into other areas of the wetland complex.

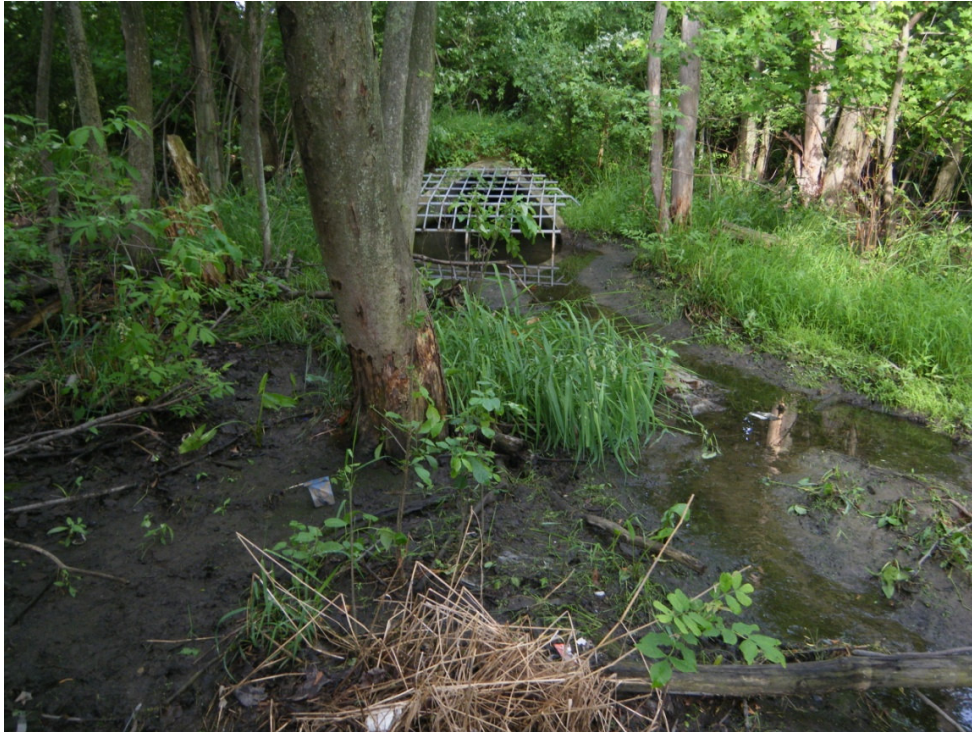
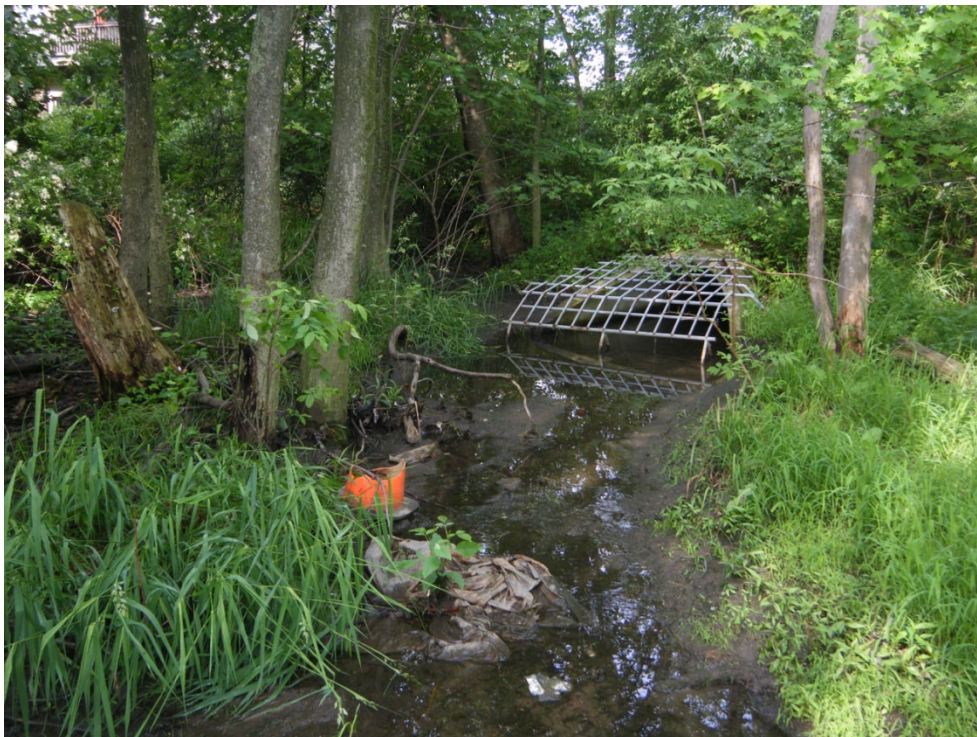
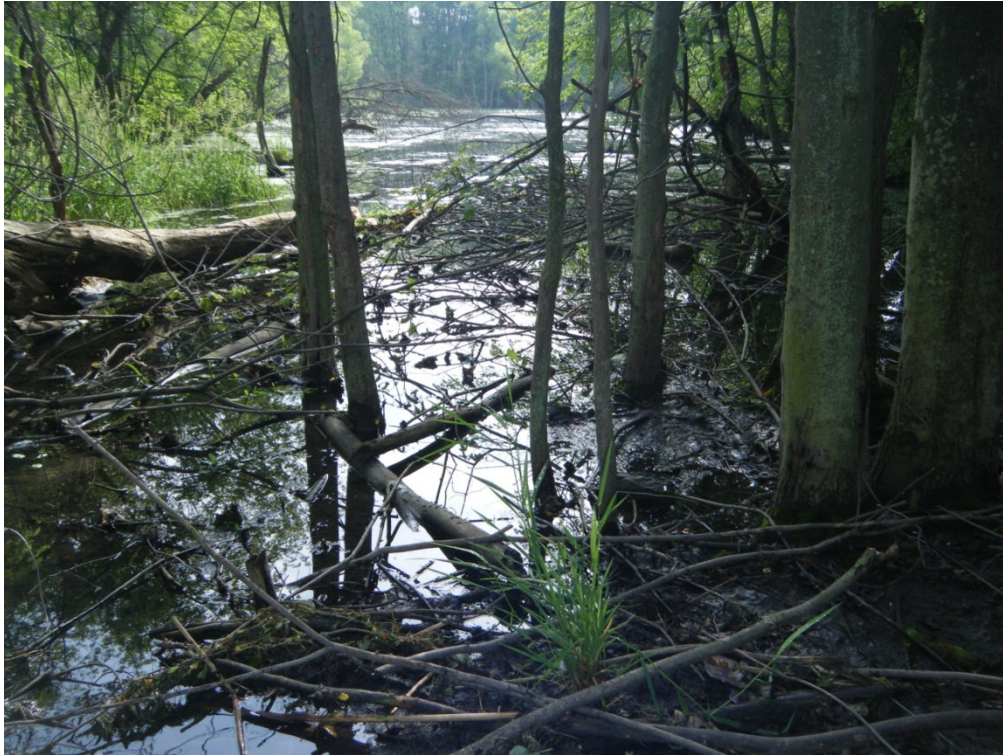
- The second and largest discharge is at the far northwestern end of the wetland complex, is over 6 feet in diameter, and located between Lots 137 and 138 (Photographs No. 6, 7 and 8). This outfall allegedly transports water from Business I-69 and Marsh Road (vicinity of Speedway and McDonalds). Based on the type of debris visible in the waters and wetlands immediately east of this outfall, this source of storm water appears likely. No plantings are recommended here due to heavy tree canopy.

Photograph No. 6 - View west at storm water outfall located between Lots 137 and 138

Photograph No. 7 - View southwest at storm water outfall located between

Photograph No. 8 - View east from storm water outfall located between
Lots 137 and 138

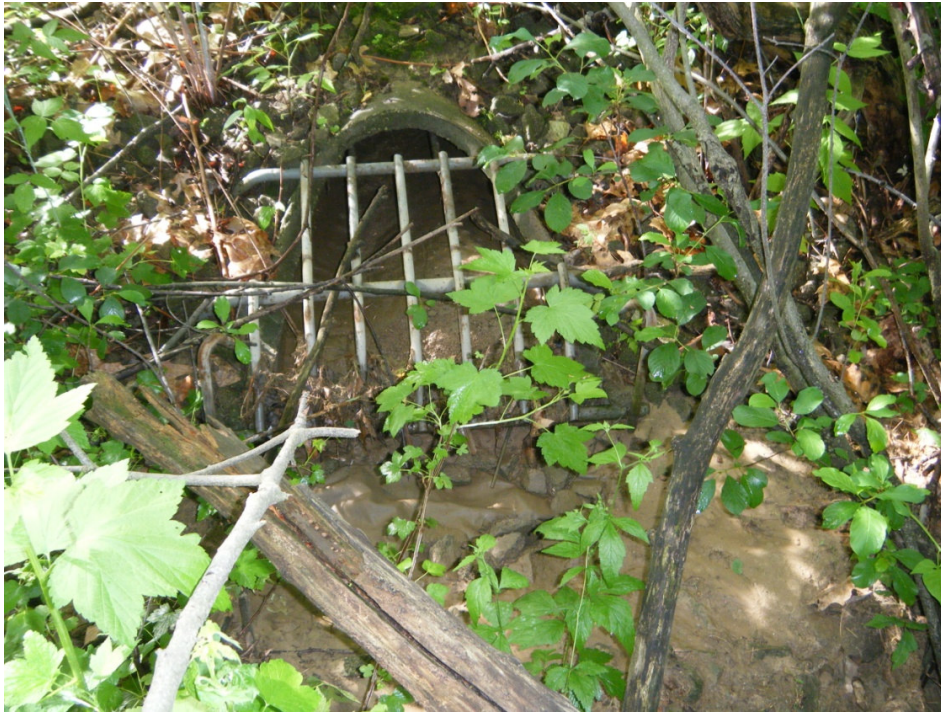
- The third discharge is located between Lots 51 and 52 and showed signs of recent discharge of sediment into the wetland complex (Photograph No. 9).
 - ➔ Recommend removing sediment from the end of the discharge pipe with a hand shovel and disposing of/stabilizing sediment in an upland area.

Photograph No. 9 - View south at storm water outfall located between Lots 51 and 52

- ➔ Recommend requesting assistance from the developer of the subdivision and/or the Clinton County Drain Commissioner to have ALL of the storm water catch basins around the wetland complex cleaned out. As we discussed, the Ingham County Drain Commissioner has equipment that can clean out these basins, and they may be interested in assisting Clinton County since this wetland complex discharges to the south into Ingham County. This drainage/detention basin system may also be part of an inter-county drain (between Ingham and Clinton) and if so, I would expect Ingham County would be interested in helping to reduce sediment loading and improving water quality.

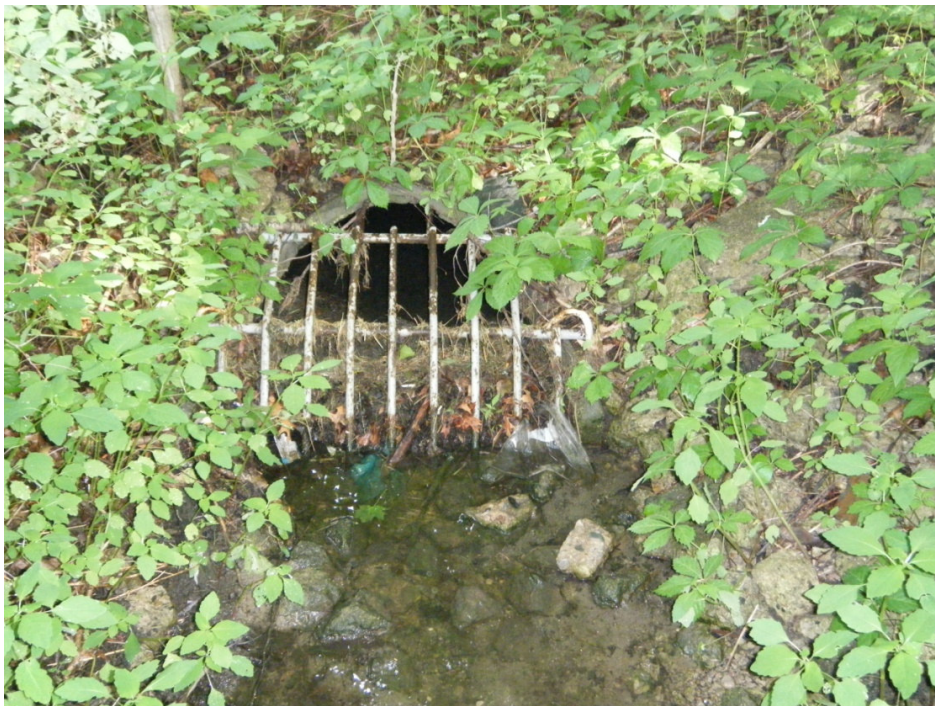
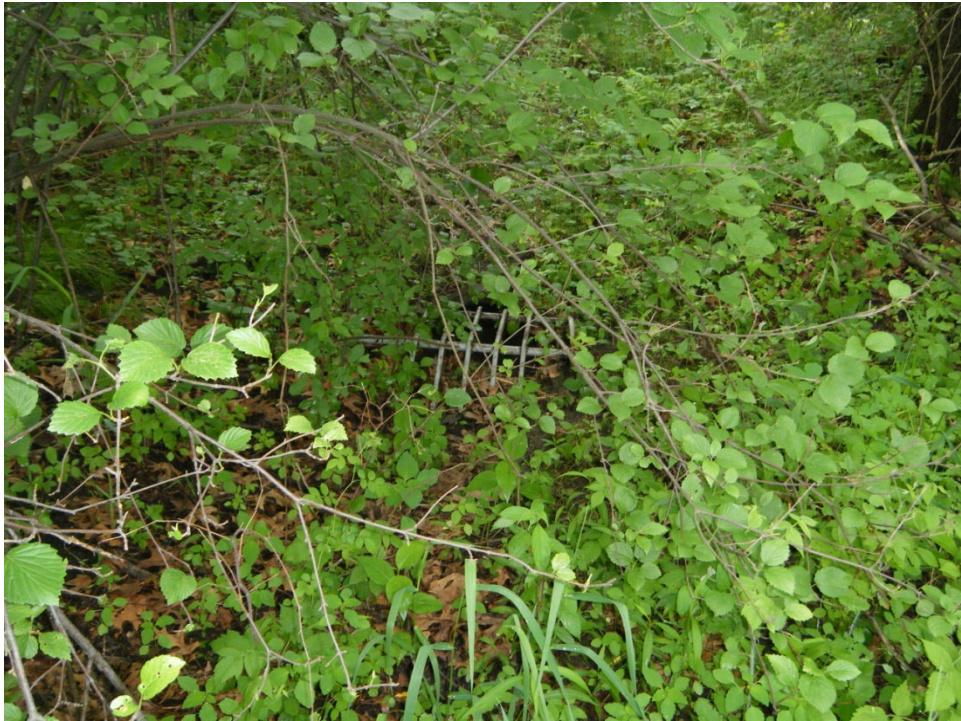
- There is an equalization culvert located north of Lots 29 and 30 that appears to convey water during high water periods between the northern and southern portions of the wetland complex (Photographs No. 10 and 11). This culvert appears to be blocked at its northern end where it is well vegetated in comparison to its southern end which appears unblocked and showing signs of standing water and wetland vegetation to the south.
 - ➔ Recommend cleaning out culvert

Photograph No. 10 - View northwest at south end of equalization culvert located north of Lots 29 and 30

Photograph No. 11 - View southeast at north end of equalization culvert located north of Lots 29 and 30
