Home Inspection Report

1604 Main St.
Oviedo, Florida 32765

Prepared for: Buyer

Prepared by: Bulldog Home Inspections, LLC
857 lagoon Drive
Oviedo, Florida 32765
407-878-9910

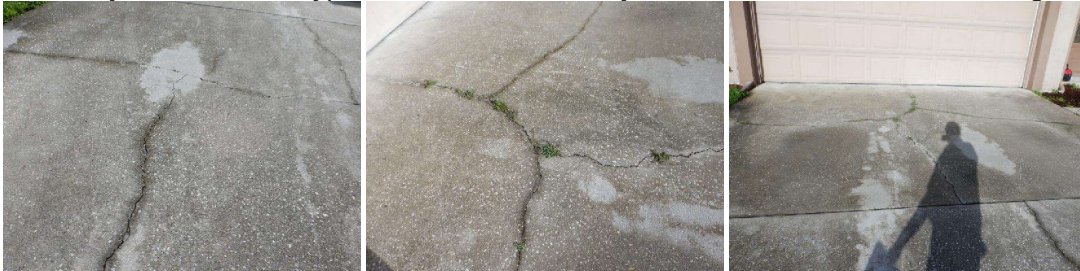
1. Driveway: Concrete - Typical cracks in driveway, recommend further monitoring for trip hazards.

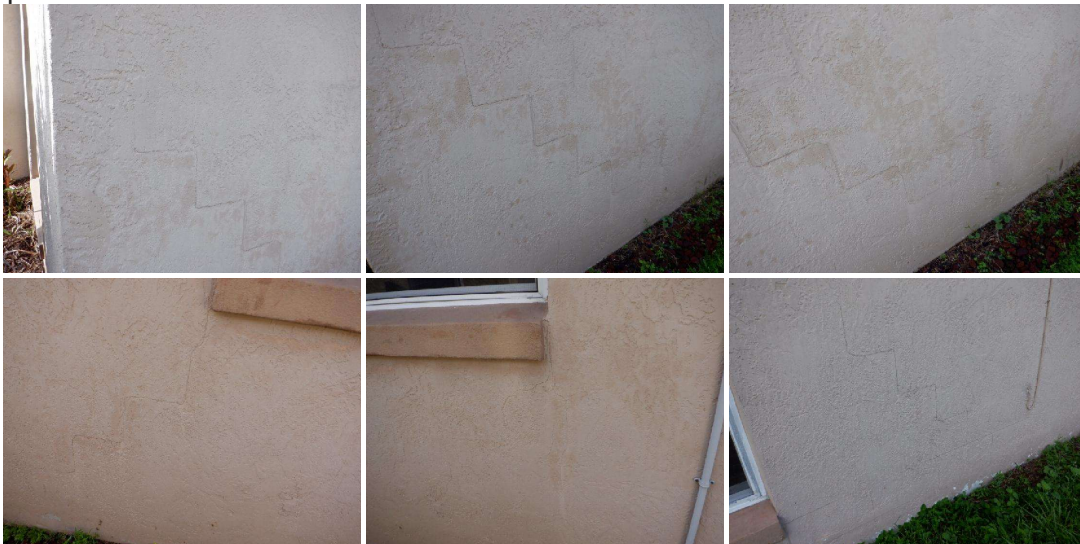
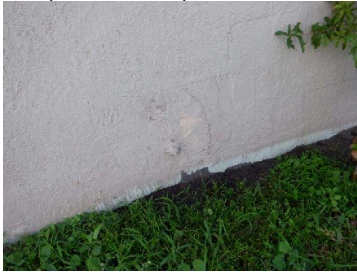
4. Entire perimeter of structure Exterior Surface Type: Stucco, Hardi-board - Paint on house is deteriorated and needs re-painted., Typical settling cracks, caulk and seal as needed., Seal around access door at left side, to prevent water intrusion.

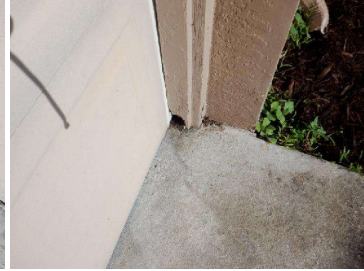
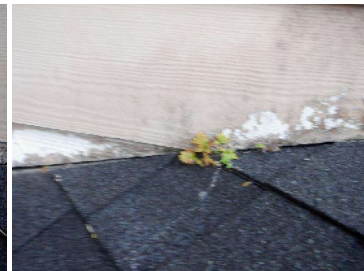
5. Trim: Wood - Wood rot to rear trim by patio and by rear upper wall, wood rot to both sides of garage door, replace all damaged wood and seal and paint.

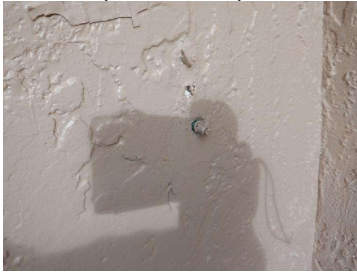
7. Door Bell: None - Exposed wires

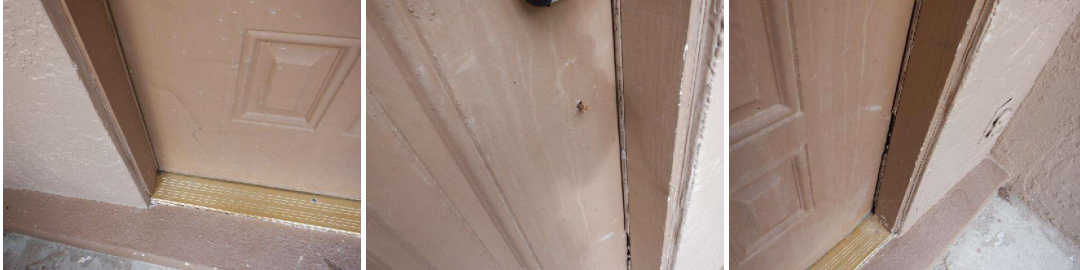
8. Entry Doors: Metal - Replace damaged weather stripping, door dented and paint bubbled, repair door.

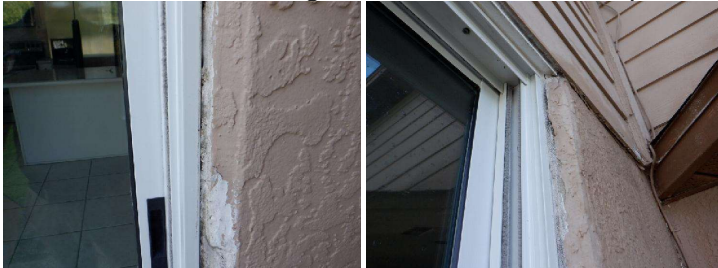
9. Patio Door: Metal sliding - Rollers need to be replaced, hard operation, caulk and seal around slider.

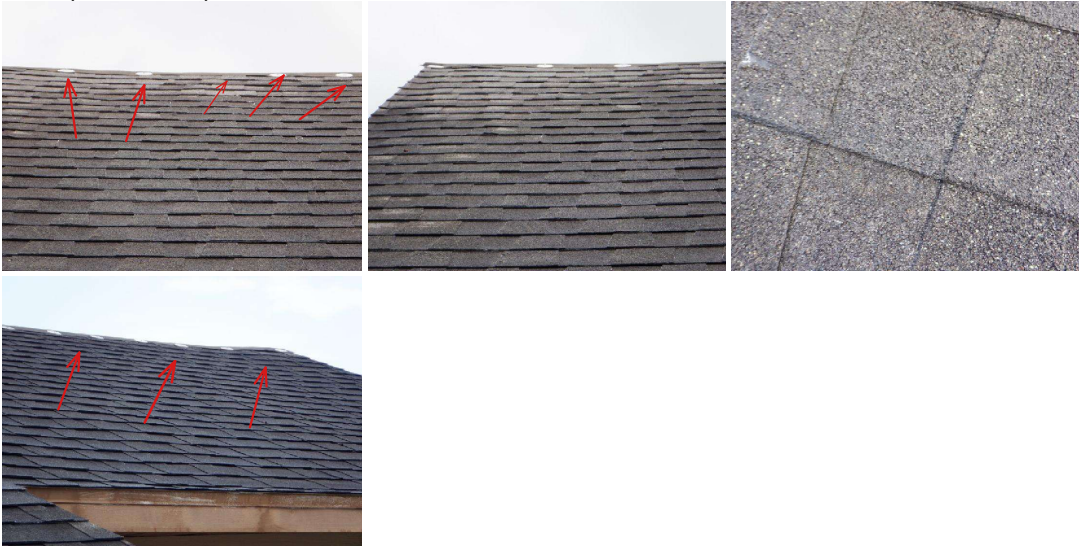
12. Main Roof Surface Material: Asphalt shingle - Damaged noted at rear ridge, and shingles are brittle and mossy, roof is at end of life, recommend a licensed roofer to estimate replacement cost. Buyer states roof replacement has been added to contract agreement.

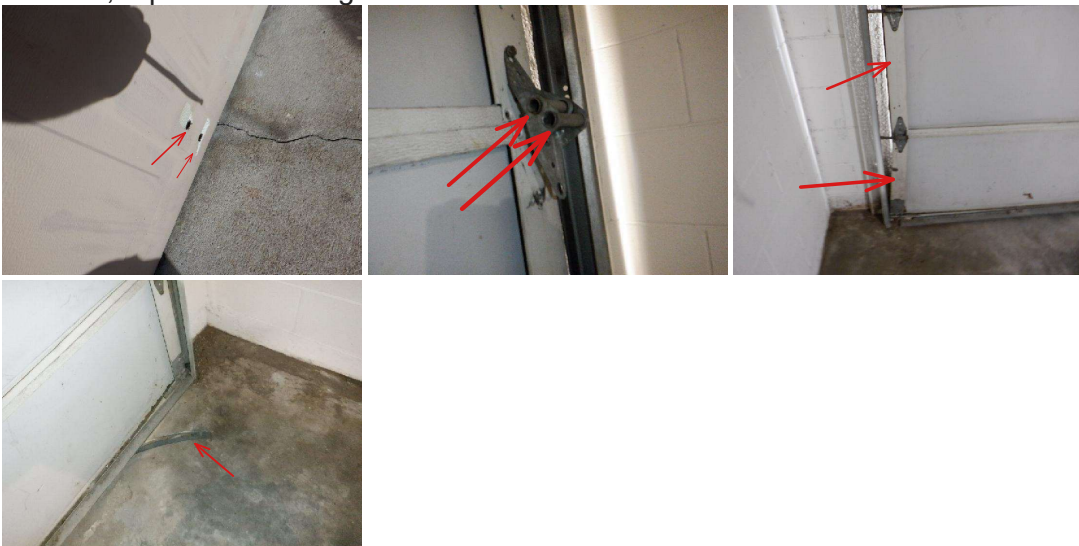
13. Front Garage Garage Doors: Metal - Door damaged, hinges off(missing wheel), panel twisted and dented, damaged weather stripping, recommend a licensed contractor to estimate cost to replace door. Wood rot to door trim, replace all damaged wood.

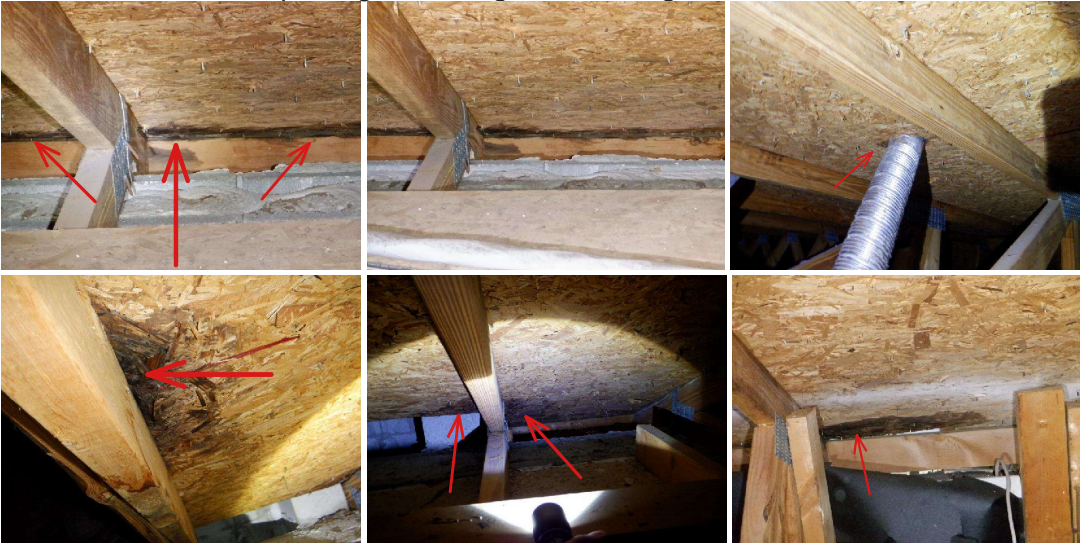
18. Main Attic Unable to Inspect: Bottom Of Trusses And Sheathing At Soffit Area - Insulation and Baffles blocks view of bottom of trusses and roof sheathing.
19. Main Attic Moisture Penetration: Previous water penetration noted with wood rot - Several spots on sheathing in attic, recommend replacing all damaged sheathing.

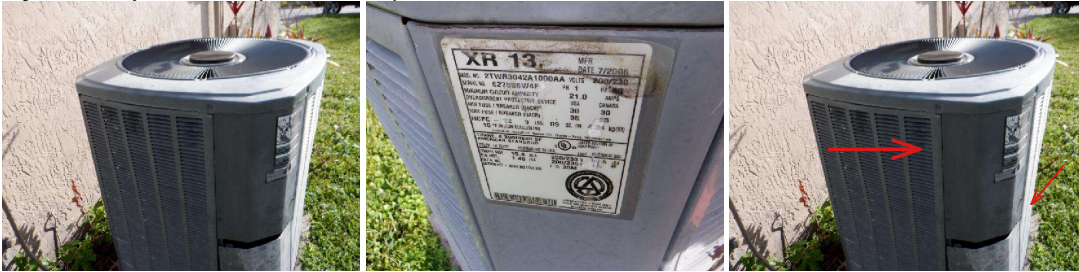
20. Left Side Of House AC System A/C System Operation: Functional - The unit is nearing the end of the manufactures stated design life, loose panel at unit, recommend a licensed HVAC contractor to evalaute and make any needed repairs.

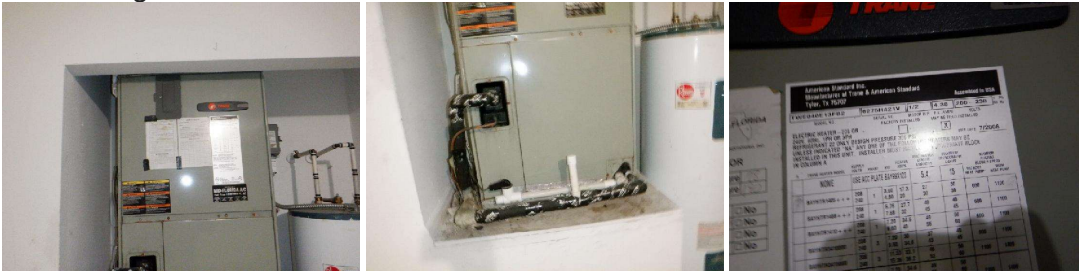
22. Garage AC System A/C System Operation: Functional - The unit is nearing the end of the manufactures stated design life

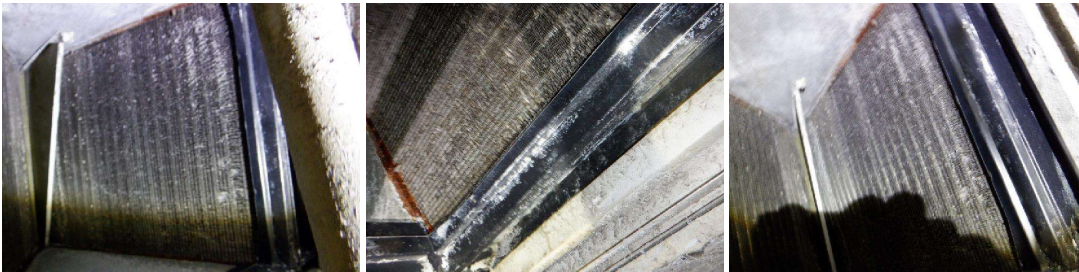
23. Garage AC System Visible Coil: Copper core with aluminum fins - Coils are dirty, recommend a licensed HVAC contractor to clean and service unit.

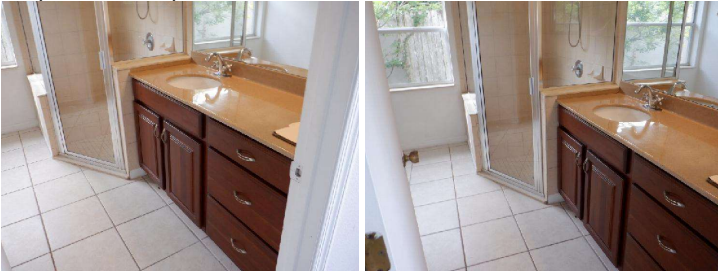
24. Master Bathroom Walls: Drywall - Patch work noted, sand and paint

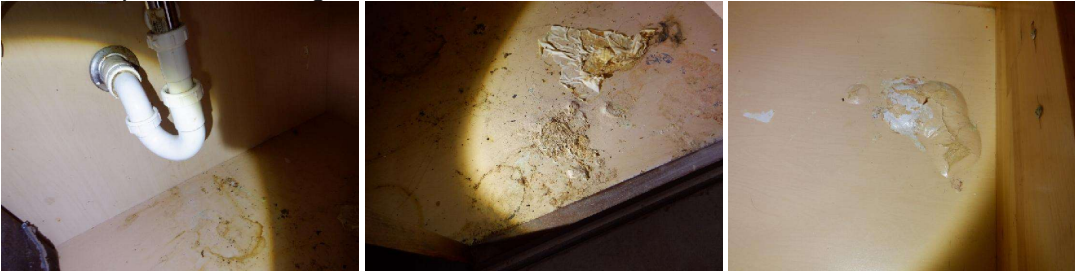
25. Master Bathroom Counter/Cabinet: Solid counter top - Water damage present under the counter and to drawer, replace all damaged materials.

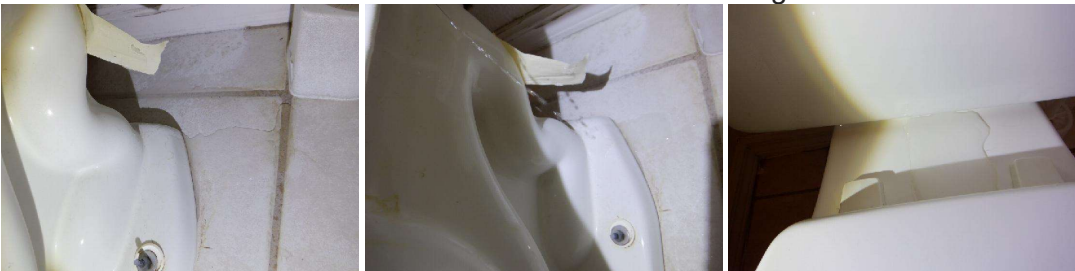
27. Master Bathroom Toilets: 1 1/2 Gallon Tank - Water leaking at tank seal

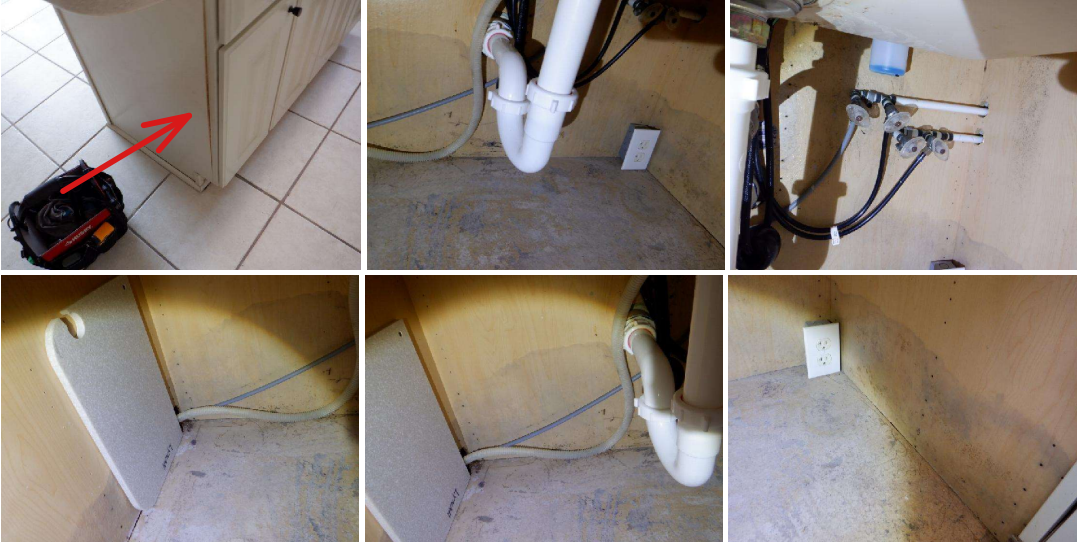
- 33. Main Kitchen Cabinets: Laminate and composite materials - Water damage present under the counter, loose side panel at island, secure.

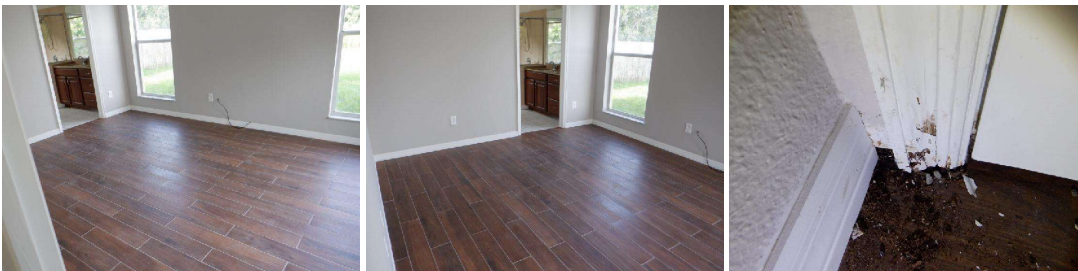
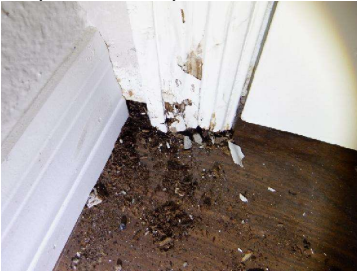
37. Master Bedroom Walls: Drywall - Evidence of termites in door casing, replace all damaged wood and treat for termites.

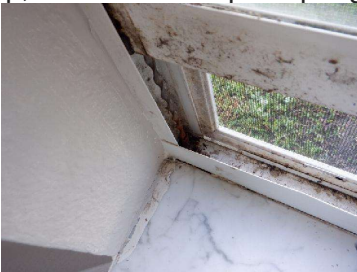
39. Master Bedroom Windows: Aluminum Single hung - Spring off sash, recommend repair., Window will not stay up, recommend repair springs

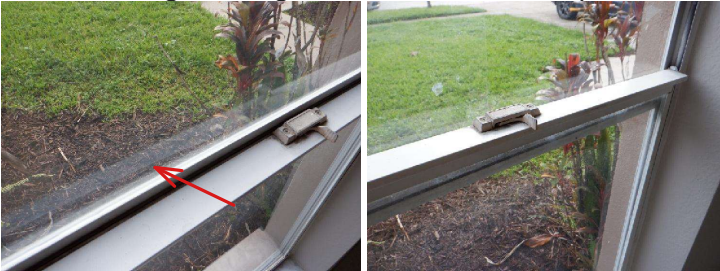
45. Living Room Living Space Windows: Aluminum Single hung - Spring off sash, recommend repair., Damaged and or missing seals, glass loose in frame, repair.

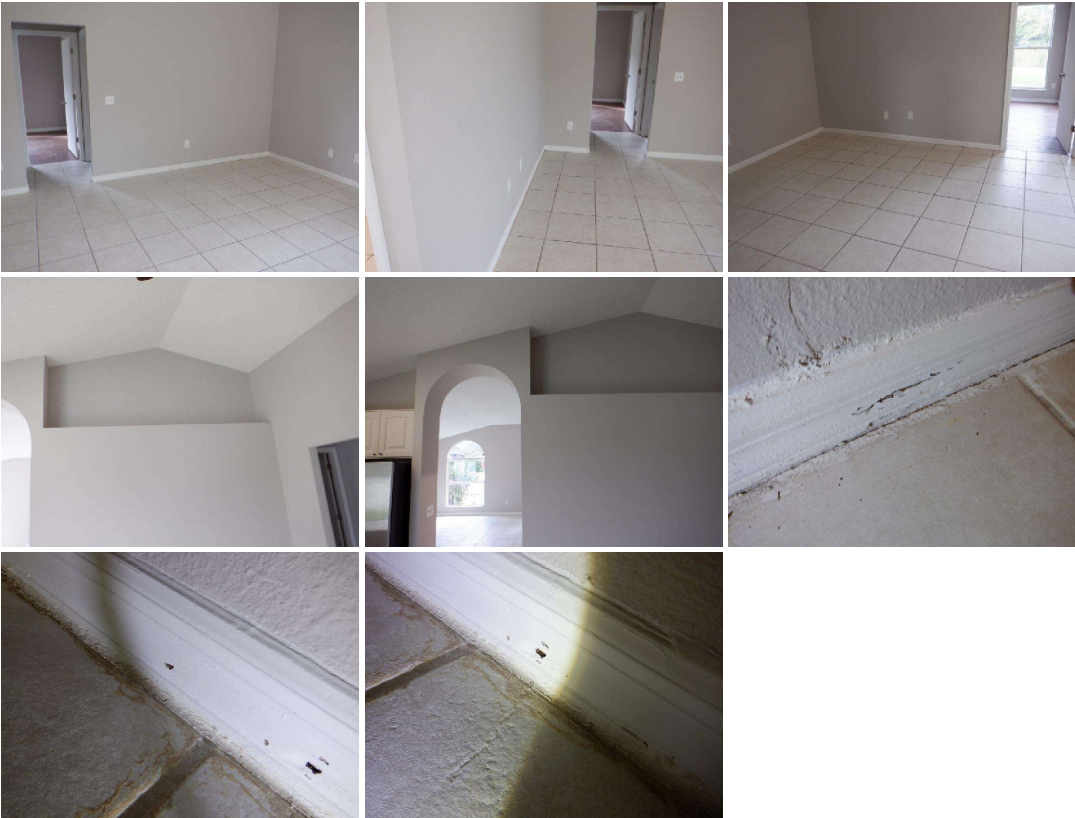
46. Family Room Living Space Walls: Drywall - Evidence of termites in baseboards, replace all damaged baseboards and treat for termites.

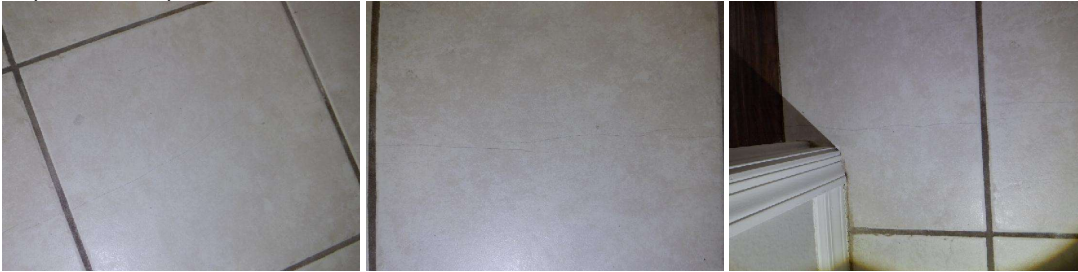
47. Family Room Living Space Floor: Tile - Cracked tiles noted, water stains on flooring.

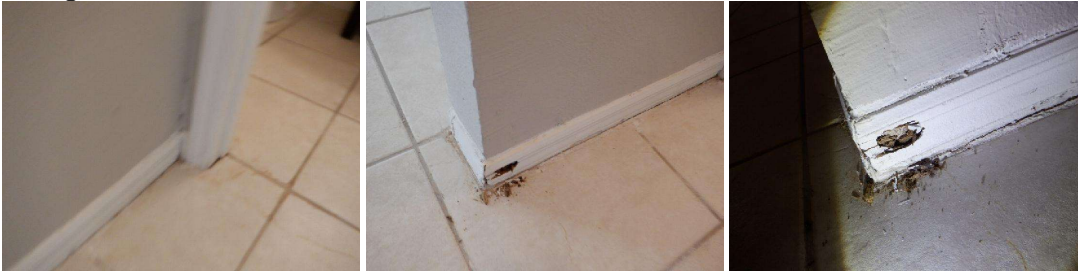
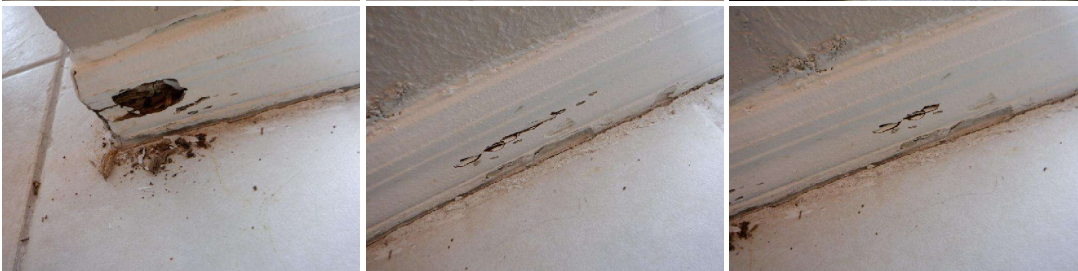
48. 1st Floor Hall Living Space Walls: Drywall - Evidence of water and termite damage to baseboards, replace all damaged wood and treat for termites.

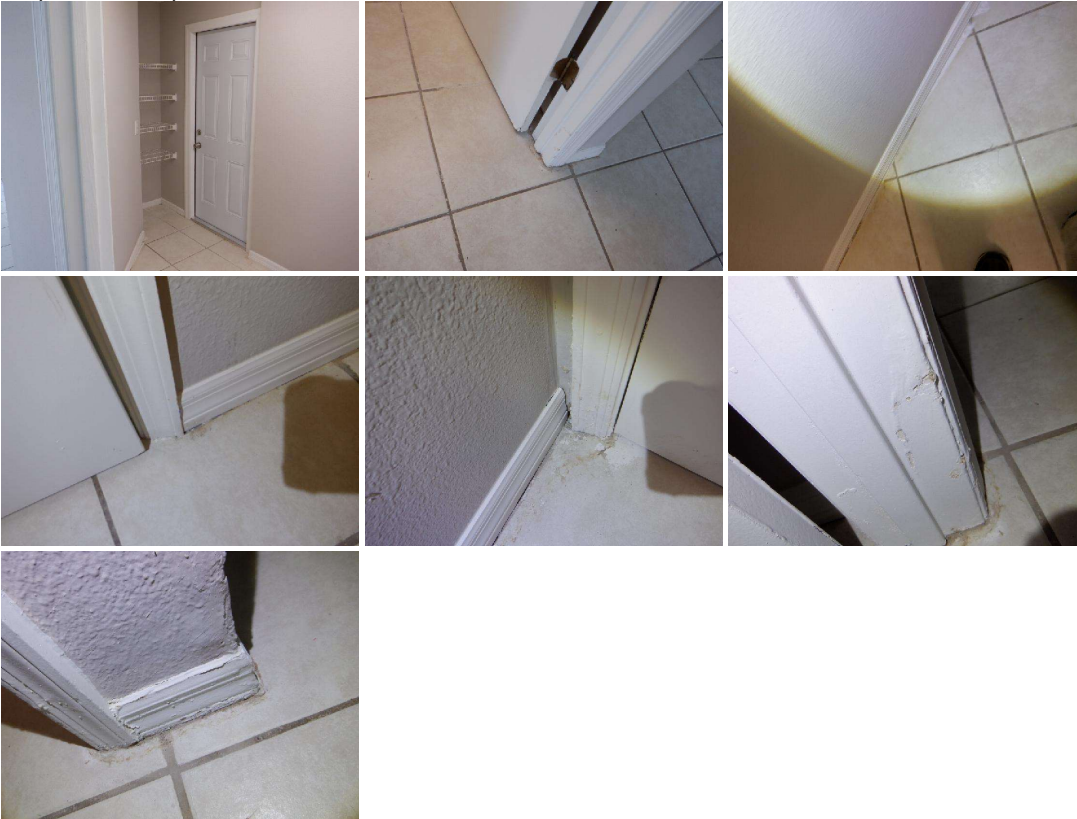
50. 1st Floor Hall Living Space Smoke Detector: Hard wired - Recommend replacing old smoke detectors.
51. Mud Room Living Space Walls: Drywall - Water damage to baseboards, replace all damaged wood.

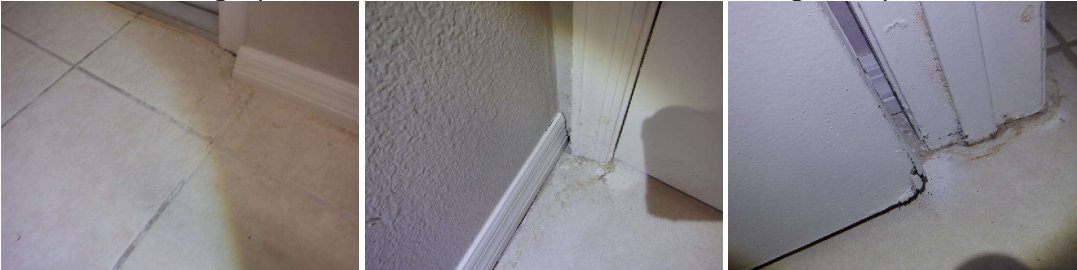
52. Mud Room Living Space Floor: Tile - Water stains on flooring from previous water leak.

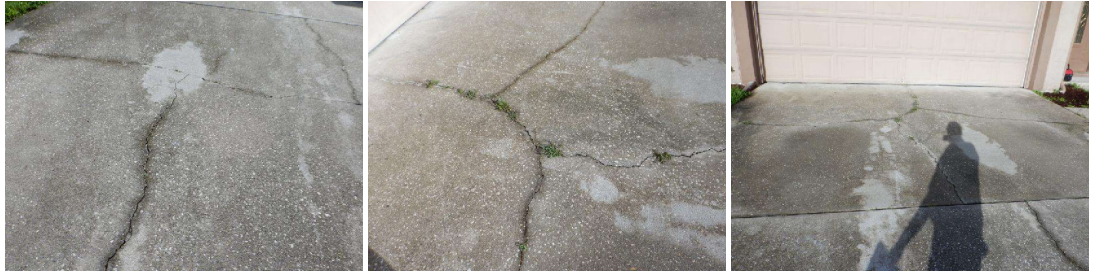
1. Acceptable, Marginal Driveway: Concrete - Typical cracks in driveway, recommend further monitoring for trip hazards.

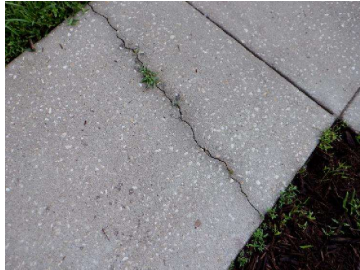
2. Acceptable, Marginal Walks: Concrete - Cracked

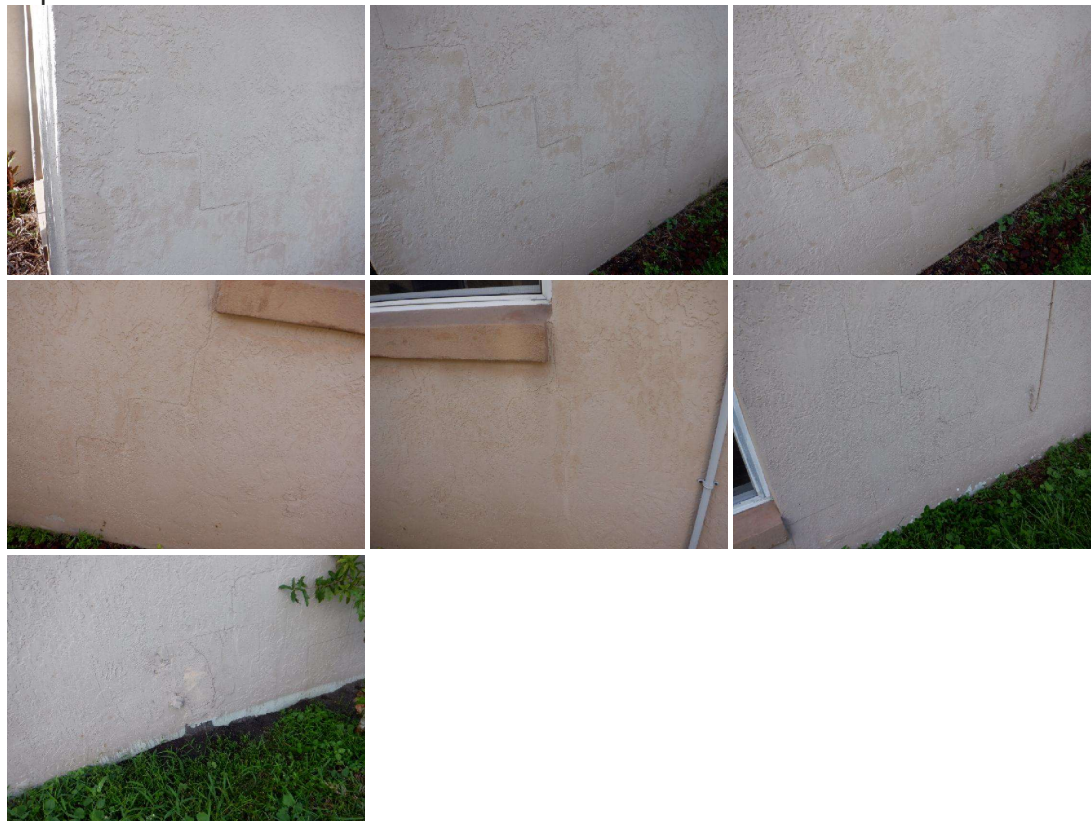
1. Acceptable, Marginal Type: Stucco, Hardi-board - Paint on house is deteriorated and needs re-painted., Typical settling cracks, caulk and seal as needed., Seal around access door at left side, to prevent water intrusion.

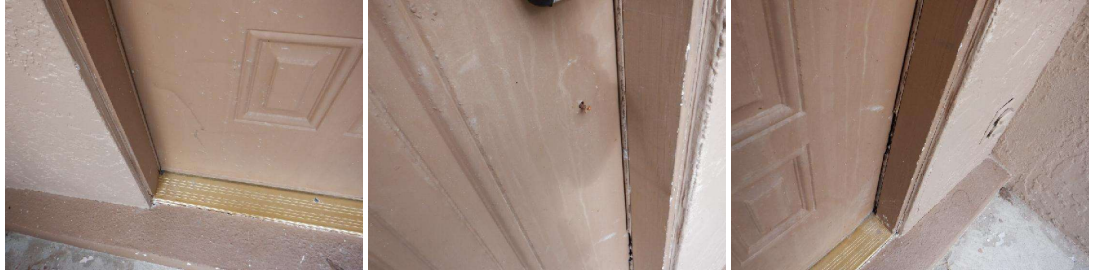
6. Acceptable, Marginal Entry Doors: Metal - Replace damaged weather stripping, door dented and paint bubbled, repair door.

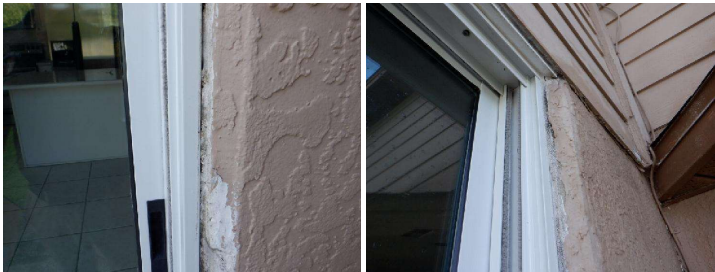
7. Marginal Patio Door: Metal sliding - Rollers need to be replaced, hard operation, caulk and seal around slider.

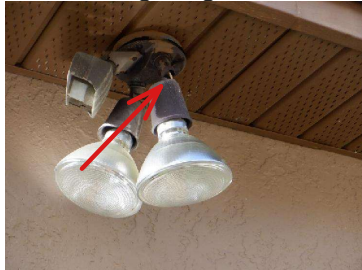
10. Acceptable, Marginal Exterior Lighting: Surface mount - Damaged soffit light, repair.

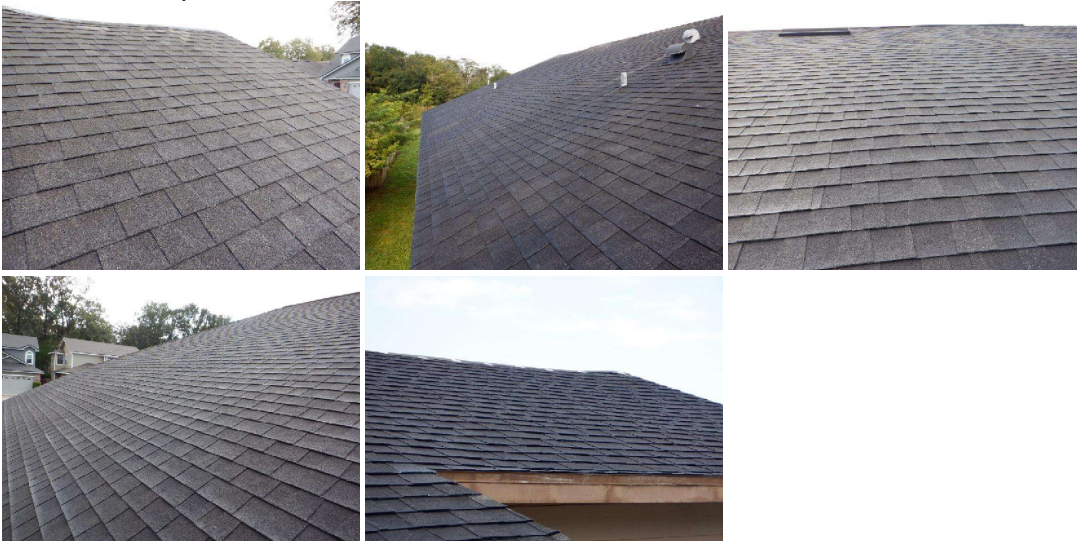
Material: Asphalt shingle - Damaged noted at rear ridge, and shingles are brittle and mossy, roof is at end of life, recommend a licensed roofer to estimate replacement cost. Buyer states roof replacement has been added to contract agreement.

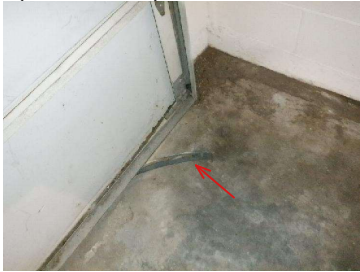
- 1. Type of Structure: Attached Car Spaces: 2
- 2. Marginal Garage Doors: Metal - Door damaged, hinges off(missing wheel), panel twisted and dented, damaged weather stripping, recommend a licensed contractor to estimate cost to replace door. Wood rot to door trim, replace all damaged wood.

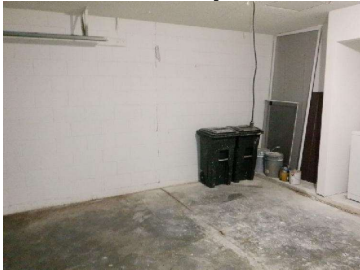
Door Operation: Mechanized
Door Opener: Genie - Recommend replacing.
Exterior Surface: Stucco
Roof: Asphalt shingle
Roof Structure: 2x4 Truss
Service Doors: Fire rated
Ceiling: Texture paint
Walls: Block, Drywall

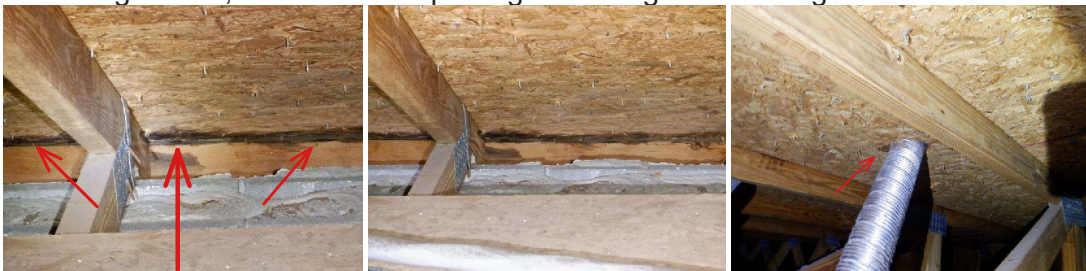
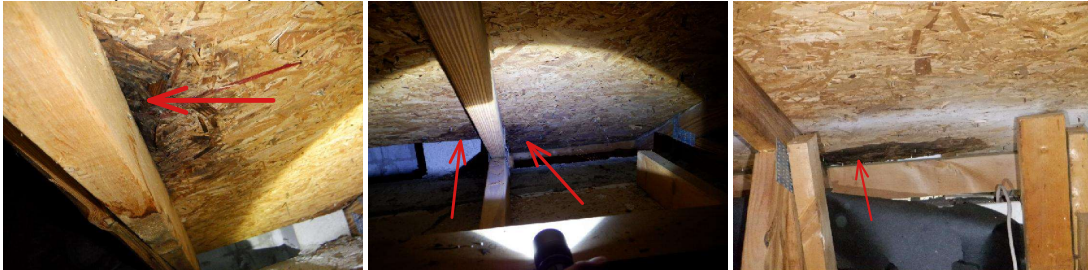
7. Acceptable Insulation Depth: 7"
8. Acceptable Wiring/Lighting: 110 VAC lighting circuit - Unable to inspect all electrical wires in attic due to insulation blocking view of wiring.
9. Marginal Moisture Penetration: Previous water penetration noted with wood rot - Several spots on sheathing in attic, recommend replacing all damaged sheathing.

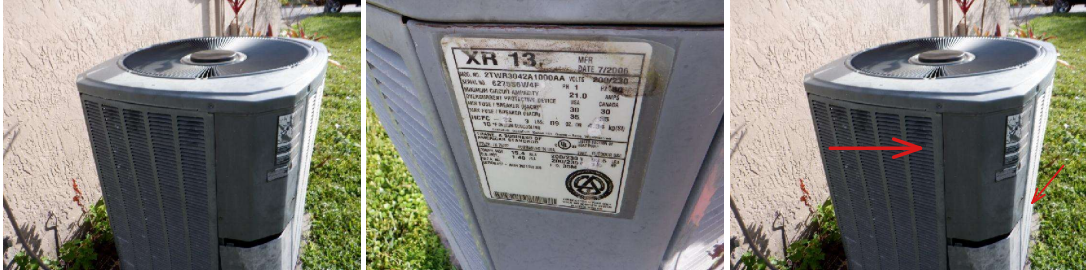
- 1. Marginal A/C System Operation: Functional - The unit is nearing the end of the manufactures stated design life, loose panel at unit, recommend a licensed HVAC contractor to evalaute and make any needed repairs.

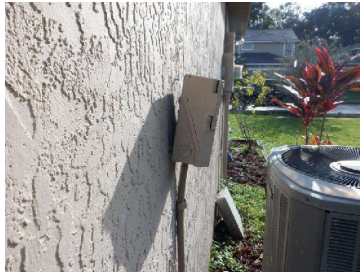
- 2. Acceptable Condensate Removal: PVC
- 3. Acceptable Exterior Unit: Pad mounted
- 4. Manufacturer: Trane
- 5. Model Number: 2TWR3042A1000AA Serial Number: 627556W4F
- 6. Area Served: 1st floor Approximate Age: 2006
- 7. Fuel Type: 208/230 VAC Temperature Differential: 15 Degrees
- 8. Type: Heat pump Capacity: 3.5 Ton
- 9. Acceptable Visible Coil: Copper core with aluminum fins
- 10. Acceptable Refrigerant Lines: Serviceable condition
- 11. Acceptable, Marginal Electrical Disconnect: Breaker disconnect - Disconnect is loose at wall, secure.

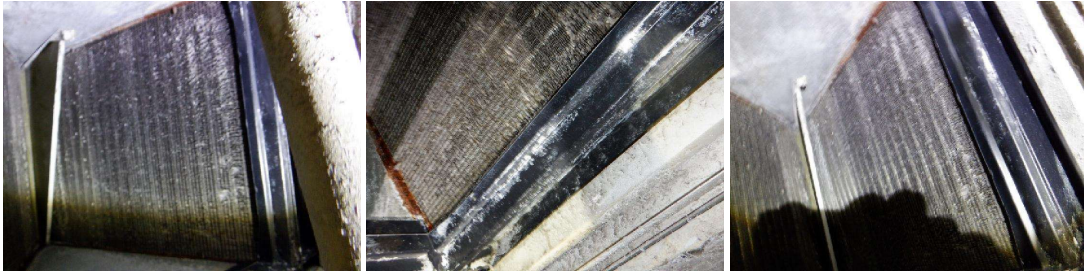
- 17. Area Served: Whole building Approximate Age: 2006
- 18. Fuel Type: 208/230 VAC Temperature Differential: 15 Degrees
- 19. Type: Air Handler Capacity: 3.5 Ton
- 20. Marginal Visible Coil: Copper core with aluminum fins - Coils are dirty, recommend a licensed HVAC contractor to clean and service unit.

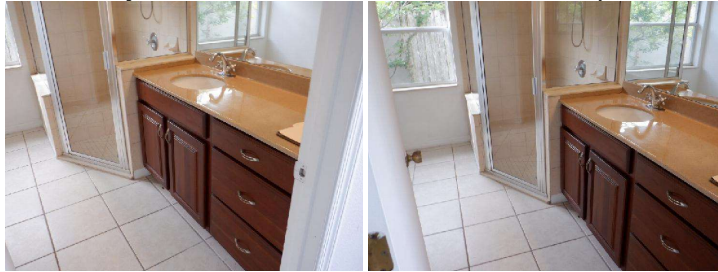
2. Acceptable, Marginal Walls: Drywall - Patch work noted, sand and paint

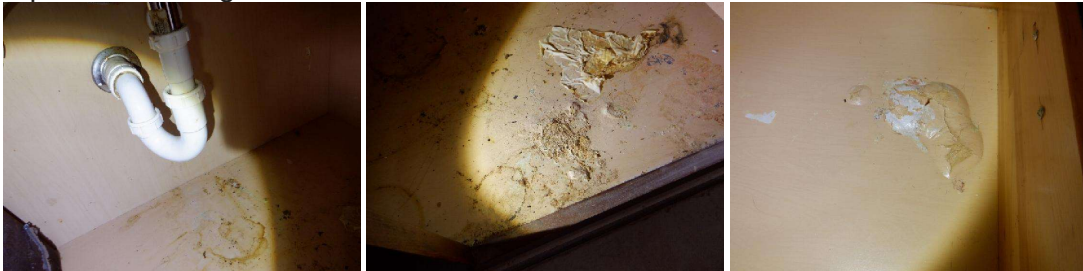
Counter/Cabinet: Solid counter top - Water damage present under the counter and to drawer, replace all damaged materials.

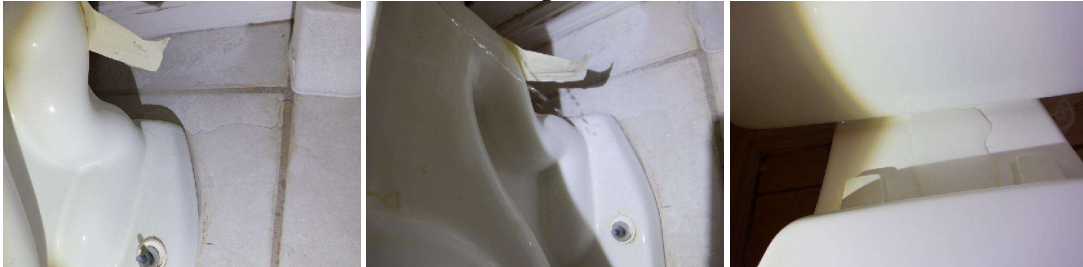
Toilets: 1 1/2 Gallon Tank - Water leaking at tank seal

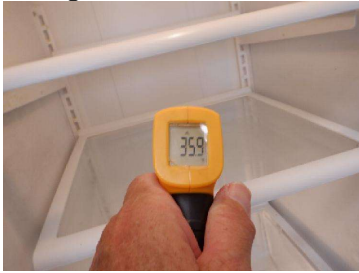
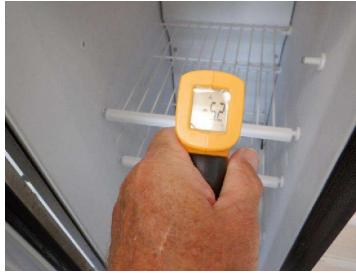
- 2. Acceptable Ventilator: Kenmore
- 3. Marginal Dishwasher: Whirlpool - Inoperative at time of inspection, failed to draw water, replace.
- 4. Air Gap Present? Yes
- 5. Acceptable Refrigerator: Kenmore

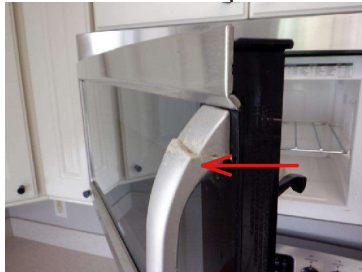
- 6. Acceptable, Marginal Microwave: Whirlpool - Broken handle, replace., Bottom light out, change bulb

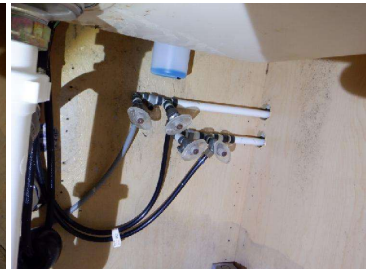
- 7. Acceptable Sink: Molded
- 8. Acceptable Electrical: 110 VAC GFCI
- 9. Acceptable Plumbing/Fixtures: Chrome
- 10. Acceptable Counter Tops: Solid
- 11. Marginal Cabinets: Laminate and composite materials - Water damage present under the counter, loose side panel at island, secure.

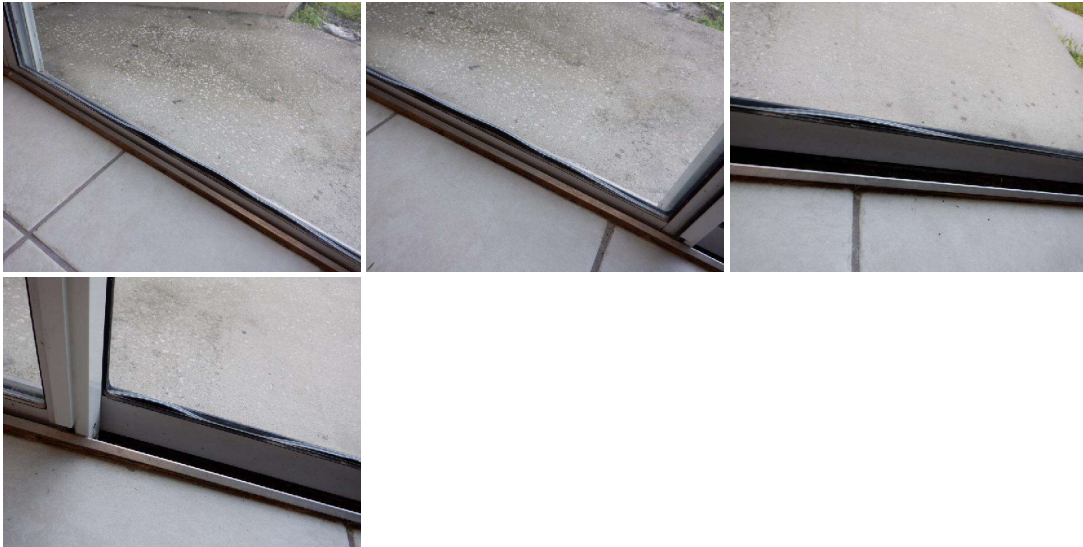
Doors: Slider - Damaged seals at glass, repair or replace, hard operation repair or replace rollers.

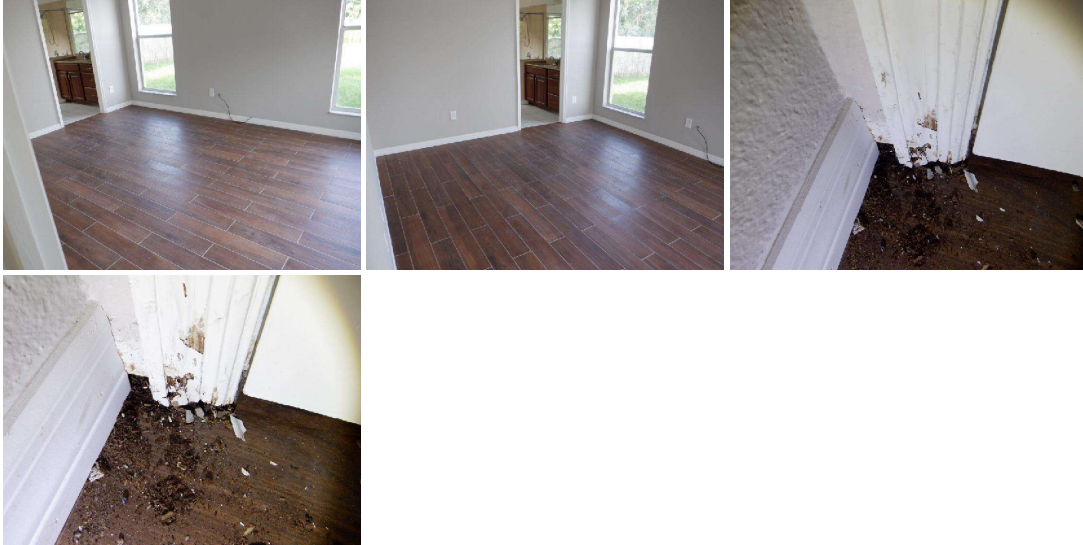
Walls: Drywall - Evidence of termites in door casing, replace all damaged wood and treat for termites.

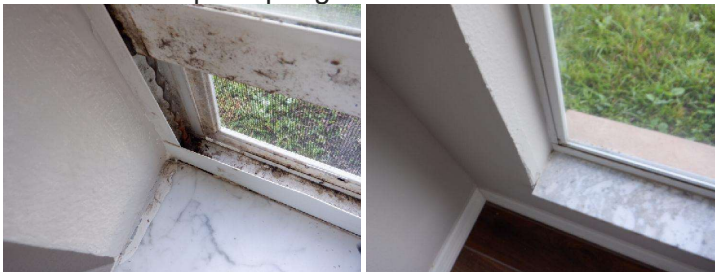
Floor: Tile
Doors: Hollow wood - Missing door stop
Windows: Aluminum Single hung - Spring off sash, recommend repair., Window will not stay up, recommend repair springs

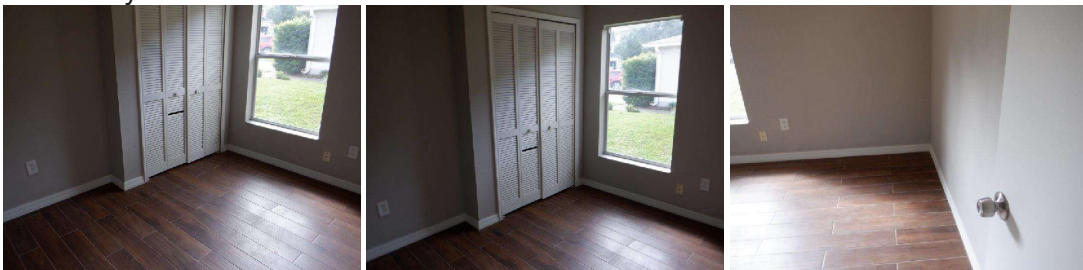
10. Acceptable, Marginal Closet: Large - Damaged closet door, replace.
11. Acceptable Ceiling: Texture paint
12. Acceptable Walls: Drywall

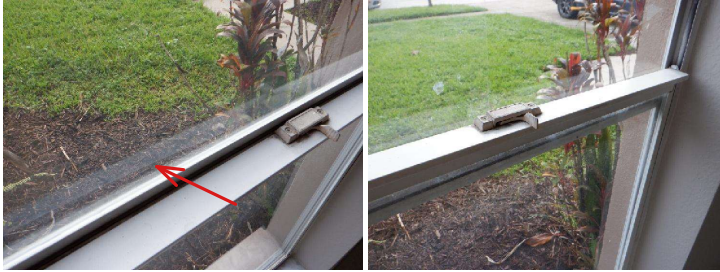
Windows: Aluminum Single hung - Spring off sash, recommend repair., Damaged and or missing seals, glass loose in frame, repair.

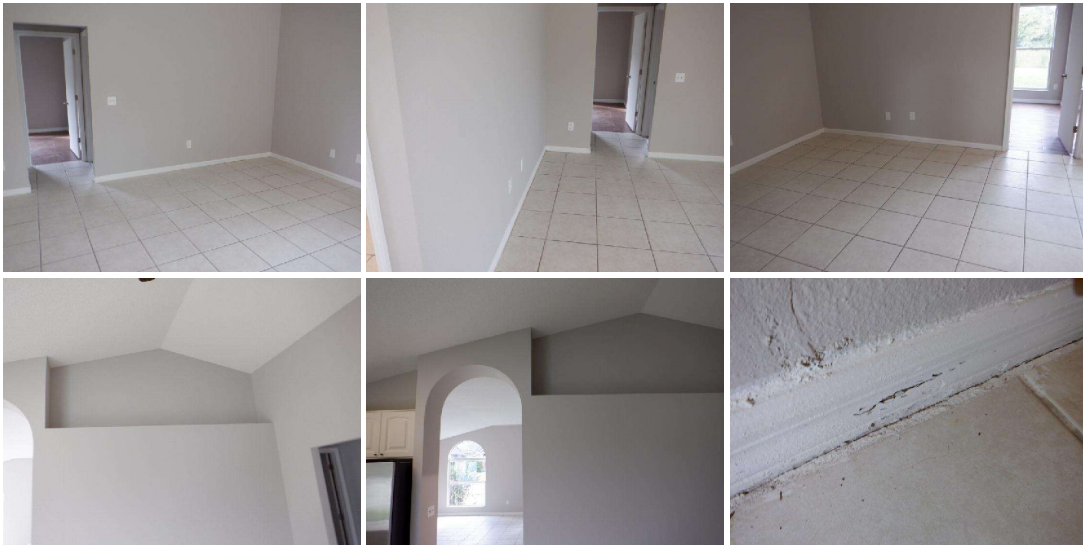
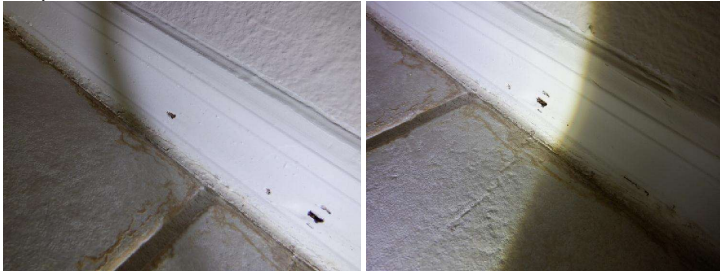
Walls: Drywall - Evidence of termites in baseboards, replace all damaged baseboards and treat for termites.

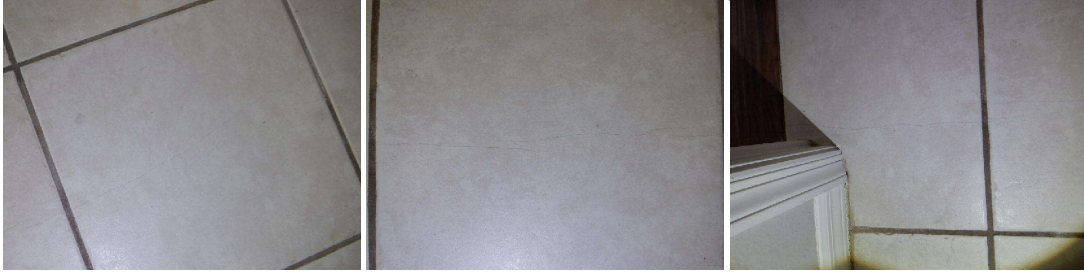
Floor: Tile - Cracked tiles noted, water stains on flooring.

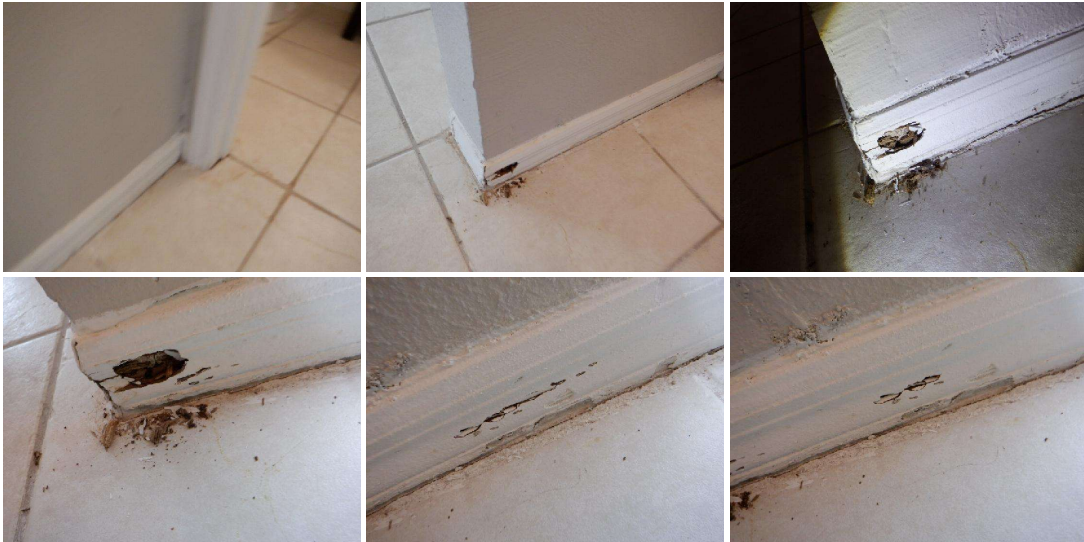
Walls: Drywall - Evidence of water and termite damage to baseboards, replace all damaged wood and treat for termites.

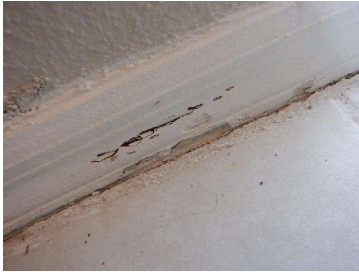
Floor: Tile - Water stains on flooring from previous water leak.

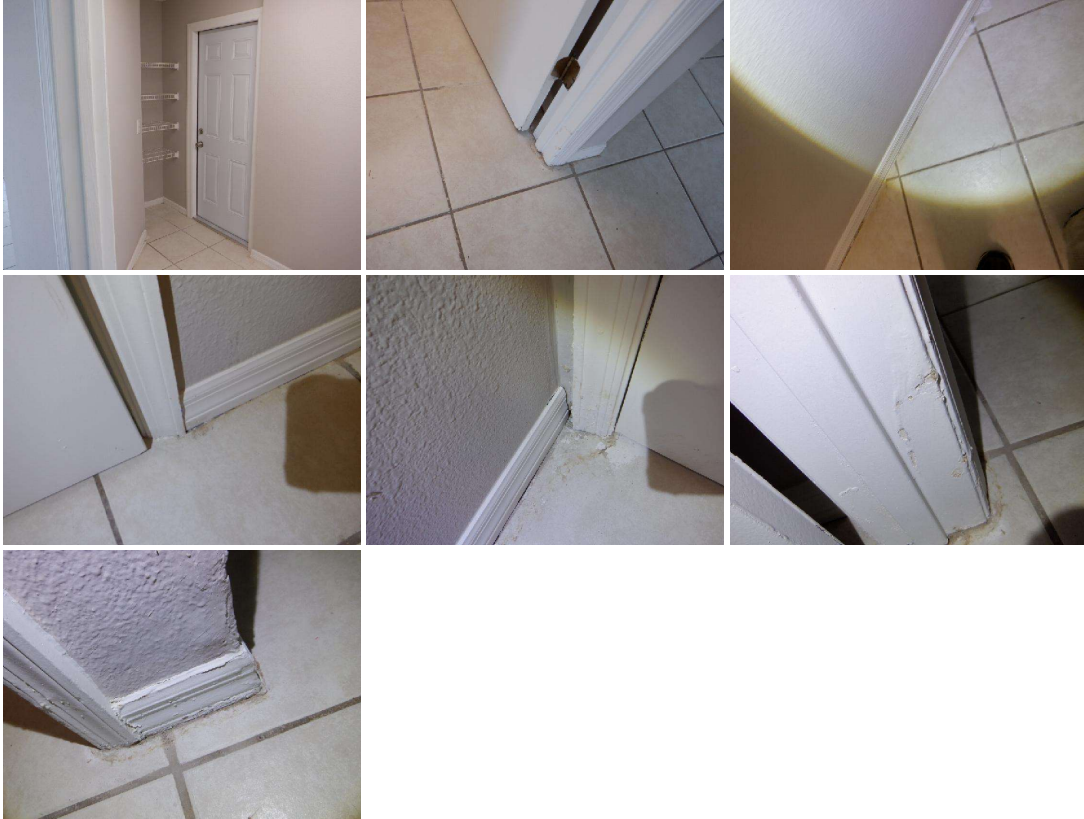
Walls: Drywall - Water damage to baseboards, replace all damaged wood.

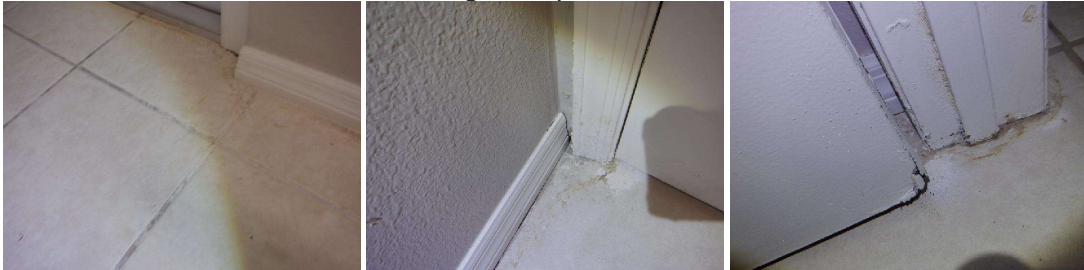
27. Marginal Floor: Tile - Water stains on flooring from previous water leak.

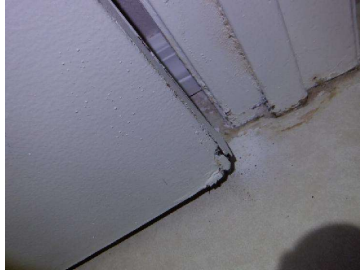
28. Acceptable, Marginal Doors: Hollow wood - Minor door damage

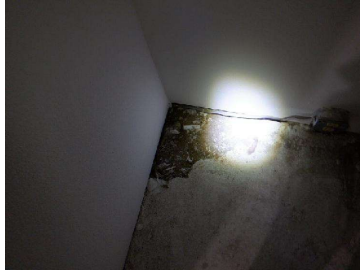
3. Acceptable, Marginal Floor: Poured - Damaged flooring.
