Homequest Home Inspections PROPERTY INSPECTED

Commercial (Retail) Inspection

PROPERTY INSPECTION REPORT

By: Christopher Juarez, Lic #22663 NM#HI0078 09/24/2021
(Name and License Number of Inspector) (Date)

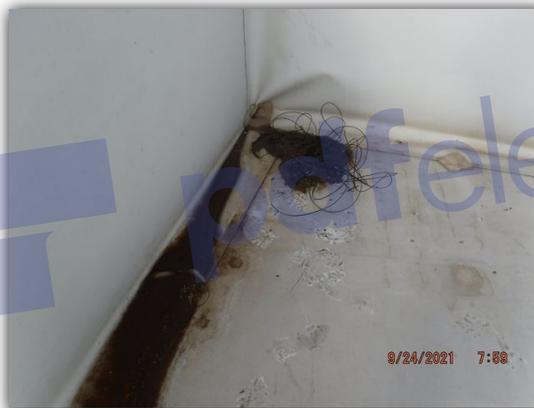
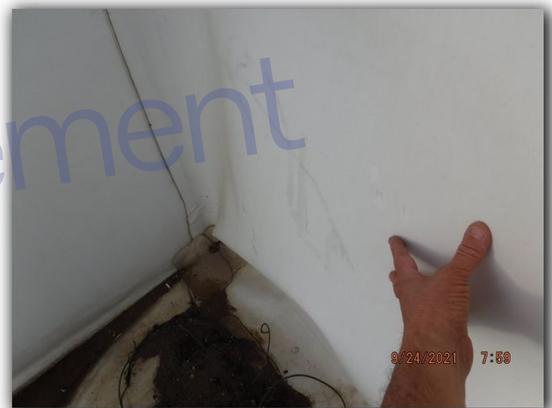
1. Debris in some areas.
2. Membrane is loose on the parapet wall at the right rear.

1. Debris in some areas.
2. Membrane is loose on the parapet wall at the right rear.

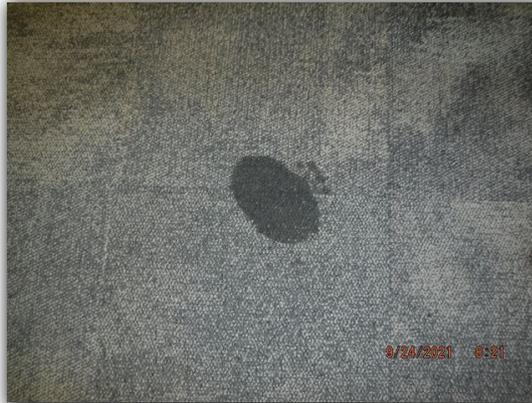
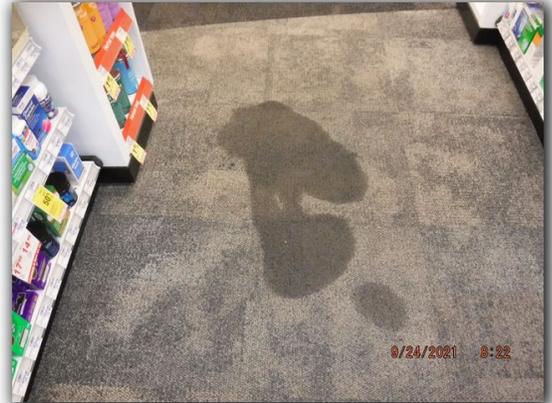
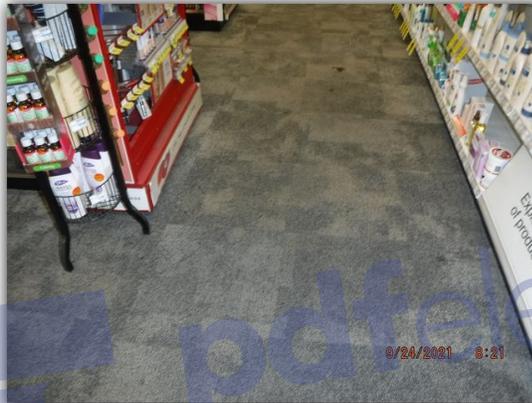
1. Carpets are stained in several areas.

1. Front : Two tiles are loose above the front entry.
2. Carpets are stained in several areas.

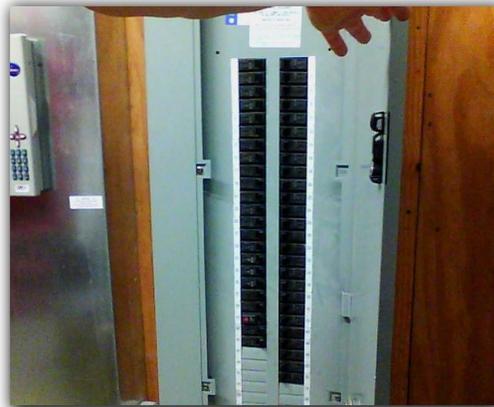
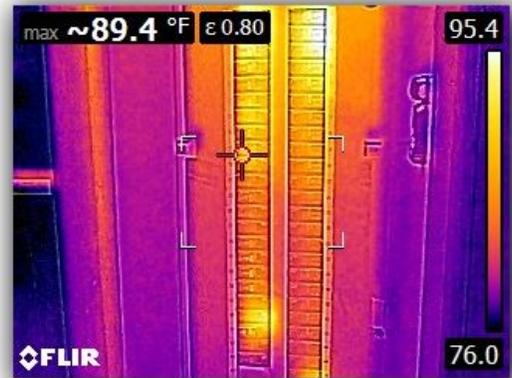
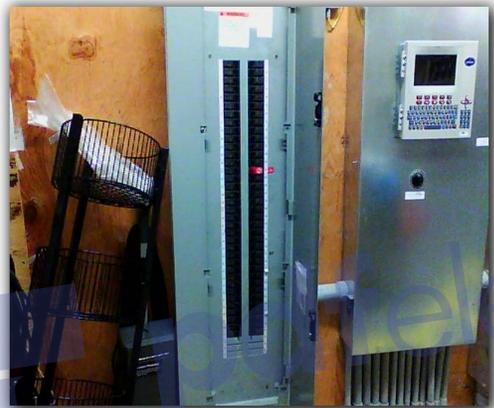
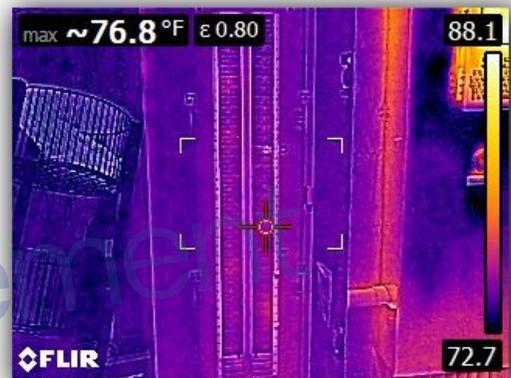
- I did not observe any indications of electrical overloads or other anomalies during my inspection of the main and sub panels.

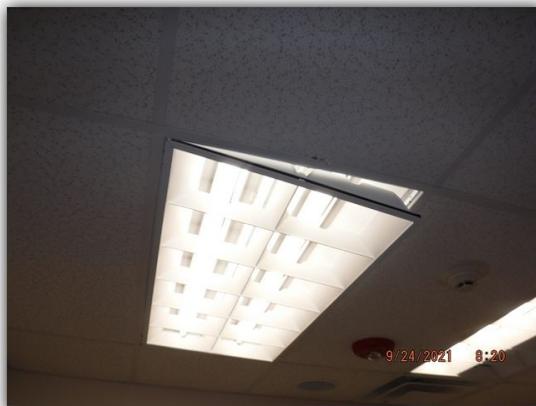
1. One fixture in the office is detached from the ceiling.

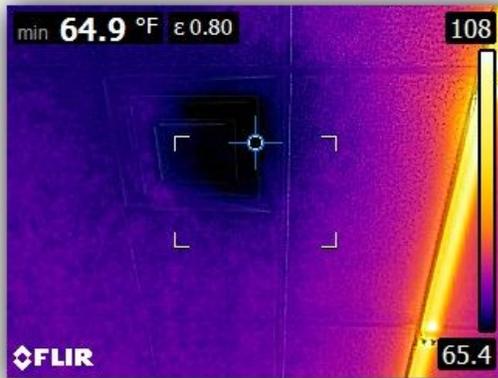
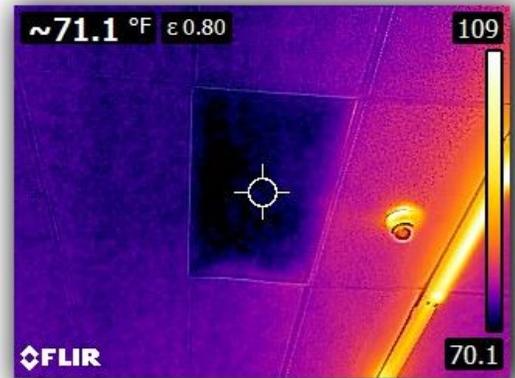
Unit 2

Supply Air Temp: 64 °F Return Air Temp: 71 °F Temp. Differential: 7 °F

- 1. Temperature differential is not within range of 14-23 degrees Fahrenheit on three units. Servicing is recommended.
- Units above the pharmacy were not inspected.

1. Temperature differential is not within range of 14-23 degrees Fahrenheit on three units. Servicing is recommended.

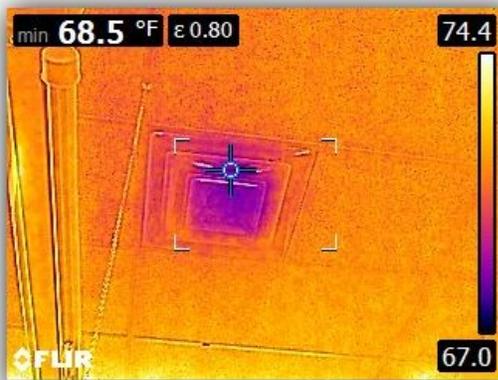
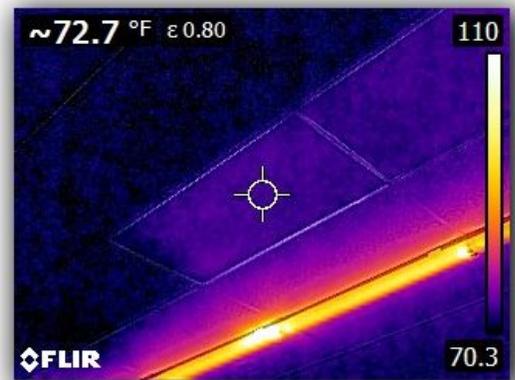
Supply Air Temp: 68 °F Return Air Temp: 73 °F Temp. Differential: 5 °F

Supply Air Temp: 68 °F Return Air Temp: 72 °F Temp. Differential: 4 °F
