HA5™

High Density Mineral Bond

Case Study Update 2013

This is an update of an ongoing case study in a private HOA comparing the side-by-side performance of a High Density Mineral Bond (HA5) to a seal coat commonly used in asphalt preservation.

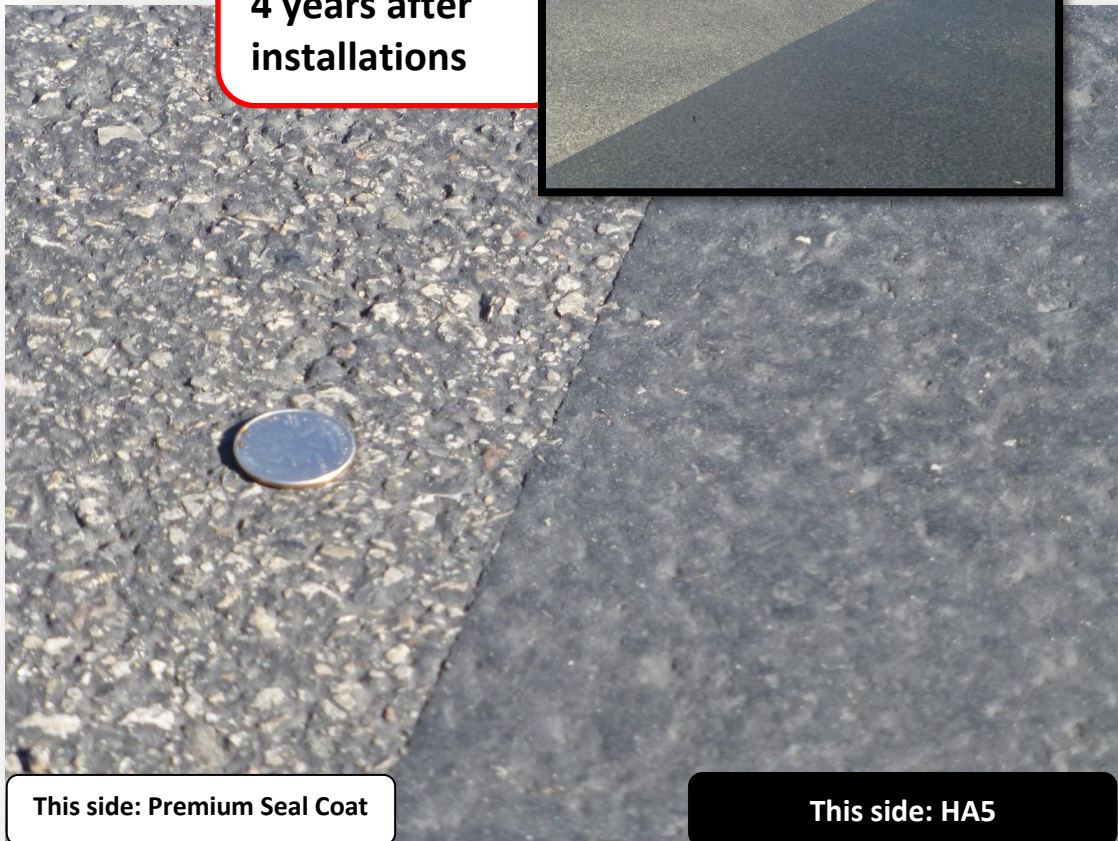
In this case, observations reveal significant deterioration of seal coat compared to HA5.

Updated picture taken:
Spring 2013
**4 years after
installations**

This side: Premium Seal Coat

This side: HA5
