## YOUR INSPECTION REPORT

Inspection Report  
421 Comstock Drive, Fruita, Colorado 81521

Report ID  
AP-803-000013

Inspection Date  
October 23, 2020 at 09:00 AM

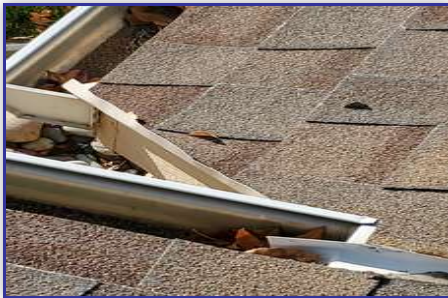
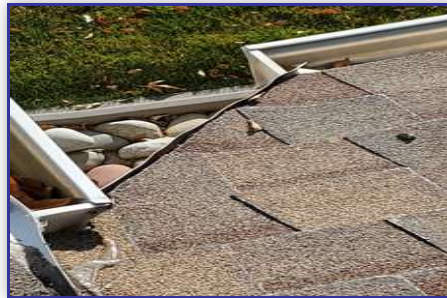
## 2.2.1 Roof Flashing(Multiple Defects)

**IMPROPER FLASHING INSTALLATION (ONE OR MORE AREAS)**

There were one or more of the roof flashing were improperly installed, which may allow moisture seepage, resulting in damage, decay and mold. The Inspector recommends that the affected area(s) be evaluated, replaced or repaired, as needed, by a professional roofing contractor.

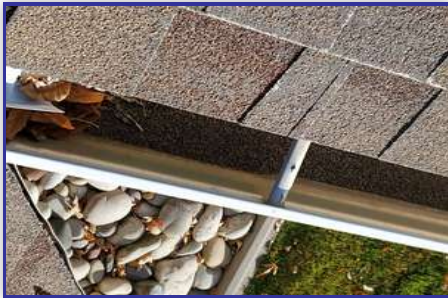
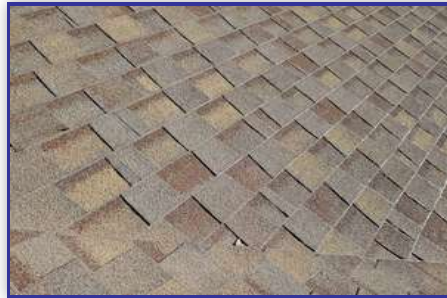
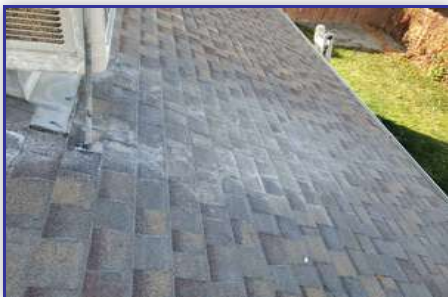
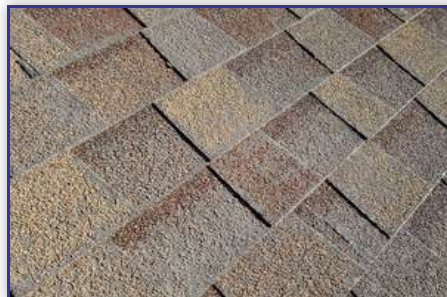
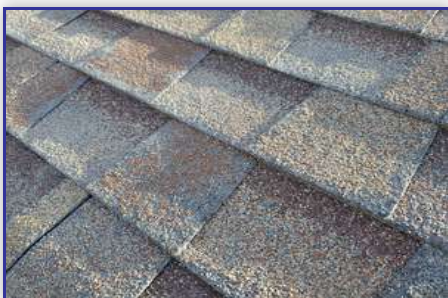
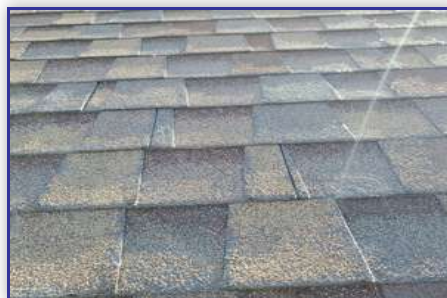
## 2.5.1 Granule loss (Repair)

At the time of inspection, patches of missing granules from the shingles in areas will need to be repaired.. The Inspector recommends that the affected area(s) be evaluated, replaced or repaired, as needed, by a professional contractor.

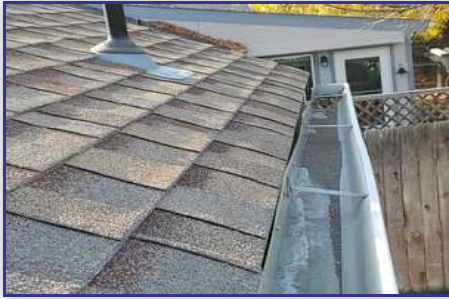
**Comment Location :** WEST/ REAR

There were one or more gutters that were loose from the home. This can cause damaged to the homes foundation and other problems due to moisture seepage into the home. The inspector recommend that the affected gutter be repaired as needed by a professional gutter contractor.

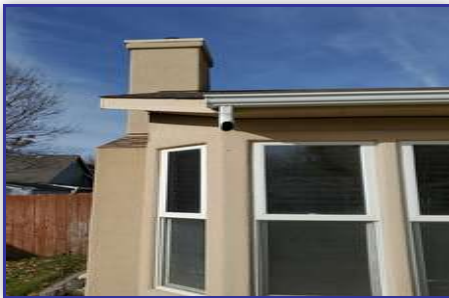
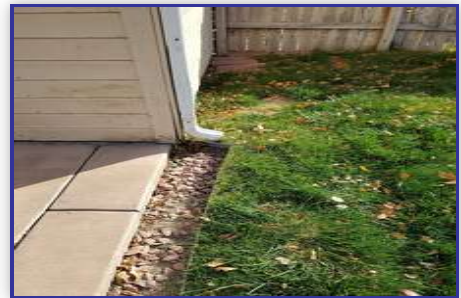
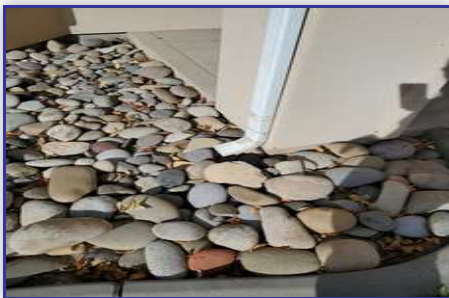
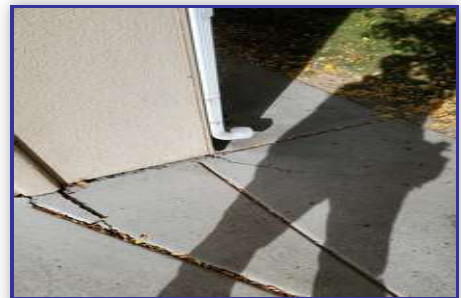
Location: EXTERIOR

## 2.6.2 Roof Drainage Components(Multiple Defects)

**Comment Location :** EXTERIOR**1. DOWNSPOUT (DAMAGED/MISSING)**

There were downspouts that were damaged or missing leaving the water drainage to close to the foundation of the home. This can cause significant damaged to the home and it s structure. We recommend that the missing downspouts be installed as needed running at least six feet from the foundation. All work should be done by a professional gutter installation company.

**2. DOWNSPOUT EXTENSION (DAMAGED)**

One or more downspout extensions were damaged at the time of the inspection. To insure proper drainage, the inspector recommends that the extension be replaced.

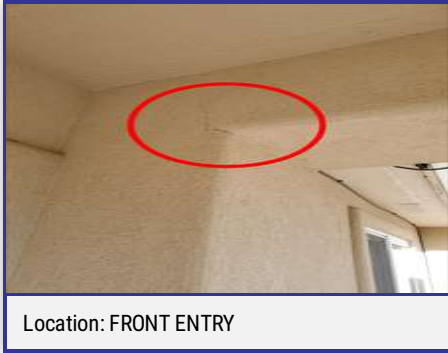
#### 3.1.1 Minor stucco cracking

At the time of inspection, one or more areas of the stucco had visible minor cracking. This happens over time from the expansion and contraction of materials between different weather temperatures. This is a cosmetic concern, not a structural problem. This type of cracking can continue over time. The Inspector recommends that the affected area(s) be evaluated, replaced or repaired, as needed, by a professional contractor.

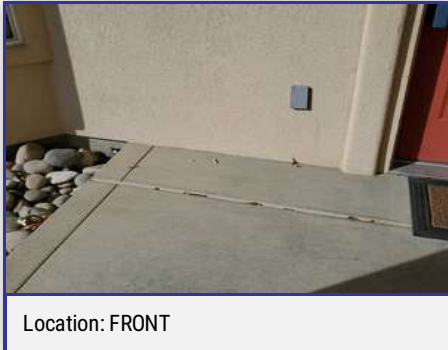
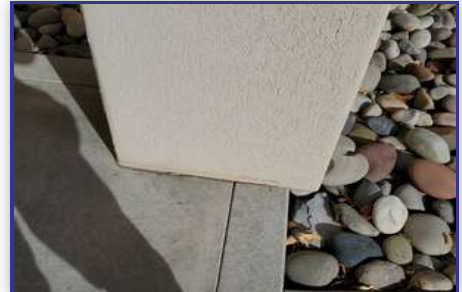
**Comment Location :** EXTERIOR

#### 3.1.3 Inadequate clearance from grade (No damage)

At the time of inspection, one or more areas of the exterior stucco wall had inadequate clearance to grade. It is necessary the the stucco terminate a minimum of 4 inches from grade, The Inspector recommends that the affected area(s) be evaluated, replaced or repaired, as needed, by a professional contractor, to prevent damage.

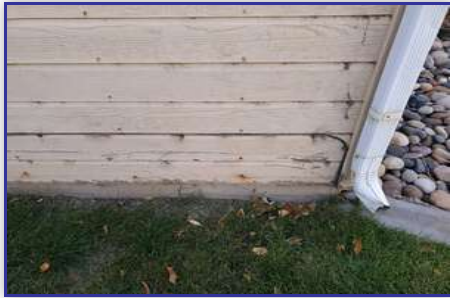
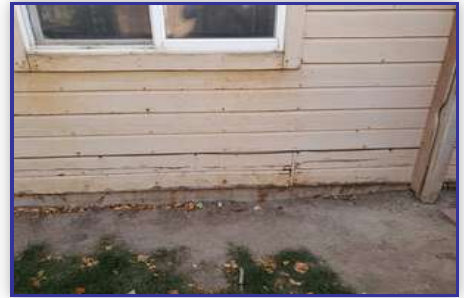
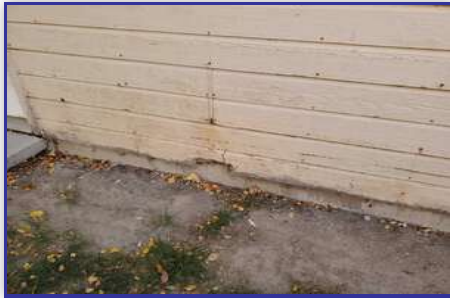
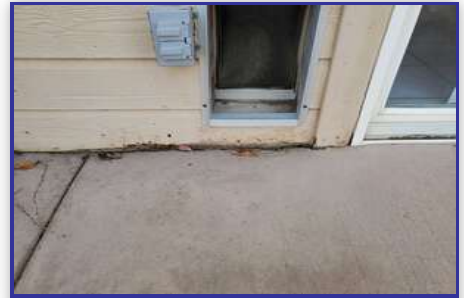
Location: EXTERIOR

At the time of inspection, moisture expansion was and along the bottom of several sections of siding around the entire home, allowing the siding to become loose and deteriorate. The Inspector recommends that the affected area(s) be evaluated, replaced or repaired, as needed, by a professional contractor.

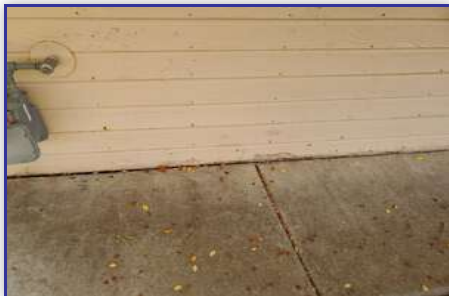
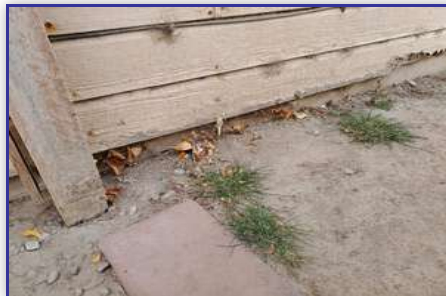
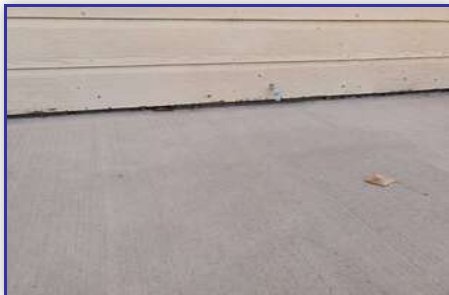
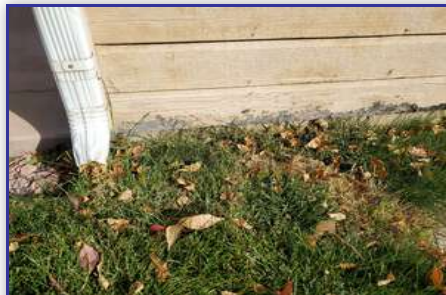
**Comment Location : EXTERIOR****1. IMPROPER SIDING CLEARANCE (ALL IN ONE)**

Clearances between the composite siding and surfaces was inadequate, resulting in potential moisture damage. Adequate minimum clearances below the bottom of of the siding and trim are:

Visible damage to lower composite siding, covering exterior wall was from inadequate clearance to grade, as a minimum of 6 inches to grade is needed. The Inspector recommends that the affected area(s) be evaluated, replaced or repaired, as needed, by a professional contractor.

The Inspector recommends that the affected area(s) be evaluated, replaced or repaired, as needed, by a professional contractor.

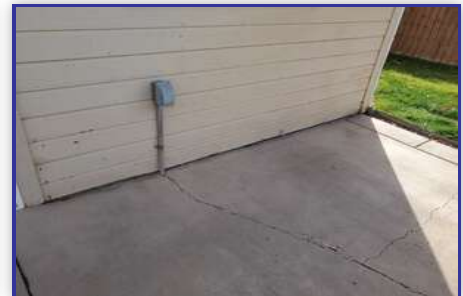
Location: EXTERIOR

**2. SIX INCH CLEARANCE (DAMAGED)**

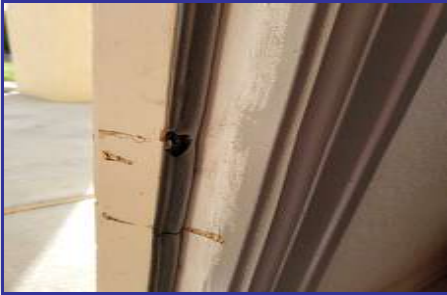
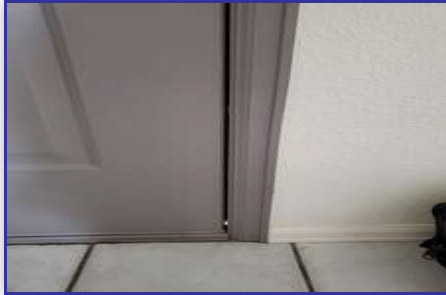
**1. DAMAGED WEATHER STRIPPING**

At the time of inspection the door weather stripping was damaged in areas. Repairs are needed so the door will shut and seal properly to prevent air loss and/or water penetration. The Inspector recommends that the affected area(s) be evaluated, replaced or repaired, as needed, by a professional contractor. Should you consider doing the repair yourself, see the DIY linked video, to assist you in your decision.

At the time of inspection, daylight was visible around one more exterior doors when it was closed. Additional weather stripping or adjustment is needed, as this is needed to prevent water, air, and insect intrusion. The Inspector recommends that the affected area(s) be evaluated, replaced or repaired, as needed, by a professional contractor. Should you consider doing the repair yourself, see the DIY linked video, to assist you in your decision.

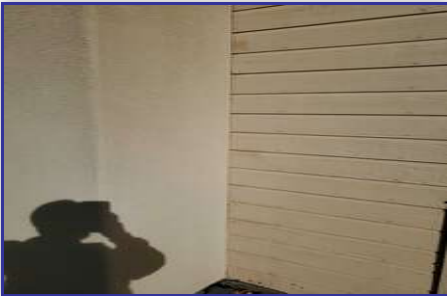
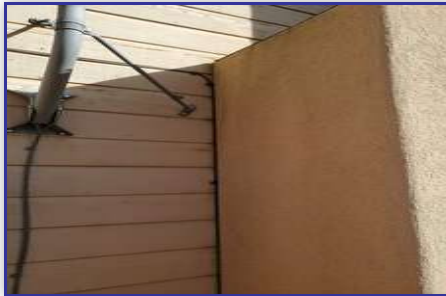
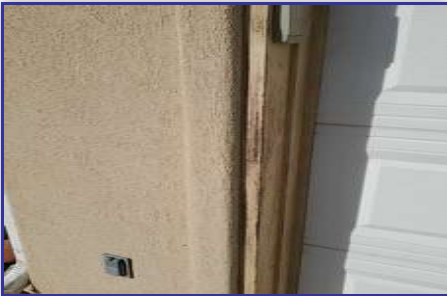
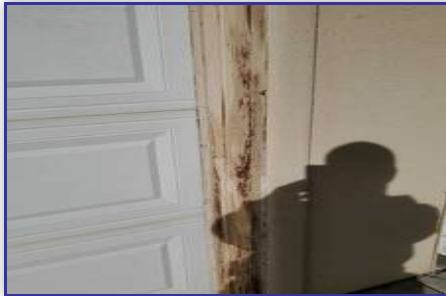
3.5.1 Material Change (No flashing)

At the time of inspection, horizontal junctions where the exterior siding/trim material changed from one material to another, were not protected by flashing, which may allow moisture penetration, resulting in moisture related damage. The Inspector recommends that the affected area(s) be evaluated, replaced or repaired, as needed, by a professional contractor.

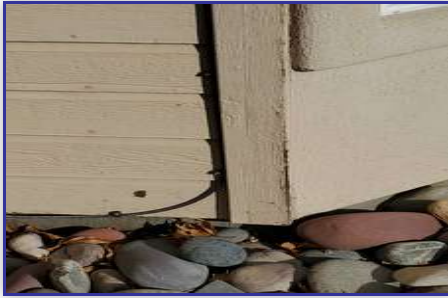
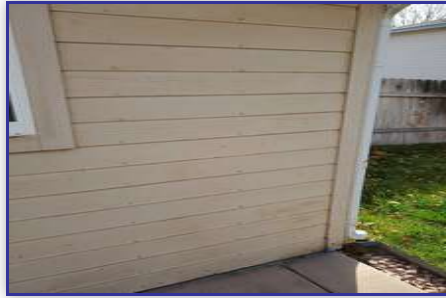
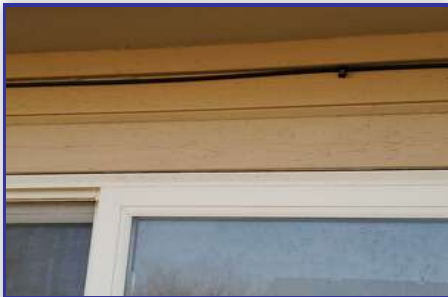
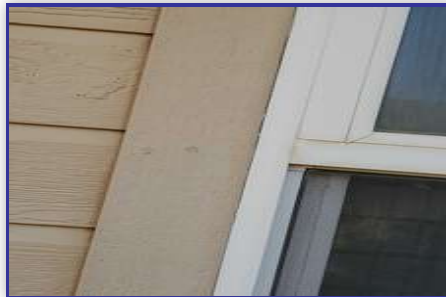
**Comment Location** : EXTERIOR**1. PAINT FAILING SOME AREAS**

At the time of inspection, paint or stain in some areas was failing (e.g. peeling, faded, worn, thinning). Siding and trim with a failing finish can be damaged by moisture. The Inspector recommends that the failing paint/stain area(s) be prep (e.g. clean, scrape, sand, prime, caulk) and repaint or re-stain, as needed, by a professional contractor, after needed siding or trim repairs are completed.

At the time of inspection, caulk was missing, deteriorated or substandard in some areas, like around windows around doors, at siding butt joints, at siding-trim junctions, or at wall penetrations. The Inspector recommends that the affected area(s) be evaluated, replaced or repaired, as needed, by a professional contractor. Should you consider doing the repair yourself, see the DIY linked video, to assist you in your decision.

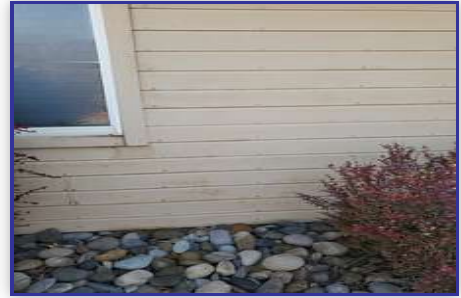
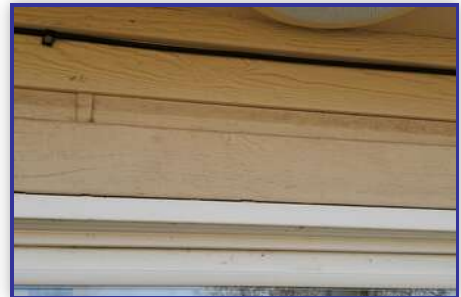
Location: ABOVE SLIDER

**2. CAULKING**

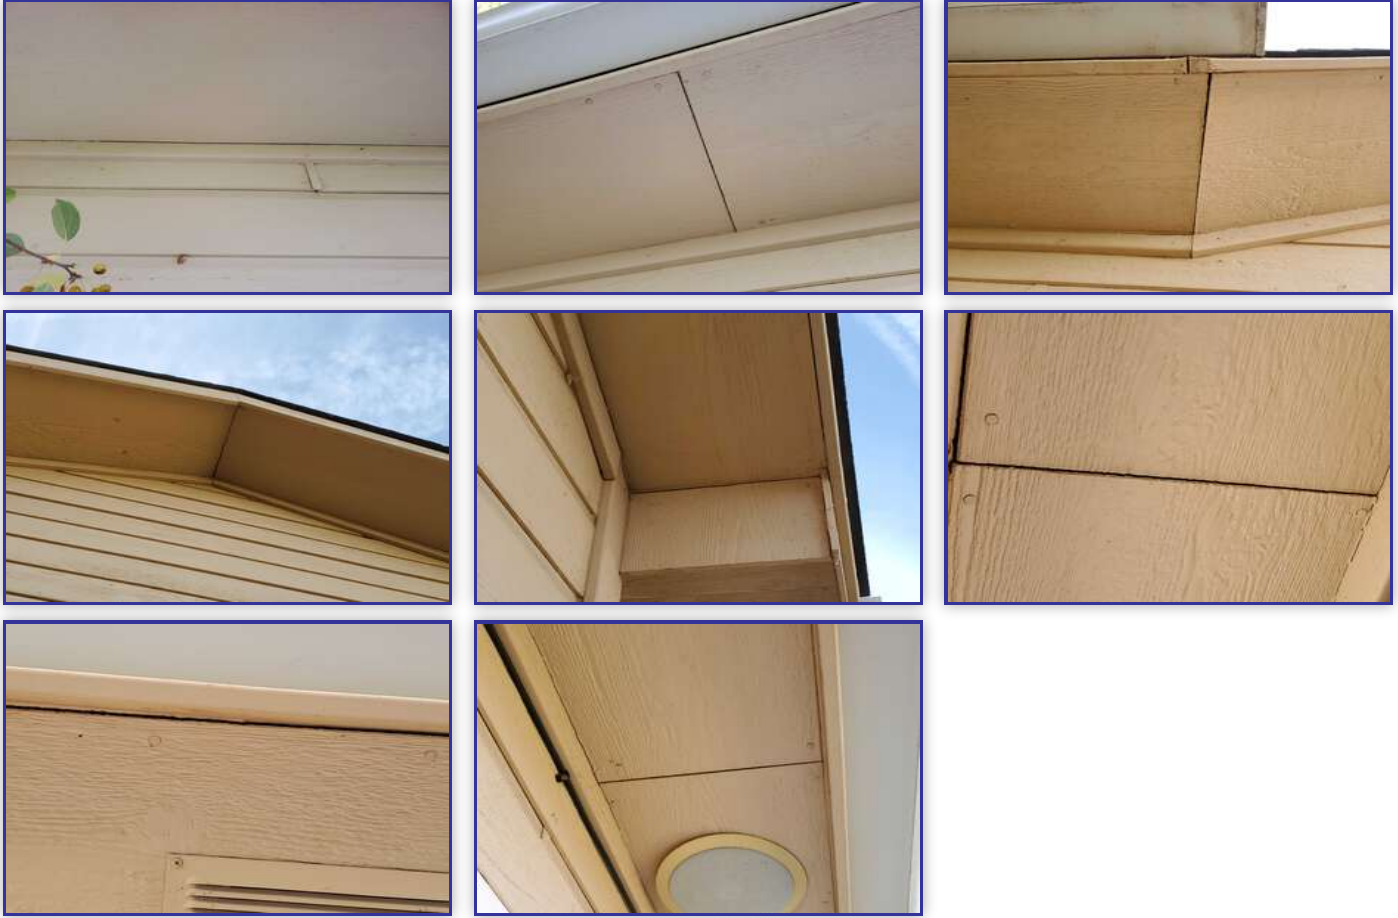
#### Comment Location : EXTERIOR

### 3.8.1 Holes or gaps in the soffit

At the time of inspection, holes or gaps were visible in the soffit and may allow moisture, insects or pests to enter the soffit and/or attic space where they may build nests or damage electrical wiring and/or insulation. The Inspector recommended sealing off holes or gaps as needed.

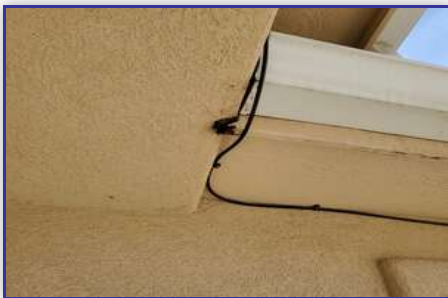
### 3.8.2 Damaged fascia

Areas of the trim or fascia were deteriorated / loose / split / warped / missing / damaged / substandard. The Inspector recommends that the affected area(s) be evaluated, replaced or repaired, as needed, by a professional contractor, to prevent further damage.

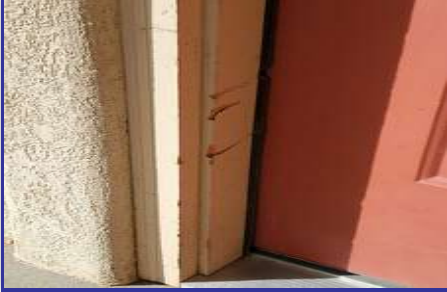
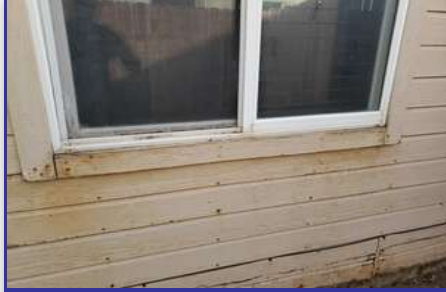
**Comment Location :** EXTERIOR**1. DAMAGED TRIM IN SEVERAL AREAS**

One or more areas of the exterior trim was damaged. The Inspector recommends that the affected area(s) be evaluated, replaced or repaired, as needed, by a professional contractor.

Area(s) of the trim had water damage, in one or more locations. The Inspector recommends that the affected area(s) be evaluated, replaced or repaired, as needed, by a professional contractor. Should you consider doing the repair yourself, see the DIY linked video, to assist you in your decision.

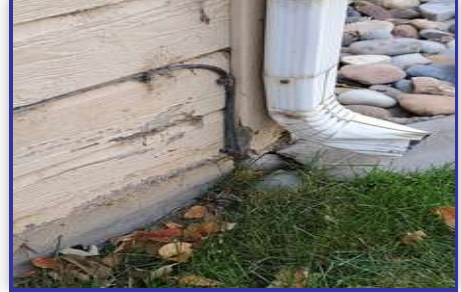
Location: EXTERIOR

**2. WATER DAMAGED TRIM**

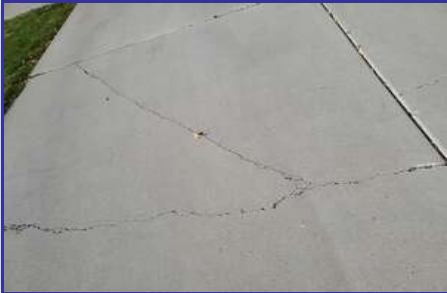
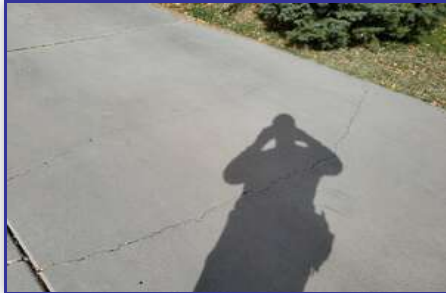
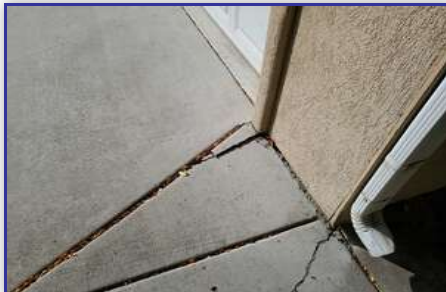
**4.1.1 Large cracks or damage (Driveway)****Comment Location :** EXTERIOR

Large visible cracks and/or badly damaged areas of the driveway. The inspector recommends, that the driveway be evaluated and repaired or replaced, by a professional concrete contractor.

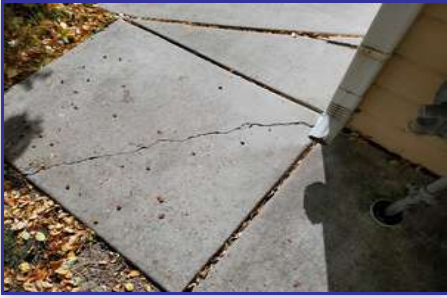
**Comment Location :** EXTERIOR NORTH WALKWAY

Large cracks were visible in the sidewalk/driveway at the time of the inspection. The inspector recommends that a professional contractor repair the concrete as needed to industry standard.

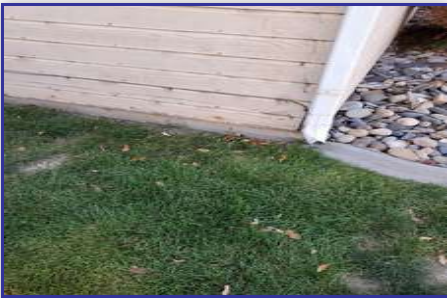
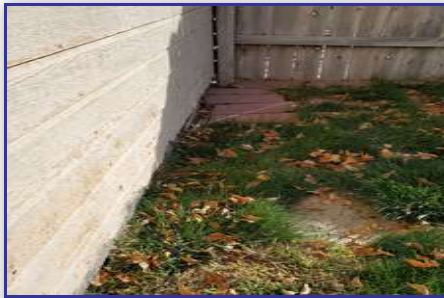
## 4.2.1 Negative grade issues

Surfaces sloped down at a negative pitch towards the home in one or more areas. This may result in water accumulating around building foundations or underneath buildings. We recommend that a professional contractor evaluate and repair the affected areas as necessary. For example, by installing drain(s) or removing old pavement and installing new. All new installations should slope at 1/4" per foot minimum for approximately six feet.

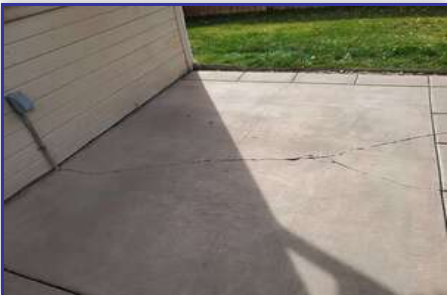
## 1. DAMAGED PATIO (REPAIR OR REPLACE)

The patio was damaged in various locations and is in need of repair or replacement. The Inspector recommends that the affected area(s) be evaluated, replaced or repaired, as needed, by a professional contractor.

## 2. PATIO CRACKING (SEAL)

Concrete patio/steps surface had cracking visible, at the time of the inspection. Cracks should be filled with an appropriate concrete patching material to help prevent and further deterioration. The sealant will need to be reapplied periodically.

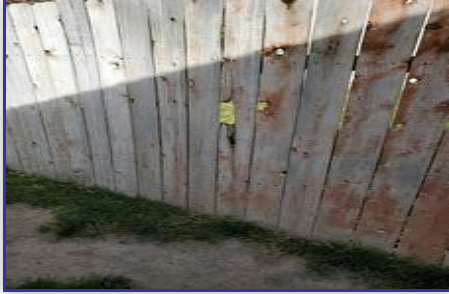
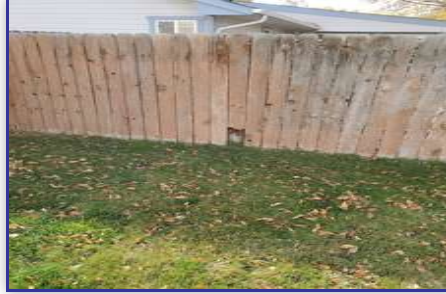
**Comment Location :** REAR**1. DAMAGED WOOD FENCE SLATS**

Wood boards forming the fence barrier were damaged, missing and in need of repair or replacement at the time of the inspection. The Inspector recommends that the affected area(s) be evaluated, replaced or repaired, as needed, by a professional fence contractor.

**2. LEANING FENCE POSTS**

The fence was leaning or damaged, indicating failure of the wood posts. The inspector recommends an evaluation and repair of the fence as needed by a professional fence repair company.

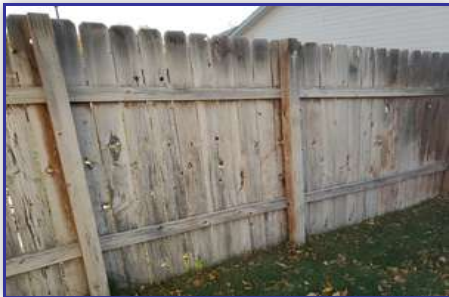
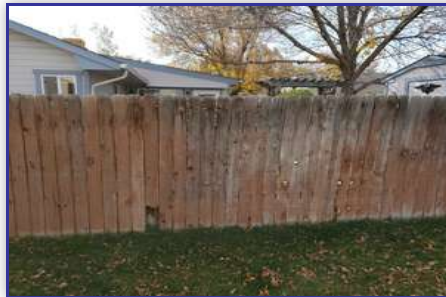
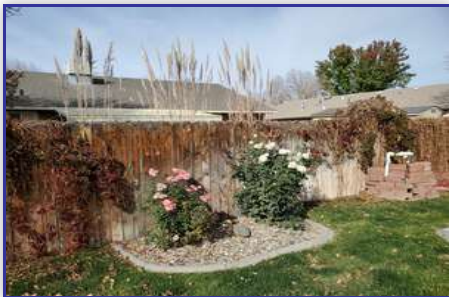
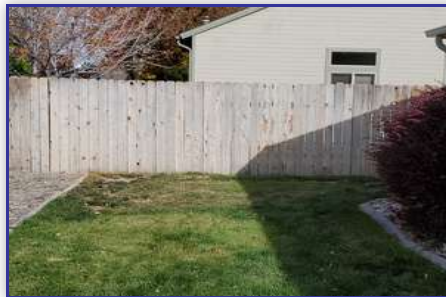
**Comment Location :** REAR

## 4.5.2 Peeling fence paint or stain

Fence had peeling paint or deteriorated stain that needs maintenance. The inspector recommends that the fence be prepped and painted/stained by a professional contractor.

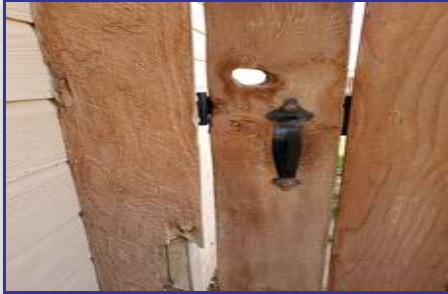
Location: NORTH EXTERIOR

**Comment Location :** NORTH EXTERIOR**1. GATE NEEDS TO BE REPLACED (DAMAGED)**

The gates were damaged and in need of replacement, at the time of the inspection. The inspector recommends that the gate be evaluated and repaired by a professional fence repair contractor.

**2. LEANING FENCE POSTS**

The fence was leaning or damaged, indicating failure of the wood posts. The inspector recommends an evaluation and repair of the fence as needed by a professional fence repair company.

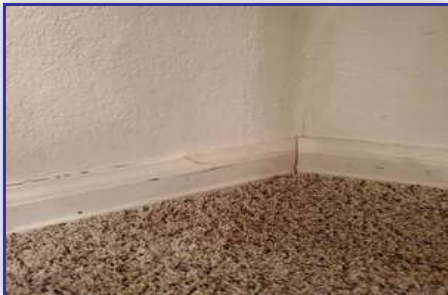
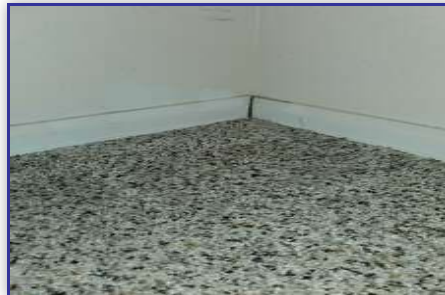
Trim was loose, missing, damaged, deteriorated and/or substandard in one or more areas. Recommend that a qualified person repair as necessary.

**2. TRIM (POORLY INSTALLED)**

The interior trim was poorly installed in one or more areas. The inspector recommends that all of the affected areas be repaired to industry standard by a professional trim repair contractor.

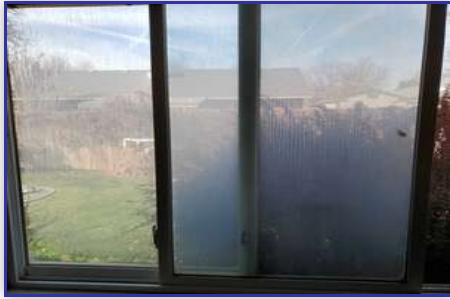
### 6.6.1 Window Dry Stains and/or Damage

One or more windows had prior moisture signs or damage around them. These areas were dry at time of inspection and may be old damage. Recommend following up with seller. If seller cannot confirm, invasive leak testing may be necessary. Please note areas behind the wall may already be damaged. Client can repair damage at their discretion.

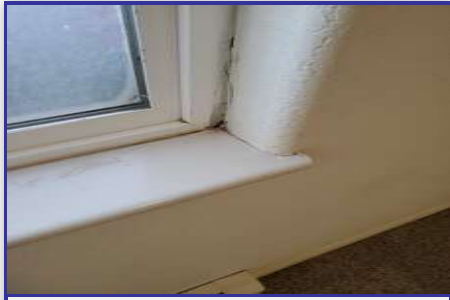
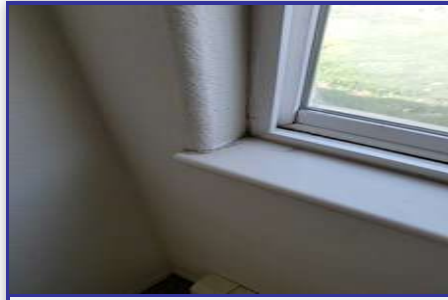
Location: MASTER BEDROOM

### 6.6.2 Window Sill Damaged

One or more window sills were damaged. We recommend that all of the affected areas be repaired by a professional contractor.

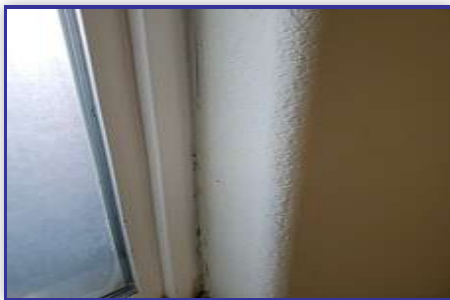
### 6.6.3 Interior Window Caulk (Cracked)

The caulking around the interior of one or more windows was cracked or failing. This is typical in a residential home unless the cracking is larger in nature. This area can be re-caulked during the next interior paint job occurrence.

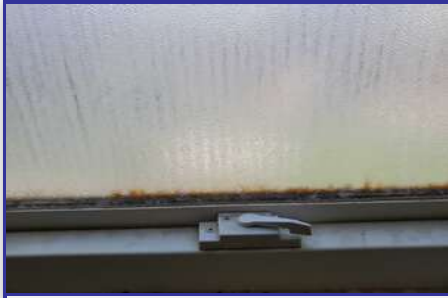
Location: MASTER BATHROOM

One or more windows were found with bubbled black seals. These windows ceased production years ago due to a known issue with the black rubber seals bubbling inside between the panes of glass, which is a noticeable cosmetic issue. It is unknown by the inspector if a repair is available or if a new window must be installed. This is noted as a cosmetic issue, however, the client should evaluate their comfort level with the condition and evaluate/repair as they feel necessary.

## 2. WINDOW (BROKEN)

There were one or more windows with chips, cracks or damage to the glass pane. We recommend that the affected windows be repaired as needed by a professional window repair contractor.

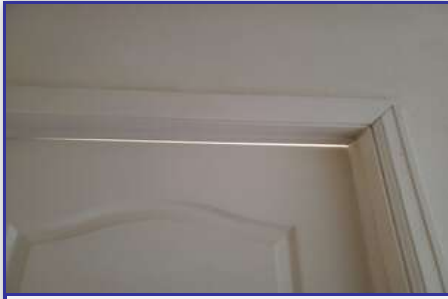
Location: BEDROOM 1

One or more interior doors were misaligned and/or had gaps at jambs. Recommend repairs be made by a qualified contractor.

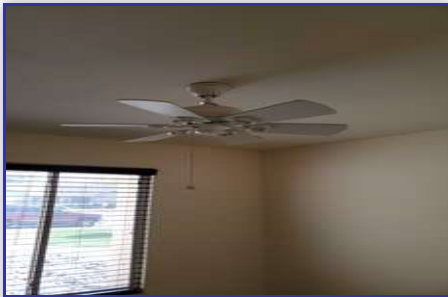
Location: BEDROOM 1

## 6.8.1 Ceiling Fan Damaged / Inoperable

One or more ceiling fans were damaged or inoperable. Recommend repair.

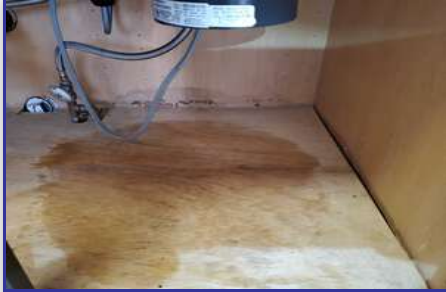
Location: KITCHEN

#### 1. CABINET SINK FLOOR DAMAGE (MOISTURE PRESENT)

The kitchen sink cabinet floor was water damaged at the time of the inspection. The water damage was recent and substandard repairs were made. We recommend that the leaks be repaired, then the cabinet replaced by professional contractors.

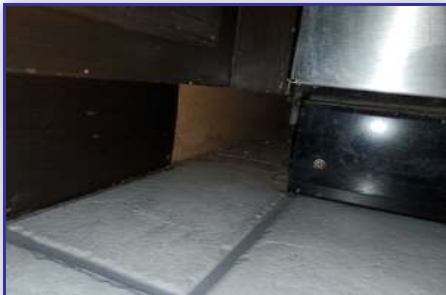
Location: KITCHEN

### 7.3.3 Missing toe kick

at the time of inspection a section of toe was missing near the dishwasher. cosmetic defect but will allow dirt and other debris behind and under dishwasher.

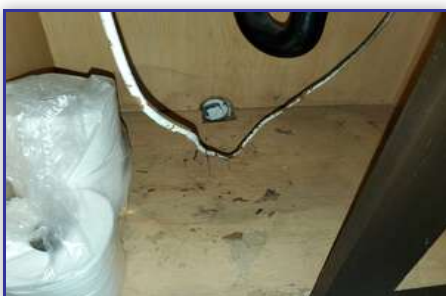
### 8.9.1 Cabinet floor minor damage (No moisture)

At the time of the inspection, the under-sink cabinet floor in the bathroom had minor damage from past moisture that appears to have been corrected. Recommended that the damaged area is repaired as needed and monitored to minimize further damage.

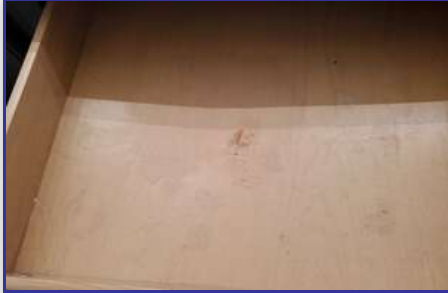
Location: MASTER BATHROOM

#### 1. CABINETS/DRAWERS DAMAGED

At the time of the inspection, one or more cabinets/drawers were damaged in areas. The Inspector recommends that the affected area(s) is evaluated, replaced or repaired, as needed, by a professional cabinet repair company.

#### 2. CABINET FLOOR MINOR DAMAGE (NO MOISTURE)

At the time of the inspection, the under-sink cabinet floor in the bathroom had minor damage from past moisture that appears to have been corrected. Recommended that the damaged area is repaired as needed and monitored to minimize further damage.

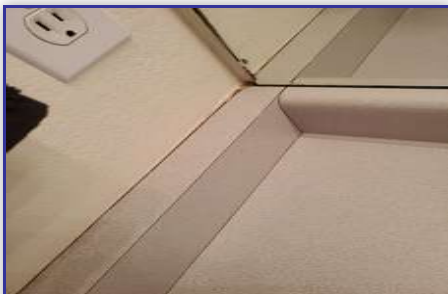
Location: MASTER BATHROOM

### 9.9.2 Damaged Caulk (Wall/Sink)

The bathroom counter caulking used to seal the sink or wall were cracked or damaged and in need of maintenance. We recommend that the affected areas be repaired as needed by a professional contractor.

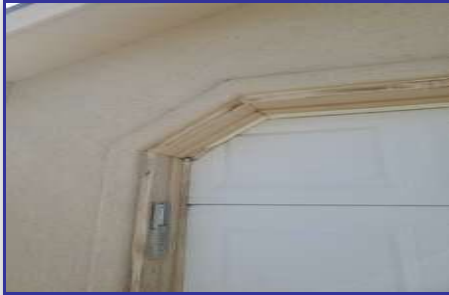
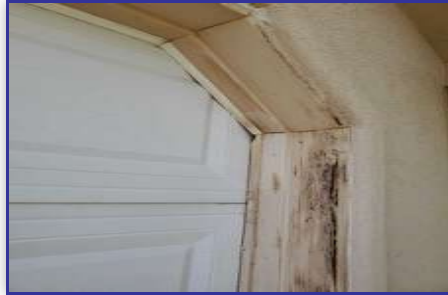
Location: EXTERIOR

### 15.3.1 Weatherstripping damage or missing

The garage door weatherstripping around the side and/or bottom was substandard, damaged and/or missing, allowing moisture and insects to enter. Recommended repair or replacement as needed by a professional contractor.

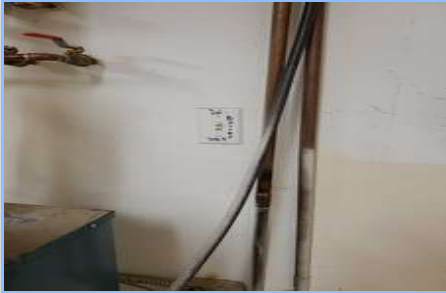
1.1 Shut off for boiler

The electrical equipment disconnect was located near the furnace and acts as a shut-off switch for use in an emergency or while servicing. The gas supply piping included a shut-off valve in the vicinity of the furnace for service personnel and emergency use. Heating systems are usually trouble-free and easy to maintain. Efficient operation is a function of proper regular maintenance. No matter what type of furnace you have, there are several things you can do to keep your heating system in top condition. You will need to change your filter every six months or as recommended by the manufacturer. Be sure to have your ducts cleaned periodically. You should always have your furnace serviced at least once a year to ensure it is functioning as intended. If you have a humidifier keep it clean, as it can easily create unhealthy conditions such as mildew growth. Servicing your furnace will prolong its life.

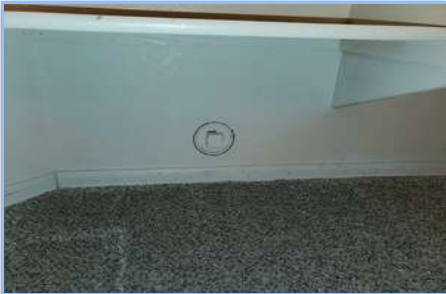
Location: MASTER CLOSET

The sewer clean-out is located in the home and is identified in the photo discription. It is not recommend to flush feminine hygiene products down a sanitary drain line or toilet. Materials can catch on tree roots or cracks creating a blockage and result in costly repairs to clean out the obstructions. Also is not recommended to dump cooking grease or oils down sinks or sanitary drains. Grease and oils have a tendency to cool and will collect creating a build-up and/or blockage in the main sewer line creating costly repairs.

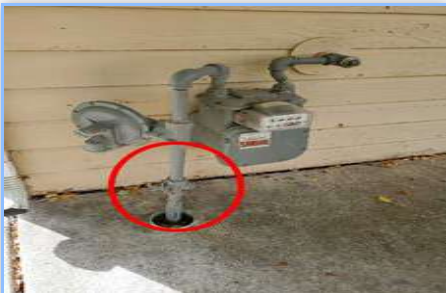
Location: NORTH SIDE OF GARAGE

The main fuel shut off is at gas meter outside. The inspector recommends hanging a small wrench on the meter in case an emergency shut off is needed.

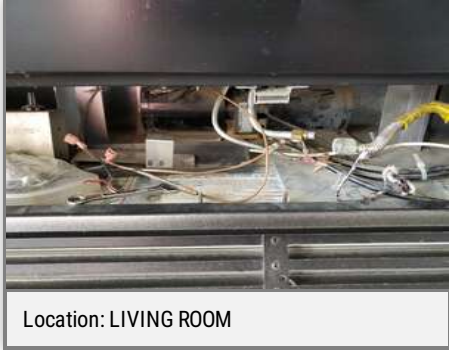
At the time inspection, the Gas Log Fireplace was not functional due to multiple disconnected fixtures and wires.

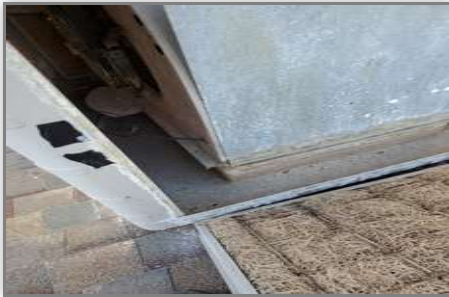
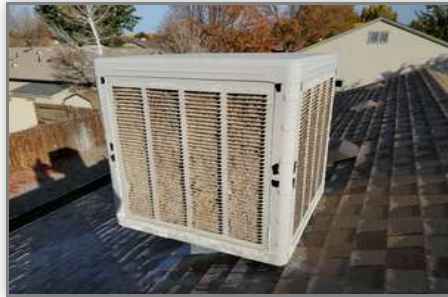
The evaporative cooler was not fully evaluated due the unit has been winterized (water off / no water in pan). We recommend that it be turned on at the least to insure that the pump and blower are working.

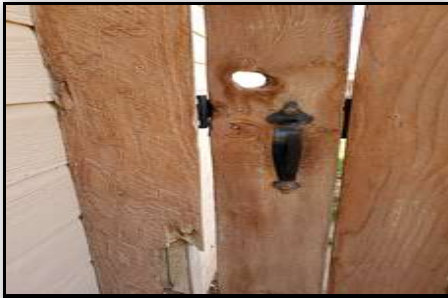
Location: NORTH EXTERIOR

The gates were damaged and in need of replacement, at the time of the inspection. The inspector recommends that the gate be evaluated and repaired by a professional fence repair contractor.

The fence was leaning or damaged, indicating failure of the wood posts. The inspector recommends an evaluation and repair of the fence as needed by a professional fence repair company.

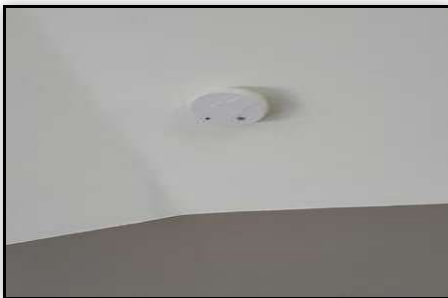
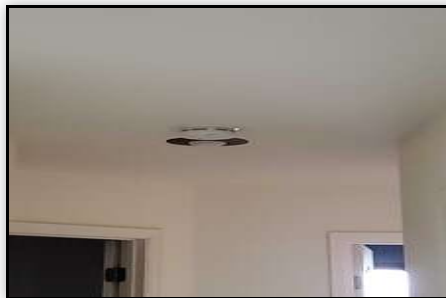
One or more smoke detectors were not hardwired / interconnected type or did not operate properly. When smoke detectors are hardwired / interconnected, all detectors will sound an alarm when just a single detector is detecting smoke. Recommend replacing any battery operated or malfunctioning smoke detectors with hardwired / interconnected type detectors.

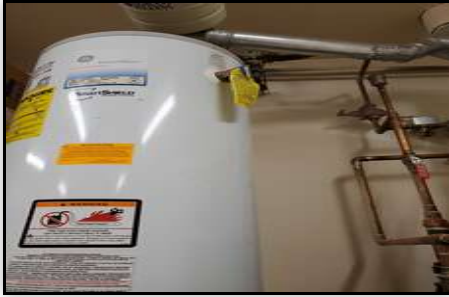
At the time of inspection, there was no discharge pipe installed on TPR valve. These pipes must be either CPVC, Copper or galvanized. and must have at least 6 six inches of clearance above pan.

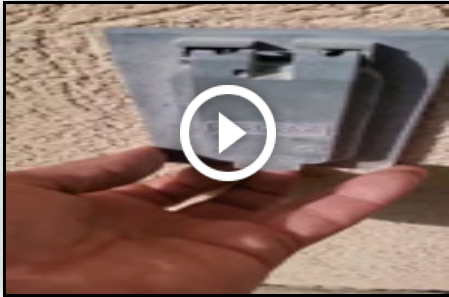
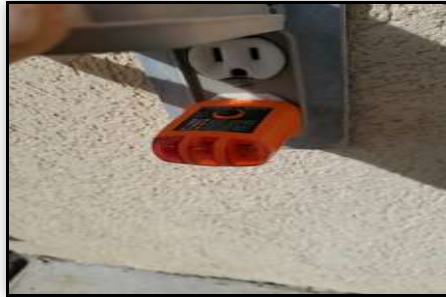
At the time of inspection, one or more exterior outlets were loose when plug was inserted. The inspector recommends that it is evaluated, repaired or replaced, as needed, by a professional electrical contractor.

One or more electric receptacles appeared to have no power. Recommend contacting the property owner about this. Switches may need to be operated or GFCI/AFCI protection may need to be reset to make some receptacles energized. If necessary, recommend that a professional electrician evaluate and repair.

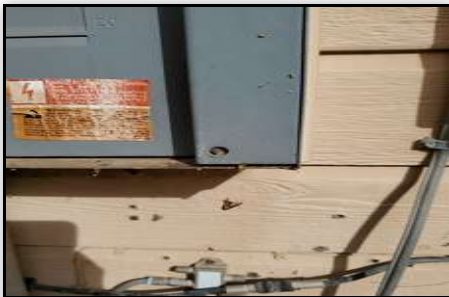
Location: SOUTH

The panel cover was missing one or more screws and should be replaced with stock screws from the panel manufacturer or their equivalent.

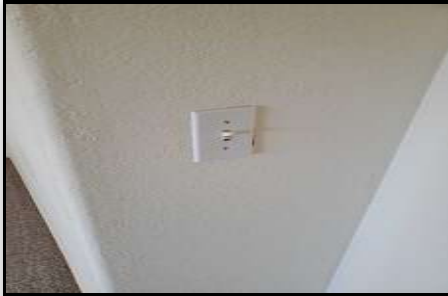
Location: MASTER BEDROOM

A switch in one or more rooms was inoperable. It may control a wall outlet installed for a light that was overlooked or a light that has been removed. Ask the seller about its operation. If they have no clue then it will need to be evaluated by a professional electrical contractor to trace its intended operation.

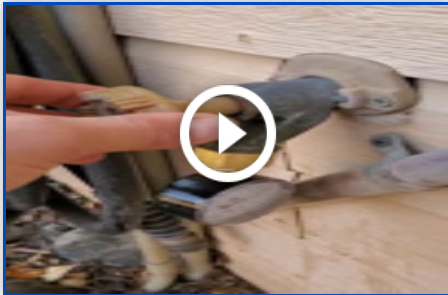
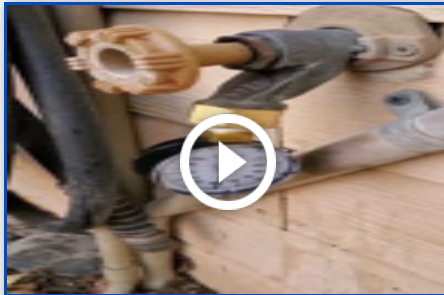
Location: WEST REAR

At the time of inspection, an exterior faucet was loose and/or installed incorrectly. The Inspector recommends that the affected area(s) be evaluated, replaced or repaired, as needed, by a professional plumbing contractor.

At the time of inspection, an exterior faucet was leaking constantly, with the pressure tester connected, which indicates a deterioration of the interior seal. The Inspector recommends that the exterior faucet be evaluated, replaced or repaired, as needed, by a professional contractor.

The water supply pressure is greater than 80 psi. Pressures above 80 psi may void warranties for some appliances such as water heaters or washing machines. Flexible supply lines to washing machines are more likely to burst with higher pressures. Typically the pressure cannot be regulated at the water meter. Recommend having a qualified plumber evaluate and make modifications to reduce the pressure below 80 psi. Installing a pressure reducing valve on the main service pipe is a common solution to this problem. If one exists, then it should be adjusted for lower pressures.

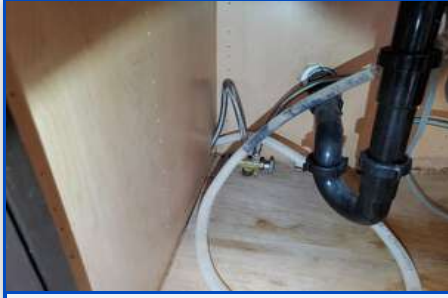
Location: KITCHEN

The dishwasher drain line is not configured with a "high loop" or "air gap". A high loop is created by routing the drain line up to the bottom surface of the countertop above and securely fastening it to that surface. It is meant to prevent water from siphoning out of the dishwasher, and to prevent water from the sink drain or food disposal from entering the dishwasher. Some dishwashers have a built-in high loop where one is not required to be configured in the drain line. The clients should try to determine if a high loop is required for this brand and model of the dishwasher (review installation instructions, etc.). If one is required, or it cannot be determined if one is not required, then a qualified contractor should install a high loop as per standard building practices. Also, no "air gap" is installed. Air gaps are another device meant to prevent water from the sink drain or food disposal from entering the dishwasher. These are required in some municipalities for new construction and when remodeling. The client(s) should consult with a qualified contractor to determine if an air gap should be installed.

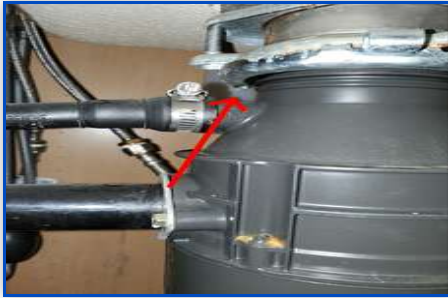
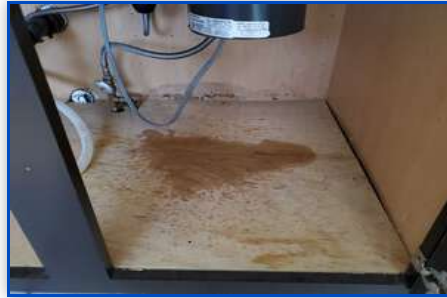
The drain under one or more kitchen sinks was leaking from the connections or other areas. We recommend that the leaks be repaired by a plumbing contractor.

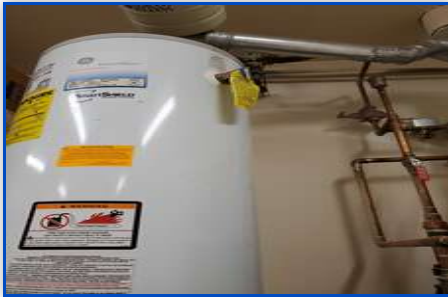
At the time of inspection, there was no discharge pipe installed on TPR valve. These pipes must be either CPVC, Copper or galvanized. and must have at least 6 six inches of clearance above pan.

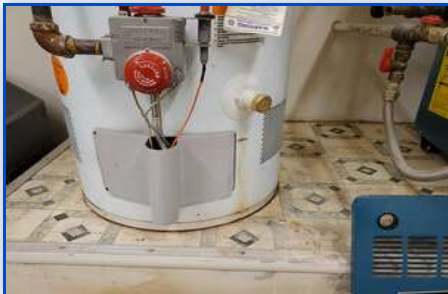
A water heater is installed that has no catch pan and drain installed. Recommend having a qualified contractor install a catch pan and drain to prevent water damage if/when the water heater develops a leak or is drained.

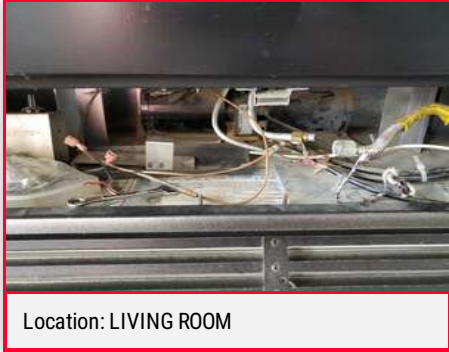
At the time inspection, the Gas Log Fireplace was not functional due to multiple disconnected fixtures and wires.

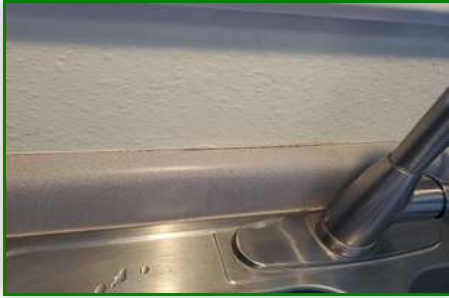
One or more areas of the kitchen countertop(s) are recommended to be re-sealed (caulked) to keep any moisture and or water out and prevent damage.

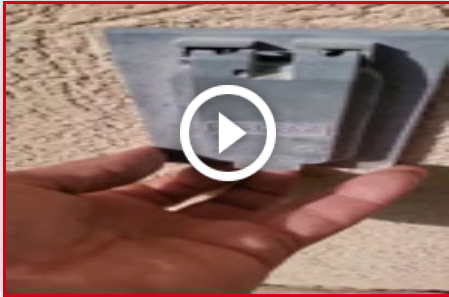
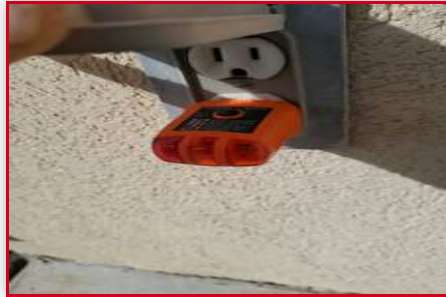
At the time of inspection, one or more exterior outlets were loose when plug was inserted. The inspector recommends that it is evaluated, repaired or replaced, as needed, by a professional electrical contractor.

One or more electric receptacles appeared to have no power. Recommend contacting the property owner about this. Switches may need to be operated or GFCI/AFCI protection may need to be reset to make some receptacles energized. If necessary, recommend that a professional electrician evaluate and repair.

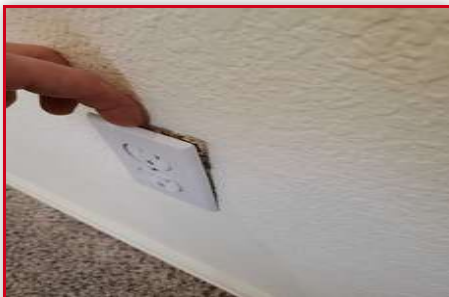
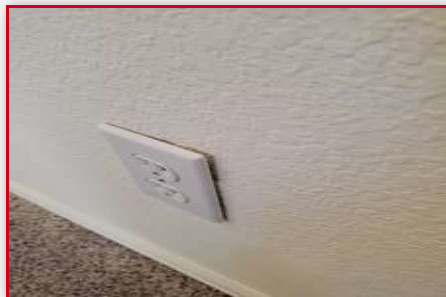
Location: BEDROOM 1

One or more electric receptacles and/or the boxes in which they were installed were loose and/or not securely anchored. Wire conductors can be damaged due to repeated movement and/or tension on wires, or insulation can be damaged. This is a shock and fire hazard. Recommend that a qualified electrician repair as necessary.

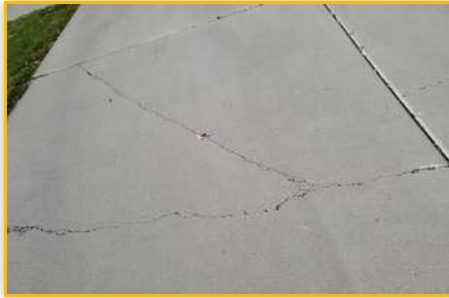
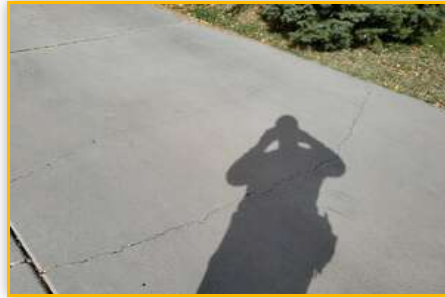
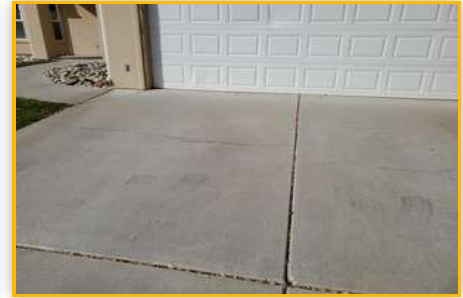
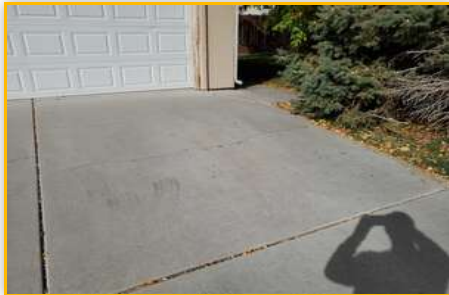
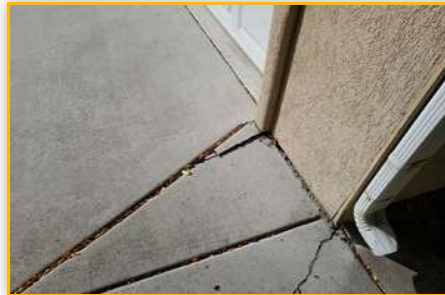
Large visible cracks and/or badly damaged areas of the driveway. The inspector recommends, that the driveway be evaluated and repaired or replaced, by a professional concrete contractor.

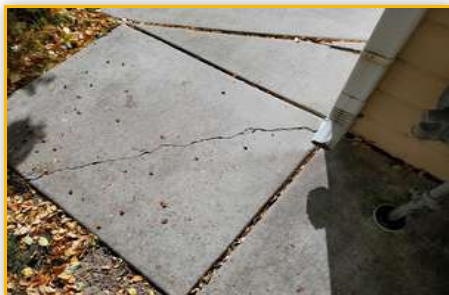
Large cracks were visible in the sidewalk/driveway at the time of the inspection. The inspector recommends that a professional contractor repair the concrete as needed to industry standard.

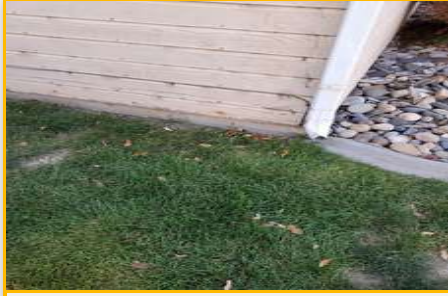
Location: NORTH

Surfaces sloped down at a negative pitch towards the home in one or more areas. This may result in water accumulating around building foundations or underneath buildings. We recommend that a professional contractor evaluate and repair the affected areas as necessary. For example, by installing drain(s) or removing old pavement and installing new. All new installations should slope at 1/4" per foot minimum for approximately six feet.

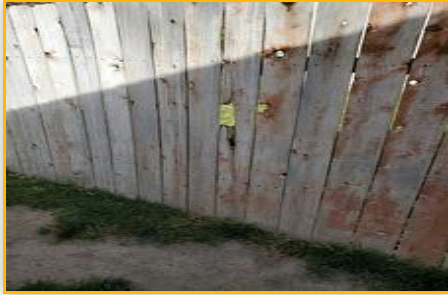
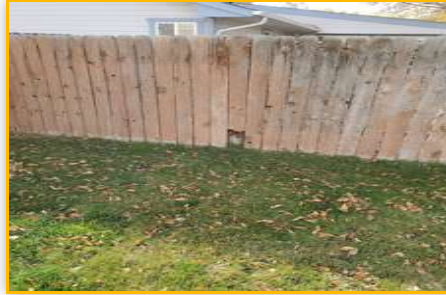
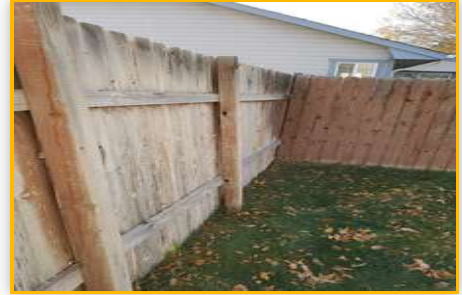
Wood boards forming the fence barrier were damaged, missing and in need of repair or replacement at the time of the inspection. The Inspector recommends that the affected area(s) be evaluated, replaced or repaired, as needed, by a professional fence contractor.

The fence was leaning or damaged, indicating failure of the wood posts. The inspector recommends an evaluation and repair of the fence as needed by a professional fence repair company.
