## YOUR INSPECTION REPORT

Inspection Report  
421 Comstock Drive, Fruita, Colorado 81521

Report ID  
AP-803-000013

Inspection Date  
October 23, 2020 at 09:00 AM

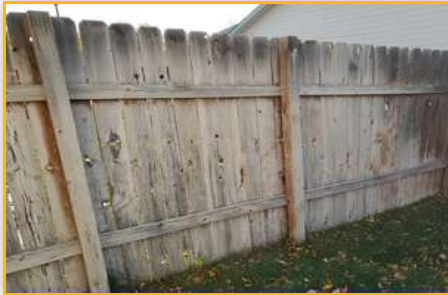
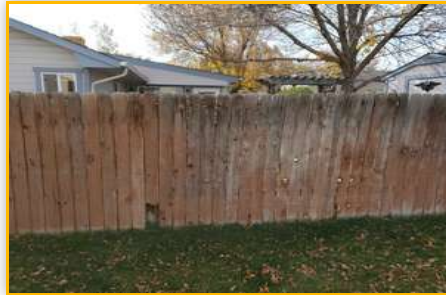
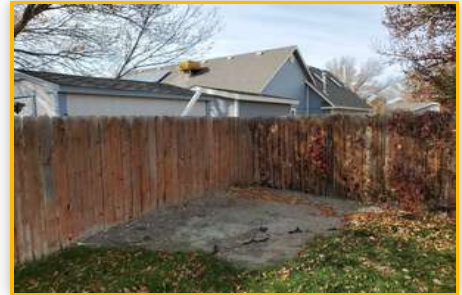
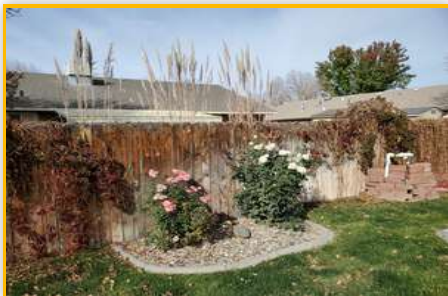
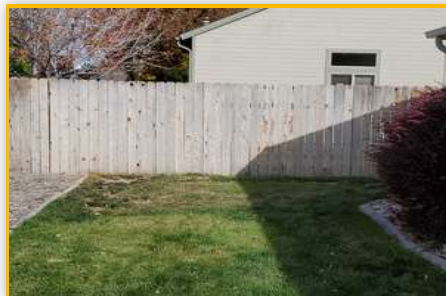
Fence had peeling paint or deteriorated stain that needs maintenance. The inspector recommends that the fence be prepped and painted/stained by a professional contractor.

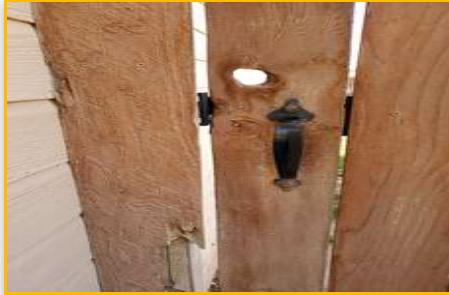
Location: NORTH EXTERIOR

The gates were damaged and in need of replacement, at the time of the inspection. The inspector recommends that the gate be evaluated and repaired by a professional fence repair contractor.

The fence was leaning or damaged, indicating failure of the wood posts. The inspector recommends an evaluation and repair of the fence as needed by a professional fence repair company.

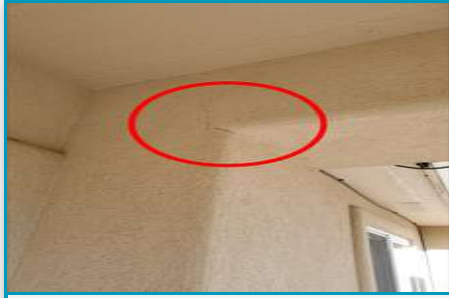
Location: FRONT ENTRY

At the time of inspection, one or more areas of the stucco had visible minor cracking. This happens over time from the expansion and contraction of materials between different weather temperatures. This is a cosmetic concern, not a structural problem. This type of cracking can continue over time. The Inspector recommends that the affected area(s) be evaluated, replaced or repaired, as needed, by a professional contractor.

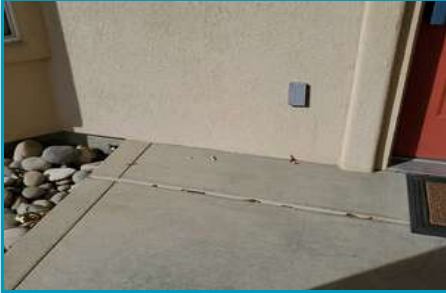
Location: FRONT

At the time of inspection, one or more areas of the exterior stucco wall had inadequate clearance to grade. It is necessary the the stucco terminate a minimum of 4 inches from grade, The Inspector recommends that the affected area(s) be evaluated, replaced or repaired, as needed, by a professional contractor, to prevent damage.

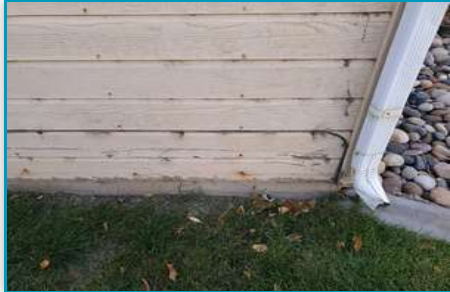
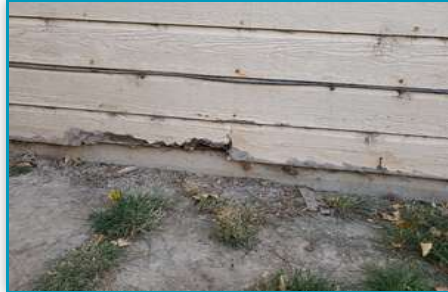
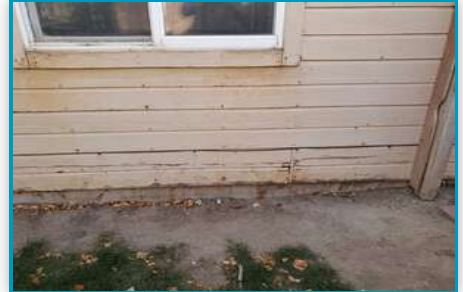
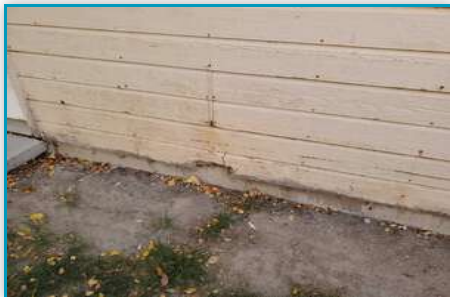
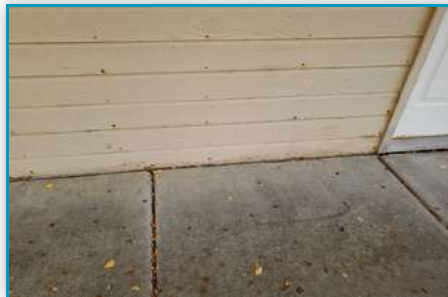
Location: EXTERIOR

At the time of inspection, moisture expansion was and along the bottom of several sections of siding around the entire home, allowing the siding to become loose and deteriorate. The Inspector recommends that the affected area(s) be evaluated, replaced or repaired, as needed, by a professional contractor.

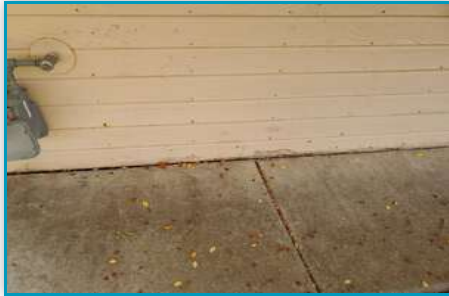
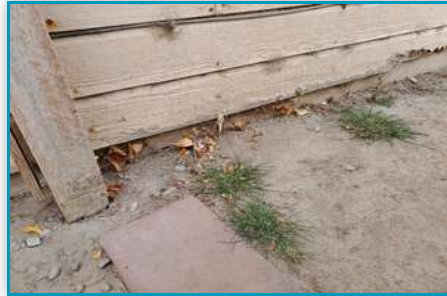
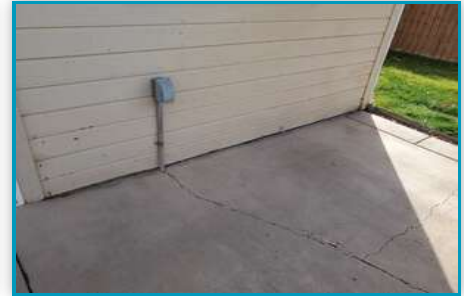
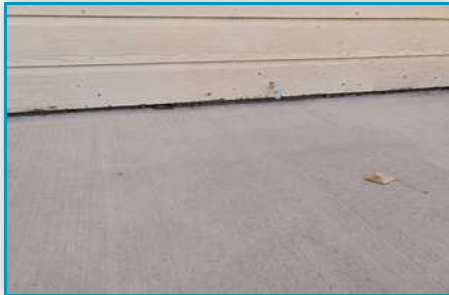
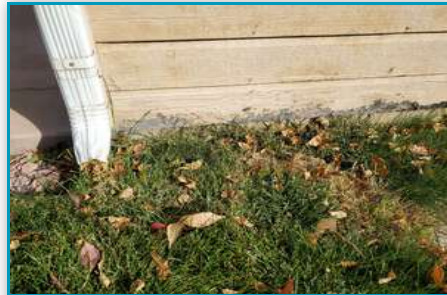
Location: EXTERIOR

Clearances between the composite siding and surfaces was inadequate, resulting in potential moisture damage. Adequate minimum clearances below the bottom of of the siding and trim are:

Visible damage to lower composite siding, covering exterior wall was from inadequate clearance to grade, as a minimum of 6 inches to grade is needed. The Inspector recommends that the affected area(s) be evaluated, replaced or repaired, as needed, by a professional contractor.

The Inspector recommends that the affected area(s) be evaluated, replaced or repaired, as needed, by a professional contractor.

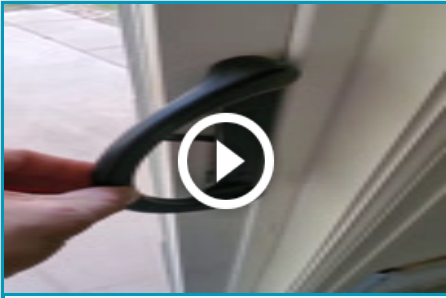
Location: REAR

Sliding glass door to back yard has a loose handle. recommend having it repaired or replaced by qualified handyman or contractor.

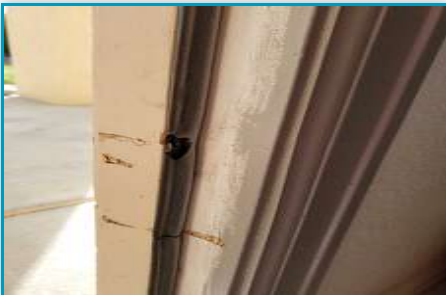
At the time of inspection the door weather stripping was damaged in areas. Repairs are needed so the door will shut and seal properly to prevent air loss and/or water penetration. The Inspector recommends that the affected area(s) be evaluated, replaced or repaired, as needed, by a professional contractor. Should you consider doing the repair yourself, see the DIY linked video, to assist you in your decision.

At the time of inspection, daylight was visible around one more exterior doors when it was closed. Additional weather stripping or adjustment is needed, as this is needed to prevent water, air, and insect intrusion. The Inspector recommends that the affected area(s) be evaluated, replaced or repaired, as needed, by a professional contractor. Should you consider doing the repair yourself, see the DIY linked video, to assist you in your decision.

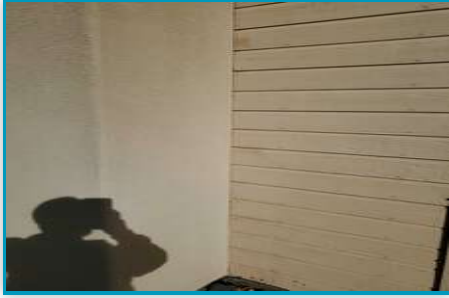
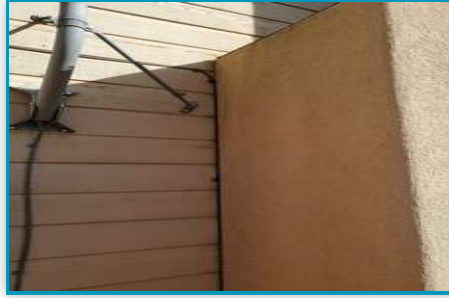
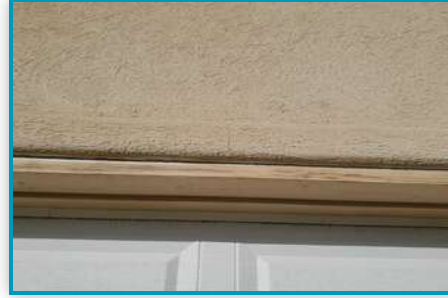
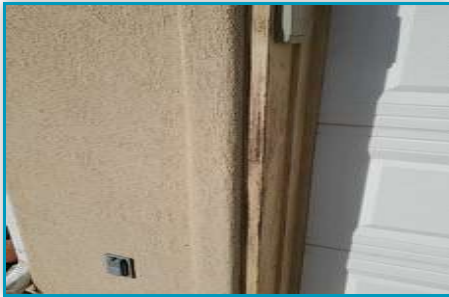
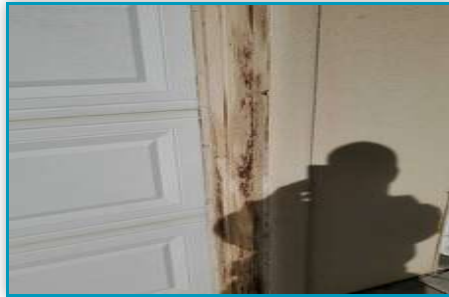
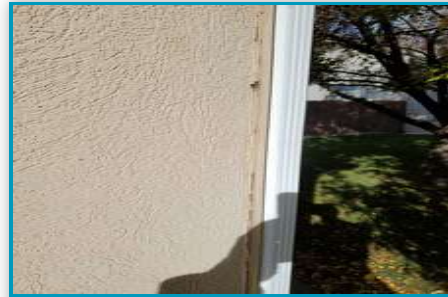
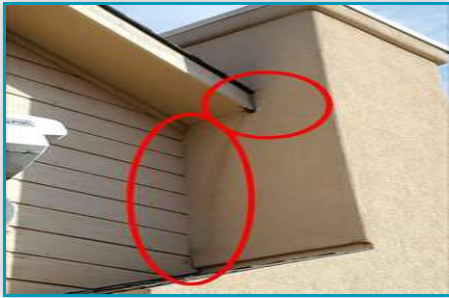
Location: GARAGE

At the time of inspection, horizontal junctions where the exterior siding/trim material changed from one material to another, were not protected by flashing, which may allow moisture penetration, resulting in moisture related damage. The Inspector recommends that the affected area(s) be evaluated, replaced or repaired, as needed, by a professional contractor.

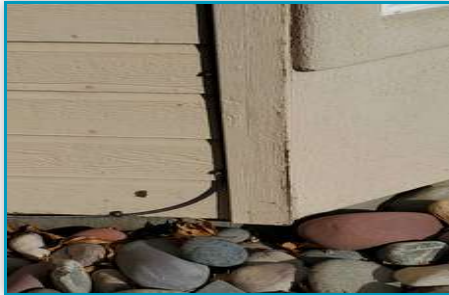
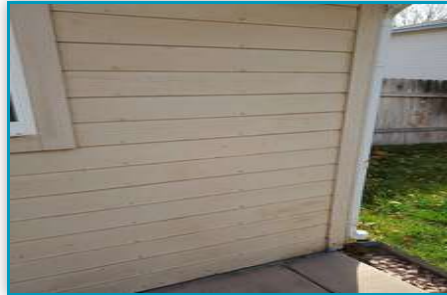
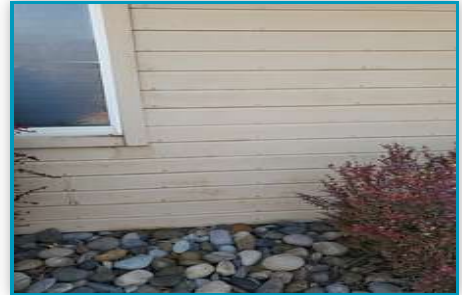
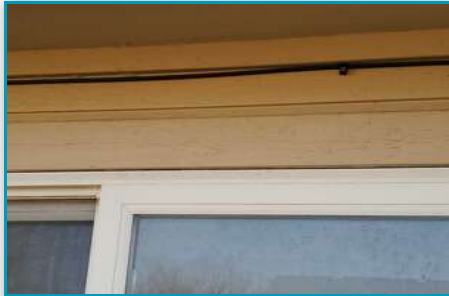
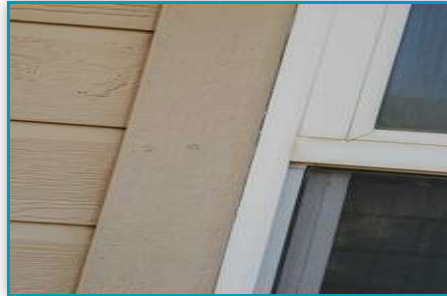
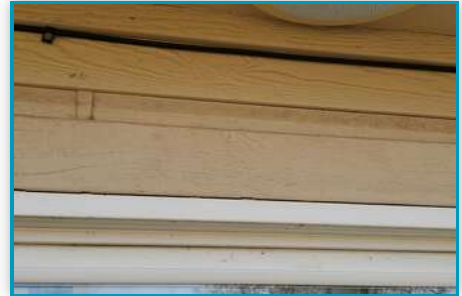
Location: ABOVE SLIDER

**Comment Location - EXTERIOR****1. PAINT FAILING SOME AREAS**

At the time of inspection, paint or stain in some areas was failing (e.g. peeling, faded, worn, thinning). Siding and trim with a failing finish can be damaged by moisture. The Inspector recommends that the failing paint/stain area(s) be prep (e.g. clean, scrape, sand, prime, caulk) and repaint or re-stain, as needed, by a professional contractor, after needed siding or trim repairs are completed.

**2. CAULKING**

At the time of inspection, caulk was missing, deteriorated or substandard in some areas, like around windows around doors, at siding butt joints, at siding-trim junctions, or at wall penetrations. The Inspector recommends that the affected area(s) be evaluated, replaced or repaired, as needed, by a professional contractor. Should you consider doing the repair yourself, see the DIY linked video, to assist you in your decision.

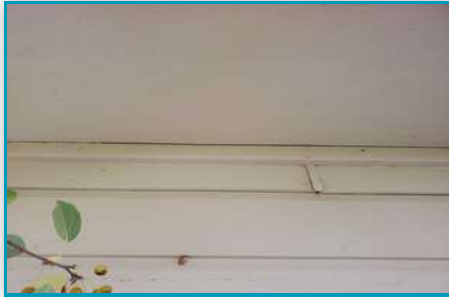
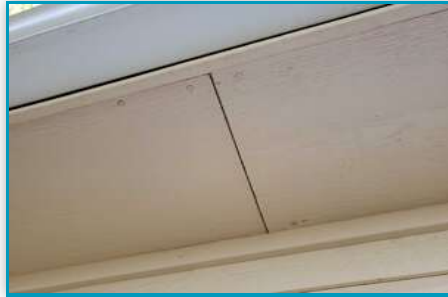
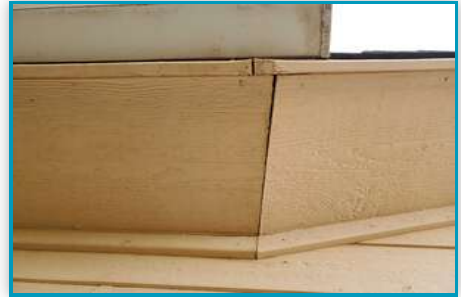
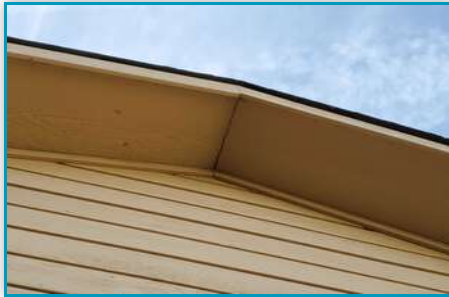
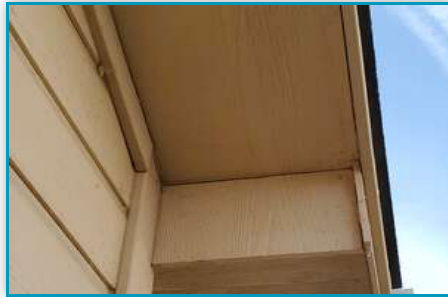
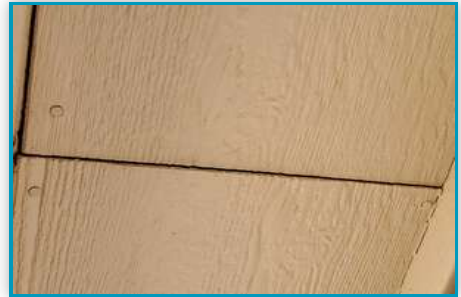
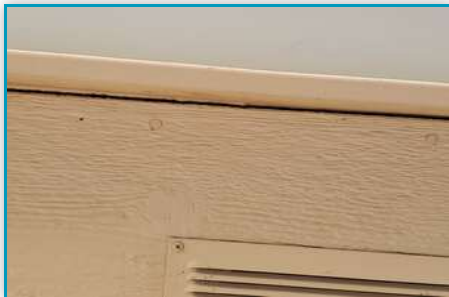
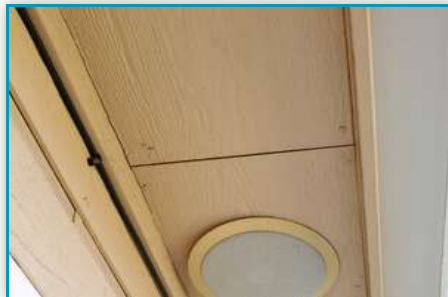
### 3.8.1 Holes or gaps in the soffit

At the time of inspection, holes or gaps were visible in the soffit and may allow moisture, insects or pests to enter the soffit and/or attic space where they may build nests or damage electrical wiring and/or insulation. The Inspector recommended sealing off holes or gaps as needed.

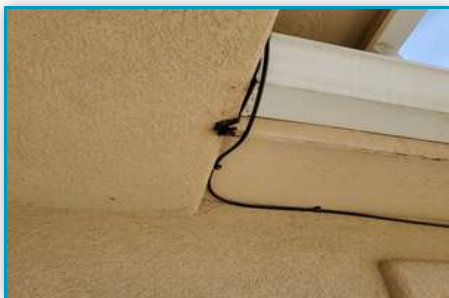
### 3.8.2 Damaged fascia

Areas of the trim or fascia were deteriorated / loose / split / warped / missing / damaged / substandard. The Inspector recommends that the affected area(s) be evaluated, replaced or repaired, as needed, by a professional contractor, to prevent further damage.

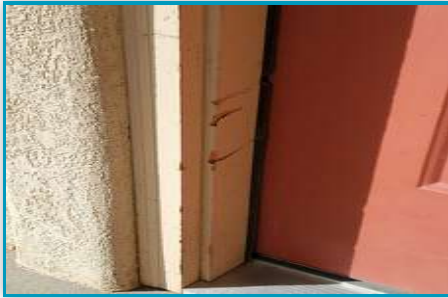
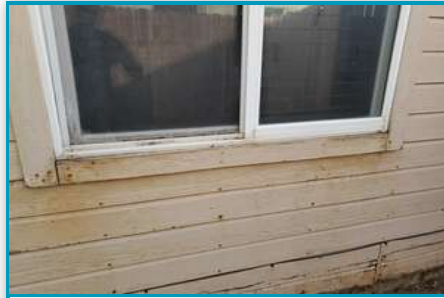
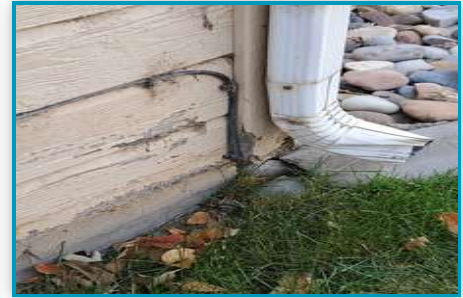
Location: EXTERIOR

1. DAMAGED TRIM IN SEVERAL AREAS

One or more areas of the exterior trim was damaged. The Inspector recommends that the affected area(s) be evaluated, replaced or repaired, as needed, by a professional contractor.

2. WATER DAMAGED TRIM

Area(s) of the trim had water damage, in one or more locations. The Inspector recommends that the affected area(s) be evaluated, replaced or repaired, as needed, by a professional contractor. Should you consider doing the repair yourself, see the DIY linked video, to assist you in your decision.

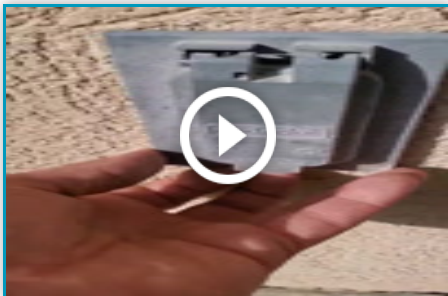
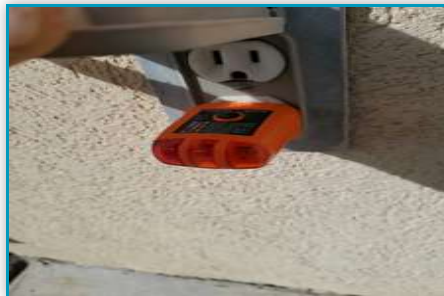
1. LOOSE OUTLET

At the time of inspection, one or more exterior outlets were loose when plug was inserted. The inspector recommends that it is evaluated, repaired or replaced, as needed, by a professional electrical contractor.

2. NO POWER

One or more electric receptacles appeared to have no power. Recommend contacting the property owner about this. Switches may need to be operated or GFCI/AFCI protection may need to be reset to make some receptacles energized. If necessary, recommend that a professional electrician evaluate and repair.

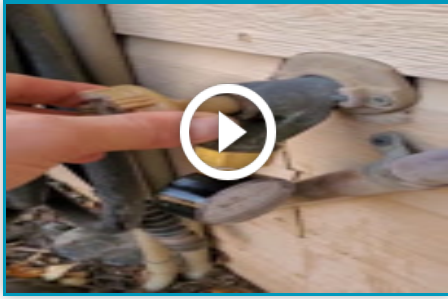
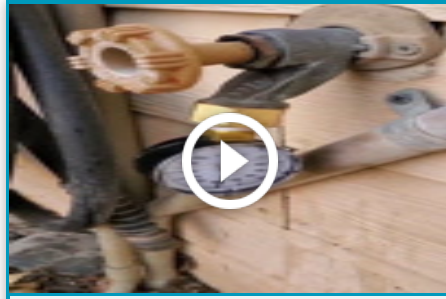
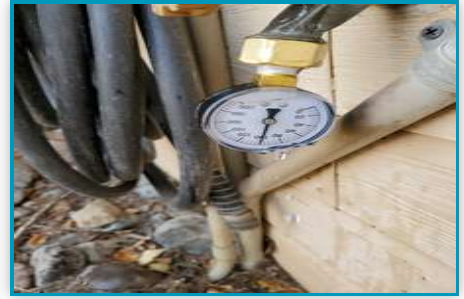
Location: WEST REAR

Plumbing Summary**Comment Location - EXTERIOR****1. LOOSE/POOR INSTALL (EXTERIOR FAUCET)**

At the time of inspection, an exterior faucet was loose and/or installed incorrectly. The Inspector recommends that the affected area(s) be evaluated, replaced or repaired, as needed, by a professional plumbing contractor.

**2. PRESSURE TESTER CONNECTED (LEAKING SEAL)**

At the time of inspection, an exterior faucet was leaking constantly, with the pressure tester connected, which indicates a deterioration of the interior seal. The Inspector recommends that the exterior faucet be evaluated, replaced or repaired, as needed, by a professional contractor.

**3. >80 PSI**

The water supply pressure is greater than 80 psi. Pressures above 80 psi may void warranties for some appliances such as water heaters or washing machines. Flexible supply lines to washing machines are more likely to burst with higher pressures. Typically the pressure cannot be regulated at the water meter. Recommend having a qualified plumber evaluate and make modifications to reduce the pressure below 80 psi. Installing a pressure reducing valve on the main service pipe is a common solution to this problem. If one exists, then it should be adjusted for lower pressures.

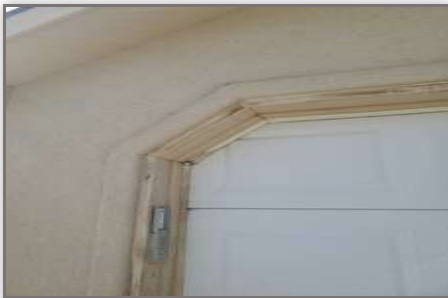
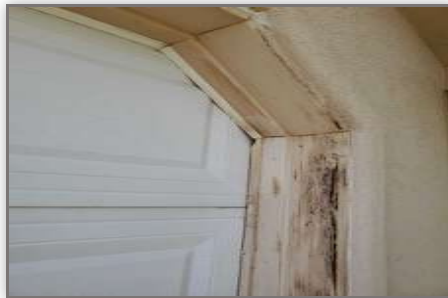
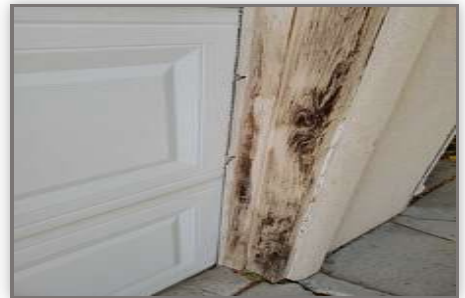
Location: EXTERIOR

### 15.3.1 Weatherstripping damage or missing

The garage door weatherstripping around the side and/or bottom was substandard, damaged and/or missing, allowing moisture and insects to enter. Recommended repair or replacement as needed by a professional contractor.

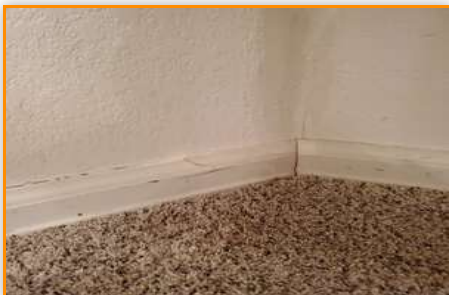
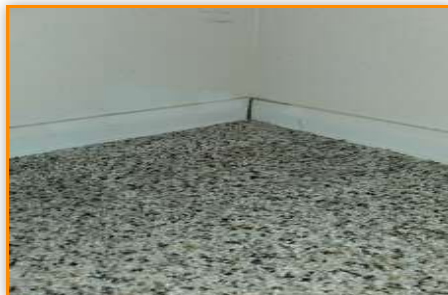
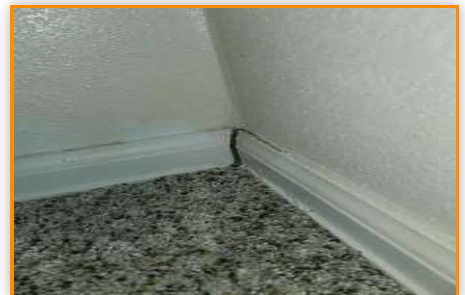
Trim was loose, missing, damaged, deteriorated and/or substandard in one or more areas. Recommend that a qualified person repair as necessary.

The interior trim was poorly installed in one or more areas. The inspector recommends that all of the affected areas be repaired to industry standard by a professional trim repair contractor.

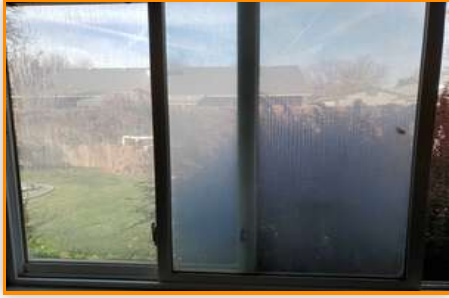
### 6.6.1 Window Dry Stains and/or Damage

One or more windows had prior moisture signs or damage around them. These areas were dry at time of inspection and may be old damage. Recommend following up with seller. If seller cannot confirm, invasive leak testing may be necessary. Please note areas behind the wall may already be damaged. Client can repair damage at their discretion.

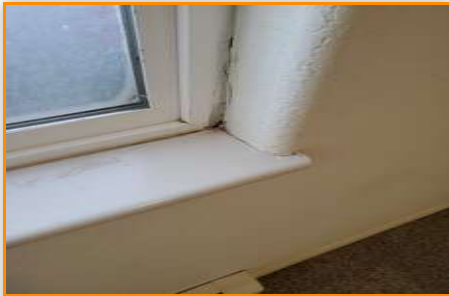
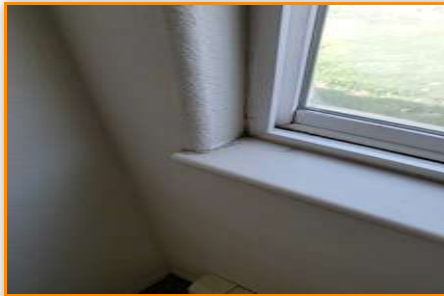
### 6.6.2 Window Sill Damaged

One or more window sills were damaged. We recommend that all of the affected areas be repaired by a professional contractor.

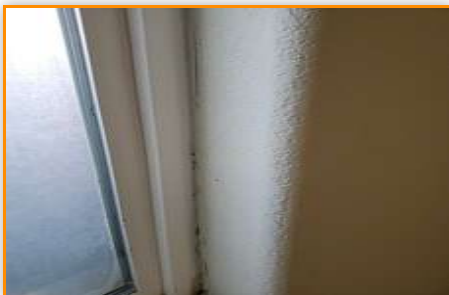
### 6.6.3 Interior Window Caulk (Cracked)

The caulking around the interior of one or more windows was cracked or failing. This is typical in a residential home unless the cracking is larger in nature. This area can be re-caulked during the next interior paint job occurrence.

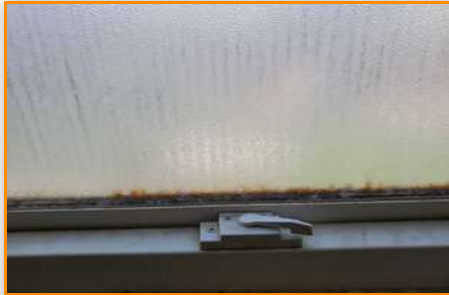
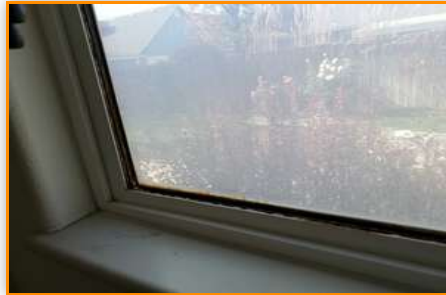
Location: MASTER BATHROOM

There were one or more windows with chips, cracks or damage to the glass pane. We recommend that the affected windows be repaired as needed by a professional window repair contractor.

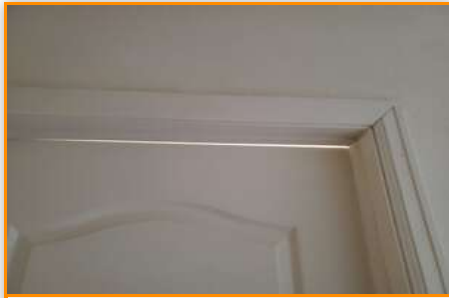
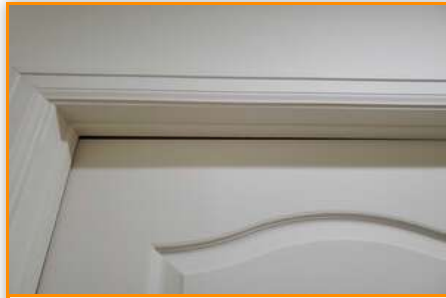
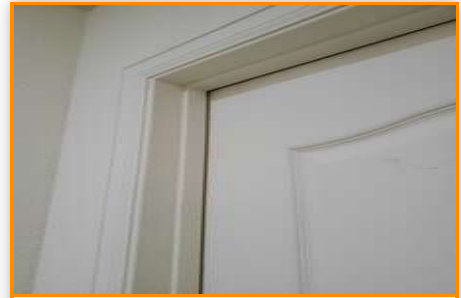
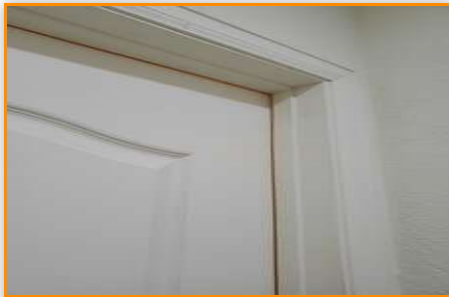
One or more interior doors were misaligned and/or had gaps at jambs. Recommend repairs be made by a qualified contractor.

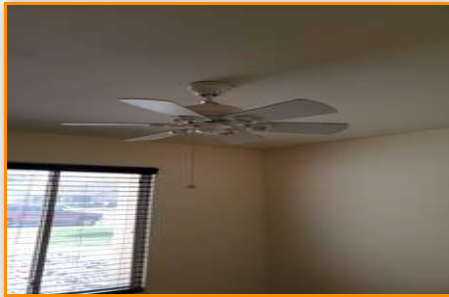
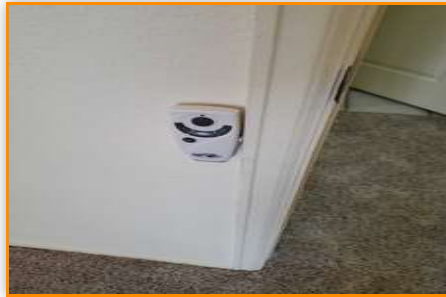
## 6.8.1 Ceiling Fan Damaged / Inoperable

One or more ceiling fans were damaged or inoperable. Recommend repair.

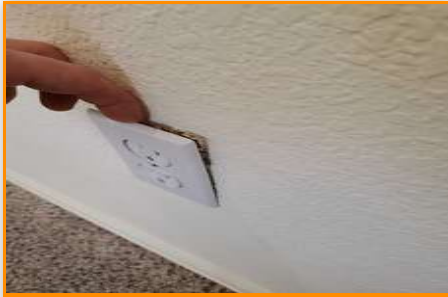
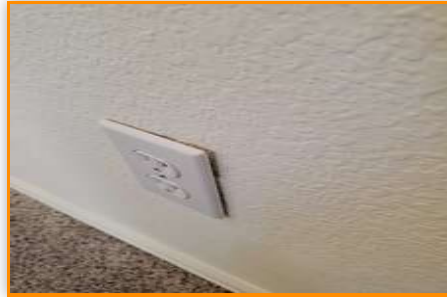
Location: BEDROOM 1

One or more electric receptacles and/or the boxes in which they were installed were loose and/or not securely anchored. Wire conductors can be damaged due to repeated movement and/or tension on wires, or insulation can be damaged. This is a shock and fire hazard. Recommend that a qualified electrician repair as necessary.

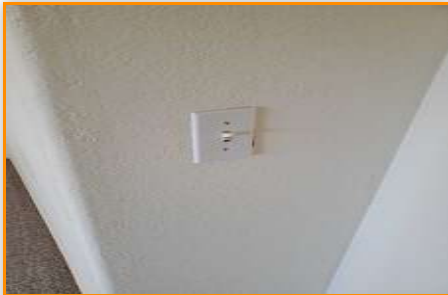
## 6.10.1 Inoperable switch

A switch in one or more rooms was inoperable. It may control a wall outlet installed for a light that was overlooked or a light that has been removed. Ask the seller about its operation. If they have no clue than it will need to be evaluated by a professional electrical contractor to trace its intended operation.

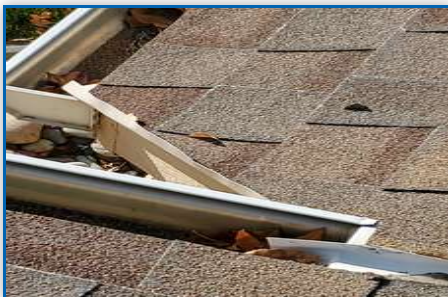
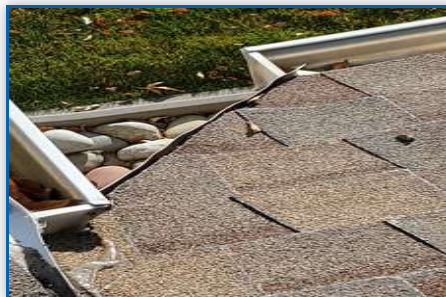
### 2.2.1 Roof Flashing(Multiple Defects)

There were one or more of the roof flashing were improperly installed, which may allow moisture seepage, resulting in damage, decay and mold. The Inspector recommends that the affected area(s) be evaluated, replaced or repaired, as needed, by a professional roofing contractor.

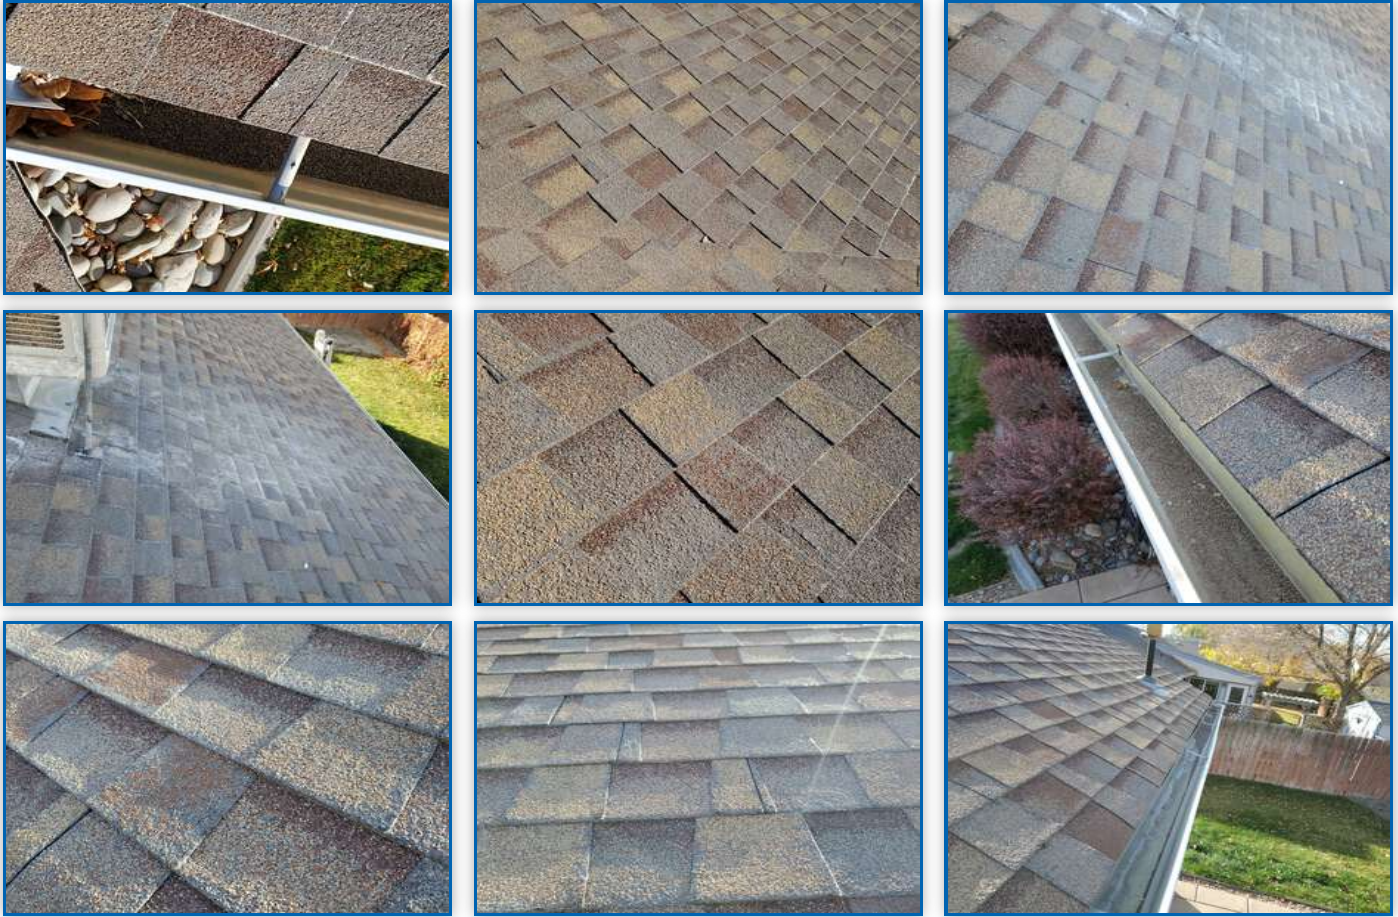
### 2.5.1 Granule loss (Repair)

At the time of inspection, patches of missing granules from the shingles in areas will need to be repaired.. The Inspector recommends that the affected area(s) be evaluated, replaced or repaired, as needed, by a professional contractor.

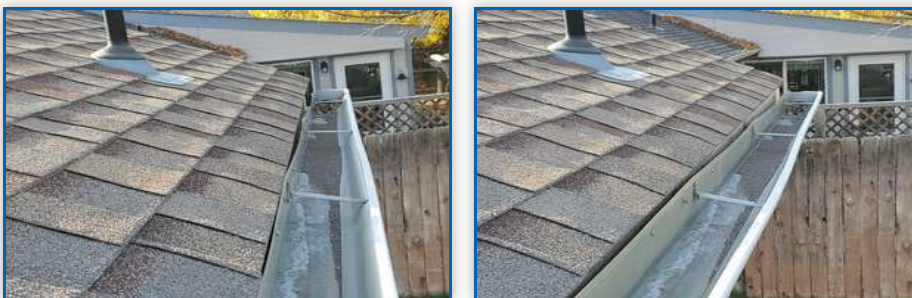
### 2.6.1 Gutters (Disconnected)

There were one or more gutters that were loose from the home. This can cause damaged to the homes foundation and other problems due to moisture seepage into the home. The inspector recommend that the affected gutter be repaired as needed by a professional gutter contractor.

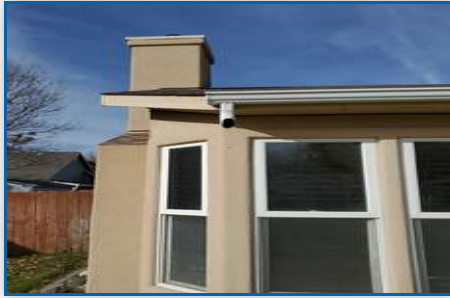
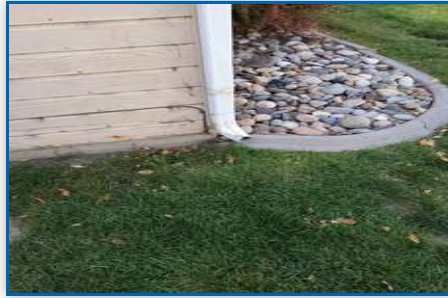
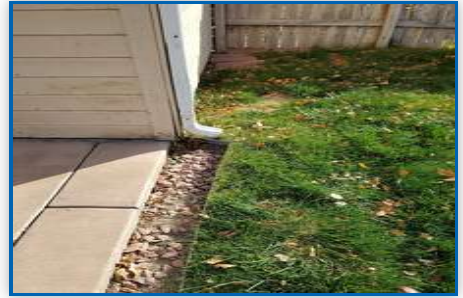
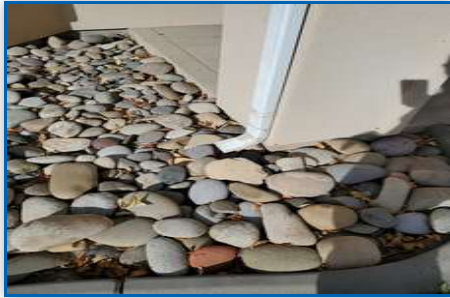
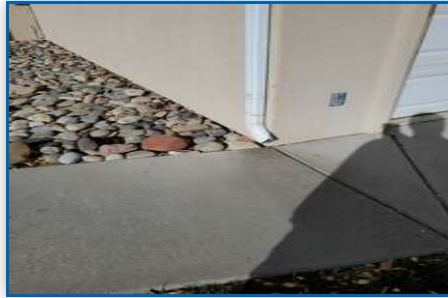
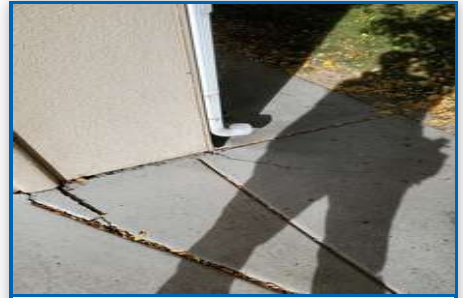
Location: EXTERIOR

There were downspouts that were damaged or missing leaving the water drainage to close to the foundation of the home. This can cause significant damaged to the home and its structure. We recommend that the missing downspouts be installed as needed running at least six feet from the foundation. All work should be done by a professional gutter installation company.

One or more downspout extensions were damaged at the time of the inspection. To insure proper drainage, the inspector recommends that the extension be replaced.

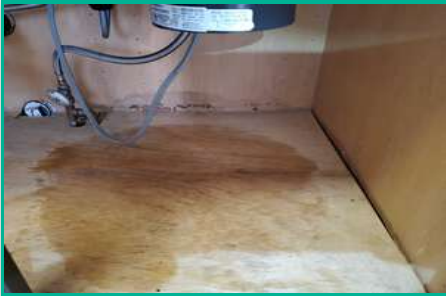
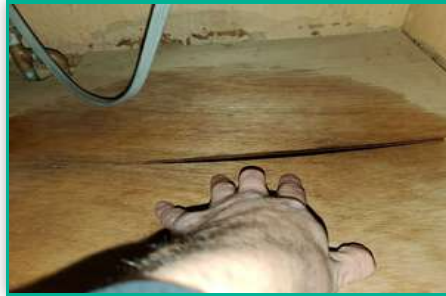
Location: KITCHEN

The kitchen sink cabinet floor was water damaged at the time of the inspection. The water damage was recent and substandard repairs were made. We recommend that the leaks be repaired, then the cabinet replaced by professional contractors.

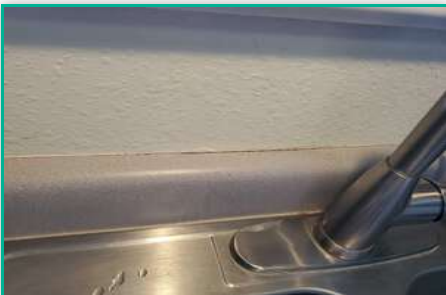
## 7.3.2 Countertop caulking

One or more areas of the kitchen countertop(s) are recommended to be re-sealed (caulked) to keep any moisture and or water out and prevent damage.

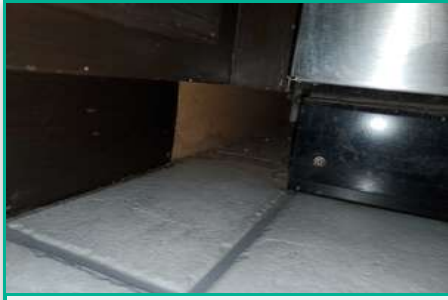
Location: KITCHEN

at the time of inspection a section of toe was missing near the dishwasher. cosmetic defect but will allow dirt and other debris behind and under dishwasher.

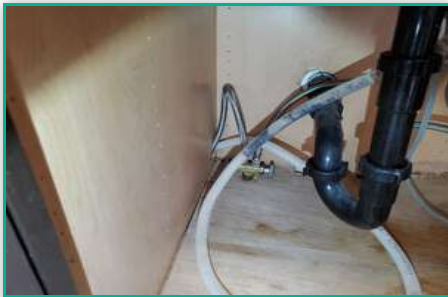
Location: KITCHEN

The dishwasher drain line is not configured with a "high loop" or "air gap". A high loop is created by routing the drain line up to the bottom surface of the countertop above and securely fastening it to that surface. It is meant to prevent water from siphoning out of the dishwasher, and to prevent water from the sink drain or food disposal from entering the dishwasher. Some dishwashers have a built-in high loop where one is not required to be configured in the drain line. The clients should try to determine if a high loop is required for this brand and model of the dishwasher (review installation instructions, etc.). If one is required, or it cannot be determined if one is not required, then a qualified contractor should install a high loop as per standard building practices. Also, no "air gap" is installed. Air gaps are another device meant to prevent water from the sink drain or food disposal from entering the dishwasher. These are required in some municipalities for new construction and when remodeling. The client(s) should consult with a qualified contractor to determine if an air gap should be installed.

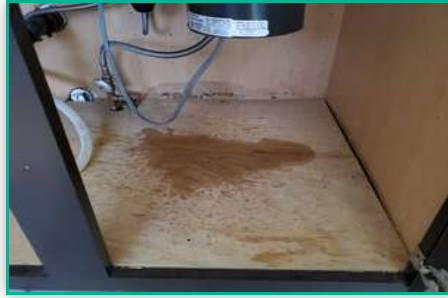
The drain under one or more kitchen sinks was leaking from the connections or other areas. We recommend that the leaks be repaired by a plumbing contractor.

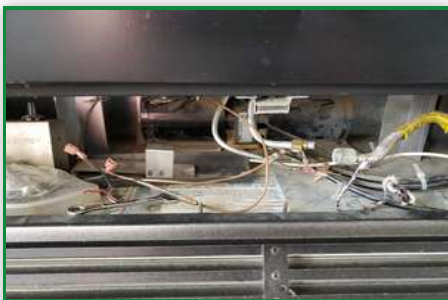
Location: LIVING ROOM

At the time inspection, the Gas Log Fireplace was not functional due to multiple disconnected fixtures and wires.

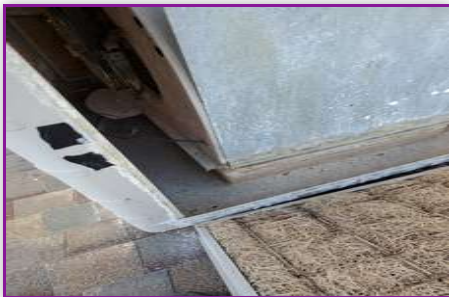
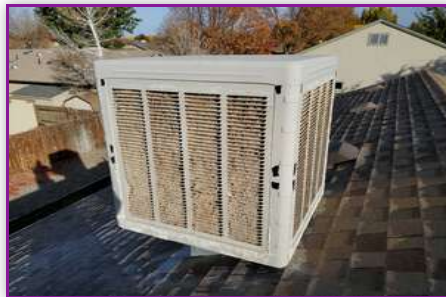
The evaporative cooler was not fully evaluated due the unit has been winterized (water off / no water in pan). We recommend that it be turned on at the least to insure that the pump and blower are working.

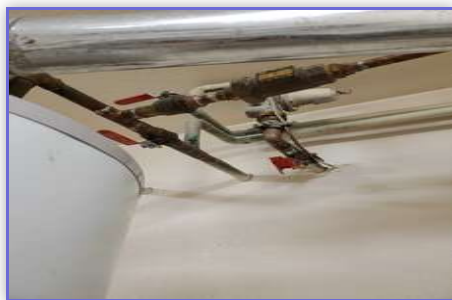
The main water shut off location is in the discription in the photo below. This is the area where you can shut off the water to your home if you need to do repairs or in an emergency.

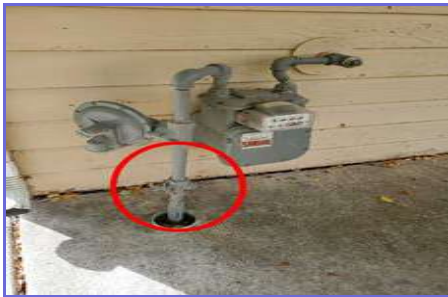
Location: NORTH SIDE OF GARAGE

The main fuel shut off is at gas meter outside. The inspector recommends hanging a small wrench on the meter in case an emergency shut off is needed.

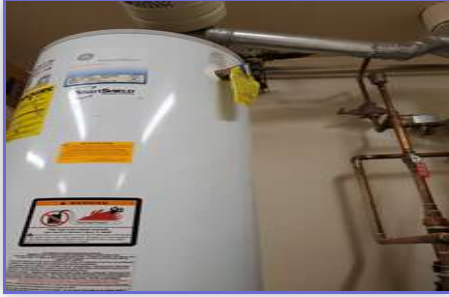
## 14.1.1 TPR valve pipe missing

At the time of inspection, there was no discharge pipe installed on TPR valve. These pipes must be either CPVC, Copper or galvanized. and must have at least 6 six inches of clearance above pan.

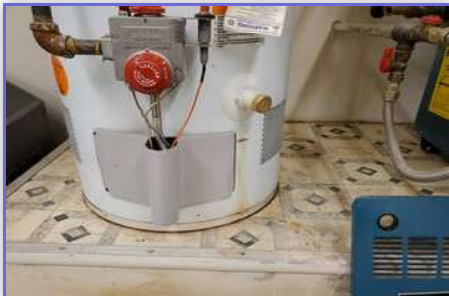
## 14.1.2 No drip pan or drain

A water heater is installed that has no catch pan and drain installed. Recommend having a qualified contractor install a catch pan and drain to prevent water damage if/when the water heater develops a leak or is drained.

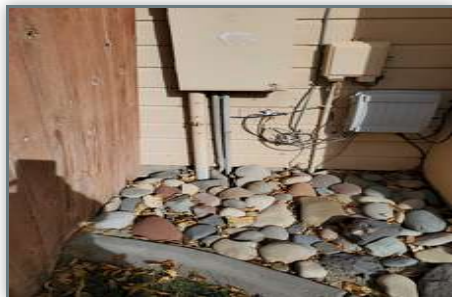
The main electrical panel location is identified in the photo s below. This is the area where you can shut off your electrical panel at the main disconnect, in case of an emergency. We also have the locations of sub panels in the home as well. All circuit breakers are much more reliable if they are exercised. Once a year you should exercise (shut them off and then turn them on) your electrical panel breakers including the main disconnect. Knowing if a circuit breaker is not functioning before a problem occurs, can be a life saving event.

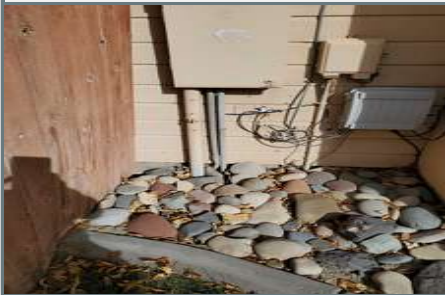
Location: NORTH

Underground service

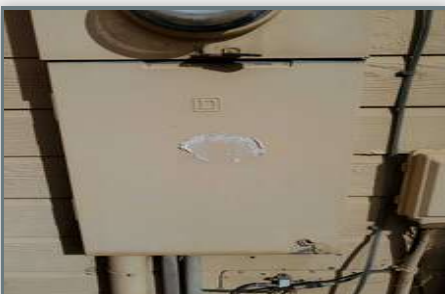
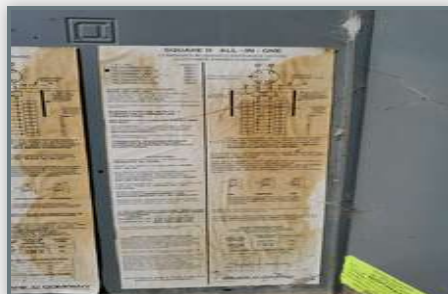
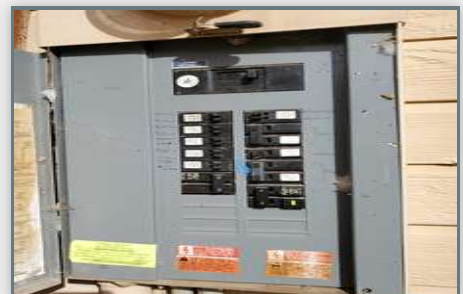
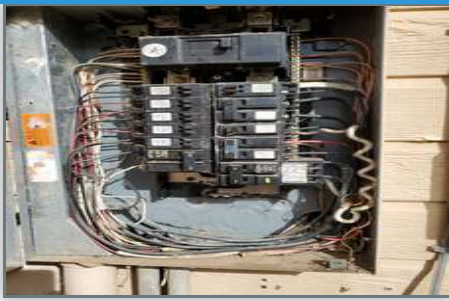
### 5.3 Service Panel Manufacturer

Square D

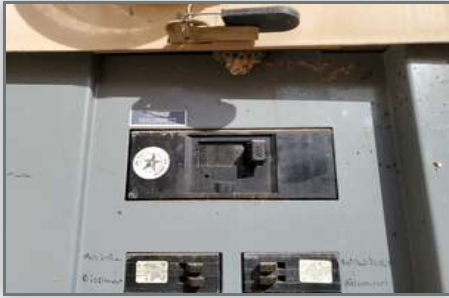
#### 5.4 Service Disconnect Location

At Service Panel

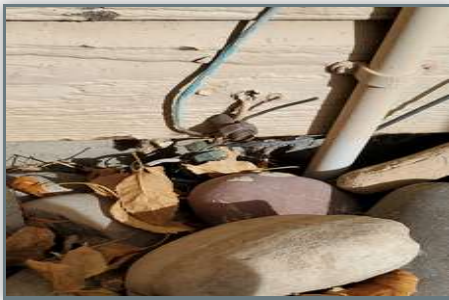
#### 5.8 Service Grounding Electrode

Driven rod

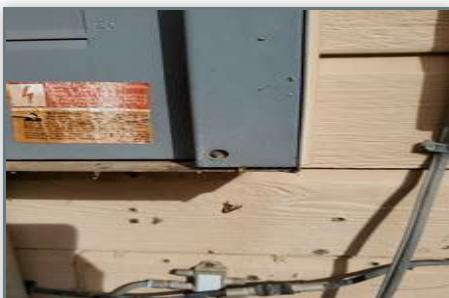
Location: SOUTH

### 5.4.1 Missing Screws

The panel cover was missing one or more screws and should be replaced with stock screws from the panel manufacturer or their equivalent.

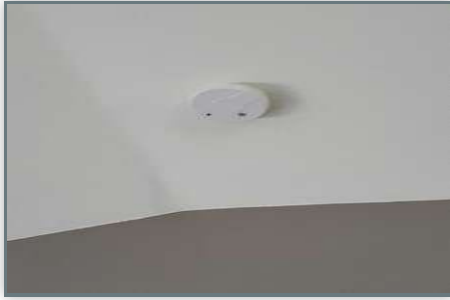
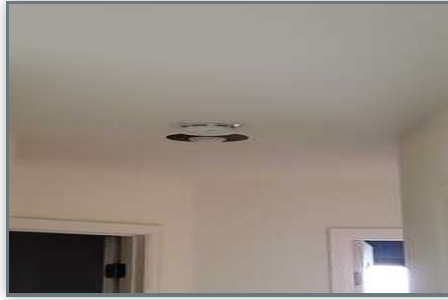
One or more smoke detectors were not hardwired / interconnected type or did not operate properly. When smoke detectors are hardwired / interconnected, all detectors will sound an alarm when just a single detector is detecting smoke. Recommend replacing any battery operated or malfunctioning smoke detectors with hardwired / interconnected type detectors.

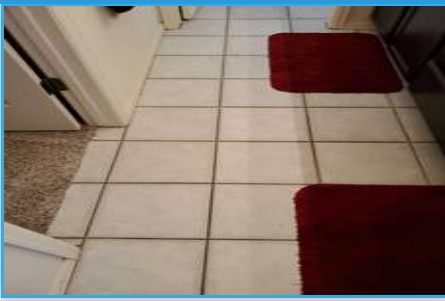
### 9.4 Floor Coverings

Tile

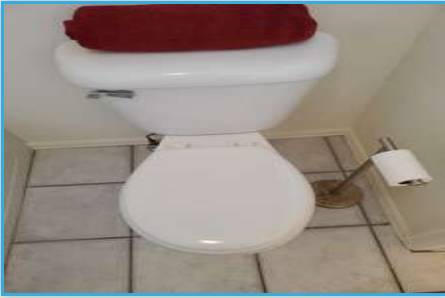
### 9.6 Toilet Type

Low-Flow

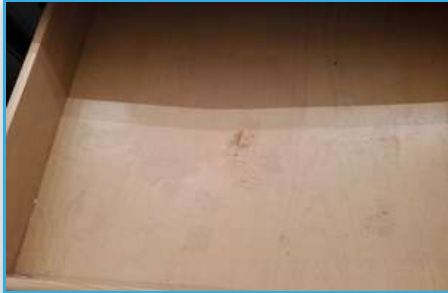
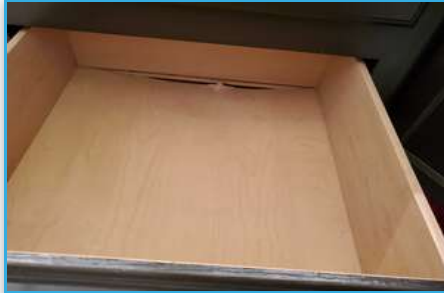
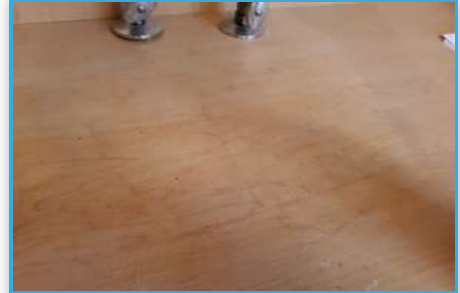
Location: MASTER BATHROOM

9.9.1 Cabinets And Counters(Multiple Defects)

1. CABINETS/DRAWERS DAMAGED

At the time of the inspection, one or more cabinets/drawers were damaged in areas. The Inspector recommends that the affected area(s) is evaluated, replaced or repaired, as needed, by a professional cabinet repair company.

2. CABINET FLOOR MINOR DAMAGE (NO MOISTURE)

At the time of the inspection, the under-sink cabinet floor in the bathroom had minor damage from past moisture that appears to have been corrected. Recommended that the damaged area is repaired as needed and monitored to minimize further damage.
