Subject: Northpoint (NP) 228<sup>th</sup> Apartments  
Unpermitted Construction Work  
Reply to Mike McCrary Letter dated October 18, 2022  
1010 – 228<sup>th</sup> Street SW, Bothell, WA  
SNOCO Code Violation Investigation Request #126404  
Ecology ERTS Investigation #717970  
DNR Permit No. 70-010402  
Snohomish County PFN: 22-102098-SPA

## 228<sup>th</sup> Multifamily Development Project Update

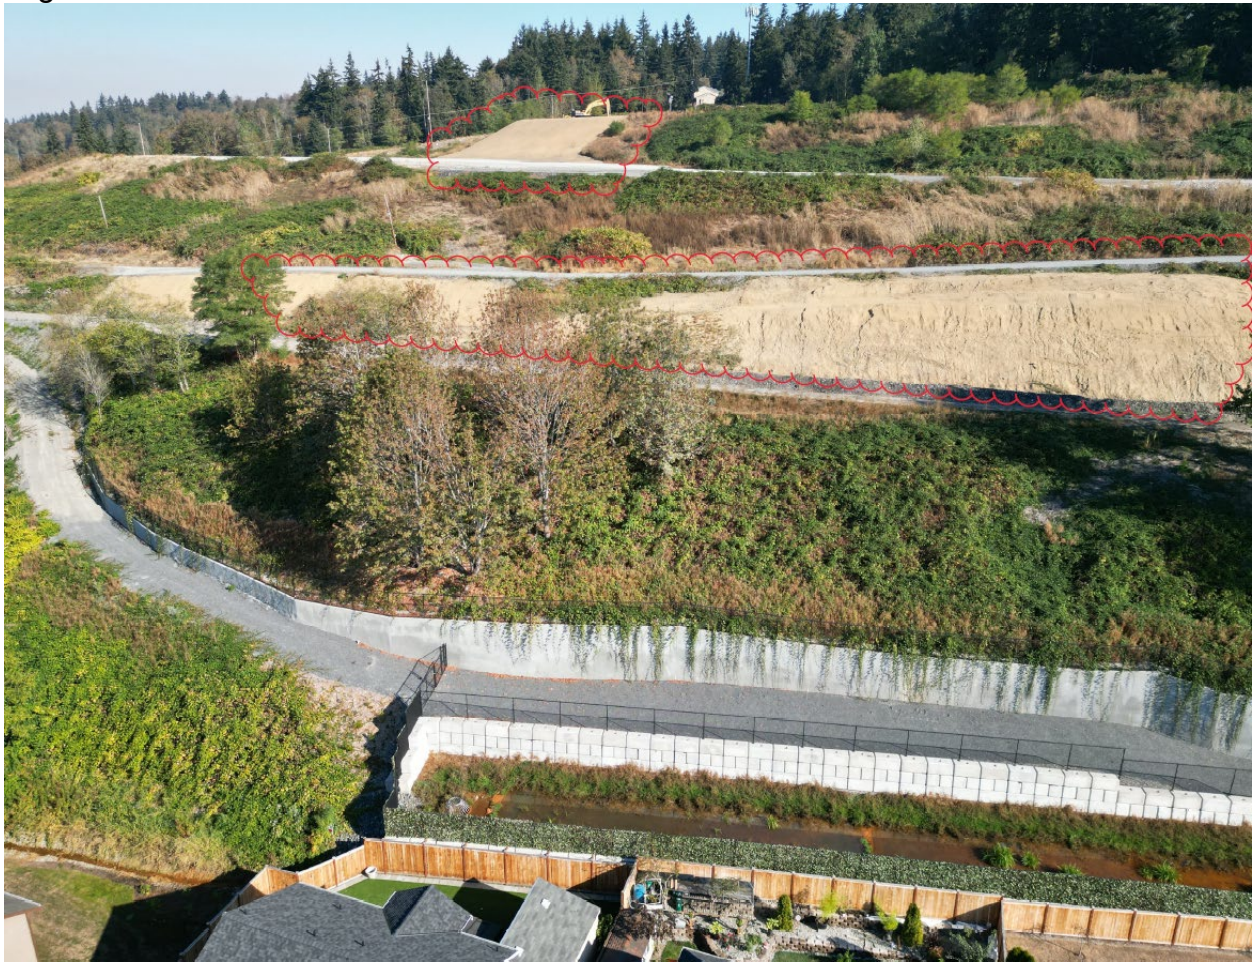
Figure 2 below shows an October 18, 2022 photo taken of illicit fill placed in previously vegetated mine reclamation area:

*Figure 2: October 18, 2022 photo of illicitly placed fill. Clouded areas show where fill placed in previously reclaimed, vegetated mine area above the failed bioretention swale. PDS required a land disturbing (LDA) permit for the swale construction, yet PDS did not require an LDA permit for excavating over 2,500 cubic yards of soil on a site with just a pending administrative site plan application (SPA) permit.*

Excavating a 2,500+ cubic yard hole in the ground, then placing the excavated fill in previously reclaimed areas is not an “insignificant deviation”. As previously stated in my other two letters referenced above regarding the illicit, unpermitted work, Northpoint must remove the unpermitted work and restore the site, prior to commencement of the 6-year development moratorium.

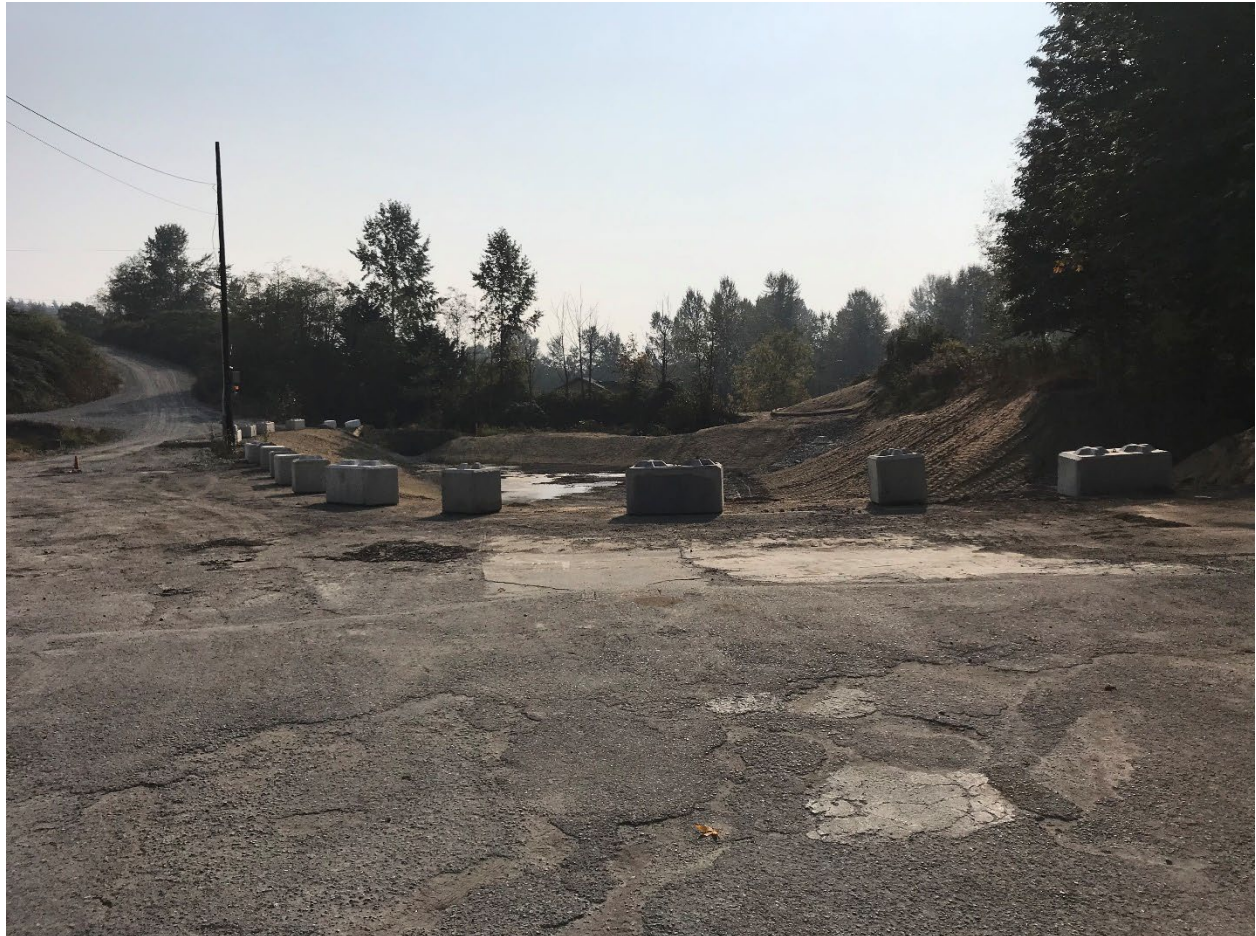
Figure 3 below shows a photograph of what is visible from this gate:

*Figure 3: October 19, 2022 photo looking over the gate from 228th Street SW. None of this work is in accordance with any design drawing submitted to the DNR, per recent public records requests. Excavated soils placed in the previously reclaimed mine area is not visible from this location.*
