Marling Farms "Beaches"

- Shoreline Erosion
- Infrastructure Deterioration
- Recent Activity
- Remediation Budgets

Objectives of this Investigation

- To document shoreline erosion issues and notable deterioration of associated structures – bulkheads, piers, stone revetments, ramps, etc.
- Seek input and recommendations from the Maryland Department of Natural Resources on code compliant remediation methods and possible grant, low or no interest loan options. Get educated on the application and feasibility of "Living Shorelines" at Marling Farms beaches.
- Conduct site visits with local marine contractors to secure recommendations and budgetary estimates for potential large ticket projects.

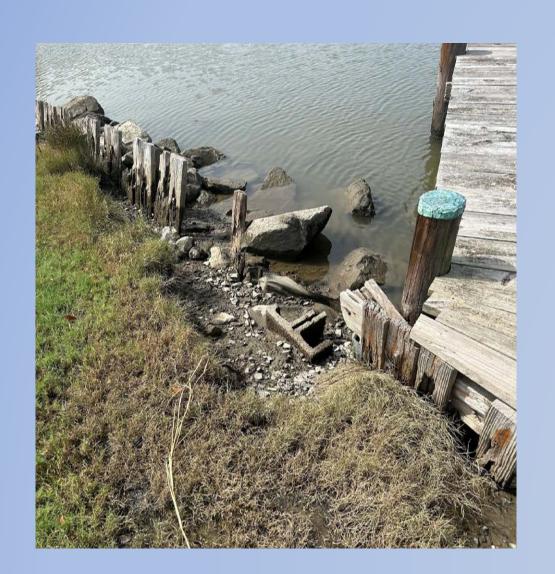
Beach 1 - Deteriorated Bulkhead

- Bulkhead totally decayed
- Sparse distribution of stone
- Considerable soil/grass erosion
- Little to no defense against wave
- Tidal flooding and rainwater runoff

- Demolish pier and bulkhead.
- Create 170 220 feet of Living Shoreline.
- Additional sand and 2000 marsh plantings.
- Demolish pier and bulkhead.
- Plant marsh grasses along existing shoreline.

DIY opportunity. (Bulkhead and pier demolition.)

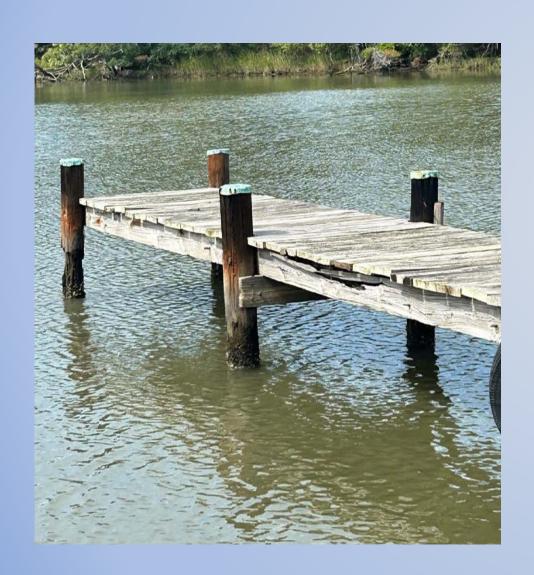
The Fishing Pier at Beach 1

- Easily accessible from mushy grass
- Structurally unsound
- Potential liability
- Who owns this pier?

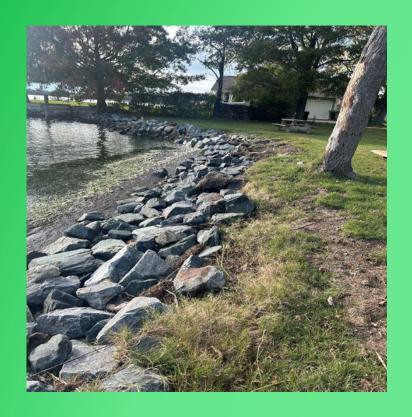
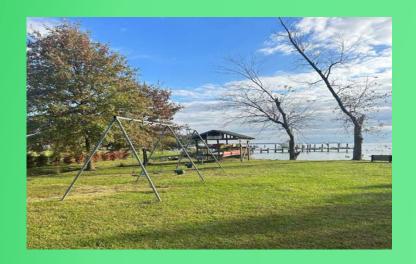
Beach 2 Status

The Beach 2 revetment can be best described as a simple "rock dump". There is no safe access across the rocks.

There is noticeable soil loss due to there being no "splash apron" behind the stone ridge.

Two trees at the revetment's edge are dead or dying and should be removed.

The kayak rack and swing set are in good shape. The picnic table (not shown) is not.

There is a seasonal mat of rotting sea lettuce. Very bad odor.

- Remove two dead and dying trees.
- Add to and re-configure existing stone.
- Create "splash apron" of flat stone or gravel.
- Safer access to beach for canoe and kayak users.

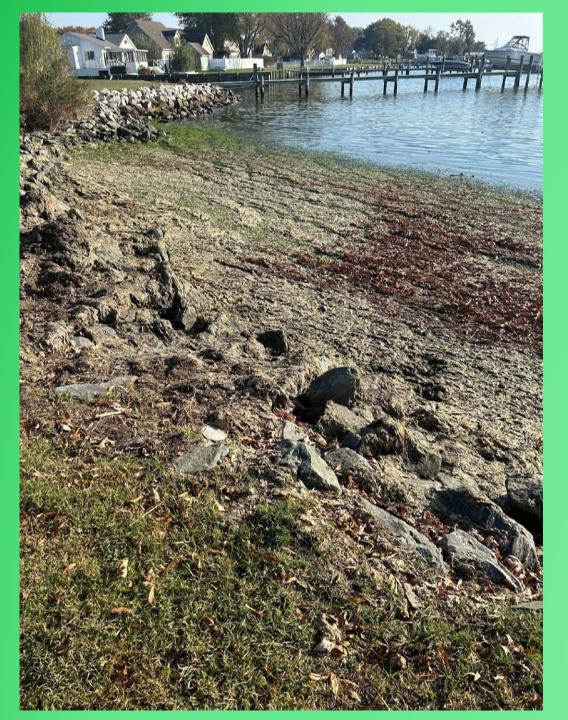
Beach 2 Rotting Sea Grass

- Expansive and thick floating mat of rotting sea grasses.
- Entire length of Beach 2.
- First noticed mid-October, lasts for several weeks.
- Extremely odiferous. (Smells like sewage run-off.)
- Environmental analyst?

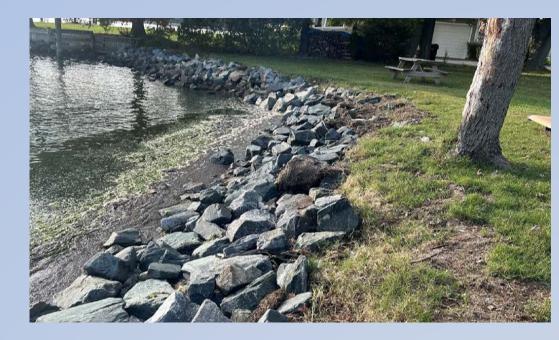
- Good candidate for Living Shoreline
- Relocate stone as starting point for "sill" construction
- Cannot disturb existing sea grass (it would)
- Place sill closer to current stone location, marsh grasses inward

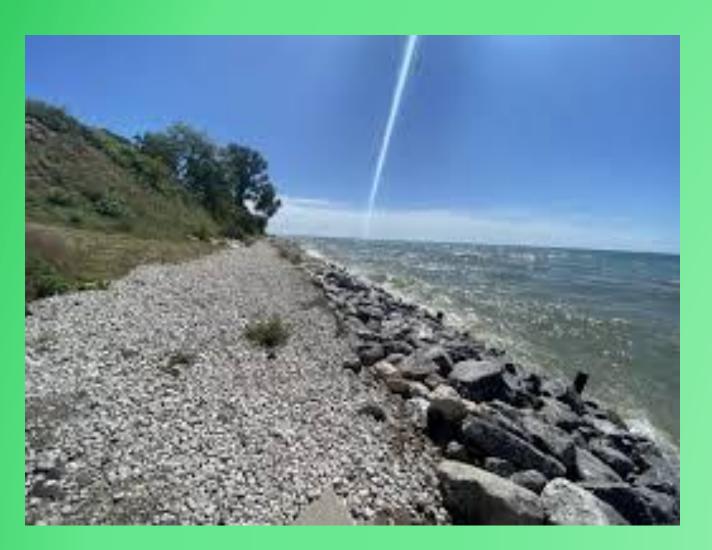
Beach 2 - Conceptual

- Add stone and reconfigure
- Create safer access to water
- Incorporate a "splash apron"
- Take down dead trees
- Add some playground equipment

Beach 2 has the potential to be a lower cost project with possibly a larger aspect of community volunteer work.

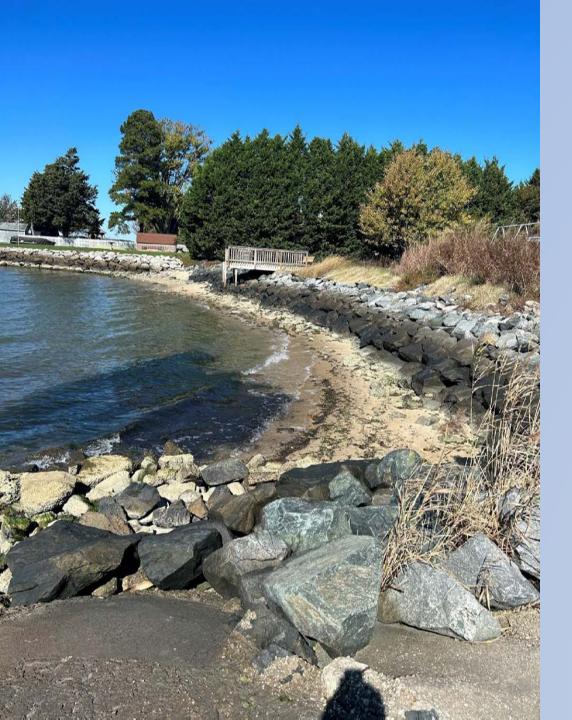
Beach 3 Issues

- Soil erosion
- Loss of beach sand
- Dangerous access
- Dilapidated observation deck
- Boat ramp deficiencies

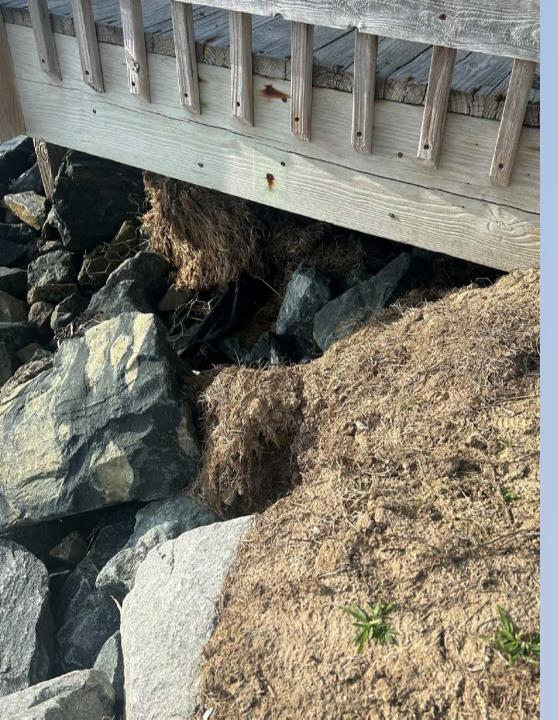
Beach 3 Stone Revetment

- Ridgeline "dips" 2 3 feet
- Extensive soil and grass erosion
- "Erosion funnel"
- Washout in front of deck
- Various large stone "roll-outs"

Demolish the observation deck.
 Repair the erosion funnel.
 Repair stone "roll-out" locations.

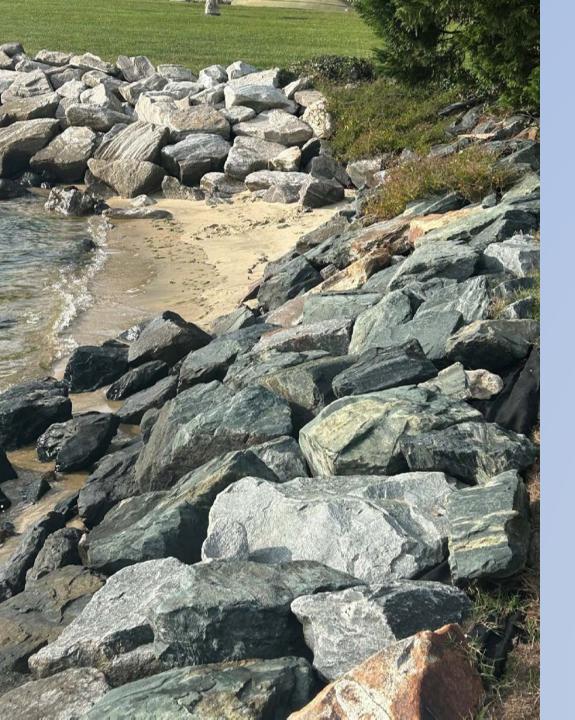
Or rather, what's left of it.

Those of you who have been around a while may recall when there were actually stairs to access Beach 3 and enough sand to spread a towel or lie in a chair as your children played.

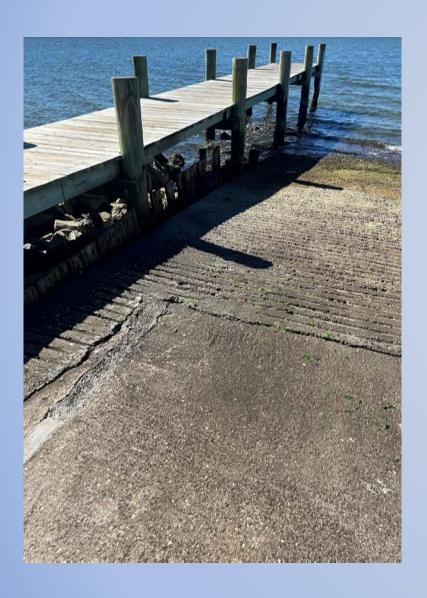
Issues

- No wave abatement
- Ramp is too flat wet axles and tailpipes
- Ideal slope of a boat ramp is 7° to 8.5°
- Too steep no traction on wet ramp
- Beach 3 ramp is at 4.8° vs. 7° minimal optimal.

- Partial demolition of the existing ramp

Extend the pier to deeper water

- Build timber breakwaters both sides of ramp

- Gravel fill to establish new grade (slope)

Install pre-cast concrete planks (interlocking)

Horizontal slab to connect ramp to parking lot

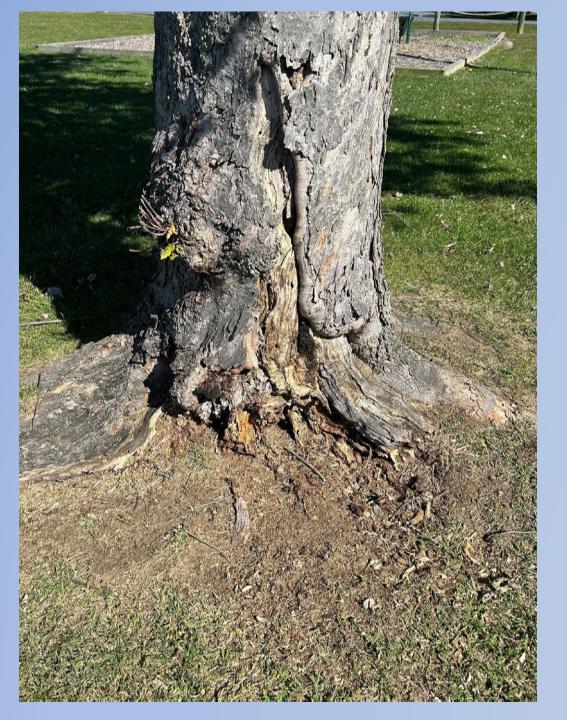
Beach 3 Tree

The tree at beach 3 is showing similar signs of distress as that seen on the two trees at Beach 2. Not as bad, but this should stay on our radar. This tree falling down unsupervised could damage the pavilion.

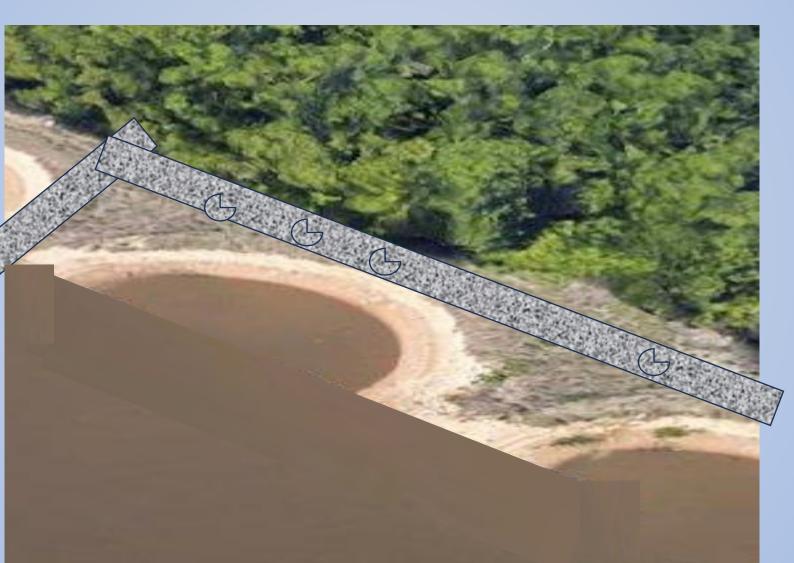
Beach 3 - Conceptual - Phase 1A

Demolish the observation deck.

Repair the revetment.

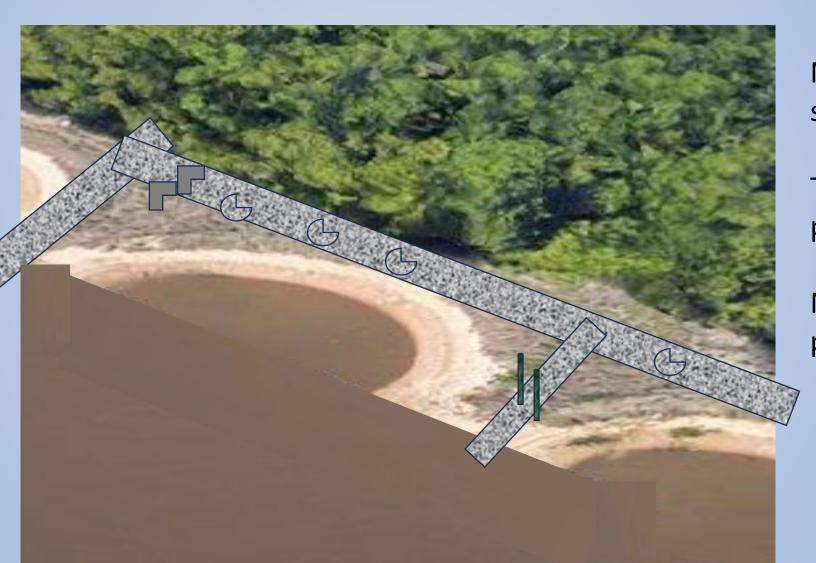
Beach 3 - Conceptual — Phase 1B

New stone steps.

Two new pilings.

New jetty perpendicular.

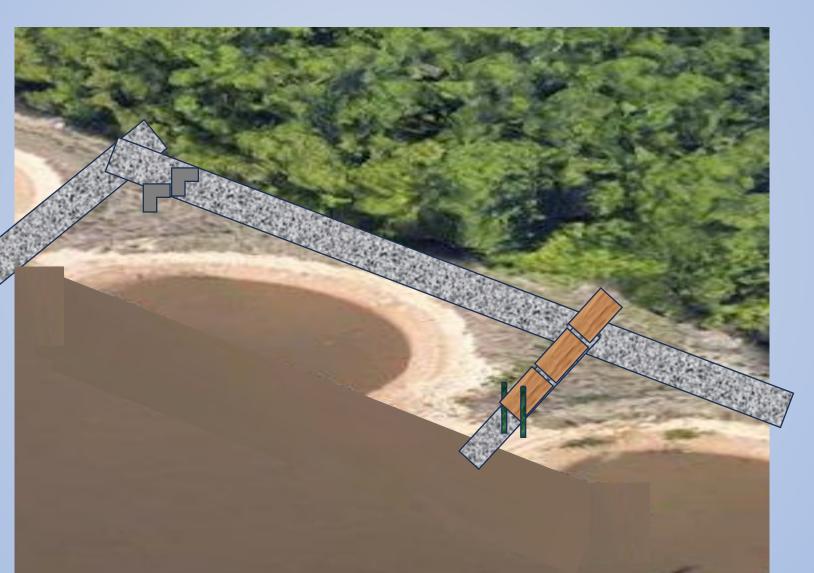
Beach 3 - Conceptual – Phase

Restore the observation deck.

(Potential DIY.)

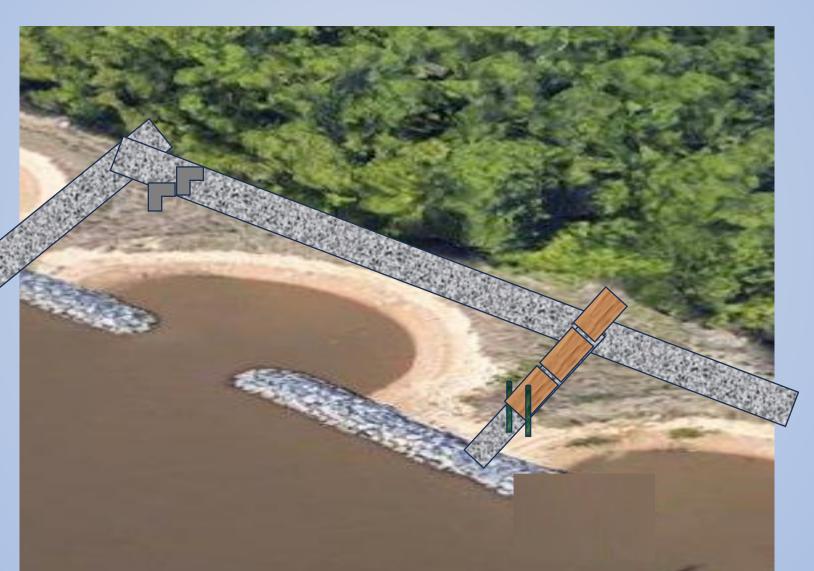
Beach 3 - Conceptual – Phase

Expand the jetty system to include legs parallel to the shore.

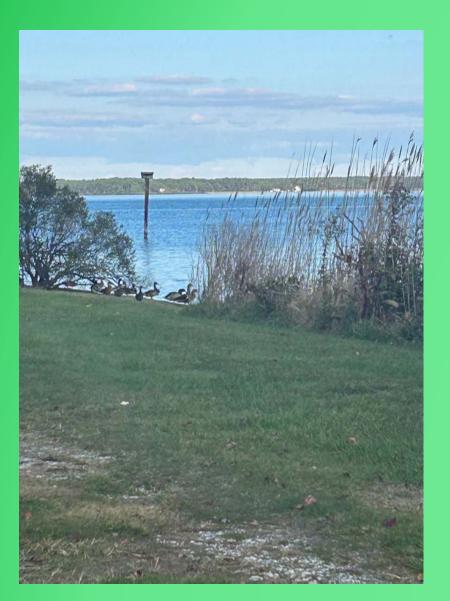
Beach 4 Status

The Beach 4 bulkhead is in good shape and does not receive as harsh a beating as do Beaches 2 and 3 when severe storms roll in. There is no serious soil erosion in this area and it already has an attractive and self-maintaining shoreline.

The kayak rack at Beach 4 is in good working order. However, the swing set, grill and picnic table area there could certainly use an upgrade at some point.
