Chorlton, Greater Manchester

Semi-Detached House In Chorlton

Upgraded semi-detached house in Chorlton, Greater Manchester

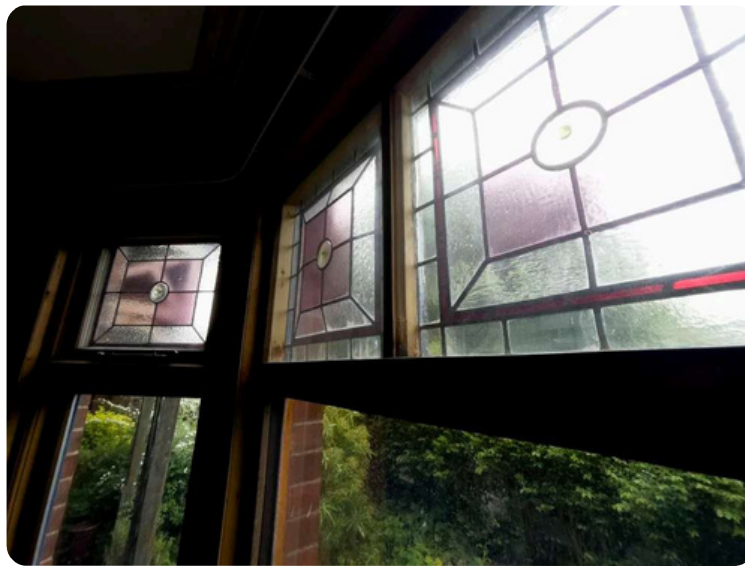
The Original Set Of Single Glazed Windows With Stained Glass Features With Double Glazing Added

- the fixed front window was replaced with a triple glazed unit held in with new hardwood beading
- the original opening casements (which were mostly rotten) were replaced with new ones that included a double glazing unit
- the stained glass feature windows had a doubled glazed unit fitted behind them
- the sash windows were refurbished, with new double glazing units and draft sealed window beads (the sash weights were increased to cope with the extra weight and pulleys and sash cords were replaced)
- on the top floor the windows were replaced with custom made triple glazed wooden windows

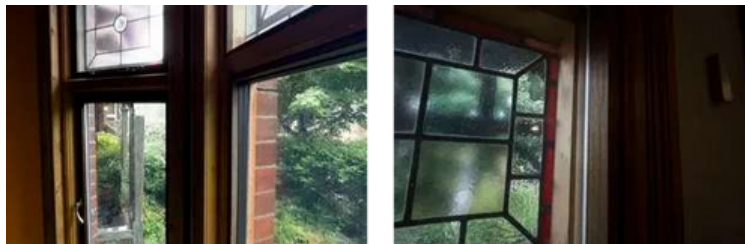
The stained glass feature windows had a doubled glazed unit fitted behind them
