Assessment of Effect of EcoShield™ on Erosion Protection

Chunyan Li and Shelley Meng

Louisiana State University

April 25, 2016

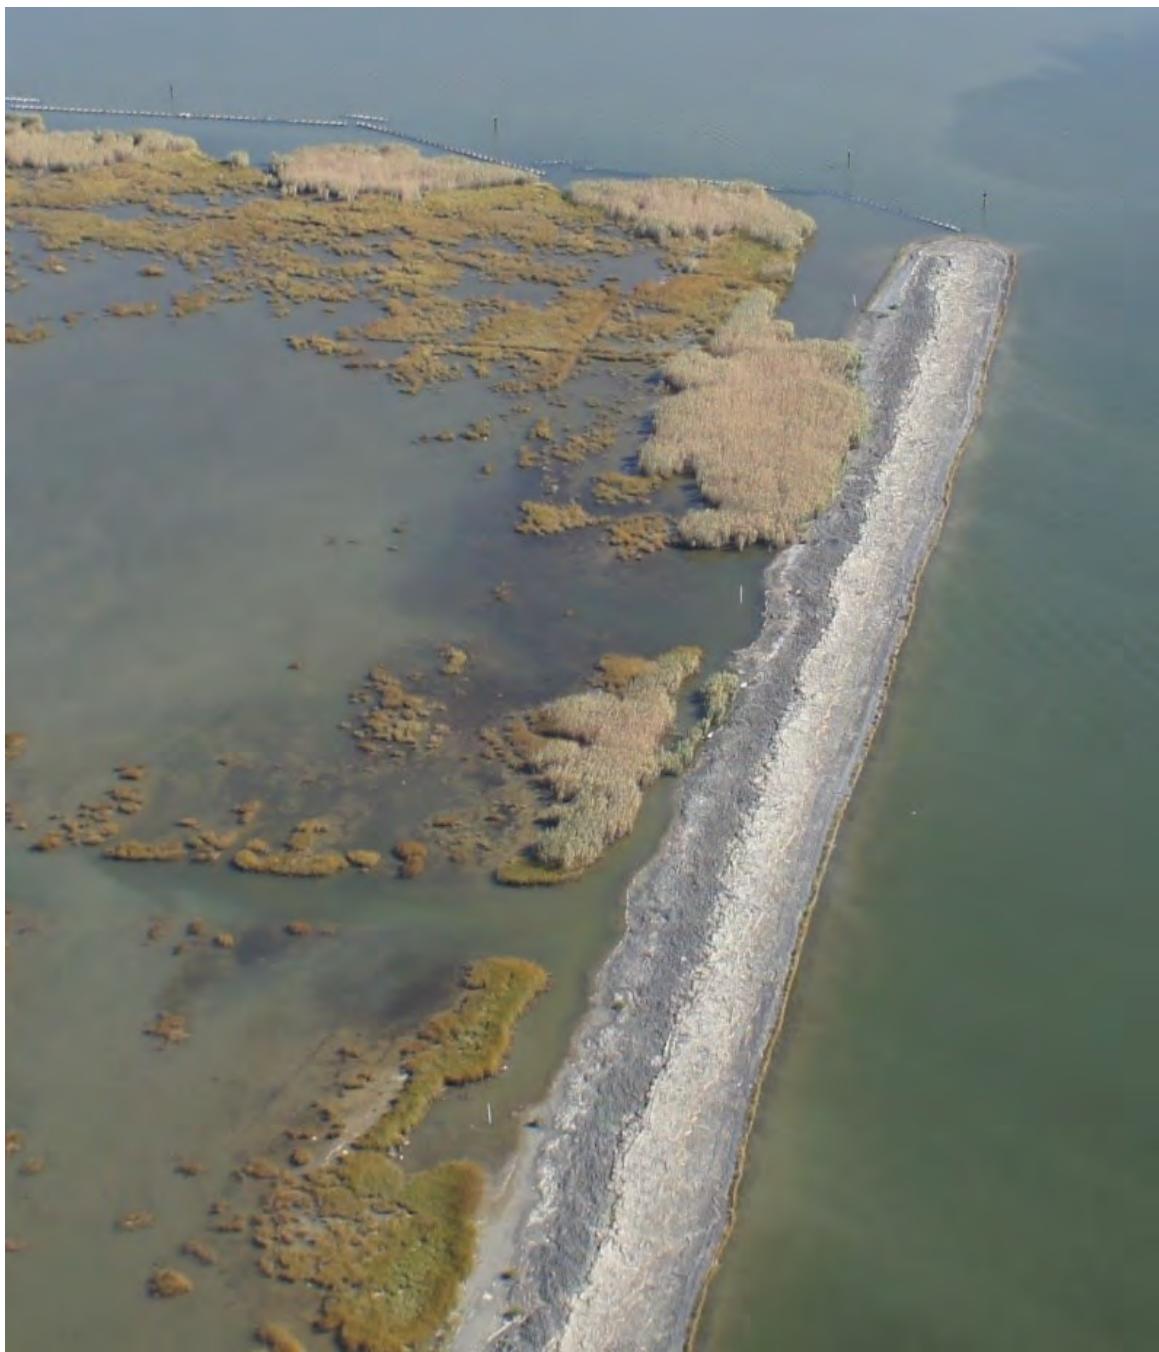
Figure 14. One of the photos from the RC airplane taken on Dec. 2, 2014.

The area is very shallow – up to ~ 8 feet deep as shown in Figures 2-3. The photos taken show the variation of the area before and after the installation of the EcoShield™. Some vegetation behind the berm can be seen over time (e.g. Figure 14, 15, 17). The later pictures from 2015 and 2016 showed extensive development of the vegetation particularly around the EcoShield™ (Figures 25-37). The installation of the EcoShield™ apparently had rooted very well that helped to keep the sediment, allowing them to grow more and spread.

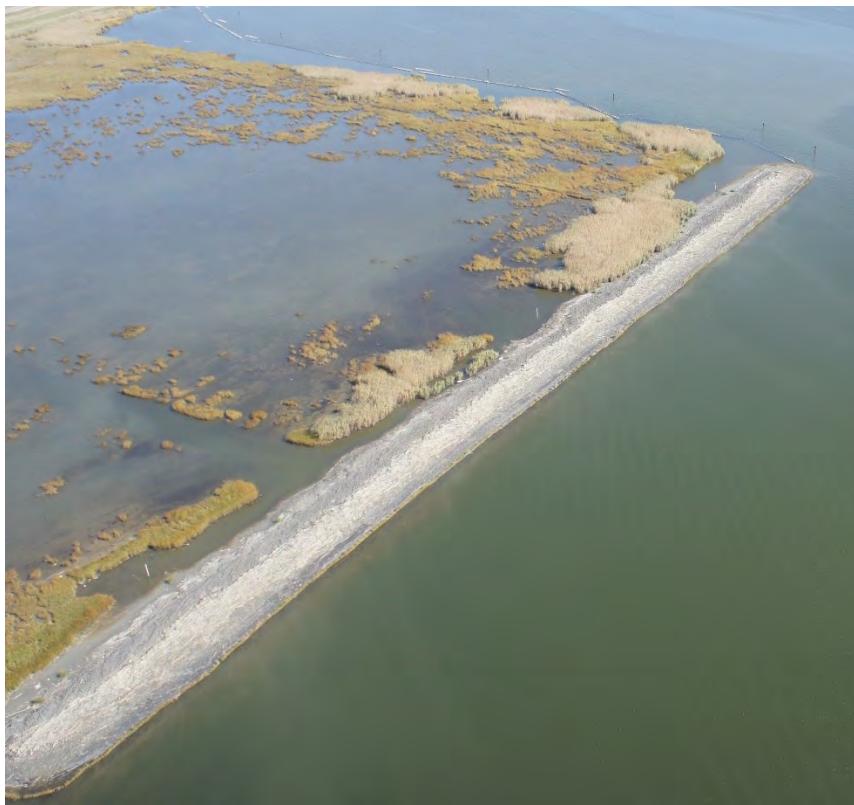
Figure 15. One of the photos from the RC airplane taken on Dec. 2, 2014.

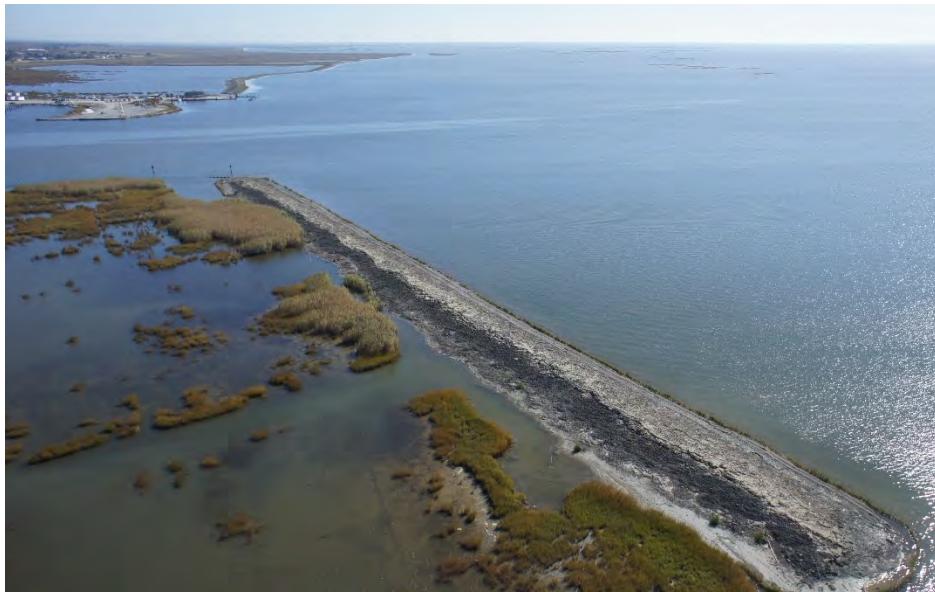
Figure 17. One of the photos from the RC airplane taken on Dec. 2, 2014.

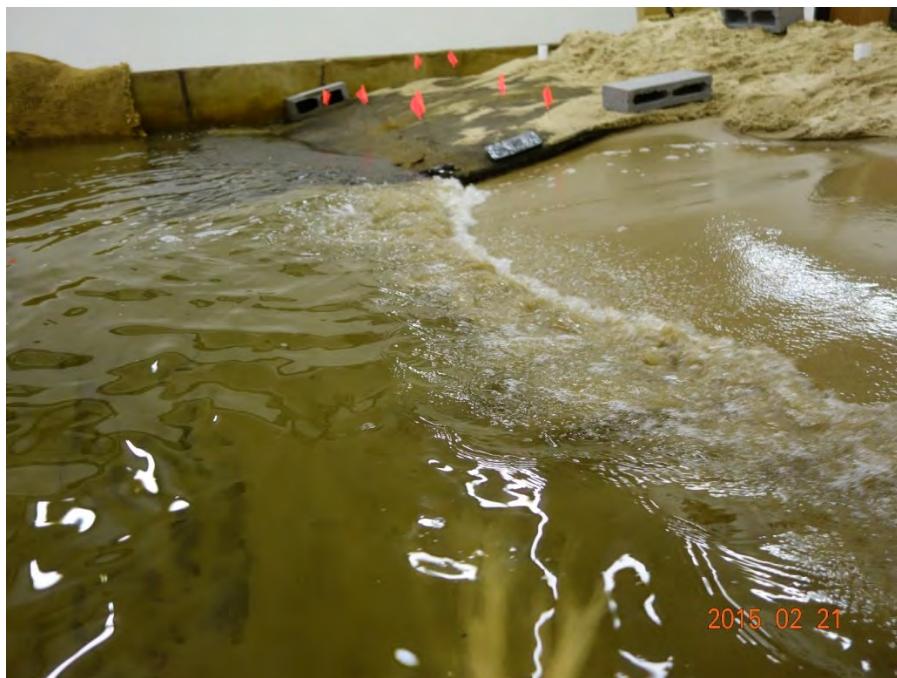
Photo 6: Showing the wave breaking in front of the bare side but wave height suppressed in front of the EcoShield™ mat.

Our first experiment has shown that (1) the side with the EcoShield™ has a significantly smaller wave height, (2) the EcoShield™ can absorb the incoming wave energy to reduce the wave breaking and reduce the impact from the waves for re-suspension; (3) the EcoShield™ provides a cover that protects the sand from the pounding waves; (4) on the side with EcoShield™, the wave run up is reduced in height; (5) the top portion under the EcoShield™ is best protected compared to the other side.

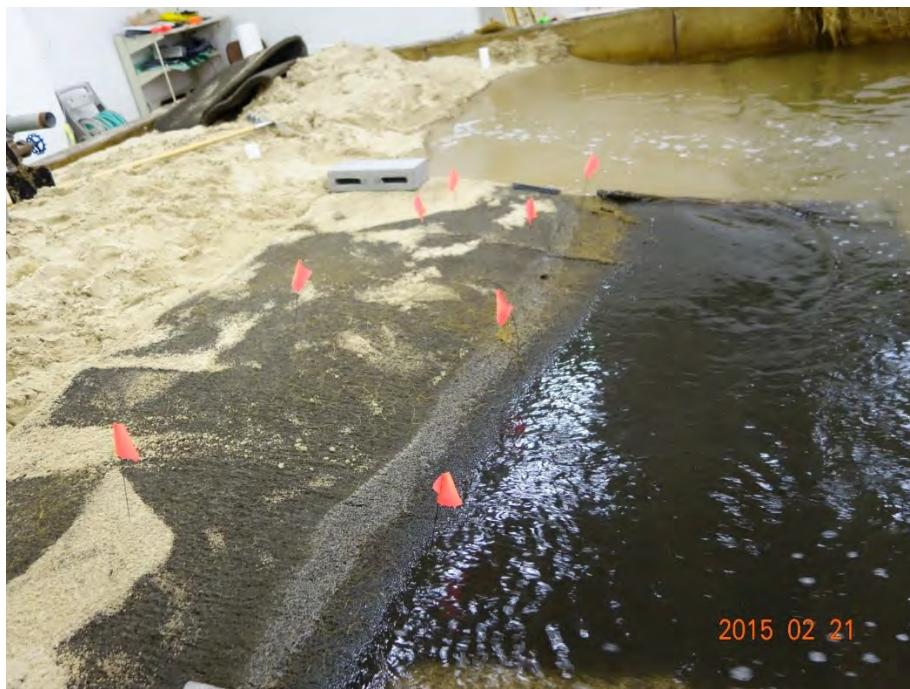
Photo 7: Showing the wave reaching further on beach in front of the bare side than that of the EcoShield™ mat.

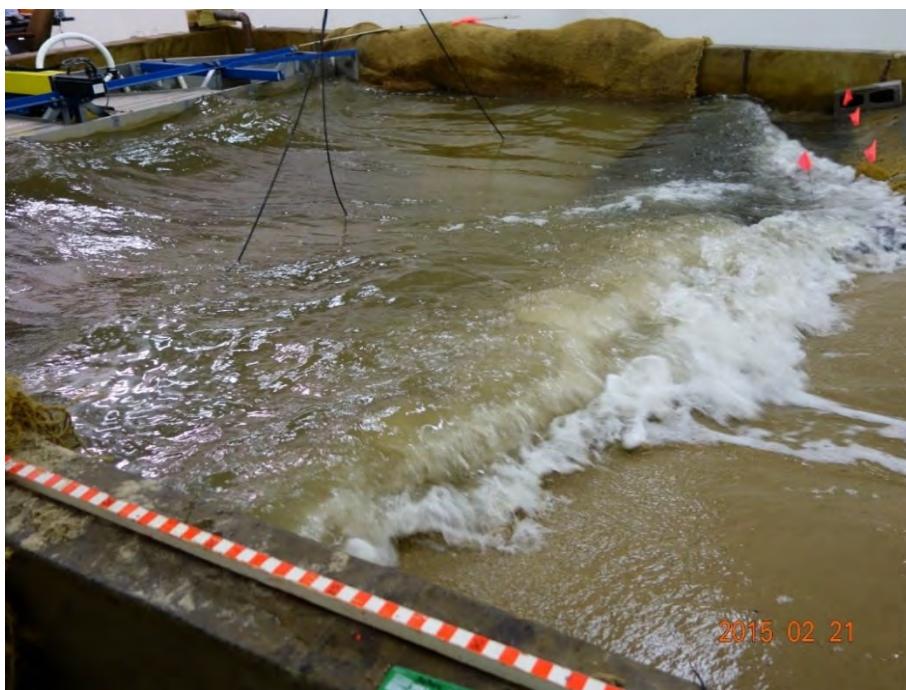
Photo 9: Showing the wave breaking in front of the bare side but wave height suppressed in front of the EcoShield™ mat.
